**MARK AND JO ROBINSON**

MILL FARM, MILL LANE, ITCHINGFIELD, HORSHAM,  
WEST SUSSEX RH13 0NP

**Preliminary Contamination Risk Assessment**

February 2026

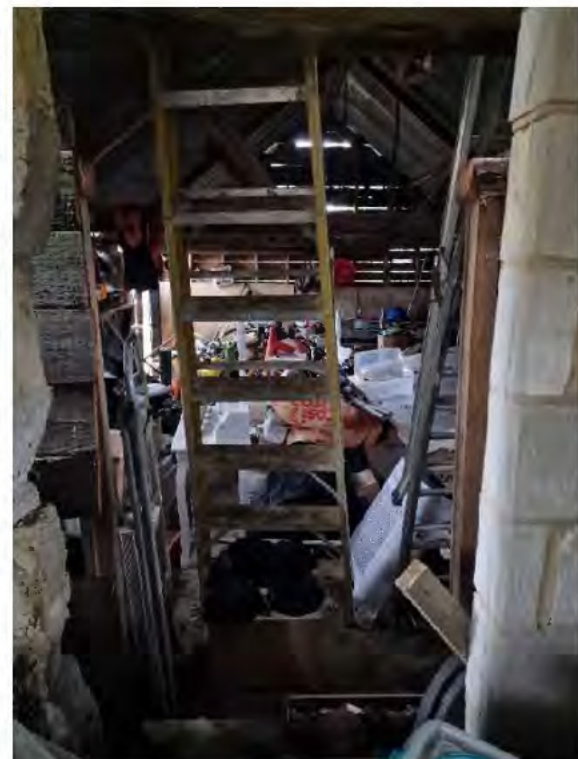
### Photographs 8 and 9:

Brick and wooden clad building with corrugated metal roof and concrete floor used to store household maintenance equipment.
