# Arboricultural Consultancy for Lloyds Bank

| Insured | Mrs Catherine McDonald-Bowyer | Address | 5 Southdown Terrace, Steyning, West Sussex, BN44 3YJ | | |
| Report Date | 11/11/2020 | | | | |

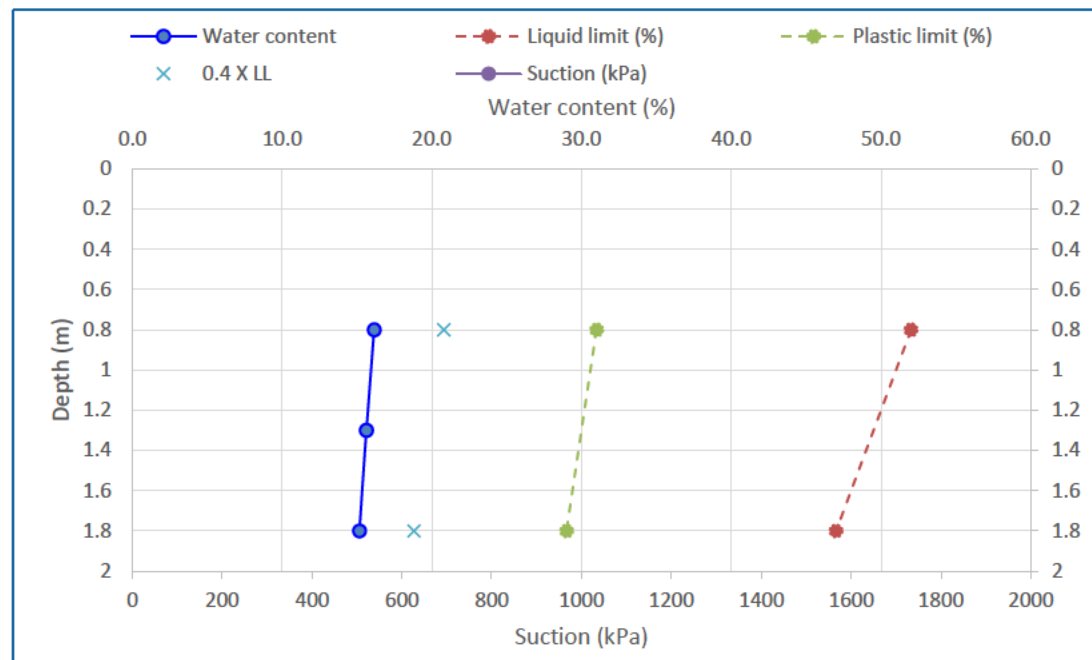
| Lab Ref | Depth (m) | MC (%) | LL (%) | PL (%) | PI (%) | .425 mm(%) | mod. PI (%) | Av. Suc. (kPa) | Description |
|---|---|---|---|---|---|---|---|---|---|
| 2 | 1.3 | 15.6 | | | | | | | Stiff light grey SILT |
| 3 | 1.8 | 15.2 | 47 | 29 | 18 | 100 | 18 | | Stiff light grey SILT |

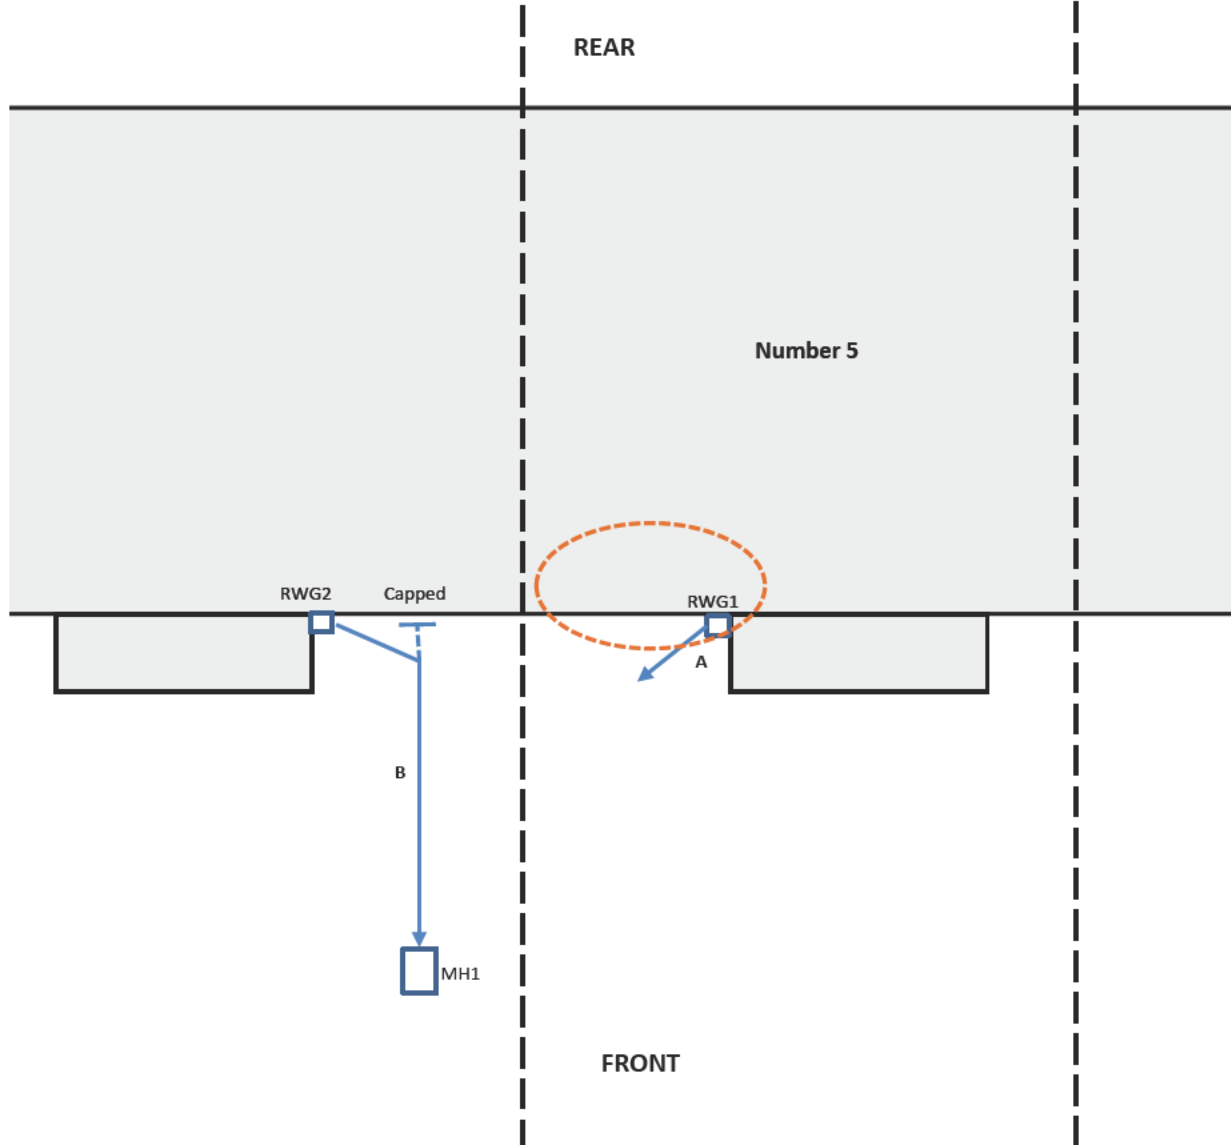
**CCTV Survey Result:** No structural damage but discharges into ground (possible catch-pit or soakaway) close to property

- 1) To excavate and replace existing gully including 1m of adjacent pipework.
- 2) To carry out a further look-see CCTV survey and report findings as to where the line discharges.
