**MANAGEMENT SURVEY FOR ASBESTOS-CONTAINING MATERIALS**

**SRP1121-EEG-XX-XX-T-O-0301-AsbestosManagementSurveyReport-ShootingField**

**CLIENT:** Arcadis UK (London)

**SITE:** Steyning Grammar School, Upper School, Shooting Field, Steyning, BN44 3RX

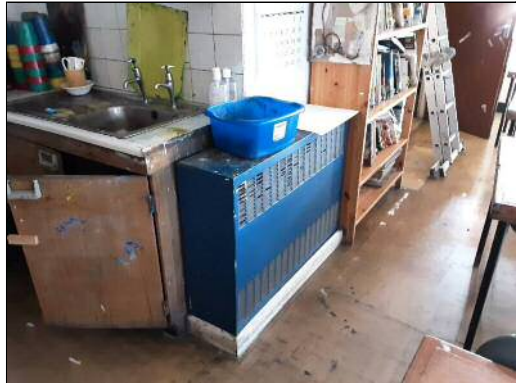
| Assessment details | | | | Comments | Photograph |
|---|---|---|---|---|---|
| Assessment no. | 0002 | Accessibility | | | |

| Assessment details | | | | Comments | Photograph |
|---|---|---|---|---|---|
| Building | Block EFAE | Floor/ room | Ground Floor / Room 301 | No access to heaters - live services | |

| Assessment details | | | | Comments | Photograph |
|---|---|---|---|---|---|
| Action | Inspect Prior to Disturbance | | | | |

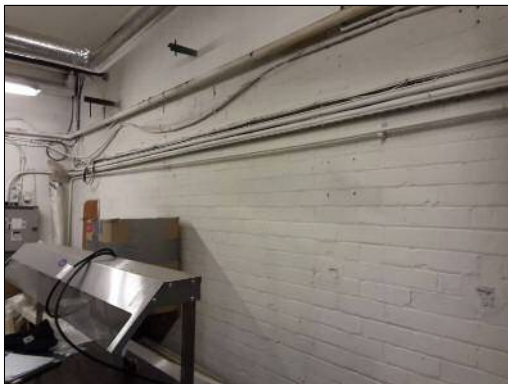
| Assessment details | | | | Comments | |
|---|---|---|---|---|---|
| Assessment no. | 0009 | Accessibility | Occasionally likely to be disturbed | | |

| Building | Floor/<br>Room | Assessment<br>Number | Location/<br>position | Product<br>type | Surface<br>treatment | Condition | Extent | Accessibility | Level of<br>identification | Asbestos<br>type | Material<br>risk | Priority<br>risk | Action |
|---|---|---|---|---|---|---|---|---|---|---|---|---|---|
| Block EFAA | Basement 1 /<br>450 Boiler room | 0009 | Thermal insulation<br>residue to right<br>wall | Hard Set<br>Lagging | Surface<br>Sealed | Good<br>Condition | 24m <sup>2</sup> | Occasionally<br>likely to be<br>disturbed | Identified | Chrysotile +<br>Amosite | ( 6 ) Low | - | Manage |

| Assessment details | | | | Comments | |
|---|---|---|---|---|---|
| Building | Block EFAA | Floor/ room | Basement 1 / 450 Boiler room | | |

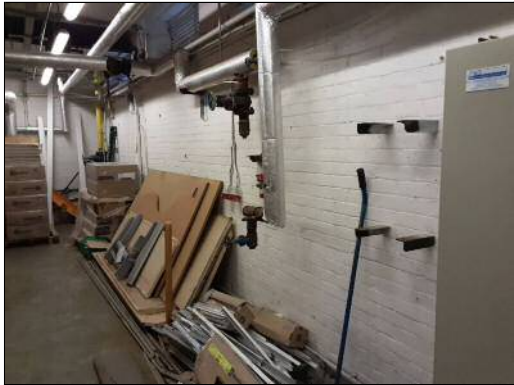
| Assessment details | | | | Comments | <div>Photograph</div> |
|---|---|---|---|---|---|
| Assessment no. | 0014 | Accessibility | Occasionally likely to be disturbed | | |

| Building | Floor/<br>Room | Assessment<br>Number | Location/<br>position | Product<br>type | Surface<br>treatment | Condition | Extent | Accessibility | Level of<br>identification | Asbestos<br>type | Material<br>risk | Priority<br>risk | Action |
|---|---|---|---|---|---|---|---|---|---|---|---|---|---|
| Block EFAA | Basement 1 /<br>450 Boiler room | 0014 | Thermal insulation<br>residue to front<br>wall | Hard Set<br>Lagging | Surface<br>Sealed | Good<br>Condition | 40m <sup>2</sup> | Occasionally<br>likely to be<br>disturbed | Identified | Amosite | ( 6 ) Low | - | Manage |

| Assessment details | | | | Comments | <div>Photograph</div> |
|---|---|---|---|---|---|
| Building | Block EFAA | Floor/ room | Basement 1 / 450 Boiler room | | |

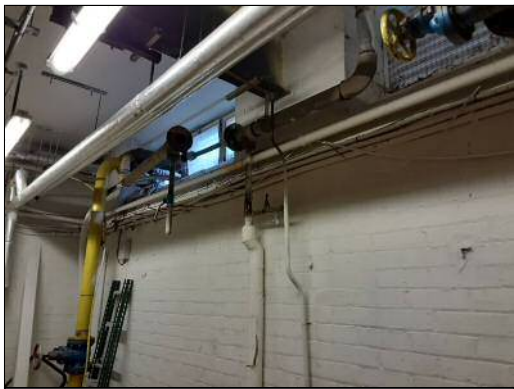
| Assessment details | | | | Comments | Photograph |
|---|---|---|---|---|---|
| Assessment no. | 0015 | Accessibility | | | |

| Assessment details | | | | Comments | Photograph |
|---|---|---|---|---|---|
| Building | Block EFAA | Floor/ room | Basement 1 / 450 Boiler room | No access to electrics including cabling - live services | |

| Assessment details | | | | Comments | Photograph |
|---|---|---|---|---|---|
| Action | Inspect Prior to Disturbance | | | | |

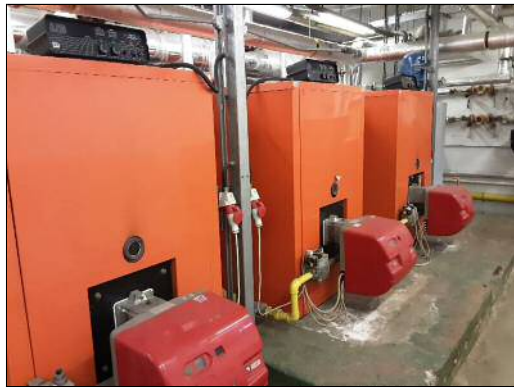
| Assessment details | | | | Comments | Photograph |
|---|---|---|---|---|---|
| Assessment no. | 0016 | Accessibility | | | |

| Assessment details | | | | Comments | Photograph |
|---|---|---|---|---|---|
| Building | Block EFAA | Floor/ room | Basement 1 / 450 Boiler room | No access to boilers - live services | |

| Assessment details | | | | Comments | Photograph |
|---|---|---|---|---|---|
| Action | Inspect Prior to Disturbance | | | | |

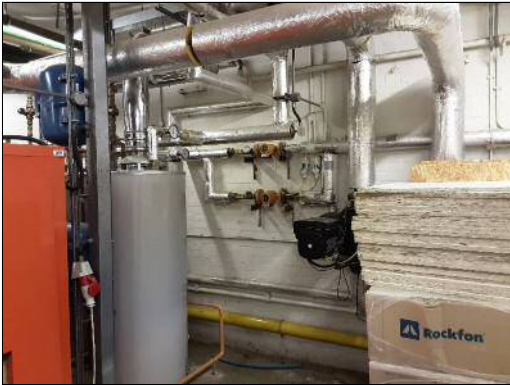
| Assessment details | | | | Comments | |
|---|---|---|---|---|---|
| Assessment no. | 0017 | Accessibility | Occasionally likely to be disturbed | | |

| Building | Floor/<br>Room | Assessment<br>Number | Location/<br>position | Product<br>type | Surface<br>treatment | Condition | Extent | Accessibility | Level of<br>identification | Asbestos<br>type | Material<br>risk | Priority<br>risk | Action |
|---|---|---|---|---|---|---|---|---|---|---|---|---|---|
| Block EFAA | Basement 1 /<br>450 Boiler room | 0017 | Thermal insulation<br>residue to left<br>wall | Hard Set<br>Lagging | Surface<br>Sealed | Good<br>Condition | 24m <sup>2</sup> | Occasionally<br>likely to be<br>disturbed | Identified | Chrysotile +<br>Amosite | ( 6 ) Low | - | Manage |

| Assessment details | | | | Comments | |
|---|---|---|---|---|---|
| Building | Block EFAA | Floor/ room | Basement 1 / 450 Boiler room | | |
| Material risk | Low | Material risk score | 6 | | |

| Assessment details | | | | Comments | |
|---|---|---|---|---|---|
| Action | Manage | | | | |

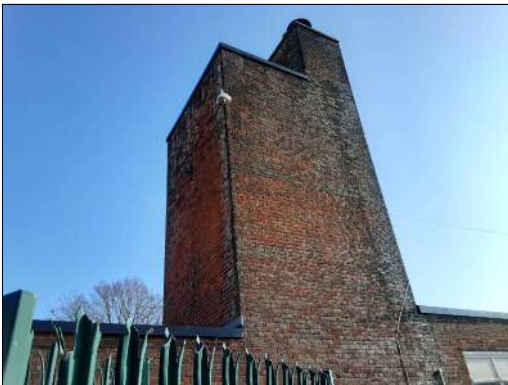
| Assessment details | | | | Comments | Photograph |
|---|---|---|---|---|---|
| Assessment no. | 0020 | Accessibility | | | |

| Assessment details | | | | Comments | Photograph |
|---|---|---|---|---|---|
| Building | Block EFAA | Floor/ room | External / Boiler room externals | No access to chimney - confined space, no viable access | |

| Assessment details | | | | Comments | Photograph |
|---|---|---|---|---|---|
| Action | Inspect Prior to Disturbance | | | | |

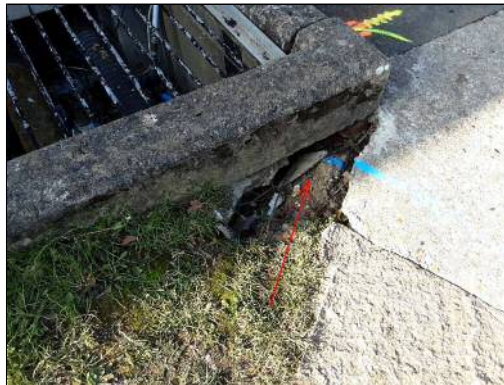
| Assessment details | | | | Comments | |
|---|---|---|---|---|---|
| Assessment no. | 0023 | Accessibility | Easily disturbed | | |

| Building | Floor/<br>Room | Assessment<br>Number | Location/<br>position | Product<br>type | Surface<br>treatment | Condition | Extent | Accessibility | Level of<br>identification | Asbestos<br>type | Material<br>risk | Priority<br>risk | Action |
|---|---|---|---|---|---|---|---|---|---|---|---|---|---|
| Block<br>EFAA | External /<br>Boiler room<br>externals | 0023 | Cement loose<br>panels to floor | Cement | Surface<br>Sealed | Medium<br>Damage | 2no. | Easily<br>disturbed | Identified | Chrysotile | ( 5 ) Low | - | Remove |

| Assessment details | | | | Comments | |
|---|---|---|---|---|---|
| Building | Block EFAA | Floor/ room | External / Boiler room externals | | |

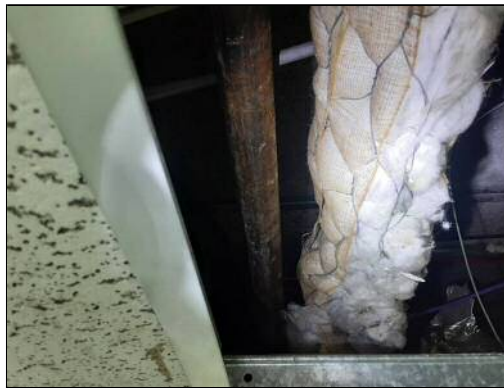
| Assessment details | | | | Comments | Photograph |
|---|---|---|---|---|---|
| Assessment no. | 0024 | Accessibility | | | |

| Assessment details | | | | Comments | Photograph |
|---|---|---|---|---|---|
| Building | Block EFAD | Floor/ room | Ground Floor / Corridor 1 | Presumed to be on all lagging | |

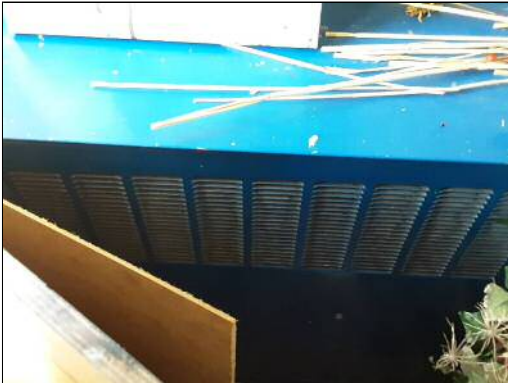
| Assessment details | | | | Comments | Photograph |
|---|---|---|---|---|---|
| Assessment no. | 0029 | Accessibility | | | |

| Assessment details | | | | Comments | Photograph |
|---|---|---|---|---|---|
| Building | Block EFAE | Floor/ room | Ground Floor / Room 303 | No access to heaters - live services | |

| Assessment details | | | | Comments | Photograph |
|---|---|---|---|---|---|
| Action | Inspect Prior to Disturbance | | | | |

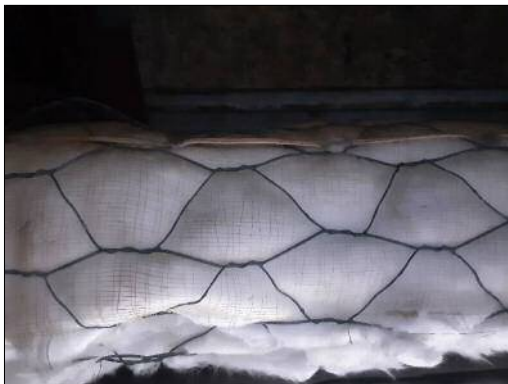
| Assessment details | | | | Comments | Photograph |
|---|---|---|---|---|---|
| Assessment no. | 0033 | Accessibility | | | |

| Assessment details | | | | Comments | Photograph |
|---|---|---|---|---|---|
| Building | Block EFAD | Floor/ room | Ground Floor / G.03 room 227 | Presumed to be on all lagging above ceiling and in risers | |

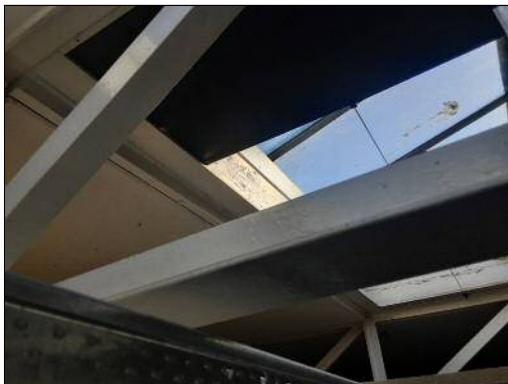
| Assessment details | | | | Comments | Photograph |
|---|---|---|---|---|---|
| Assessment no. | 0041 | Accessibility | | | |

| Assessment details | | | | Comments | Photograph |
|---|---|---|---|---|---|
| Building | Block EFAD | Floor/ room | Ground Floor / G.05 room 225 | No access to skylight - above suspended ceiling | |

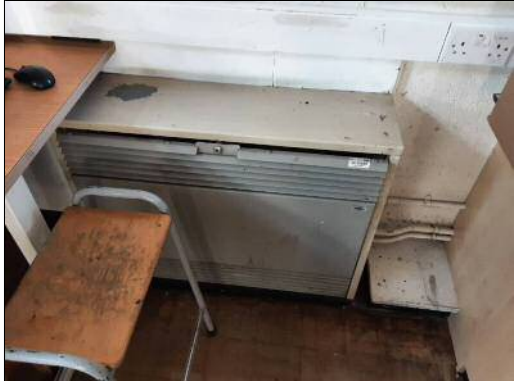
| Assessment details | | | | Comments | Photograph |
|---|---|---|---|---|---|
| Assessment no. | 0042 | Accessibility | | | |

| Assessment details | | | | Comments | Photograph |
|---|---|---|---|---|---|
| Building | Block EFAE | Floor/ room | Ground Floor / Room 304 | No access to heaters - live services | |
| Identification | Inaccessible (Presumed) | Condition | n/a | | |

| Assessment details | | | | Comments | Photograph |
|---|---|---|---|---|---|
| Action | Inspect Prior to Disturbance | | | | |

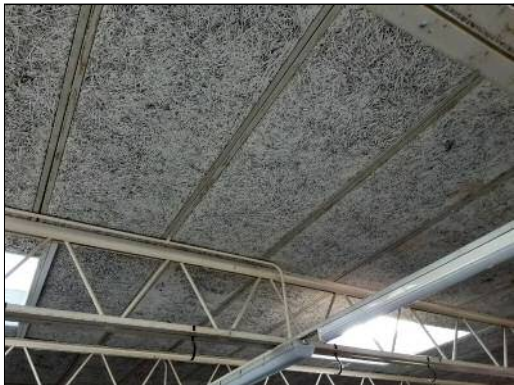
| Assessment details | | | | Comments | Photograph |
|---|---|---|---|---|---|
| Assessment no. | 0045 | Accessibility | | | |

| Assessment details | | | | Comments | Photograph |
|---|---|---|---|---|---|
| Building | Block EFAE | Floor/ room | Ground Floor / Room 304 | Also in cupboards | |

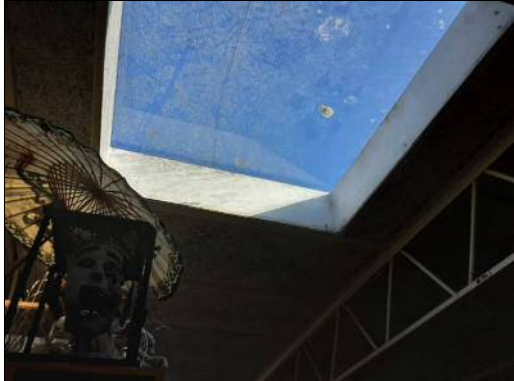
| Assessment details | | | | Comments | Photograph |
|---|---|---|---|---|---|
| Assessment no. | 0047 | Accessibility | Usually inaccessible or unlikely to be disturbed | | |

| Assessment details | | | | Comments | Photograph |
|---|---|---|---|---|---|
| Building | Block EFAE | Floor/ room | Ground Floor / Room 304 | 6 skylights | |
| Identification | Presumed | Condition | Good Condition | | |

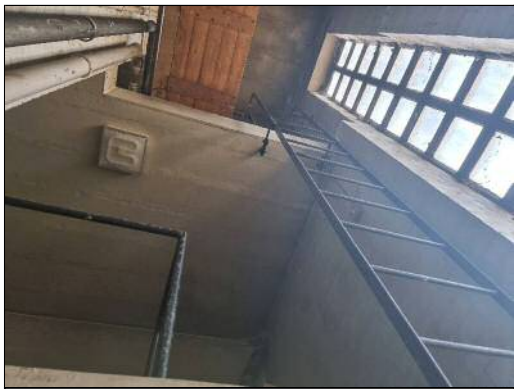
| Assessment details | | | | Comments | Photograph |
|---|---|---|---|---|---|
| Building | Block EFAA | Floor/ room | Ground Floor / Water tank tower | No access to upper levels (2nd & 3rd) - fixed ladder has no fall protection or harness attachments | |
| Identification | Inaccessible (Presumed) | Condition | n/a | | |

| Assessment details | | | | Comments | Photograph |
|---|---|---|---|---|---|
| Action | Inspect Prior to Disturbance | | | | |

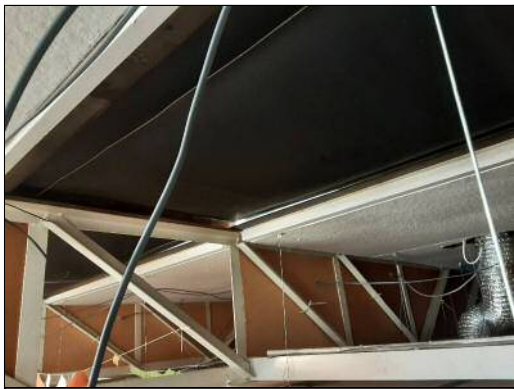
| Assessment details | | | | Comments | Photograph |
|---|---|---|---|---|---|
| Assessment no. | 0050 | Accessibility | | | |

| Assessment details | | | | Comments | Photograph |
|---|---|---|---|---|---|
| Building | Block EFAD | Floor/ room | Ground Floor / G.06 room 223 | No access to skylight - above plastic sheeting above suspended ceiling | |
| Identification | Inaccessible (Presumed) | Condition | n/a | | |

| Assessment details | | | | Comments | Photograph |
|---|---|---|---|---|---|
| Action | Inspect Prior to Disturbance | | | | |

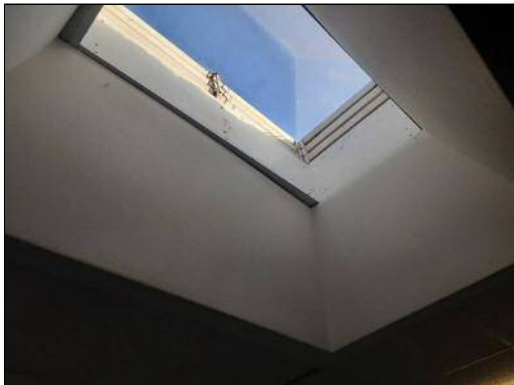
| Assessment details | | | | Comments | Photograph |
|---|---|---|---|---|---|
| Assessment no. | 0054 | Accessibility | Usually inaccessible or unlikely to be disturbed | | |

| Assessment details | | | | Comments | Photograph |
|---|---|---|---|---|---|
| Building | Block EFAD | Floor/ room | Ground Floor / Corridor 2 | 5 no at 2m2 each | |
| Identification | Identified | Condition | Good Condition | | |

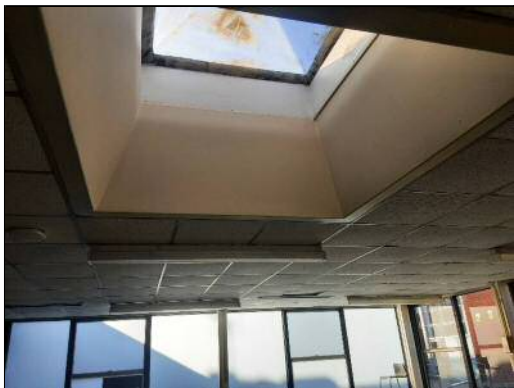
| Assessment details | | | | Comments | Photograph |
|---|---|---|---|---|---|
| Assessment no. | 0059 | Accessibility | Usually inaccessible or unlikely to be disturbed | | |

| Assessment details | | | | Comments | Photograph |
|---|---|---|---|---|---|
| Building | Block EFAD | Floor/ room | Ground Floor / G.08 room 222 | 3 no at 2m2 each | |
| Identification | Strongly Presumed (054) | Condition | Good Condition | | |

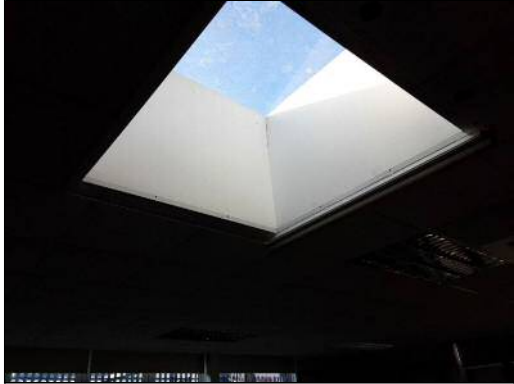
| Assessment details | | | | Comments | Photograph |
|---|---|---|---|---|---|
| Assessment no. | 0060 | Accessibility | Usually inaccessible or unlikely to be disturbed | | |

| Assessment details | | | | Comments | Photograph |
|---|---|---|---|---|---|
| Building | Block EFAE | Floor/ room | Ground Floor / Room 305 | | |
| Identification | Presumed | Condition | Medium Damage | | |

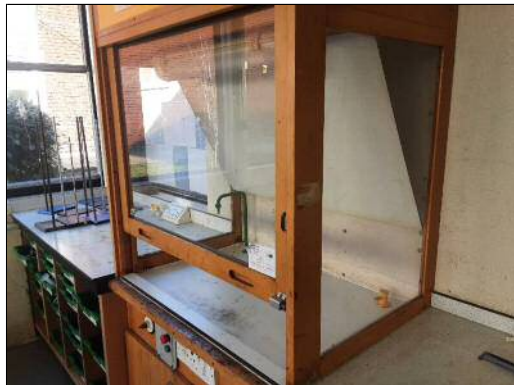
| Assessment details | | | | Comments | Photograph |
|---|---|---|---|---|---|
| Assessment no. | 0062 | Accessibility | Occasionally likely to be disturbed | | |

| Assessment details | | | | Comments | Photograph |
|---|---|---|---|---|---|
| Building | Block EFAD | Floor/ room | Ground Floor / G.08 room 222 | Presumed as unable to sample without compromising the integrity of the fume cabinet | |
| Identification | Presumed | Condition | Good Condition | | |

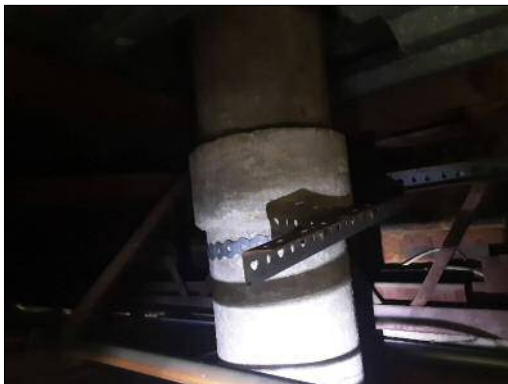
| Assessment details | | | | Comments | Photograph |
|---|---|---|---|---|---|
| Assessment no. | 0067 | Accessibility | Usually inaccessible or unlikely to be disturbed | | |

| Assessment details | | | | Comments | Photograph |
|---|---|---|---|---|---|
| Building | Block EFAD | Floor/ room | Ground Floor / G.08 room 222 | Above suspended ceiling | |
| Identification | Identified | Condition | Good Condition | | |

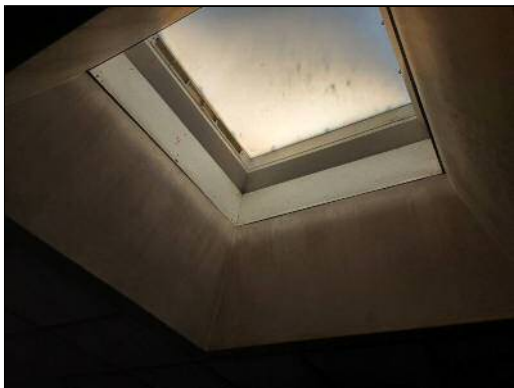
| Assessment details | | | | Comments | Photograph |
|---|---|---|---|---|---|
| Assessment no. | 0077 | Accessibility | Usually inaccessible or unlikely to be disturbed | | |

| Assessment details | | | | Comments | Photograph |
|---|---|---|---|---|---|
| Building | Block EFAD | Floor/ room | Ground Floor / G.09 room 215 | 4 no at 2m2 each | |
| Identification | Strongly Presumed (054) | Condition | Good Condition | | |

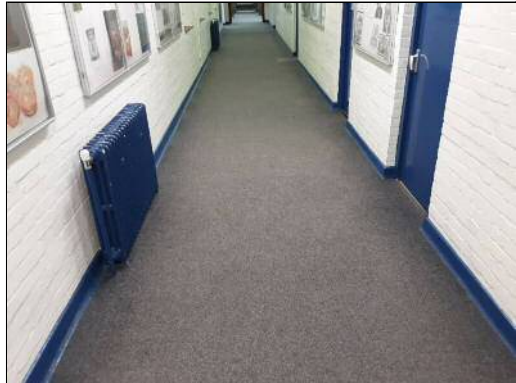
| Assessment details | | | | Comments | Photograph |
|---|---|---|---|---|---|
| Assessment no. | 0081 | Accessibility | | | |

| Assessment details | | | | Comments | Photograph |
|---|---|---|---|---|---|
| Building | Block EFAA | Floor/ room | Ground Floor / Corridor 1 | No access to floor ducts - fitted carpet covering ducts | |
| Identification | Inaccessible (Presumed) | Condition | n/a | | |

| Assessment details | | | | Comments | Photograph |
|---|---|---|---|---|---|
| Action | Inspect Prior to Disturbance | | | | |

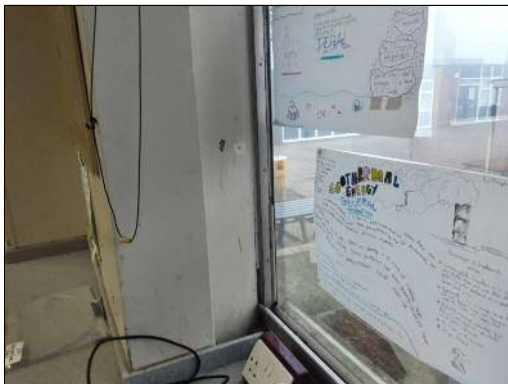
| Assessment details | | | | Comments | Photograph |
|---|---|---|---|---|---|
| Assessment no. | 0082 | Accessibility | Easily disturbed | | |

| Assessment details | | | | Comments | Photograph |
|---|---|---|---|---|---|
| Building | Block EFAD | Floor/ room | Ground Floor / G.03 room 227 | 4 panels at 2lm each | |
| Identification | Strongly Presumed (034) | Condition | Good Condition | | |

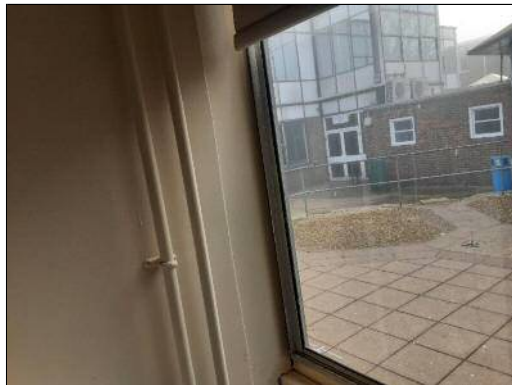
| Assessment details | | | | Comments | Photograph |
|---|---|---|---|---|---|
| Building | Block EFAD | Floor/ room | Ground Floor / G.11 office 228 | | |
| Identification | Strongly Presumed (034) | Condition | Good Condition | | |

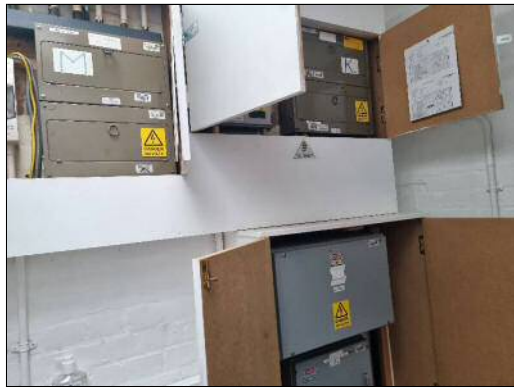
| Assessment details | | | | Comments | Photograph |
|---|---|---|---|---|---|
| Building | Block EFAA | Floor/ room | Ground Floor / Room 77 office | No access to electrics - live services | |
| Identification | Inaccessible (Presumed) | Condition | n/a | | |

| Assessment details | | | | Comments | Photograph |
|---|---|---|---|---|---|
| Action | Inspect Prior to Disturbance | | | | |

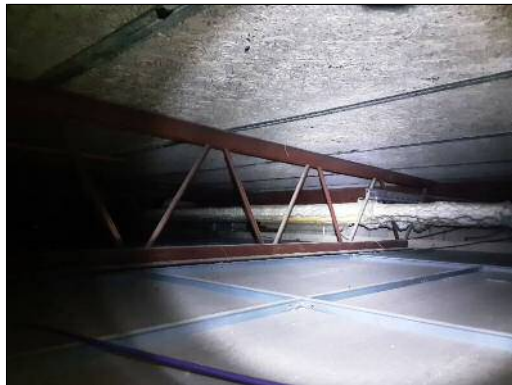
| Assessment details | | | | Comments | Photograph |
|---|---|---|---|---|---|
| Building | Block EFAD | Floor/ room | Ground Floor / G.12 room 201 | Presumed to be on all lagging above ceiling and in risers | |
| Identification | Strongly Presumed (024) | Condition | | | |

| Assessment details | | | | Comments | Photograph |
|---|---|---|---|---|---|
| Action | No further action required | | | | |

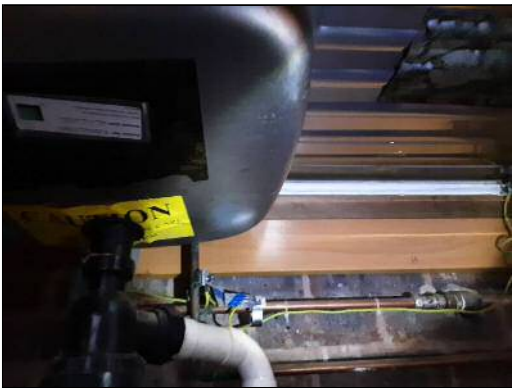
| Assessment details | | | | Comments | |
|---|---|---|---|---|---|
| Building | Block EFAE | Floor/ room | Ground Floor / Room 309 | | |
| Identification | Identified | Condition | | | |

| Assessment details | | | | Comments | |
|---|---|---|---|---|---|
| Action | No further action required | | | | |

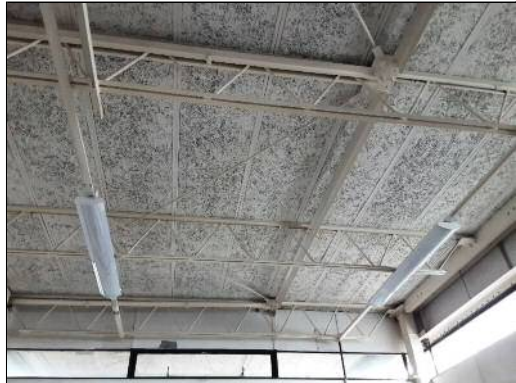
| Assessment details | | | | Comments | Photograph |
|---|---|---|---|---|---|
| Building | Block EFAE | Floor/ room | Ground Floor / Room 309 | | |
| Identification | Strongly Presumed (006) | Condition | | | |

| Assessment details | | | | Comments | Photograph |
|---|---|---|---|---|---|
| Action | No further action required | | | | |

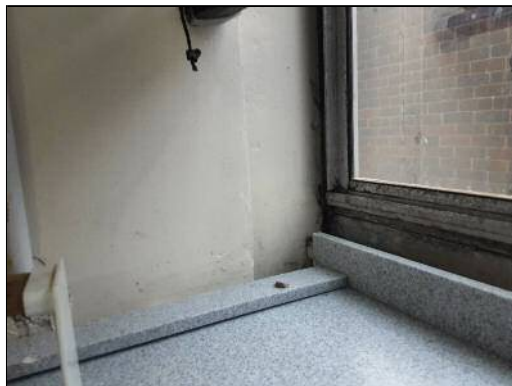
| Assessment details | | | | Comments | Photograph |
|---|---|---|---|---|---|
| Building | Block EFAD | Floor/ room | Ground Floor / G.12 room 201 | 2no at 3lm each | |
| Identification | Strongly Presumed (034) | Condition | Good Condition | | |

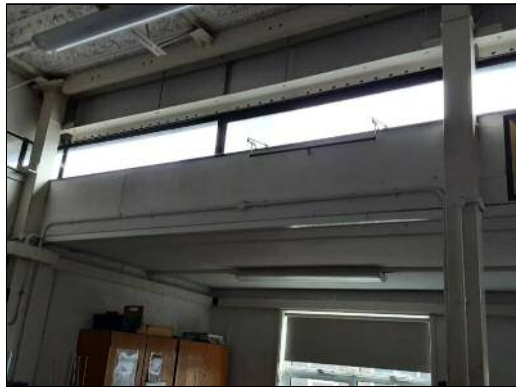
| Assessment details | | | | Comments | |
|---|---|---|---|---|---|
| Building | Block EFAE | Floor/ room | Ground Floor / Room 309 | | |
| Identification | Identified | Condition | | | |

| Assessment details | | | | Comments | |
|---|---|---|---|---|---|
| Action | No further action required | | | | |

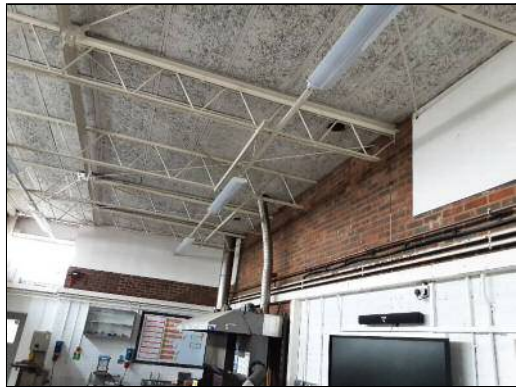
| Assessment details | | | | Comments | |
|---|---|---|---|---|---|
| Building | Block EFAE | Floor/ room | Ground Floor / Room 309 | | |
| Identification | Identified | Condition | | | |

| Assessment details | | | | Comments | |
|---|---|---|---|---|---|
| Action | No further action required | | | | |

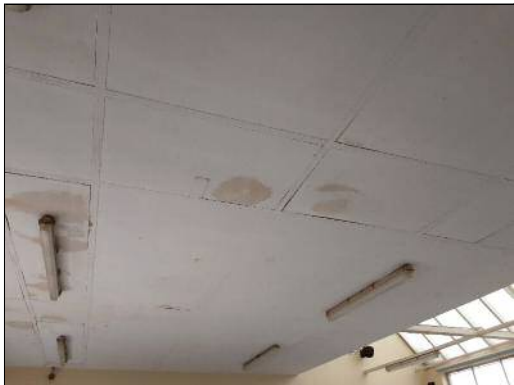
| Assessment details | | | | Comments | Photograph |
|---|---|---|---|---|---|
| Building | Block EFAA | Floor/ room | Ground Floor / Room 78 classroom | | |
| Identification | Identified | Condition | | | |

| Assessment details | | | | Comments | Photograph |
|---|---|---|---|---|---|
| Action | No further action required | | | | |

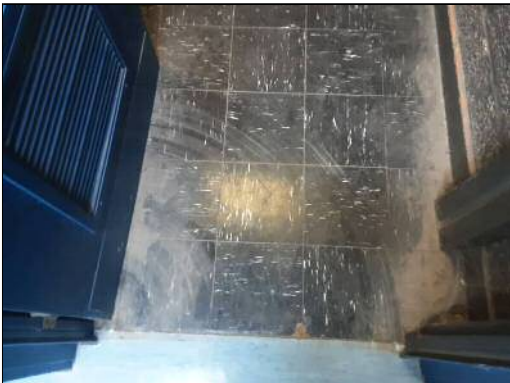
| Assessment details | | | | Comments | <div>Photograph</div> |
|---|---|---|---|---|---|
| Building | Block EFAD | Floor/ room | Ground Floor / G.13 Store | | |
| Identification | Identified | Condition | Low Damage | | |

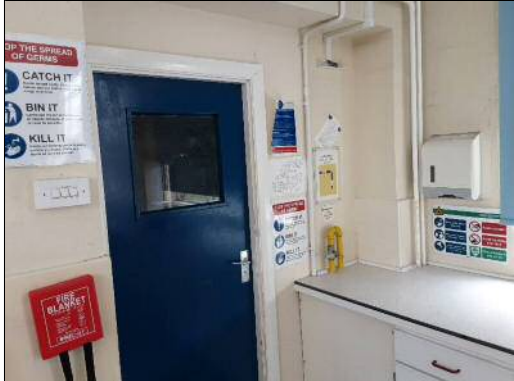
| Assessment details | | | | Comments | Photograph |
|---|---|---|---|---|---|
| Building | Block EFAA | Floor/ room | Ground Floor / Room 78 classroom | Panels to both sides of door | |
| Identification | Identified | Condition | | | |

| Assessment details | | | | Comments | Photograph |
|---|---|---|---|---|---|
| Action | No further action required | | | | |

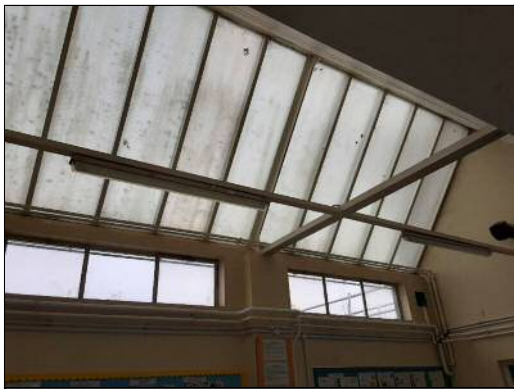
| Assessment details | | | | Comments | Photograph |
|---|---|---|---|---|---|
| Building | Block EFAA | Floor/ room | Ground Floor / Room 78 classroom | Plastic skylights are blocking access to metal skylights above | |
| Identification | Presumed | Condition | Good Condition | | |

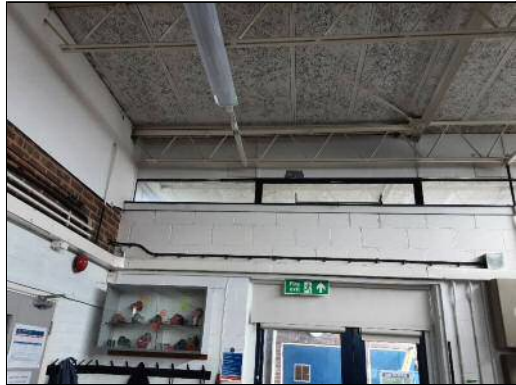
| Assessment details | | | | Comments | |
|---|---|---|---|---|---|
| Building | Block EFAE | Floor/ room | Ground Floor / Room 309 | | |
| Identification | Identified | Condition | | | |

| Assessment details | | | | Comments | |
|---|---|---|---|---|---|
| Action | No further action required | | | | |

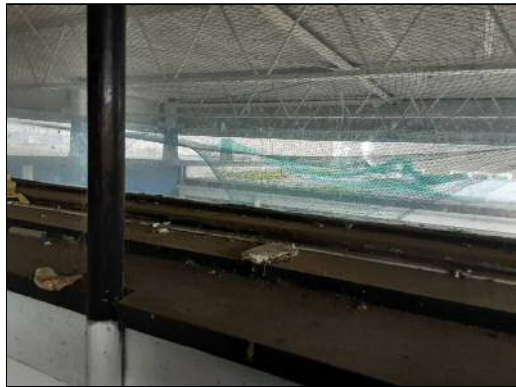
| Assessment details | | | | Comments | |
|---|---|---|---|---|---|
| Building | Block EFAE | Floor/ room | Ground Floor / Room 309 | | |
| Identification | Identified | Condition | | | |

| Assessment details | | | | Comments | |
|---|---|---|---|---|---|
| Action | No further action required | | | | |

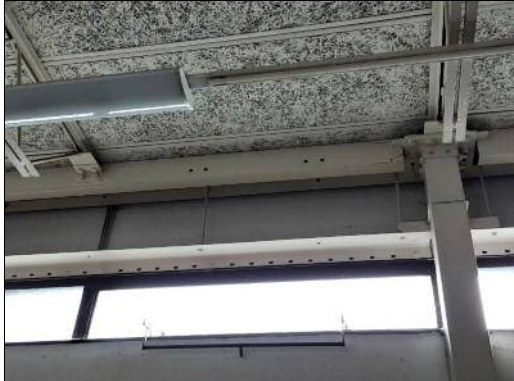
| Assessment details | | | | Comments | |
|---|---|---|---|---|---|
| Building | Block EFAE | Floor/ room | Ground Floor / Room 309 | | |
| Identification | Identified | Condition | Good Condition | | |

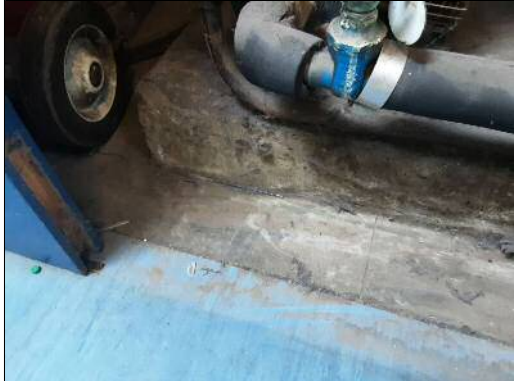
| Assessment details | | | | Comments | Photograph |
|---|---|---|---|---|---|
| Building | Block EFAD | Floor/ room | Ground Floor / G.14 calorifier room | | |
| Identification | Identified | Condition | Low Damage | | |

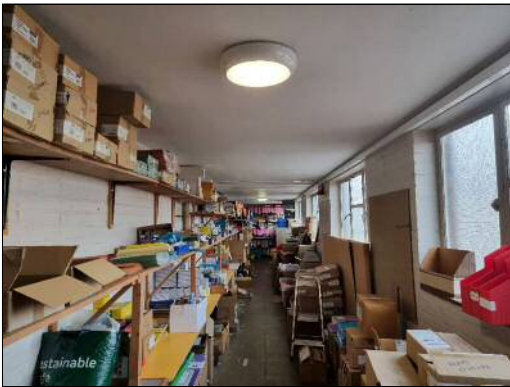
| Assessment details | | | | Comments | <div>Photograph</div> |
|---|---|---|---|---|---|
| Building | Block EFAA | Floor/ room | Ground Floor / Corridor store | | |
| Identification | Strongly Presumed (076) | Condition | | | |

| Assessment details | | | | Comments | <div>Photograph</div> |
|---|---|---|---|---|---|
| Action | No further action required | | | | |

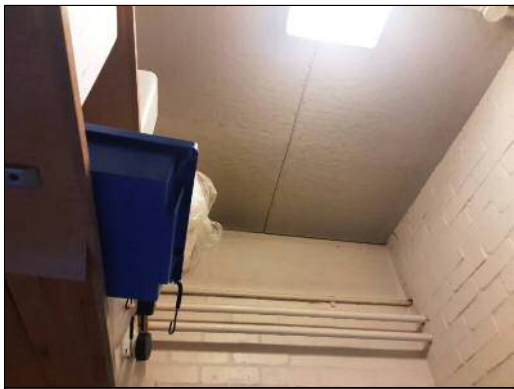
| Assessment details | | | | Comments | Photograph |
|---|---|---|---|---|---|
| Building | Block EFAD | Floor/ room | Ground Floor / G.15 Lobby to 224 | | |
| Identification | Strongly Presumed (038) | Condition | | | |

| Assessment details | | | | Comments | Photograph |
|---|---|---|---|---|---|
| Action | No further action required | | | | |

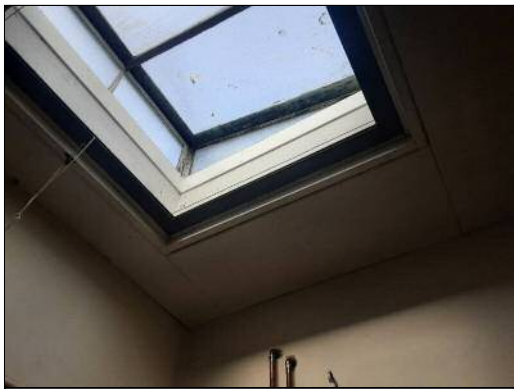
| Assessment details | | | | Comments | Photograph |
|---|---|---|---|---|---|
| Building | Block EFAD | Floor/ room | Ground Floor / G.16 room 224 | No access to skylight (3.5m+) - high level access required | |
| Identification | Inaccessible (Presumed) | Condition | n/a | | |

| Assessment details | | | | Comments | Photograph |
|---|---|---|---|---|---|
| Action | Inspect Prior to Disturbance | | | | |

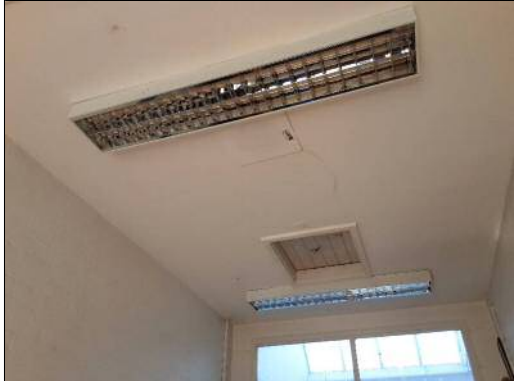
| Assessment details | | | | Comments | Photograph |
|---|---|---|---|---|---|
| Building | Block EFAA | Floor/ room | Ground Floor / Room 78A office | | |
| Identification | Identified | Condition | | | |

| Assessment details | | | | Comments | Photograph |
|---|---|---|---|---|---|
| Action | No further action required | | | | |

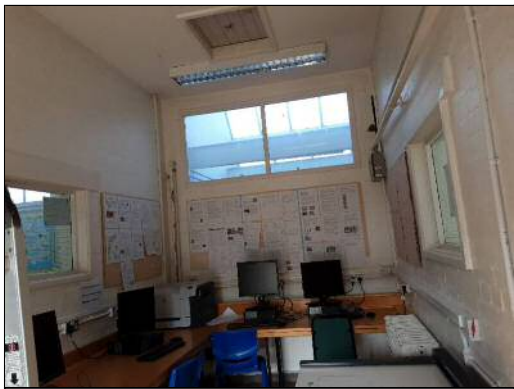
| Assessment details | | | | Comments | Photograph |
|---|---|---|---|---|---|
| Building | Block EFAA | Floor/ room | Ground Floor / Room 78A office | No access to loft - fixed item below prevent access for tower scaffold | |
| Identification | Inaccessible (Presumed) | Condition | n/a | | |

| Assessment details | | | | Comments | Photograph |
|---|---|---|---|---|---|
| Action | Inspect Prior to Disturbance | | | | |

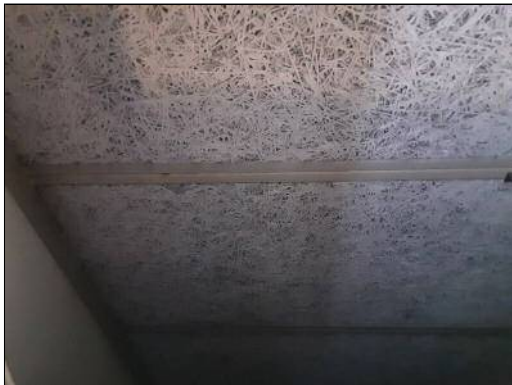
| Assessment details | | | | Comments | Photograph |
|---|---|---|---|---|---|
| Building | Block EFAE | Floor/ room | Ground Floor / Room 310 | | |
| Identification | Strongly Presumed (006) | Condition | | | |

| Assessment details | | | | Comments | Photograph |
|---|---|---|---|---|---|
| Action | No further action required | | | | |

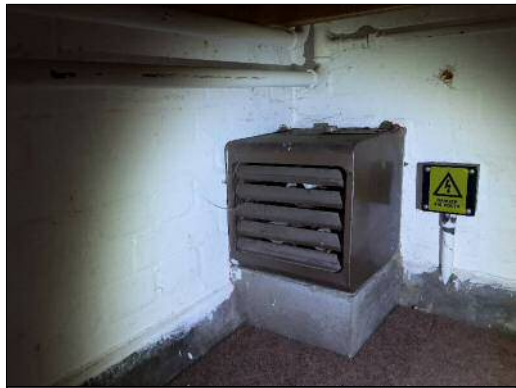
| Assessment details | | | | Comments | Photograph |
|---|---|---|---|---|---|
| Building | Block EFAA | Floor/ room | Ground Floor / Room 78A office | | |
| Identification | Identified | Condition | Low Damage | | |

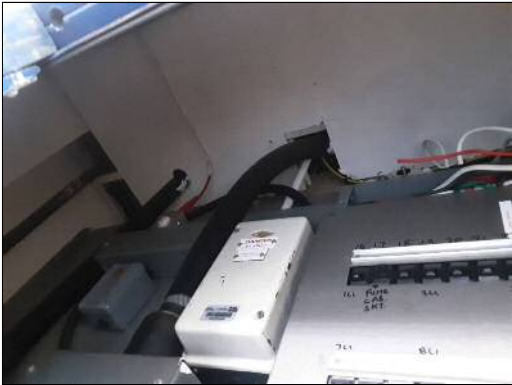
| Assessment details | | | | Comments | <div>Photograph</div> |
|---|---|---|---|---|---|
| Building | Block EFAD | Floor/ room | Ground Floor / G.17 Electrics cupboard | | |
| Identification | Identified | Condition | Low Damage | | |

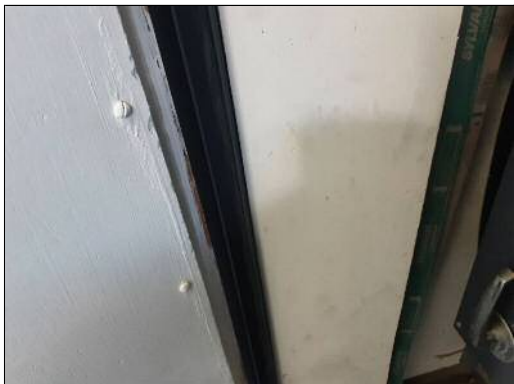
| Assessment details | | | | Comments | Photograph |
|---|---|---|---|---|---|
| Building | Block EFAD | Floor/ room | Ground Floor / G.17 Electrics cupboard | | |
| Identification | Identified | Condition | Low Damage | | |

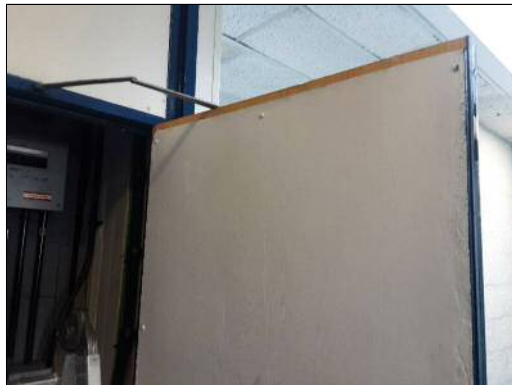
| Assessment details | | | | Comments | Photograph |
|---|---|---|---|---|---|
| Building | Block EFAD | Floor/ room | Ground Floor / G.17 Electrics cupboard | 2 panels 2m2 each | |
| Identification | Identified | Condition | Low Damage | | |

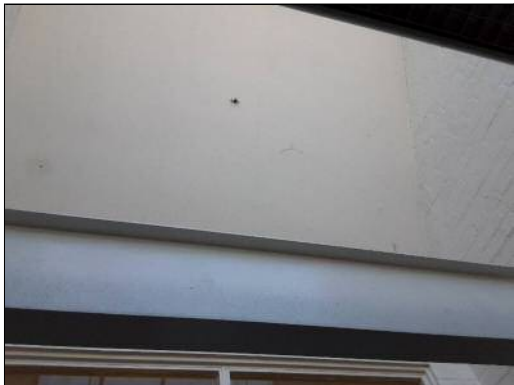
| Assessment details | | | | Comments | Photograph |
|---|---|---|---|---|---|
| Building | Block EFAA | Floor/ room | Ground Floor / Room 79A store | | |
| Identification | Identified | Condition | | | |

| Assessment details | | | | Comments | Photograph |
|---|---|---|---|---|---|
| Action | No further action required | | | | |

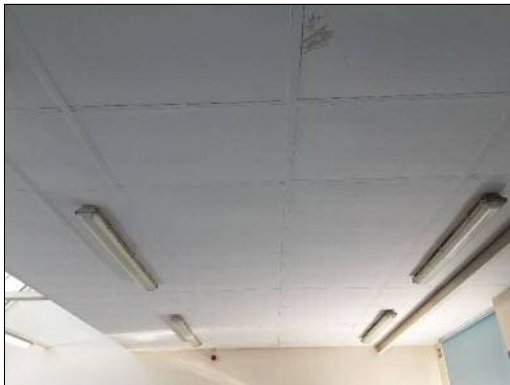
| Assessment details | | | | Comments | Photograph |
|---|---|---|---|---|---|
| Building | Block EFAA | Floor/ room | Ground Floor / Room 79 classroom | | |
| Identification | Strongly Presumed (091) | Condition | | | |

| Assessment details | | | | Comments | Photograph |
|---|---|---|---|---|---|
| Action | No further action required | | | | |

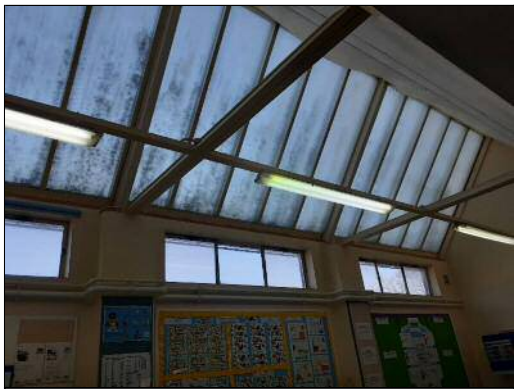
| Assessment details | | | | Comments | Photograph |
|---|---|---|---|---|---|
| Building | Block EFAA | Floor/ room | Ground Floor / Room 79 classroom | Plastic skylights are blocking access to metal skylights above | |
| Identification | Presumed | Condition | Good Condition | | |

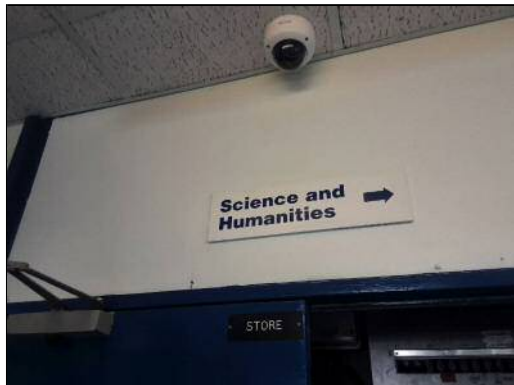
| Assessment details | | | | Comments | Photograph |
|---|---|---|---|---|---|
| Building | Block EFAD | Floor/ room | Ground Floor / G.17 Electrics cupboard | 2 panels 2m2 each | |
| Identification | Strongly Presumed (108) | Condition | Low Damage | | |

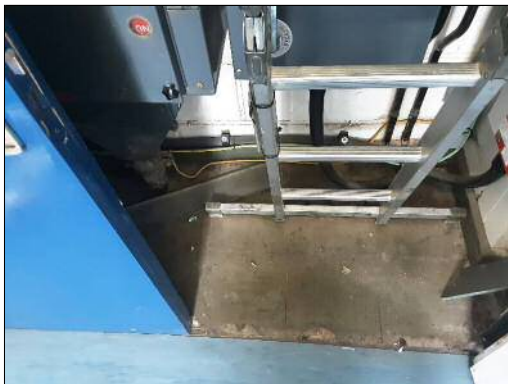
| Assessment details | | | | Comments | <div>Photograph</div> |
|---|---|---|---|---|---|
| Building | Block EFAD | Floor/ room | Ground Floor / G.17 Electrics cupboard | | |
| Identification | Strongly Presumed (098) | Condition | Low Damage | | |

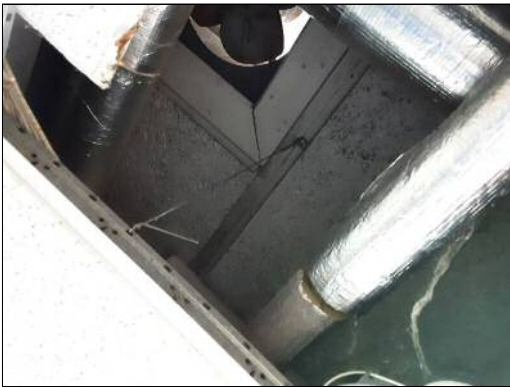
| Assessment details | | | | Comments | <div>Photograph</div> |
|---|---|---|---|---|---|
| Building | Block EFAE | Floor/ room | Ground Floor / Room 314A | | |
| Identification | Strongly Presumed (006) | Condition | | | |

| Assessment details | | | | Comments | <div>Photograph</div> |
|---|---|---|---|---|---|
| Action | No further action required | | | | |

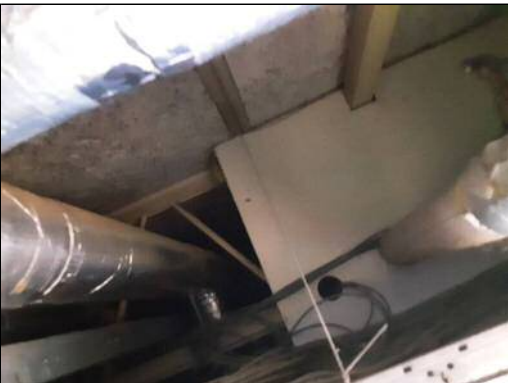
| Assessment details | | | | Comments | <div>Photograph</div> |
|---|---|---|---|---|---|
| Building | Block EFAE | Floor/ room | Ground Floor / Room 314A | | |
| Identification | Strongly Presumed (012) | Condition | | | |

| Assessment details | | | | Comments | <div>Photograph</div> |
|---|---|---|---|---|---|
| Action | No further action required | | | | |

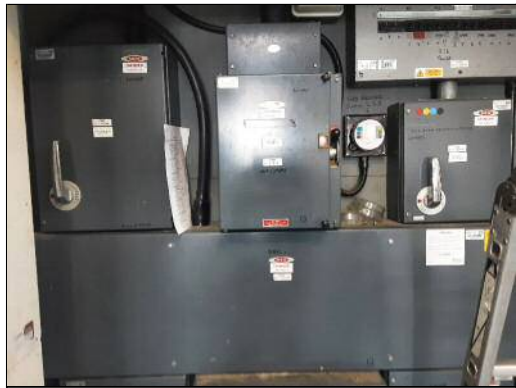
| Assessment details | | | | Comments | Photograph |
|---|---|---|---|---|---|
| Building | Block EFAD | Floor/ room | Ground Floor / G.17 Electrics cupboard | No access to electrics - live services | |
| Identification | Inaccessible (Presumed) | Condition | n/a | | |

| Assessment details | | | | Comments | Photograph |
|---|---|---|---|---|---|
| Action | Inspect Prior to Disturbance | | | | |

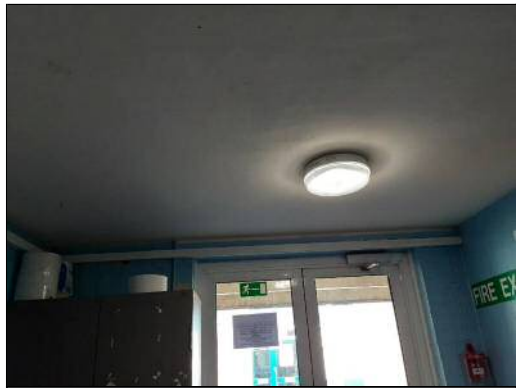
| Assessment details | | | | Comments | Photograph |
|---|---|---|---|---|---|
| Building | Block EFAA | Floor/ room | Ground Floor / Room 80 office | | |
| Identification | Strongly Presumed (110) | Condition | | | |

| Assessment details | | | | Comments | Photograph |
|---|---|---|---|---|---|
| Action | No further action required | | | | |

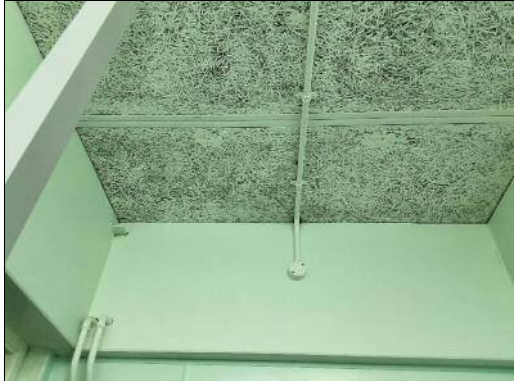
| Assessment details | | | | Comments | Photograph |
|---|---|---|---|---|---|
| Building | Block EFAE | Floor/ room | Ground Floor / Room 312 | Also in cupboard | |
| Identification | Strongly Presumed (006) | Condition | | | |

| Assessment details | | | | Comments | Photograph |
|---|---|---|---|---|---|
| Action | No further action required | | | | |

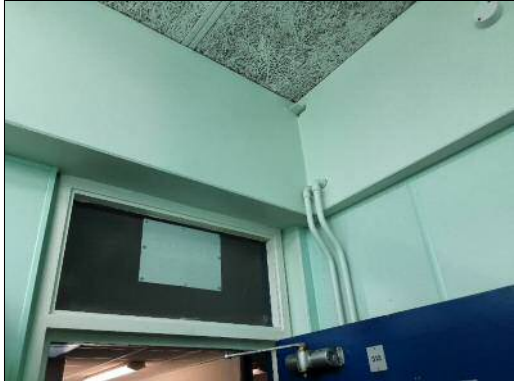
| Assessment details | | | | Comments | Photograph |
|---|---|---|---|---|---|
| Building | Block EFAE | Floor/ room | Ground Floor / Room 312 | | |
| Identification | Strongly Presumed (012) | Condition | | | |

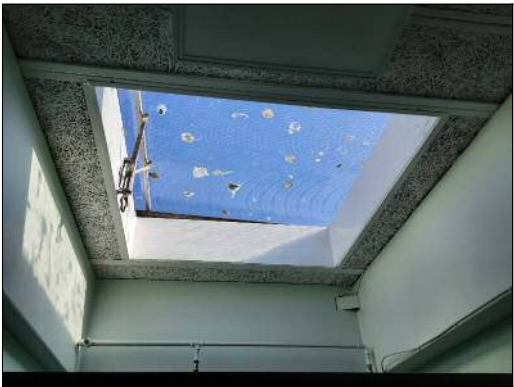
| Assessment details | | | | Comments | |
|---|---|---|---|---|---|
| Building | Block EFAE | Floor/ room | Ground Floor / Room 312 | | |

| Assessment details | | | | Comments | |
|---|---|---|---|---|---|
| Identification | Presumed | Condition | Good Condition | | |
| Material risk | Very low | Material risk score | 4 | | |

| Assessment details | | | | Comments | |
|---|---|---|---|---|---|
| Action | Manage | | | | |

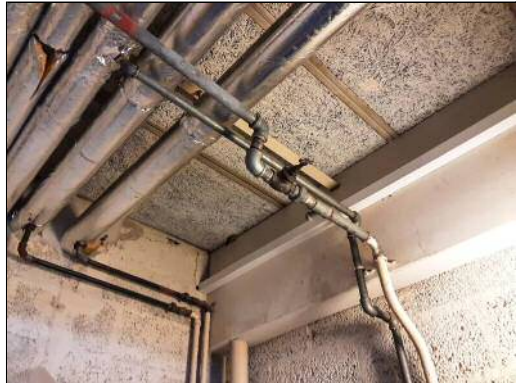
| Assessment details | | | | Comments | <div>Photograph</div> |
|---|---|---|---|---|---|
| Building | Block EFAE | Floor/ room | Ground Floor / Room 313 | | |

| Assessment details | | | | Comments | <div>Photograph</div> |
|---|---|---|---|---|---|
| Identification | Strongly Presumed (006) | Condition | | | |

| Assessment details | | | | Comments | <div>Photograph</div> |
|---|---|---|---|---|---|
| Action | No further action required | | | | |

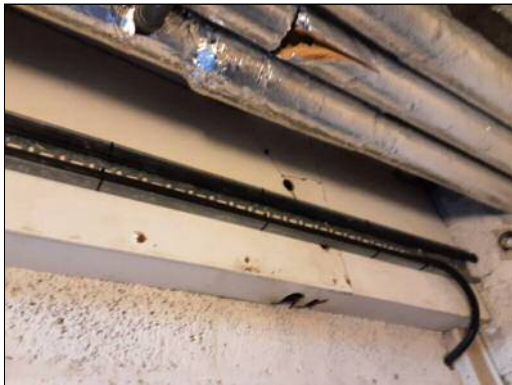
| Assessment details | | | | Comments | Photograph |
|---|---|---|---|---|---|
| Building | Block EFAE | Floor/ room | Ground Floor / Room 313 | | |

| Assessment details | | | | Comments | Photograph |
|---|---|---|---|---|---|
| Identification | Strongly Presumed (012) | Condition | | | |

| Assessment details | | | | Comments | Photograph |
|---|---|---|---|---|---|
| Action | No further action required | | | | |

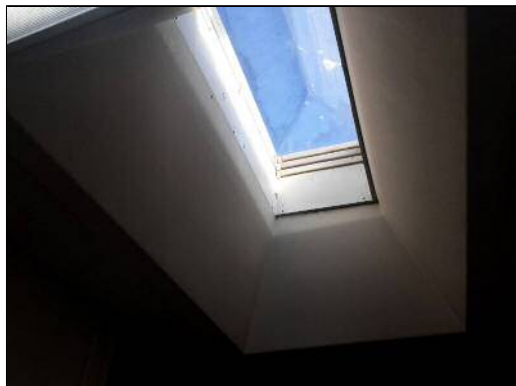
| Assessment details | | | | Comments | Photograph |
|---|---|---|---|---|---|
| Building | Block EFAD | Floor/ room | Ground Floor / G.18 store 216 | 2 no at 2m2 each | |
| Identification | Strongly Presumed (034) | Condition | Good Condition | | |

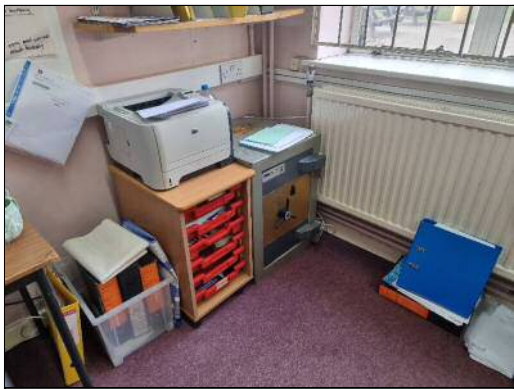
| Assessment details | | | | Comments | Photograph |
|---|---|---|---|---|---|
| Building | Block EFAA | Floor/ room | Ground Floor / Room 75 office | No access to safe - locked/sealed unit | |
| Identification | Inaccessible (Presumed) | Condition | n/a | | |

| Assessment details | | | | Comments | Photograph |
|---|---|---|---|---|---|
| Action | Inspect Prior to Disturbance | | | | |

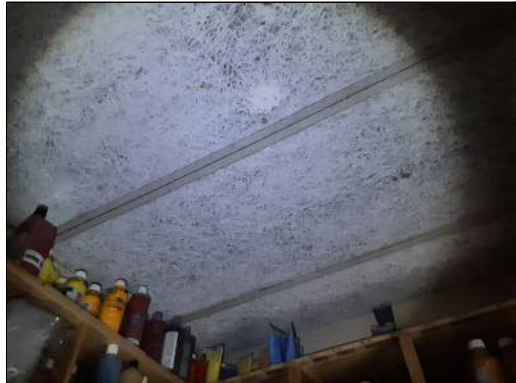
| Assessment details | | | | Comments | Photograph |
|---|---|---|---|---|---|
| Building | Block EFAE | Floor/ room | Ground Floor / Room 315 | | |

| Assessment details | | | | Comments | Photograph |
|---|---|---|---|---|---|
| Identification | Strongly Presumed (006) | Condition | | | |

| Assessment details | | | | Comments | Photograph |
|---|---|---|---|---|---|
| Action | No further action required | | | | |

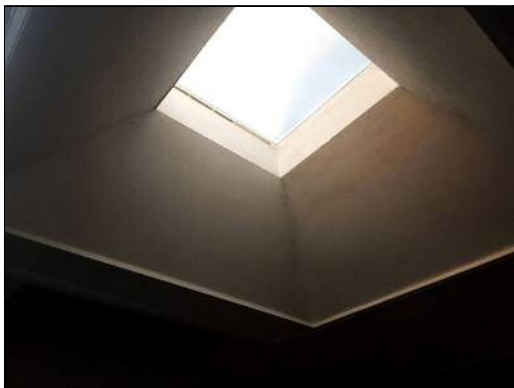
| Assessment details | | | | Comments | <div>Photograph</div> |
|---|---|---|---|---|---|
| Building | Block EFAD | Floor/ room | Ground Floor / G.19 Prep room | | |

| Assessment details | | | | Comments | <div>Photograph</div> |
|---|---|---|---|---|---|
| Identification | Strongly Presumed (034) | Condition | Good Condition | | |

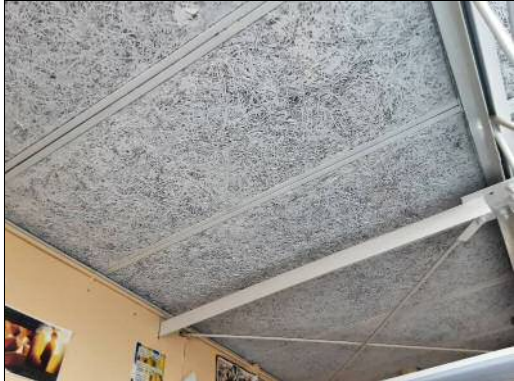
| Assessment details | | | | Comments | Photograph |
|---|---|---|---|---|---|
| Building | Block EFAE | Floor/ room | Ground Floor / Room 316 | | |

| Assessment details | | | | Comments | Photograph |
|---|---|---|---|---|---|
| Identification | Strongly Presumed (006) | Condition | | | |

| Assessment details | | | | Comments | Photograph |
|---|---|---|---|---|---|
| Action | No further action required | | | | |

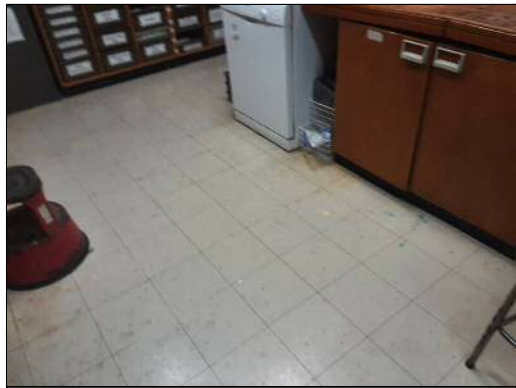
| Assessment details | | | | Comments | <div>Photograph</div> |
|---|---|---|---|---|---|
| Building | Block EFAD | Floor/ room | Ground Floor / G.19 Prep room | | |

| Assessment details | | | | Comments | <div>Photograph</div> |
|---|---|---|---|---|---|
| Identification | Strongly Presumed (036) | Condition | Good Condition | | |

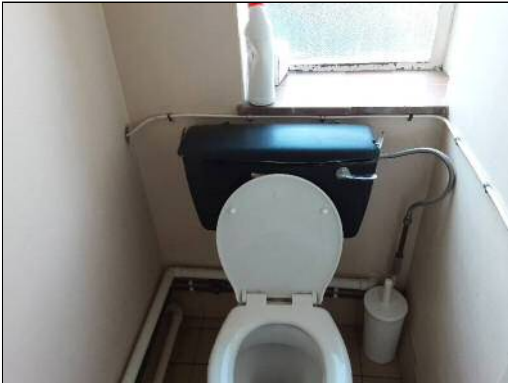
| Assessment details | | | | Comments | Photograph |
|---|---|---|---|---|---|
| Building | Block EFAA | Floor/ room | Ground Floor / Room 70A welfare | | |

| Assessment details | | | | Comments | Photograph |
|---|---|---|---|---|---|
| Identification | Identified | Condition | | | |

| Assessment details | | | | Comments | Photograph |
|---|---|---|---|---|---|
| Action | No further action required | | | | |

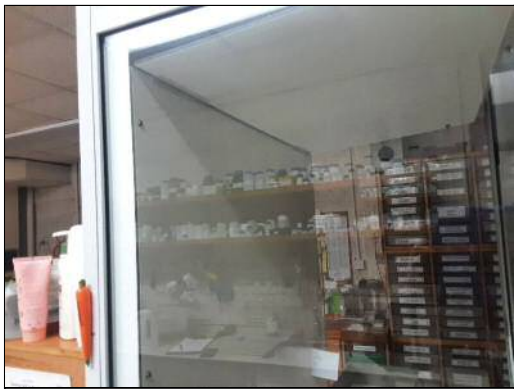
| Assessment details | | | | Comments | Photograph |
|---|---|---|---|---|---|
| Building | Block EFAD | Floor/ room | Ground Floor / G.19 Prep room | Presumed as unable to sample without compromising the integrity of the fume cabinet | |
| Identification | Presumed | Condition | Good Condition | | |
