**MANAGEMENT SURVEY FOR ASBESTOS-CONTAINING MATERIALS**

**SRP1121-EEG-XX-XX-T-O-0301-AsbestosManagementSurveyReport-ShootingField**

**CLIENT:** Arcadis UK (London)

**SITE:** Steyning Grammar School, Upper School, Shooting Field, Steyning, BN44 3RX

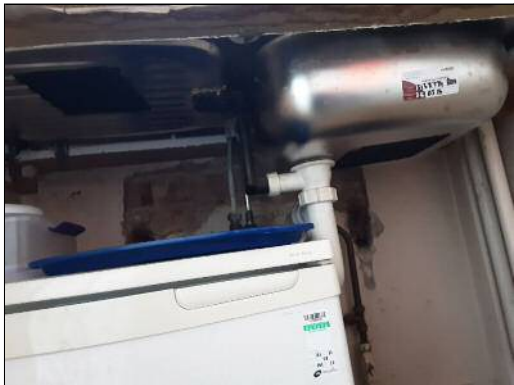
| Assessment details | | | | Comments | Photograph |
|---|---|---|---|---|---|
| Building | Block EFAA | Floor/ room | Ground Floor / Room 70A welfare | | |

| Assessment details | | | | Comments | Photograph |
|---|---|---|---|---|---|
| Identification | Identified | Condition | | | |

| Assessment details | | | | Comments | Photograph |
|---|---|---|---|---|---|
| Action | No further action required | | | | |

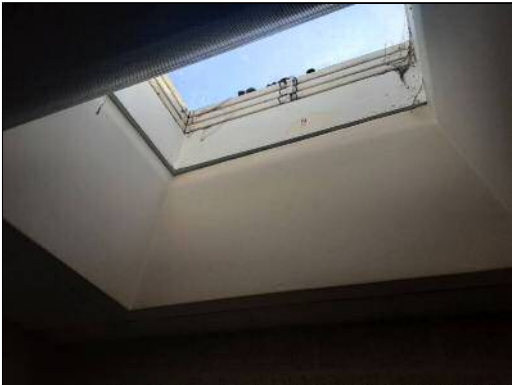
| Assessment details | | | | Comments | <div></div> |
|---|---|---|---|---|---|
| Building | Block EFAD | Floor/ room | Ground Floor / G.20 Office in Prep room | | |

| Assessment details | | | | Comments | <div></div> |
|---|---|---|---|---|---|
| Identification | Strongly Presumed (034) | Condition | Good Condition | | |

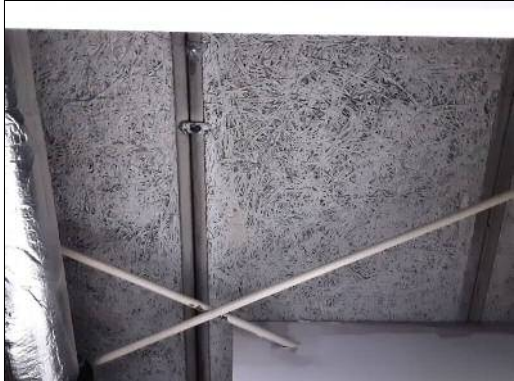
| Assessment details | | | | Comments | Photograph |
|---|---|---|---|---|---|
| Building | Block EFAE | Floor/ room | Ground Floor / Room 314 | Also in cupboard | |
| Identification | Strongly Presumed (006) | Condition | | | |

| Assessment details | | | | Comments | Photograph |
|---|---|---|---|---|---|
| Action | No further action required | | | | |

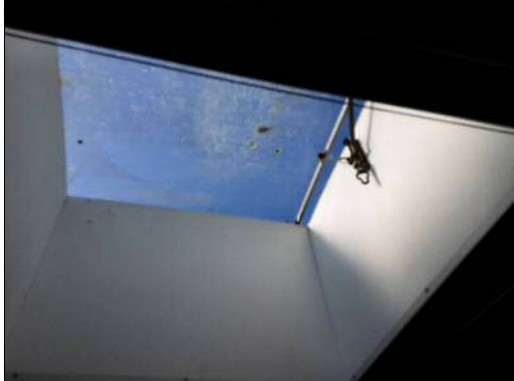
| Assessment details | | | | Comments | Photograph |
|---|---|---|---|---|---|
| Building | Block EFAE | Floor/ room | Ground Floor / Room 314 | | |

| Assessment details | | | | Comments | Photograph |
|---|---|---|---|---|---|
| Identification | Presumed | Condition | Good Condition | | |

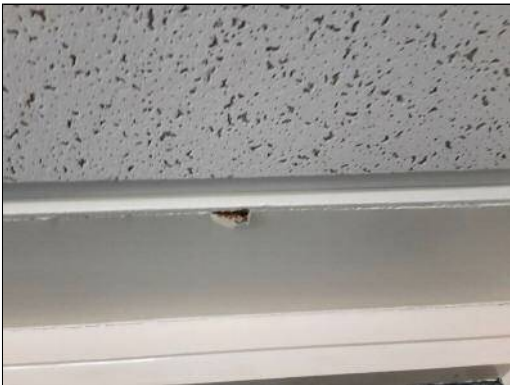
| Assessment details | | | | Comments | Photograph |
|---|---|---|---|---|---|
| Building | Block EFAE | Floor/ room | Ground Floor / Room 314 | Unsealed in ceiling void | |
| Identification | Strongly Presumed (012) | Condition | | | |

| Assessment details | | | | Comments | Photograph |
|---|---|---|---|---|---|
| Action | No further action required | | | | |

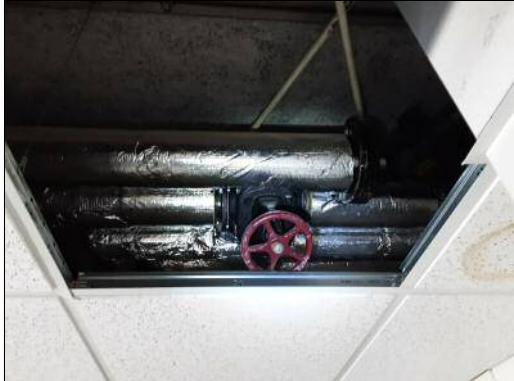
| Assessment details | | | | Comments | Photograph |
|---|---|---|---|---|---|
| Building | Block EFAE | Floor/ room | Ground Floor / Room 314 | Partly unsealed within ceiling void, Also in cupboard | |
| Identification | Identified | Condition | Good Condition | | |

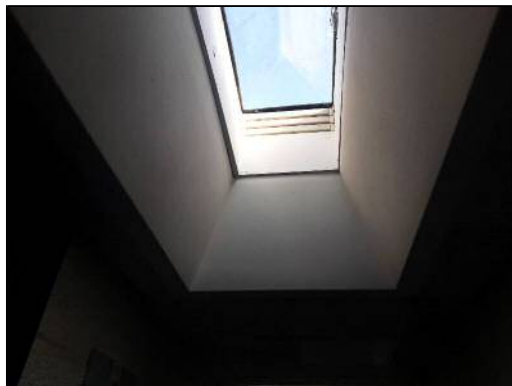
| Assessment details | | | | Comments | Photograph |
|---|---|---|---|---|---|
| Building | Block EFAD | Floor/ room | Ground Floor / G.21 Corridor 3 | 5 no at 2m2 each | |
| Identification | Strongly Presumed (054) | Condition | Good Condition | | |

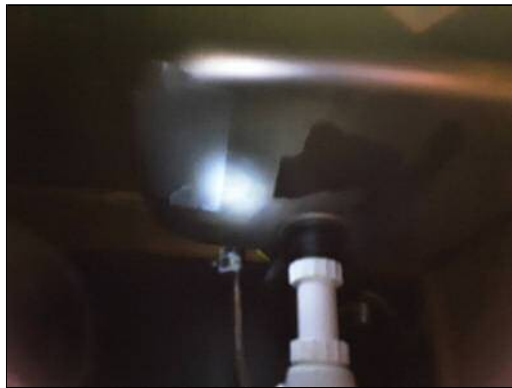
| Assessment details | | | | Comments | Photograph |
|---|---|---|---|---|---|
| Building | Block EFAE | Floor/ room | Ground Floor / Room 311 | | |

| Assessment details | | | | Comments | Photograph |
|---|---|---|---|---|---|
| Identification | Identified | Condition | | | |

| Assessment details | | | | Comments | Photograph |
|---|---|---|---|---|---|
| Action | No further action required | | | | |

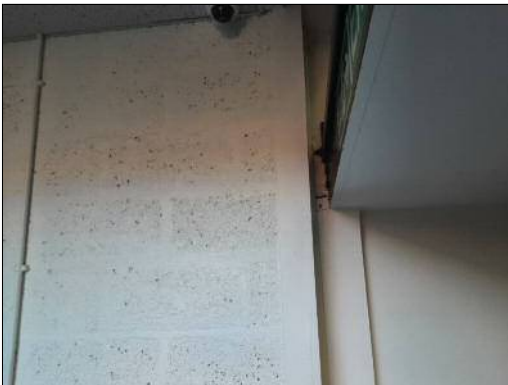
| Assessment details | | | | Comments | Photograph |
|---|---|---|---|---|---|
| Building | Block EFAD | Floor/ room | Ground Floor / G.21 Corridor 3 | At corner of stairs below landing | |
| Identification | Strongly Presumed (107) | Condition | Low Damage | | |

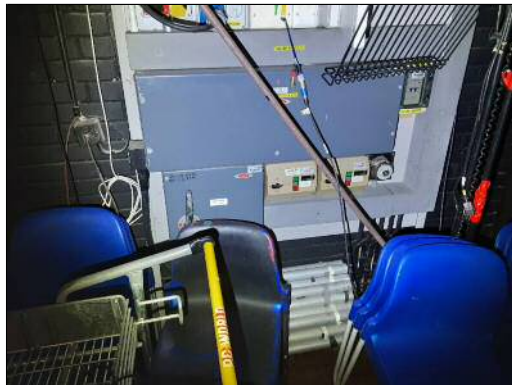
| Assessment details | | | | Comments | Photograph |
|---|---|---|---|---|---|
| Building | Block EFAA | Floor/ room | Ground Floor / Room 4<br>Drama studio | No access to electrics - live services | |
| Identification | Inaccessible<br>(Presumed) | Condition | n/a | | |

| Assessment details | | | | Comments | Photograph |
|---|---|---|---|---|---|
| Action | Inspect Prior to Disturbance | | | | |

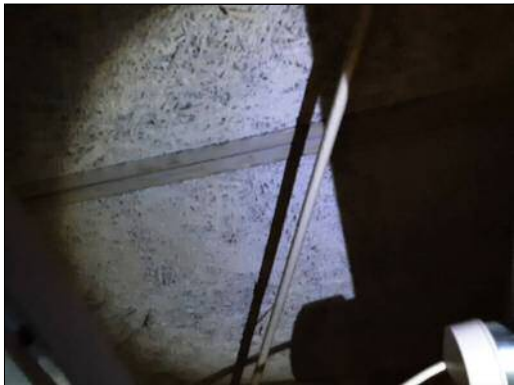
| Assessment details | | | | Comments | Photograph |
|---|---|---|---|---|---|
| Building | Block EFAE | Floor/ room | Ground Floor / Room 311 | | |

| Assessment details | | | | Comments | Photograph |
|---|---|---|---|---|---|
| Identification | Strongly Presumed (006) | Condition | | | |

| Assessment details | | | | Comments | Photograph |
|---|---|---|---|---|---|
| Action | No further action required | | | | |

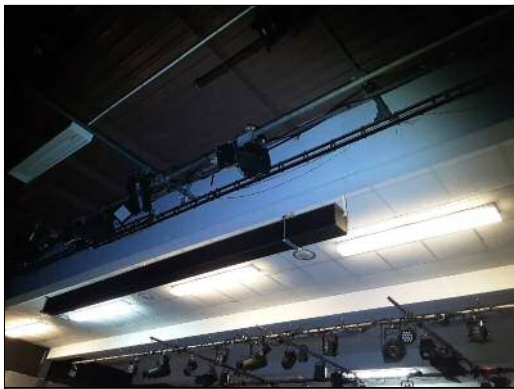
| Assessment details | | | | Comments | Photograph |
|---|---|---|---|---|---|
| Building | Block EFAA | Floor/ room | Ground Floor / Room 4<br>Drama studio | | |

| Assessment details | | | | Comments | Photograph |
|---|---|---|---|---|---|
| Identification | Identified | Condition | Good Condition | | |

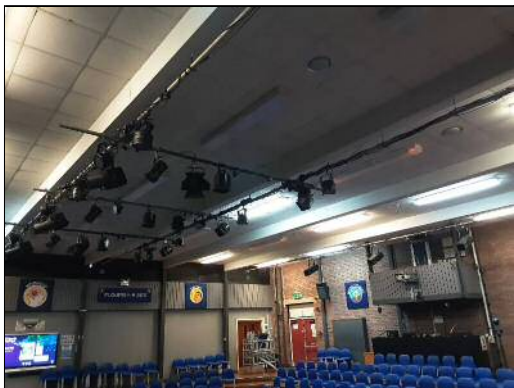
| Assessment details | | | | Comments | Photograph |
|---|---|---|---|---|---|
| Building | Block EFAA | Floor/ room | Ground Floor / Room 4<br>Drama studio | | |

| Assessment details | | | | Comments | Photograph |
|---|---|---|---|---|---|
| Identification | Strongly Presumed (145) | Condition | Good Condition | | |

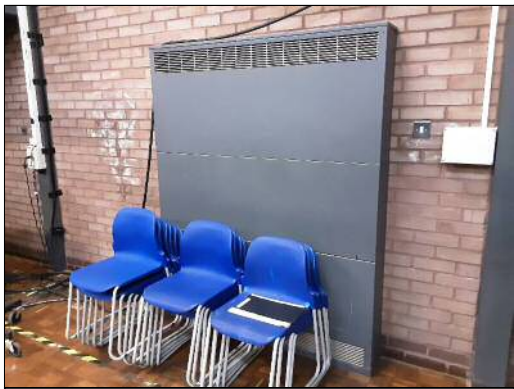
| Assessment details | | | | Comments | Photograph |
|---|---|---|---|---|---|
| Building | Block EFAA | Floor/ room | Ground Floor / Room 4<br>Drama studio | No access to heaters - live services | |
| Identification | Inaccessible (Presumed) | Condition | n/a | | |

| Assessment details | | | | Comments | Photograph |
|---|---|---|---|---|---|
| Action | Inspect Prior to Disturbance | | | | |

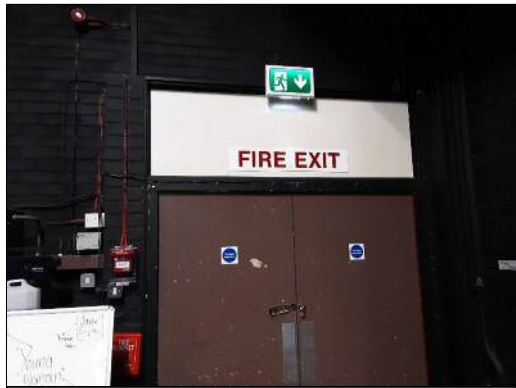
| Assessment details | | | | Comments | Photograph |
|---|---|---|---|---|---|
| Building | Block EFAA | Floor/ room | Ground Floor / Room 4<br>Drama studio | | |

| Assessment details | | | | Comments | Photograph |
|---|---|---|---|---|---|
| Identification | Identified | Condition | Good Condition | | |

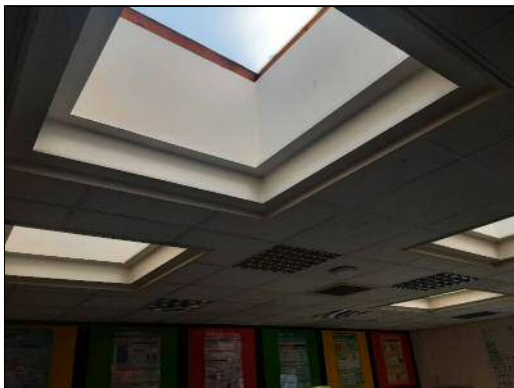
| Assessment details | | | | Comments | Photograph |
|---|---|---|---|---|---|
| Building | Block EFAD | Floor/ room | Ground Floor / G.22 room 202 | 8 no at 2m2 each | |
| Identification | Strongly Presumed (054) | Condition | Good Condition | | |

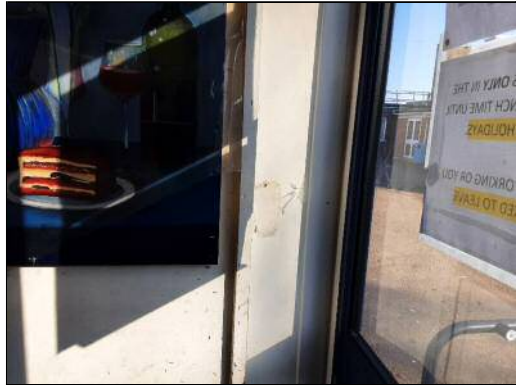
| Assessment details | | | | Comments | Photograph |
|---|---|---|---|---|---|
| Building | Block EFAE | Floor/ room | Ground Floor / Corridor 1 | Small area unsealed | |
| Identification | Identified | Condition | | | |

| Assessment details | | | | Comments | Photograph |
|---|---|---|---|---|---|
| Action | No further action required | | | | |

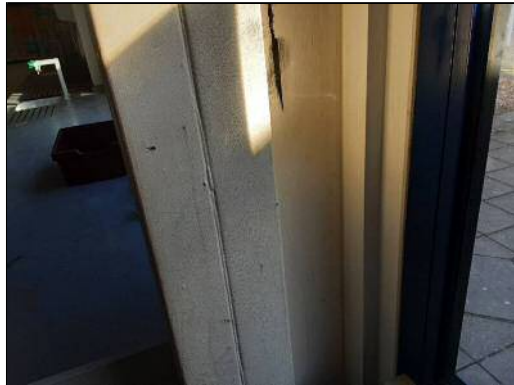
| Assessment details | | | | Comments | Photograph |
|---|---|---|---|---|---|
| Building | Block EFAD | Floor/ room | Ground Floor / G.22 room 202 | Beside column near fire exit door | |
| Identification | Strongly Presumed (108) | Condition | Low Damage | | |

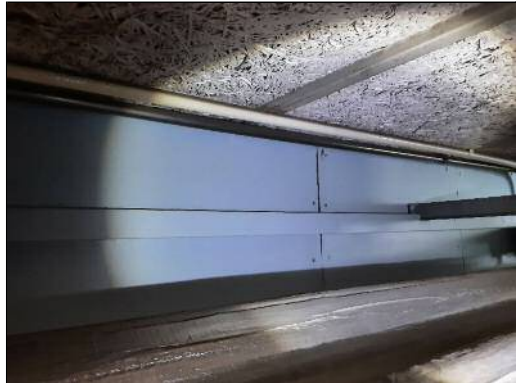
| Assessment details | | | | Comments | Photograph |
|---|---|---|---|---|---|
| Building | Block EFAE | Floor/ room | Ground Floor / Corridor 1 | | |

| Assessment details | | | | Comments | Photograph |
|---|---|---|---|---|---|
| Identification | Strongly Presumed (012) | Condition | | | |

| Assessment details | | | | Comments | Photograph |
|---|---|---|---|---|---|
| Action | No further action required | | | | |

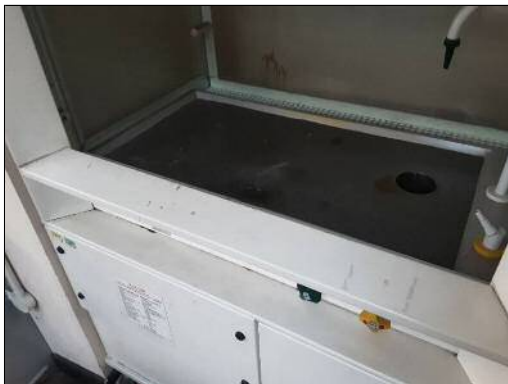
| Assessment details | | | | Comments | Photograph |
|---|---|---|---|---|---|
| Building | Block EFAD | Floor/ room | Ground Floor / G.22 room 202 | Presumed as unable to sample without compromising the integrity of the fume cabinet | |
| Identification | Presumed | Condition | Good Condition | | |

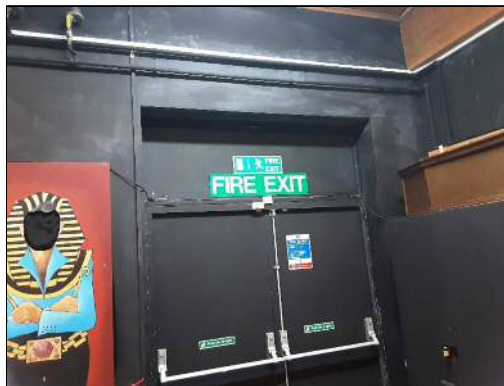
| Assessment details | | | | Comments | Photograph |
|---|---|---|---|---|---|
| Building | Block EFAA | Floor/ room | Ground Floor / Room 97 classroom | | |

| Assessment details | | | | Comments | Photograph |
|---|---|---|---|---|---|
| Identification | Strongly Presumed (148) | Condition | Good Condition | | |

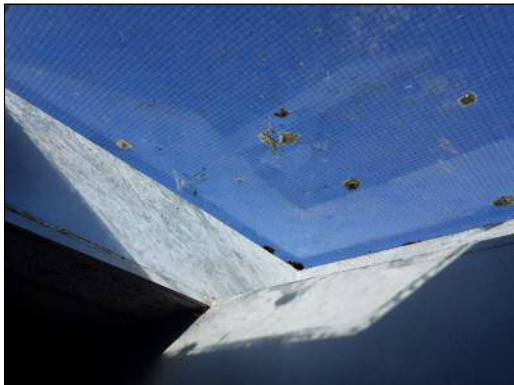
| Assessment details | | | | Comments | Photograph |
|---|---|---|---|---|---|
| Building | Block EFAE | Floor/ room | Ground Floor / Corridor 1 | | |

| Assessment details | | | | Comments | Photograph |
|---|---|---|---|---|---|
| Identification | Presumed | Condition | Good Condition | | |

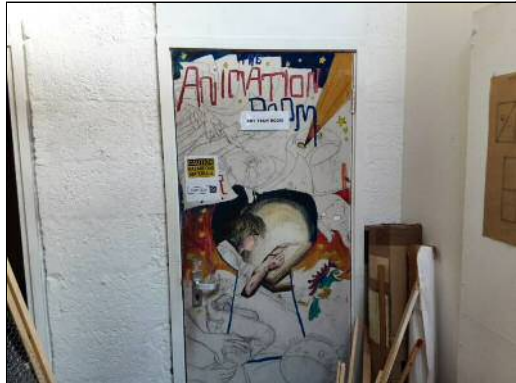
| Assessment details | | | | Comments | Photograph |
|---|---|---|---|---|---|
| Building | Block EFAE | Floor/ room | Ground Floor / Room 304 | No access to right hand cupboard<br>- locked, no key available at time of survey | |
| Identification | Inaccessible (Presumed) | Condition | n/a | | |

| Assessment details | | | | Comments | Photograph |
|---|---|---|---|---|---|
| Action | Inspect Prior to Disturbance | | | | |

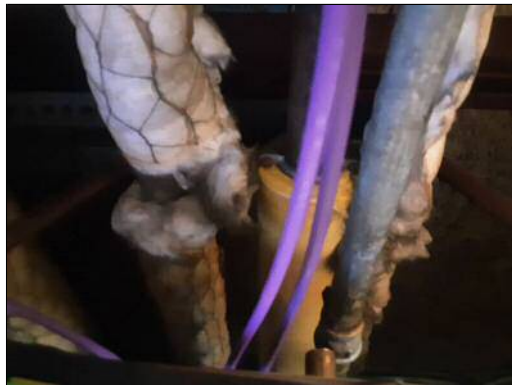
| Assessment details | | | | Comments | Photograph |
|---|---|---|---|---|---|
| Building | Block EFAD | Floor/ room | Ground Floor / G.23 store next to room 202 | Presumed to be on all lagging | |
| Identification | Strongly Presumed (024) | Condition | | | |

| Assessment details | | | | Comments | Photograph |
|---|---|---|---|---|---|
| Action | No further action required | | | | |

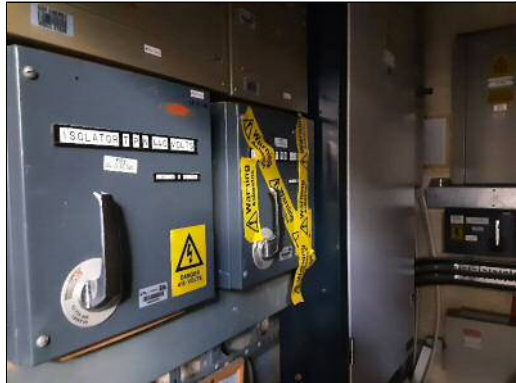
| Assessment details | | | | Comments | Photograph |
|---|---|---|---|---|---|
| Building | Block EFAE | Floor/ room | Ground Floor / Room 307 | No access to electrics - live services | |
| Identification | Inaccessible (Presumed) | Condition | n/a | | |

| Assessment details | | | | Comments | Photograph |
|---|---|---|---|---|---|
| Action | Inspect Prior to Disturbance | | | | |

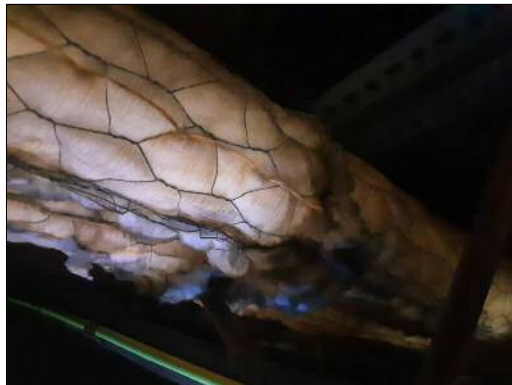
| Assessment details | | | | Comments | Photograph |
|---|---|---|---|---|---|
| Building | Block EFAD | Floor/ room | Ground Floor / G.22 room 202 | Presumed to be on all lagging | |
| Identification | Strongly Presumed (024) | Condition | | | |

| Assessment details | | | | Comments | Photograph |
|---|---|---|---|---|---|
| Action | No further action required | | | | |

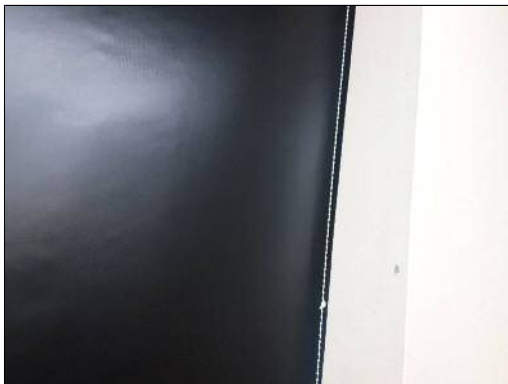
| Assessment details | | | | Comments | Photograph |
|---|---|---|---|---|---|
| Building | Block EFAD | Floor/ room | Ground Floor / G.24 room 204 | Beside columns by windows 2 no at 3lm each | |
| Identification | Strongly Presumed (034) | Condition | Good Condition | | |

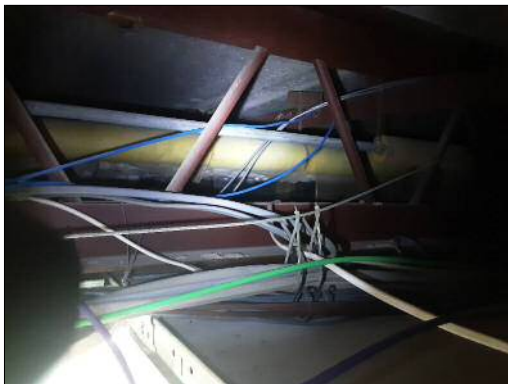
| Assessment details | | | | Comments | Photograph |
|---|---|---|---|---|---|
| Building | Block EFAD | Floor/ room | Ground Floor / G.24 room 204 | Presumed to be on all lagging | |
| Identification | Strongly Presumed (024) | Condition | | | |

| Assessment details | | | | Comments | Photograph |
|---|---|---|---|---|---|
| Action | No further action required | | | | |

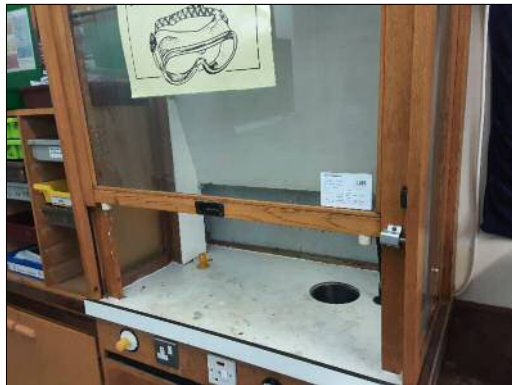
| Assessment details | | | | Comments | Photograph |
|---|---|---|---|---|---|
| Building | Block EFAD | Floor/ room | Ground Floor / G.24 room 204 | Presumed as unable to sample without compromising the integrity of the fume cabinet | |
| Identification | Presumed | Condition | Good Condition | | |

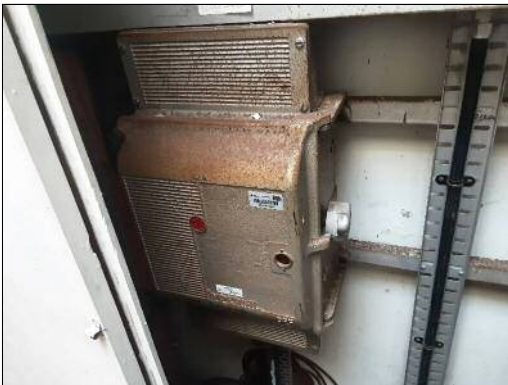
| Assessment details | | | | Comments | Photograph |
|---|---|---|---|---|---|
| Building | Block EFAD | Floor/ room | Ground Floor / G.25 store in room 204 | No access to electrics - live services | |
| Identification | Inaccessible (Presumed) | Condition | n/a | | |

| Assessment details | | | | Comments | Photograph |
|---|---|---|---|---|---|
| Action | Inspect Prior to Disturbance | | | | |

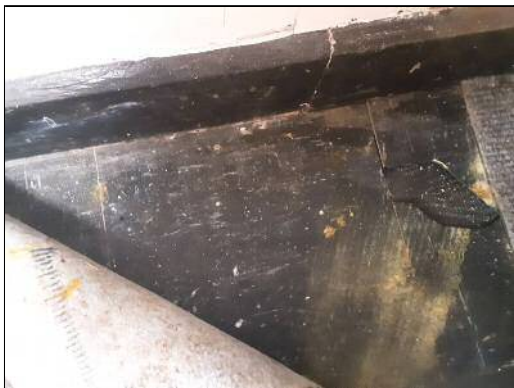
| Assessment details | | | | Comments | Photograph |
|---|---|---|---|---|---|
| Building | Block EFAD | Floor/ room | Ground Floor / G.25 store in room 204 | | |
| Identification | Strongly Presumed (092) | Condition | Low Damage | | |

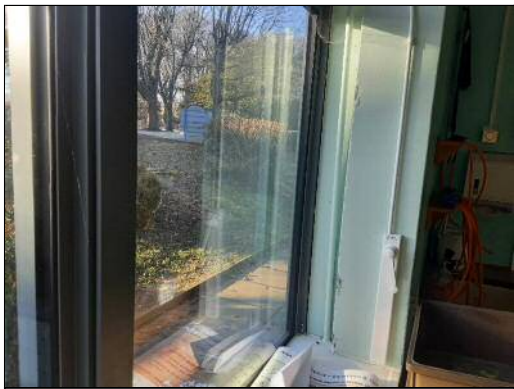
| Assessment details | | | | Comments | Photograph |
|---|---|---|---|---|---|
| Building | Block EFAD | Floor/ room | Ground Floor / G.26 room 205 | Beside columns by windows 4 no at 3lm each | |
| Identification | Strongly Presumed (034) | Condition | Good Condition | | |

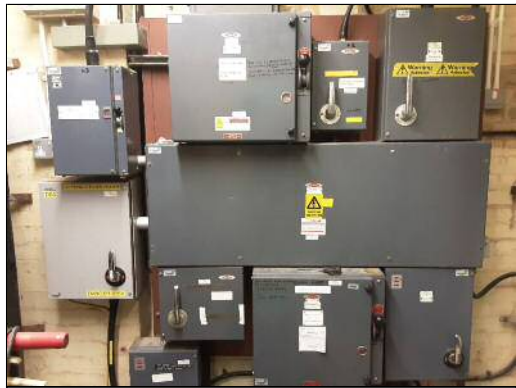
| Assessment details | | | | Comments | Photograph |
|---|---|---|---|---|---|
| Building | Block EFAA | Floor/ room | Ground Floor / Room 5A<br>mains intake | No access to electrics - live services | |
| Identification | Inaccessible (Presumed) | Condition | n/a | | |

| Assessment details | | | | Comments | Photograph |
|---|---|---|---|---|---|
| Action | Inspect Prior to Disturbance | | | | |

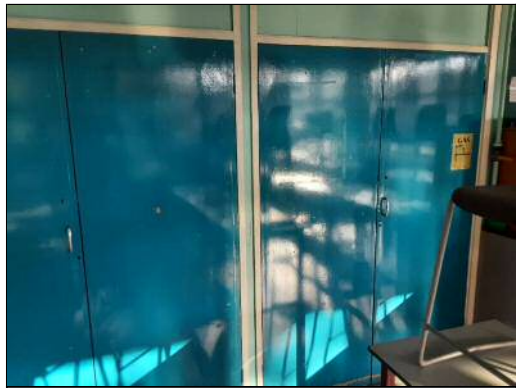
| Assessment details | | | | Comments | Photograph |
|---|---|---|---|---|---|
| Building | Block EFAD | Floor/ room | Ground Floor / G.26 room 205 | No access to cupboards - locked, no keys available at time of survey | |
| Identification | Inaccessible (Presumed) | Condition | n/a | | |

| Assessment details | | | | Comments | Photograph |
|---|---|---|---|---|---|
| Action | Inspect Prior to Disturbance | | | | |

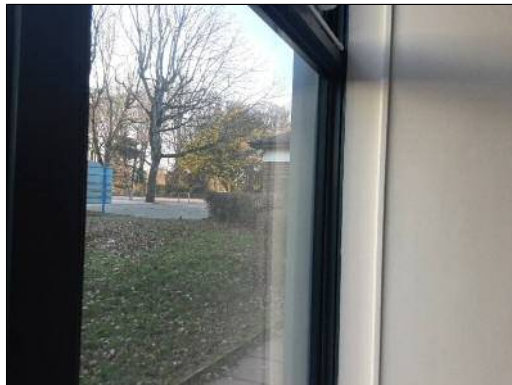
| Assessment details | | | | Comments | Photograph |
|---|---|---|---|---|---|
| Building | Block EFAD | Floor/ room | Ground Floor / G.27 room 206 | To columns and by windows 3 no at 3lm each | |
| Identification | Strongly Presumed (034) | Condition | Low Damage | | |

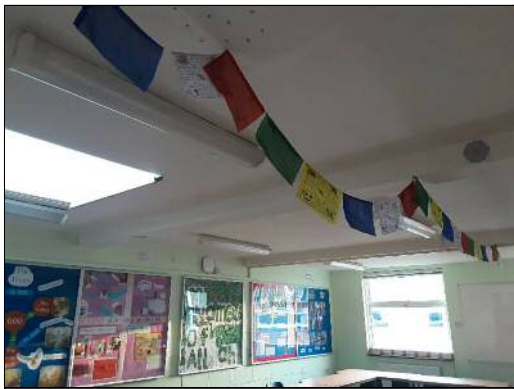
| Assessment details | | | | Comments | Photograph |
|---|---|---|---|---|---|
| Building | Block EFAA | Floor/ room | Ground Floor / Room 29 classroom | Also in cupboard | |
| Identification | Identified | Condition | Good Condition | | |

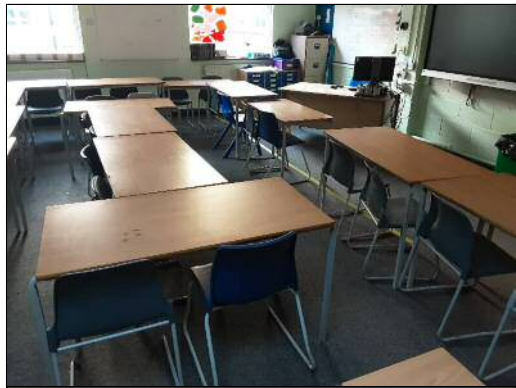
| Assessment details | | | | Comments | Photograph |
|---|---|---|---|---|---|
| Building | Block EFAA | Floor/ room | Ground Floor / Room 29 classroom | Also in cupboard | |
| Identification | Identified | Condition | Good Condition | | |

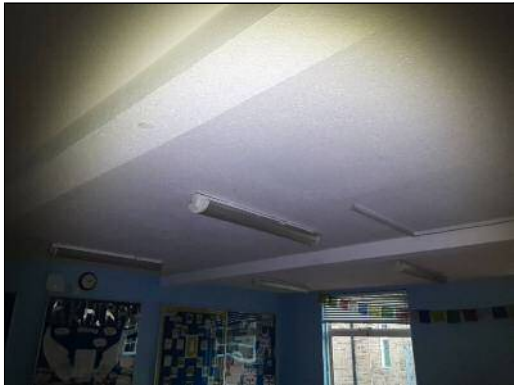
| Assessment details | | | | Comments | Photograph |
|---|---|---|---|---|---|
| Building | Block EFAA | Floor/ room | Ground Floor / Room 28 classroom | Also in cupboard | |
| Identification | Strongly Presumed (183) | Condition | Good Condition | | |

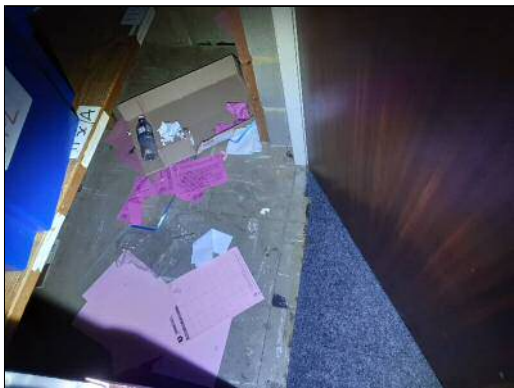
| Assessment details | | | | Comments | Photograph |
|---|---|---|---|---|---|
| Building | Block EFAA | Floor/ room | Ground Floor / Room 28 classroom | Also in cupboard | |
| Identification | Strongly Presumed (184) | Condition | Good Condition | | |

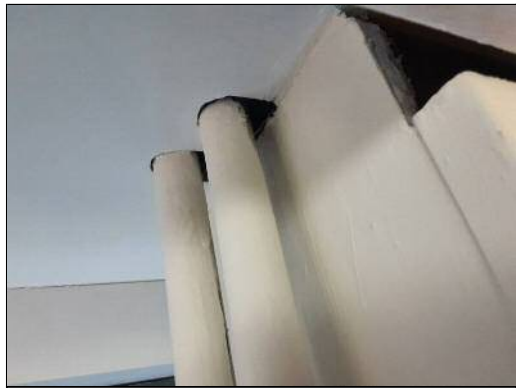
| Assessment details | | | | Comments | Photograph |
|---|---|---|---|---|---|
| Building | Block EFAD | Floor/ room | Ground Floor / G.28 room 207 | To columns and by windows 9 no at 3lm each | |
| Identification | Strongly Presumed (034) | Condition | Low Damage | | |

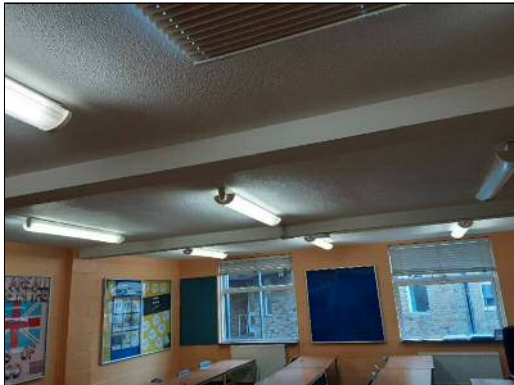
| Assessment details | | | | Comments | Photograph |
|---|---|---|---|---|---|
| Building | Block EFAA | Floor/ room | Ground Floor / Room 27 classroom | Also in cupboard | |
| Identification | Strongly Presumed (183) | Condition | Good Condition | | |

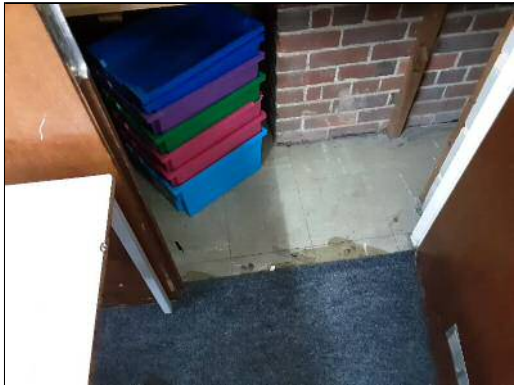
| Assessment details | | | | Comments | Photograph |
|---|---|---|---|---|---|
| Building | Block EFAA | Floor/ room | Ground Floor / Room 27 classroom | Also in cupboard | |
| Identification | Strongly Presumed (184) | Condition | Good Condition | | |

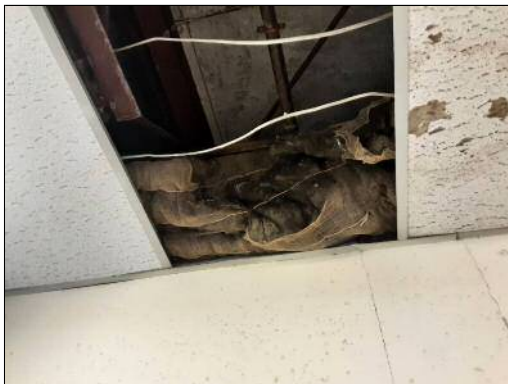
| Assessment details | | | | Comments | Photograph |
|---|---|---|---|---|---|
| Building | Block EFAD | Floor/ room | Ground Floor / G.28 room 207 | Above suspended deiling | |
| Identification | Strongly Presumed (024) | Condition | | | |

| Assessment details | | | | Comments | Photograph |
|---|---|---|---|---|---|
| Action | No further action required | | | | |

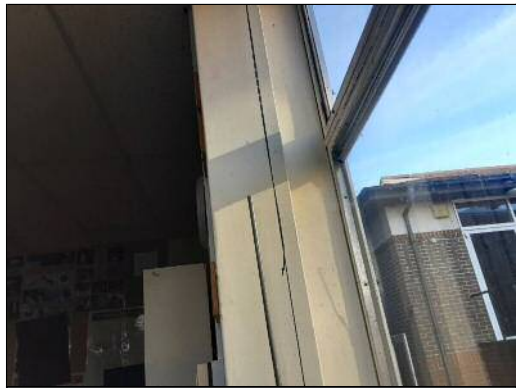
| Assessment details | | | | Comments | Photograph |
|---|---|---|---|---|---|
| Building | Block EFAD | Floor/ room | Ground Floor / G.30 room 210 | To columns and by windows 6 no at 3lm each | |
| Identification | Strongly Presumed (034) | Condition | Low Damage | | |

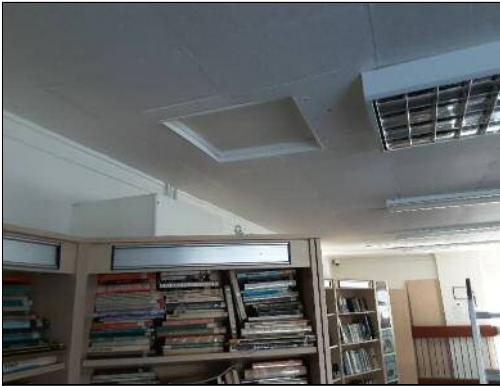
| Assessment details | | | | Comments | Photograph |
|---|---|---|---|---|---|
| Building | Block EFAA | Floor/ room | Ground Floor / Room 6 library | No access to loft - fitted shelving below prevents access | |
| Identification | Inaccessible (Presumed) | Condition | n/a | | |

| Assessment details | | | | Comments | Photograph |
|---|---|---|---|---|---|
| Action | Inspect Prior to Disturbance | | | | |

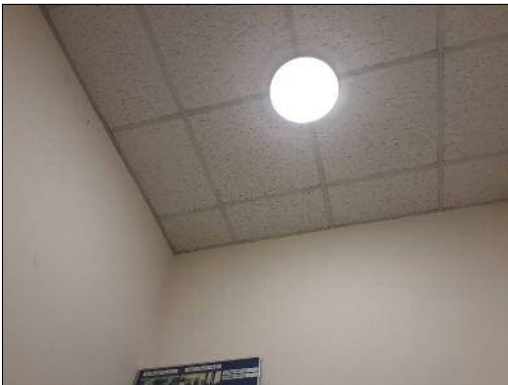
| Assessment details | | | | Comments | Photograph |
|---|---|---|---|---|---|
| Building | Block EFAA | Floor/ room | Ground Floor / Room 7A office | No access to ceiling void - ceiling too high for stepladder and area too small for tower scaffold | |
| Identification | Inaccessible (Presumed) | Condition | n/a | | |

| Assessment details | | | | Comments | Photograph |
|---|---|---|---|---|---|
| Action | Inspect Prior to Disturbance | | | | |

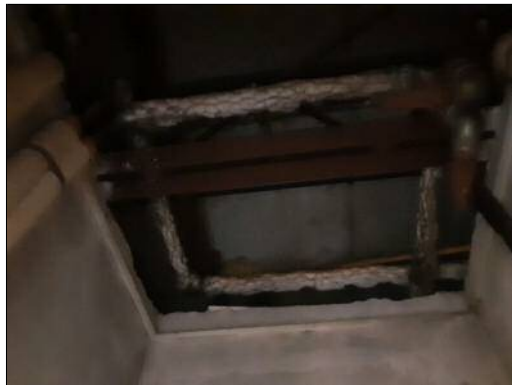
| Assessment details | | | | Comments | Photograph |
|---|---|---|---|---|---|
| Building | Block EFAD | Floor/ room | Ground Floor / G.33<br>Calorifier room in male toilets | Ceiling | |
| Identification | Strongly Presumed (024) | Condition | | | |

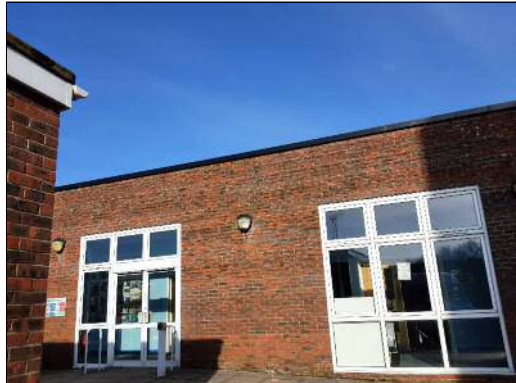
| Assessment details | | | | Comments | Photograph |
|---|---|---|---|---|---|
| Building | Block EFAF | Floor/ room | External / Externals | No access to roof - no safe access/edge protection | |
| Identification | Inaccessible (Presumed) | Condition | n/a | | |

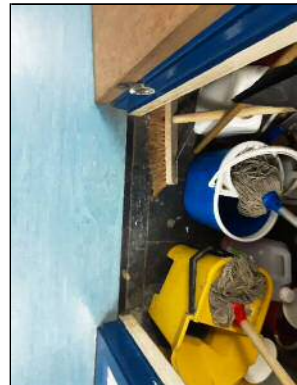
| Assessment details | | | | Comments | Photograph |
|---|---|---|---|---|---|
| Building | Block EFAD | Floor/ room | Ground Floor / G.34 cleaners cupboard | | |
| Identification | Strongly Presumed (092) | Condition | Low Damage | | |

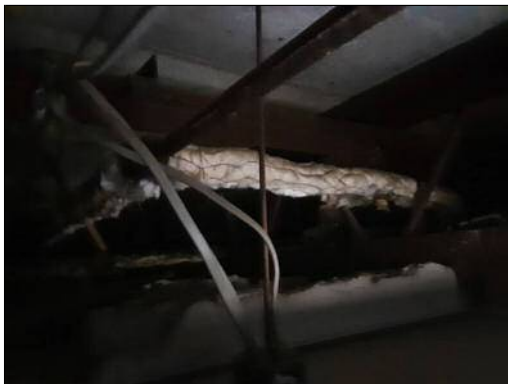
| Assessment details | | | | Comments | Photograph |
|---|---|---|---|---|---|
| Building | Block EFAD | Floor/ room | Ground Floor / G.36 Female toilets | Presumed to be on all lagging | |
| Identification | Strongly Presumed (024) | Condition | | | |

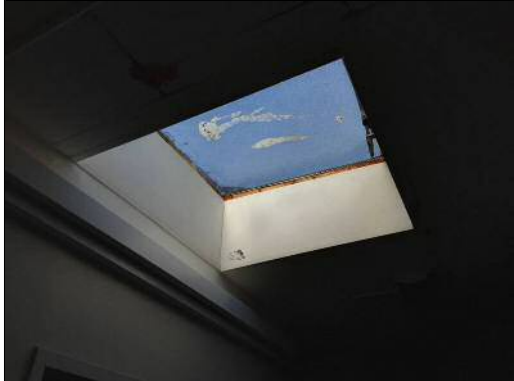
| Assessment details | | | | Comments | Photograph |
|---|---|---|---|---|---|
| Building | Block EFAA | Floor/ room | Ground Floor / Corridor 2 | 3 skylights | |
| Identification | Identified | Condition | Good Condition | | |

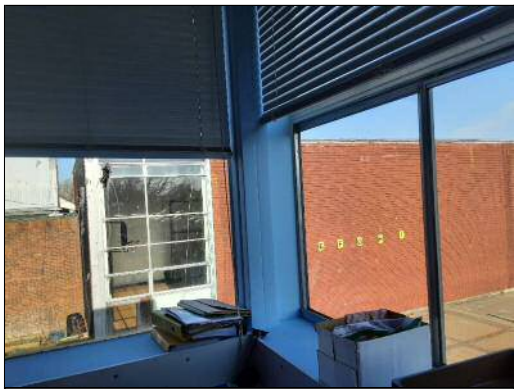
| Assessment details | | | | Comments | Photograph |
|---|---|---|---|---|---|
| Building | Block EFAD | Floor/ room | 1st Floor / 1.01 Staffroom 256 | 4 no at 3lm each | |
| Identification | Identified | Condition | Good Condition | | |

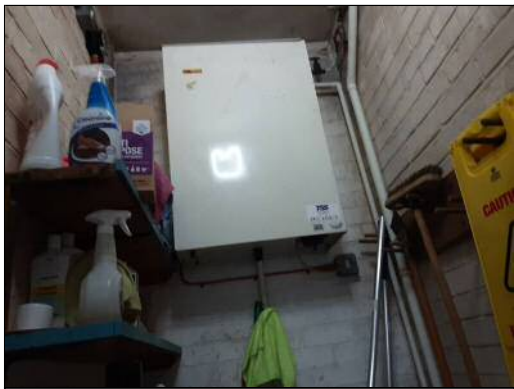
| Assessment details | | | | Comments | Photograph |
|---|---|---|---|---|---|
| Building | Block EFAA | Floor/ room | Ground Floor / Room 25 store | No access to water heater - live services | |
| Identification | Inaccessible (Presumed) | Condition | n/a | | |

| Assessment details | | | | Comments | Photograph |
|---|---|---|---|---|---|
| Action | Inspect Prior to Disturbance | | | | |

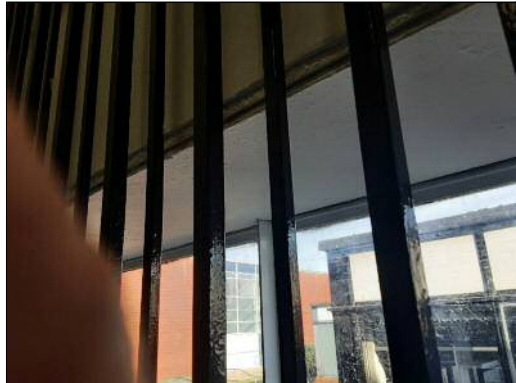
| Assessment details | | | | Comments | |
|---|---|---|---|---|---|
| Building | Block EFAD | Floor/ room | 1st Floor / 1.03 Stairwell | | |
| Identification | Identified | Condition | Low Damage | | |

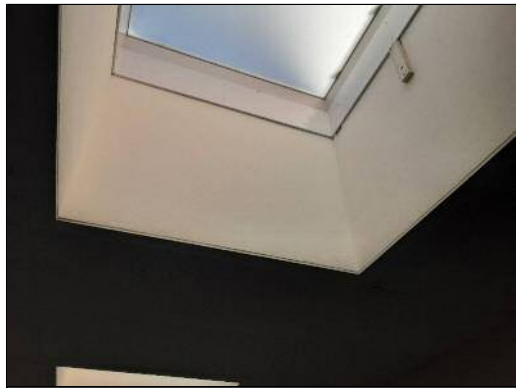
| Assessment details | | | | Comments | Photograph |
|---|---|---|---|---|---|
| Building | Block EFAD | Floor/ room | 1st Floor / 1.03 Stairwell | 2 no skylights 2m2 each | |
| Identification | Strongly Presumed (207) | Condition | Good Condition | | |

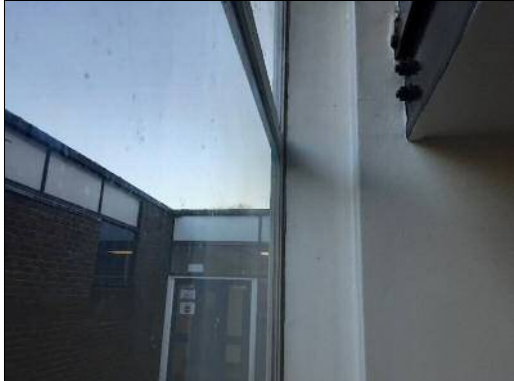
| Assessment details | | | | Comments | Photograph |
|---|---|---|---|---|---|
| Building | Block EFAD | Floor/ room | 1st Floor / 1.03 Stairwell | To large window and door on ground floor 2 panels at 3lm each | |

| Assessment details | | | | Comments | Photograph |
|---|---|---|---|---|---|
| Assessment no. | 0238 | Accessibility | Easily disturbed | | |
| Identification | Strongly Presumed (231) | Condition | Good Condition | | |

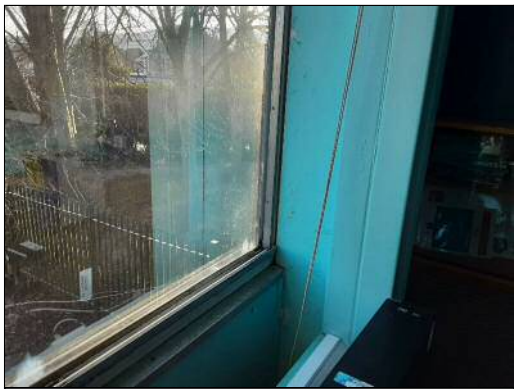
| Assessment details | | | | Comments | Photograph |
|---|---|---|---|---|---|
| Building | Block EFAD | Floor/ room | 1st Floor / 1.10 room 250 | Beside windows. 4 no at 3lm each | |

| Assessment details | | | | Comments | Photograph |
|---|---|---|---|---|---|
| Assessment no. | 0254 | Accessibility | Occasionally likely to be disturbed | | |
| Identification | Strongly Presumed (207) | Condition | Good Condition | | |

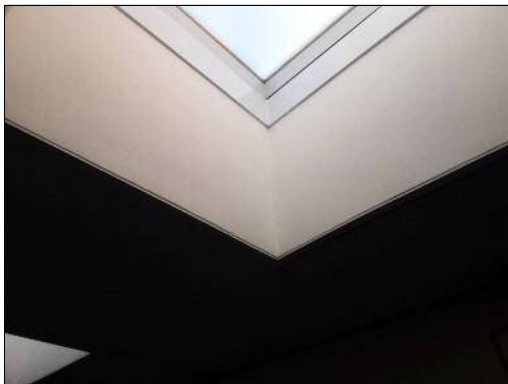
| Assessment details | | | | Comments | Photograph |
|---|---|---|---|---|---|
| Building | Block EFAD | Floor/ room | 1st Floor / 1.11 Stairwell | 2 no skylights 2m2 each | |

| Assessment details | | | | Comments | Photograph |
|---|---|---|---|---|---|
| Assessment no. | 0258 | Accessibility | Usually inaccessible or unlikely to be disturbed | | |
| Identification | Strongly Presumed (207) | Condition | Good Condition | | |

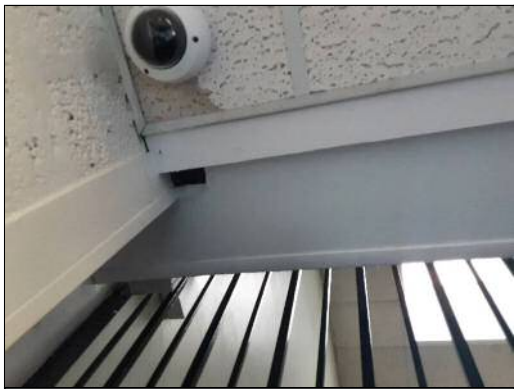
| Assessment details | | | | Comments | Photograph |
|---|---|---|---|---|---|
| Building | Block EFAD | Floor/ room | 1st Floor / 1.11 Stairwell | | |

| Assessment details | | | | Comments | Photograph |
|---|---|---|---|---|---|
| Assessment no. | 0259 | Accessibility | Usually inaccessible or unlikely to be disturbed | | |
| Identification | Strongly Presumed (231) | Condition | Low Damage | | |

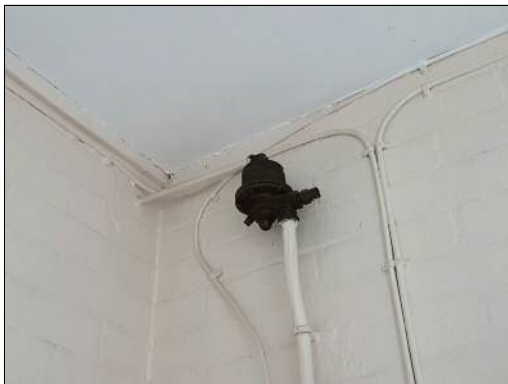
| Assessment details | | | | Comments | Photograph |
|---|---|---|---|---|---|
| Building | Block EFAA | Floor/ room | 1st Floor / Room 124A kitchen | Unable to sample gasket as flange is sealed shut | |

| Assessment details | | | | Comments | Photograph |
|---|---|---|---|---|---|
| Assessment no. | 0264 | Accessibility | Usually inaccessible or unlikely to be disturbed | | |
| Identification | Presumed | Condition | Good Condition | | |

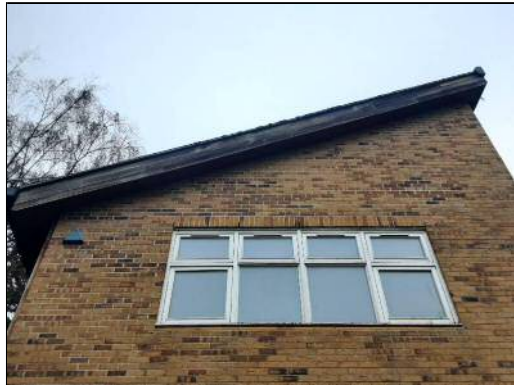
| Assessment details | | | | Comments | Photograph |
|---|---|---|---|---|---|
| Building | Block EFAC | Floor/ room | Ground Floor / G.38<br>Externals and covered walkway | No access to roof (3.5m+) - high level access required | |

| Assessment details | | | | Comments | Photograph |
|---|---|---|---|---|---|
| Identification | Inaccessible (Presumed) | Condition | n/a | | |

| Assessment details | | | | Comments | Photograph |
|---|---|---|---|---|---|
| Action | Inspect Prior to Disturbance | | | | |

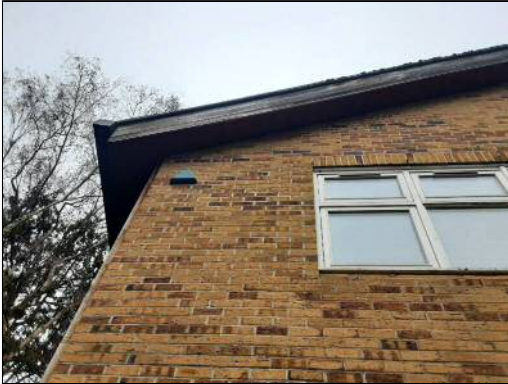
| Assessment details | | | | Comments | Photograph |
|---|---|---|---|---|---|
| Building | Block EFAC | Floor/ room | Ground Floor / G.38<br>Externals and covered walkway | Presume due to height | |

| Assessment details | | | | Comments | Photograph |
|---|---|---|---|---|---|
| Assessment no. | 0267 | Accessibility | Usually inaccessible or unlikely to be disturbed | | |
| Identification | Presumed | Condition | Low Damage | | |

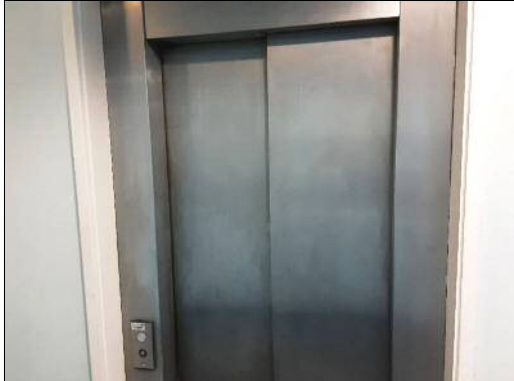
| Assessment details | | | | Comments | Photograph |
|---|---|---|---|---|---|
| Building | Block EFAC | Floor/ room | Ground Floor / G.50 Lift | No access to lift/shaft - kept locked, lift engineer required | |

| Assessment details | | | | Comments | Photograph |
|---|---|---|---|---|---|
| Identification | Inaccessible (Presumed) | Condition | n/a | | |

| Assessment details | | | | Comments | Photograph |
|---|---|---|---|---|---|
| Action | Inspect Prior to Disturbance | | | | |

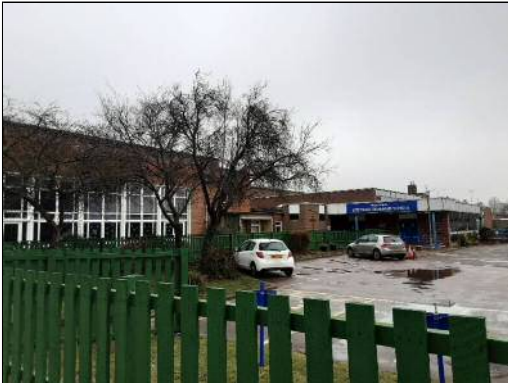
| Assessment details | | | | Comments | Photograph |
|---|---|---|---|---|---|
| Building | Block EFAA | Floor/ room | External / EFAA externals | No access to flat roofs - high level access required, aslo no edge protection | |

| Assessment details | | | | Comments | Photograph |
|---|---|---|---|---|---|
| Identification | Inaccessible (Presumed) | Condition | n/a | | |

| Assessment details | | | | Comments | Photograph |
|---|---|---|---|---|---|
| Action | Inspect Prior to Disturbance | | | | |

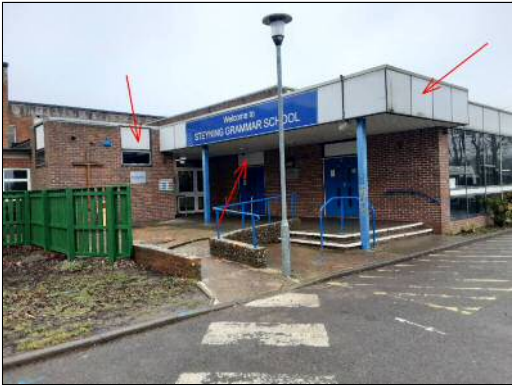
| Assessment details | | | | Comments | |
|---|---|---|---|---|---|
| Building | Block EFAA | Floor/ room | External / EFAA externals | | |

| Assessment details | | | | Comments | |
|---|---|---|---|---|---|
| Assessment no. | 0274 | Accessibility | Occasionally likely to be disturbed | | |
| Identification | Strongly Presumed (273) | Condition | Good Condition | | |
| Material risk | Very low | Material risk score | 3 | | |

| Assessment details | | | | Comments | |
|---|---|---|---|---|---|
| Action | Manage | | | | |

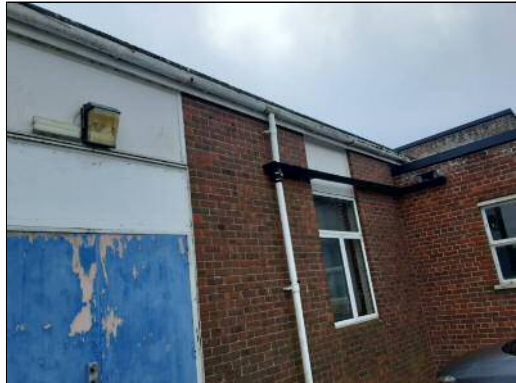
| Assessment details | | | | Comments | Photograph |
|---|---|---|---|---|---|
| Building | Block EFAA | Floor/ room | External / EFAA externals | Plastic guttering and steps blocking access with stepladder | |

| Assessment details | | | | Comments | Photograph |
|---|---|---|---|---|---|
| Assessment no. | 0275 | Accessibility | Occasionally likely to be disturbed | | |
| Identification | Presumed | Condition | Good Condition | | |

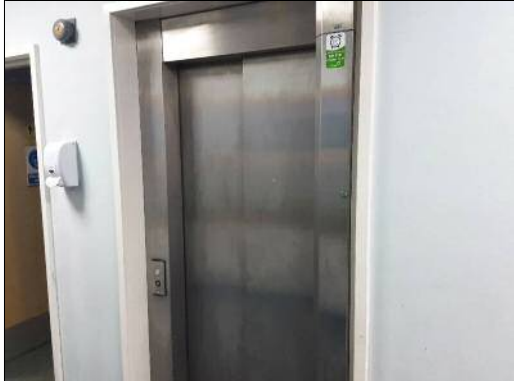
| Assessment details | | | | Comments | Photograph |
|---|---|---|---|---|---|
| Assessment no. | 0282 | Accessibility | | | |

| Assessment details | | | | Comments | Photograph |
|---|---|---|---|---|---|
| Building | Block EFAC | Floor/ room | 1st Floor / 1.20 Lift | No access to lift/shaft - kept locked, lift engineer required | |
| Identification | Inaccessible (Presumed) | Condition | n/a | | |

| Assessment details | | | | Comments | Photograph |
|---|---|---|---|---|---|
| Action | Inspect Prior to Disturbance | | | | |

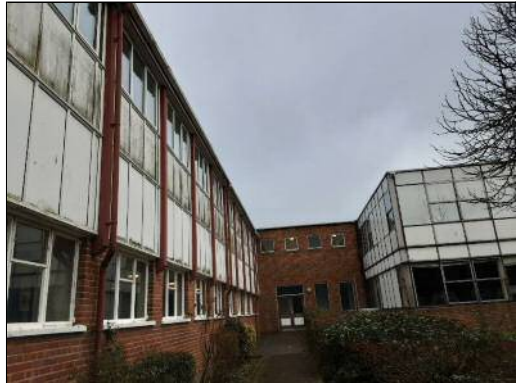
| Assessment details | | | | Comments | Photograph |
|---|---|---|---|---|---|
| Assessment no. | 0283 | Accessibility | | | |

| Assessment details | | | | Comments | Photograph |
|---|---|---|---|---|---|
| Building | Block EFAB | Floor/ room | External / EFAB externals | No access to roofs - high level access & edge protection required | |
| Identification | Inaccessible (Presumed) | Condition | n/a | | |

| Assessment details | | | | Comments | Photograph |
|---|---|---|---|---|---|
| Action | Inspect Prior to Disturbance | | | | |

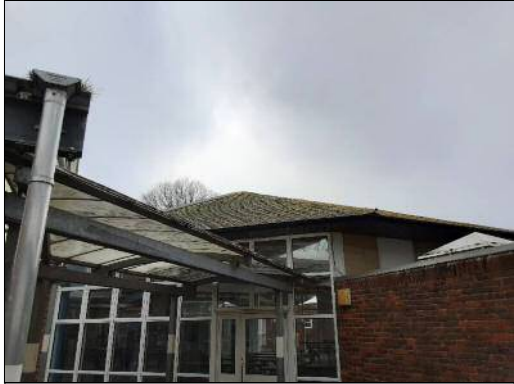
| Assessment details | | | | Comments | Photograph |
|---|---|---|---|---|---|
| Assessment no. | 0287 | Accessibility | Occasionally likely to be disturbed | | |

| Assessment details | | | | Comments | Photograph |
|---|---|---|---|---|---|
| Building | Block EFAB | Floor/ room | External / EFAB externals | Presumed as no safe access to roof | |
| Identification | Presumed | Condition | Good Condition | | |

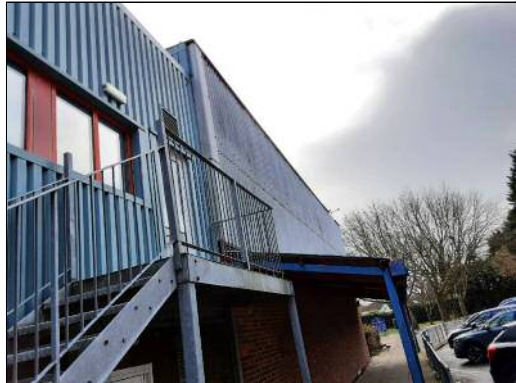
| Assessment details | | | | Comments | Photograph |
|---|---|---|---|---|---|
| Assessment no. | 0292 | Accessibility | Occasionally likely to be disturbed | | |

| Assessment details | | | | Comments | Photograph |
|---|---|---|---|---|---|
| Building | Block EFAG | Floor/ room | External / EFAG externals | No safe access to sample Cement | |

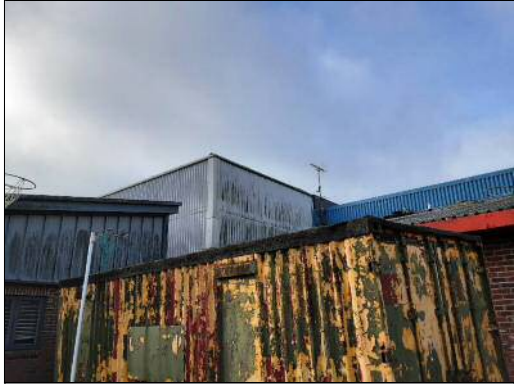
| Assessment details | | | | Comments | Photograph |
|---|---|---|---|---|---|
| Assessment no. | 0293 | Accessibility | | | |

| Assessment details | | | | Comments | Photograph |
|---|---|---|---|---|---|
| Building | Block EFAG | Floor/ room | External / EFAG externals | No access to roofs - high level access & edge protection required | |
| Identification | Inaccessible (Presumed) | Condition | n/a | | |

| Assessment details | | | | Comments | Photograph |
|---|---|---|---|---|---|
| Action | Inspect Prior to Disturbance | | | | |

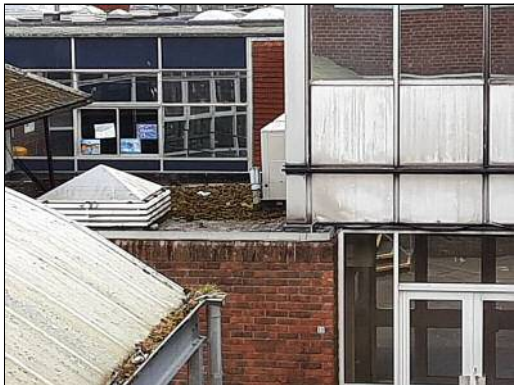
| Assessment details | | | | Comments | Photograph |
|---|---|---|---|---|---|
| Assessment no. | 0297 | Accessibility | Occasionally likely to be disturbed | | |

| Assessment details | | | | Comments | Photograph |
|---|---|---|---|---|---|
| Building | Block EFAB | Floor/ room | External / EFAB externals | No edge protection on roof | |
| Identification | Presumed | Condition | Good Condition | | |

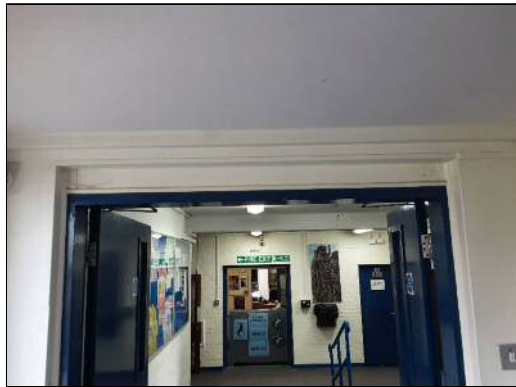
| Assessment details | | | | Comments | Photograph |
|---|---|---|---|---|---|
| Assessment no. | 0298 | Accessibility | | | |

| Assessment details | | | | Comments | Photograph |
|---|---|---|---|---|---|
| Building | Block EFAB | Floor/ room | Ground Floor / G.01 corridor | Both sides of 2 no doors | |

| Assessment details | | | | Comments | Photograph |
|---|---|---|---|---|---|
| Action | No further action required | | | | |

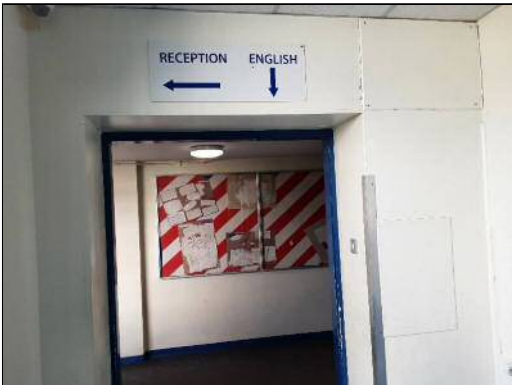
| Assessment details | | | | Comments | Photograph |
|---|---|---|---|---|---|
| Building | Block EFAB | Floor/ room | Ground Floor / corridor | Various materials around door.<br>Some insulating board, some<br>timber overcladding, some modern<br>board | |

| Assessment details | | | | Comments | Photograph |
|---|---|---|---|---|---|
| Action | No further action required | | | | |

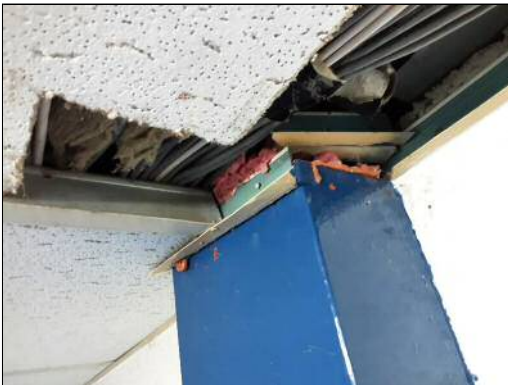
| Assessment details | | | | Comments | Photograph |
|---|---|---|---|---|---|
| Assessment no. | 0300 | Accessibility | | | |

| Assessment details | | | | Comments | Photograph |
|---|---|---|---|---|---|
| Building | Block EFAB | Floor/ room | Ground Floor / corridor | Within and around 2 no columns<br>Visible but inaccessible to sample | |

| Assessment details | | | | Comments | Photograph |
|---|---|---|---|---|---|
| Action | No further action required | | | | |

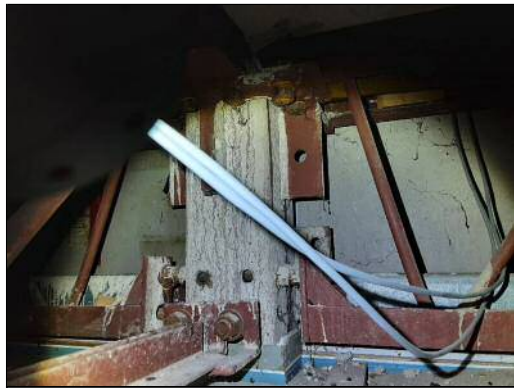
| Assessment details | | | | Comments | Photograph |
|---|---|---|---|---|---|
| Assessment no. | 0301 | Accessibility | | | |

| Assessment details | | | | Comments | Photograph |
|---|---|---|---|---|---|
| Building | Block EFAB | Floor/ room | Ground Floor / Room 45 Classroom | 3 no columns at 3lm | |

| Assessment details | | | | Comments | Photograph |
|---|---|---|---|---|---|
| Action | No further action required | | | | |
