**MANAGEMENT SURVEY FOR ASBESTOS-CONTAINING MATERIALS**

**SRP1121-EEG-XX-XX-T-O-0301-AsbestosManagementSurveyReport-ShootingField**

**CLIENT:** Arcadis UK (London)

**SITE:** Steyning Grammar School, Upper School, Shooting Field, Steyning, BN44 3RX

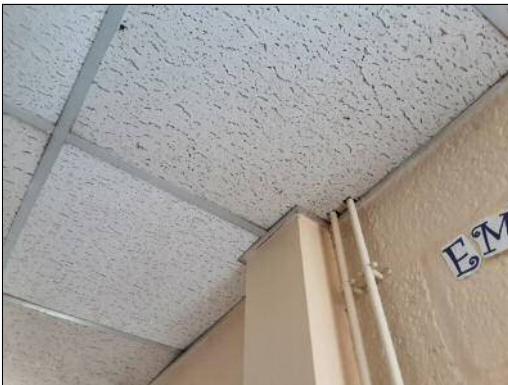
| Assessment details | | | | Comments | Photograph |
|---|---|---|---|---|---|
| Assessment no. | 0302 | Accessibility | | | |

| Assessment details | | | | Comments | Photograph |
|---|---|---|---|---|---|
| Building | Block EFAB | Floor/ room | Ground Floor / Room 46 Classroom | 6 no columns at 3lm | |

| Assessment details | | | | Comments | Photograph |
|---|---|---|---|---|---|
| Action | No further action required | | | | |

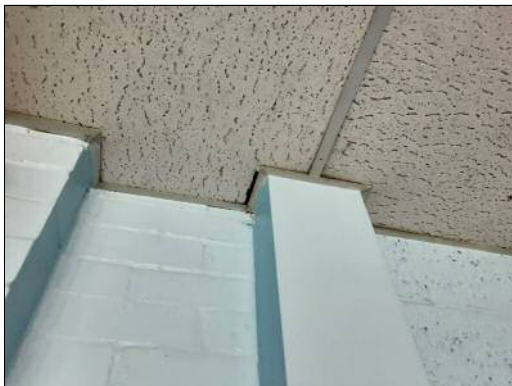
| Assessment details | | | | Comments | Photograph |
|---|---|---|---|---|---|
| Assessment no. | 0303 | Accessibility | | | |

| Assessment details | | | | Comments | Photograph |
|---|---|---|---|---|---|
| Building | Block EFAB | Floor/ room | Ground Floor / Room 47 Classroom | 4 no columns at 3lm | |

| Assessment details | | | | Comments | Photograph |
|---|---|---|---|---|---|
| Action | No further action required | | | | |

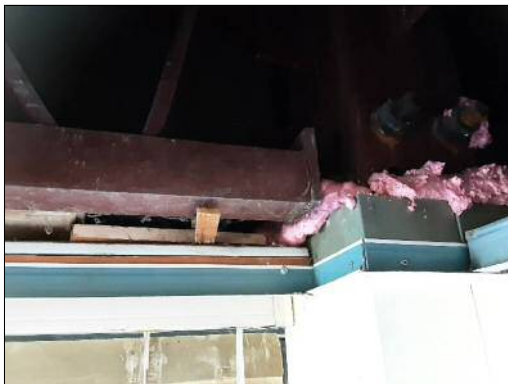
| Assessment details | | | | Comments | Photograph |
|---|---|---|---|---|---|
| Assessment no. | 0304 | Accessibility | | | |

| Assessment details | | | | Comments | Photograph |
|---|---|---|---|---|---|
| Building | Block EFAB | Floor/ room | Ground Floor / Room 48 Classroom | 6 no columns at 3lm Foam sealed | |

| Assessment details | | | | Comments | Photograph |
|---|---|---|---|---|---|
| Action | No further action required | | | | |

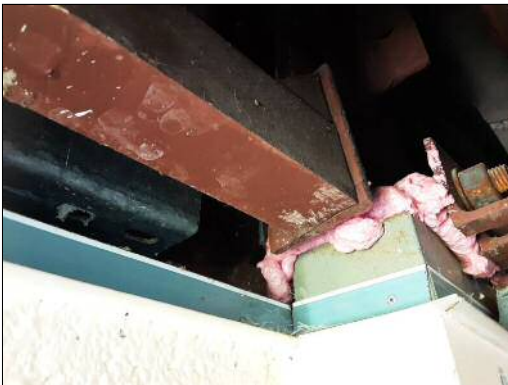
| Assessment details | | | | Comments | Photograph |
|---|---|---|---|---|---|
| Assessment no. | 0305 | Accessibility | | | |

| Assessment details | | | | Comments | Photograph |
|---|---|---|---|---|---|
| Building | Block EFAB | Floor/ room | Ground Floor / Room 50 Classroom | 5 no columns at 3lm Foam sealed | |

| Assessment details | | | | Comments | Photograph |
|---|---|---|---|---|---|
| Action | No further action required | | | | |

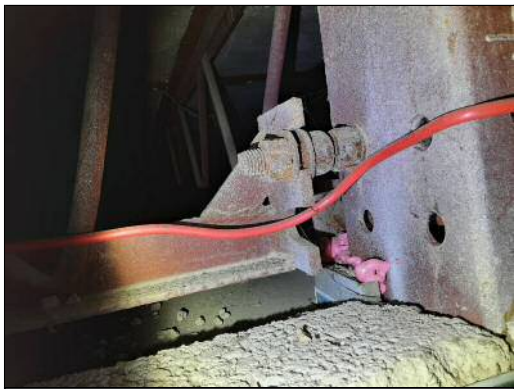
| Assessment details | | | | Comments | Photograph |
|---|---|---|---|---|---|
| Assessment no. | 0309 | Accessibility | | | |

| Assessment details | | | | Comments | Photograph |
|---|---|---|---|---|---|
| Building | Block EFAB | Floor/ room | Ground Floor / Corridor and stairwell | Foam sealed | |

| Assessment details | | | | Comments | Photograph |
|---|---|---|---|---|---|
| Action | No further action required | | | | |

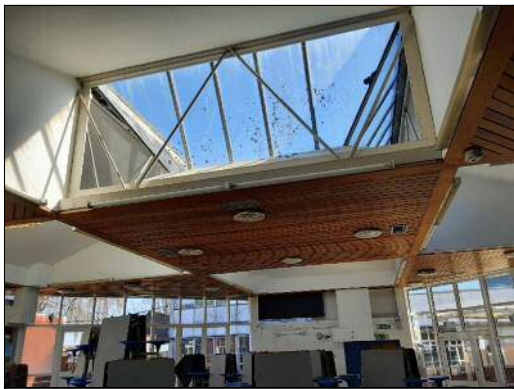
| Assessment details | | | | Comments | Photograph |
|---|---|---|---|---|---|
| Assessment no. | 0310 | Accessibility | | | |

| Assessment details | | | | Comments | Photograph |
|---|---|---|---|---|---|
| Building | Block EFAB | Floor/ room | Ground Floor / Room 29 Dining Room | No access to skylights - high level access required | |
| Identification | Inaccessible (Presumed) | Condition | n/a | | |

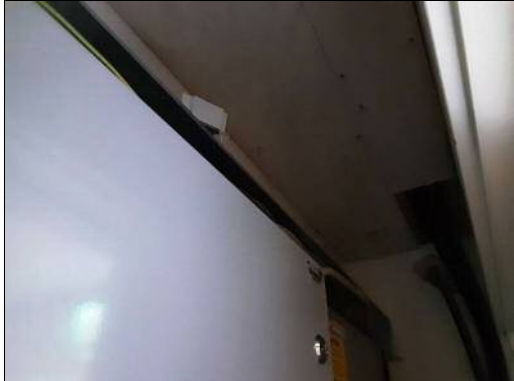
| Assessment details | | | | Comments | Photograph |
|---|---|---|---|---|---|
| Assessment no. | 0313 | Accessibility | | | |

| Assessment details | | | | Comments | Photograph |
|---|---|---|---|---|---|
| Building | Block EFAB | Floor/ room | Ground Floor / Room 34<br>electrics | Modern | |

| Assessment details | | | | Comments | Photograph |
|---|---|---|---|---|---|
| Action | No further action required | | | | |

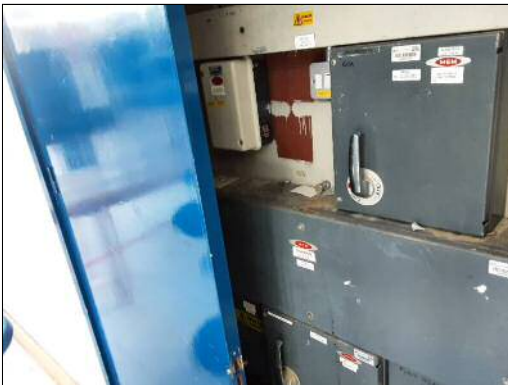
| Assessment details | | | | Comments | Photograph |
|---|---|---|---|---|---|
| Assessment no. | 0316 | Accessibility | | | |

| Assessment details | | | | Comments | Photograph |
|---|---|---|---|---|---|
| Building | Block EFAB | Floor/ room | Ground Floor / Room 45<br>electrics cupboard | No access to electrics - live services | |
| Identification | Inaccessible<br>(Presumed) | Condition | n/a | | |

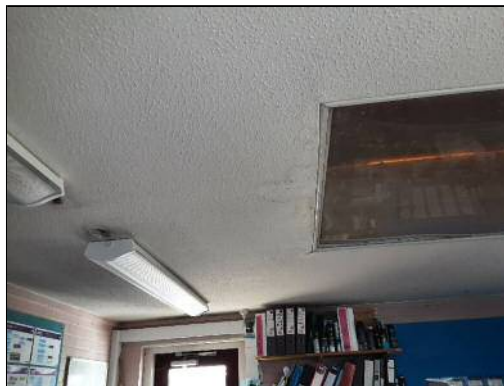
| Assessment details | | | | Comments | |
|---|---|---|---|---|---|
| Building | Block EFAB | Floor/ room | Ground Floor / Room 42<br>Office 58 | | |

| Assessment details | | | | Comments | |
|---|---|---|---|---|---|
| Identification | Strongly Presumed (314) | Condition | Good Condition | | |

| Assessment details | | | | Comments | Photograph |
|---|---|---|---|---|---|
| Action | Inspect Prior to Disturbance | | | | |

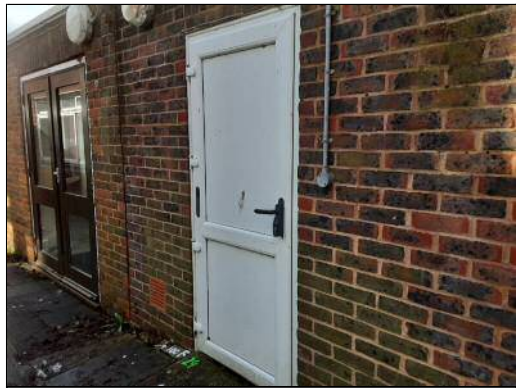
| Assessment details | | | | Comments | Photograph |
|---|---|---|---|---|---|
| Building | Block EFAB | Floor/ room | Ground Floor / Room 47<br>chemical store | No access - locked, no keys<br>available at time of survey | |

| Assessment details | | | | Comments | Photograph |
|---|---|---|---|---|---|
| Identification | Inaccessible<br>(Presumed) | Condition | n/a | | |

| Assessment details | | | | Comments | Photograph |
|---|---|---|---|---|---|
| Action | Inspect Prior to Disturbance | | | | |

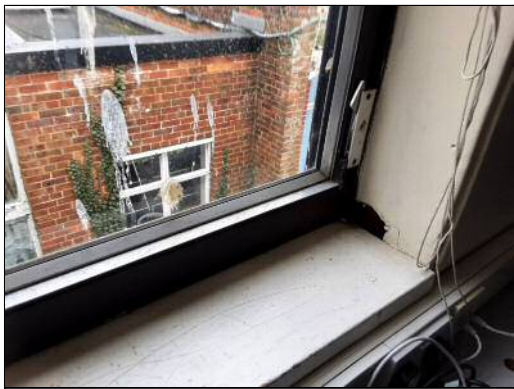
| Assessment details | | | | Comments | Photograph |
|---|---|---|---|---|---|
| Building | Block EFAB | Floor/ room | 1st Floor / Room 1.21<br>Classroom 118 | 10 no panels at 3lm | |

| Assessment details | | | | Comments | Photograph |
|---|---|---|---|---|---|
| Identification | Strongly Presumed (329) | Condition | | | |

| Assessment details | | | | Comments | Photograph |
|---|---|---|---|---|---|
| Action | No further action required | | | | |

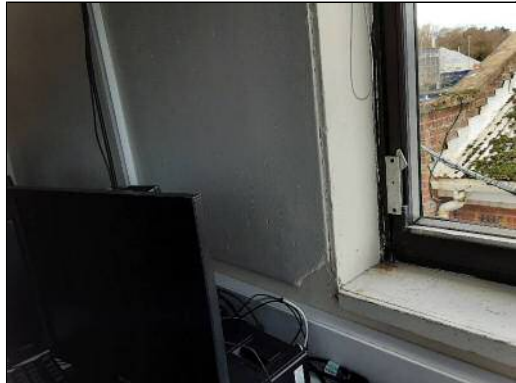
| Assessment details | | | | Comments | Photograph |
|---|---|---|---|---|---|
| Building | Block EFAB | Floor/ room | 1st Floor / Room 1.21<br>Classroom 118 | Wall panels between windows | |

| Assessment details | | | | Comments | Photograph |
|---|---|---|---|---|---|
| Identification | Identified | Condition | | | |

| Assessment details | | | | Comments | Photograph |
|---|---|---|---|---|---|
| Action | No further action required | | | | |

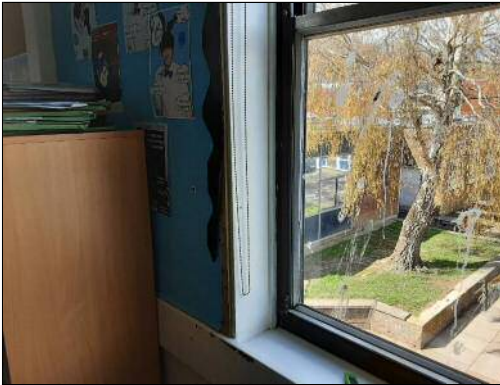
| Assessment details | | | | Comments | Photograph |
|---|---|---|---|---|---|
| Building | Block EFAB | Floor/ room | 1st Floor / Room 1.22<br>Classroom 116 | 10 no panels at 3lm | |

| Assessment details | | | | Comments | Photograph |
|---|---|---|---|---|---|
| Identification | Strongly Presumed (329) | Condition | | | |

| Assessment details | | | | Comments | Photograph |
|---|---|---|---|---|---|
| Action | No further action required | | | | |

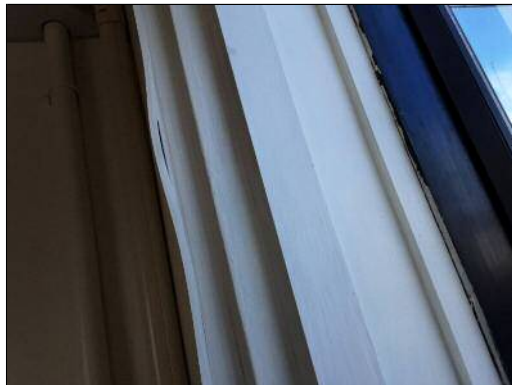
| Assessment details | | | | Comments | Photograph |
|---|---|---|---|---|---|
| Building | Block EFAB | Floor/ room | 1st Floor / Room 1.23 storeroom 114 | 2 no panels at 3lm | |

| Assessment details | | | | Comments | Photograph |
|---|---|---|---|---|---|
| Identification | Strongly Presumed (329) | Condition | | | |

| Assessment details | | | | Comments | Photograph |
|---|---|---|---|---|---|
| Action | No further action required | | | | |

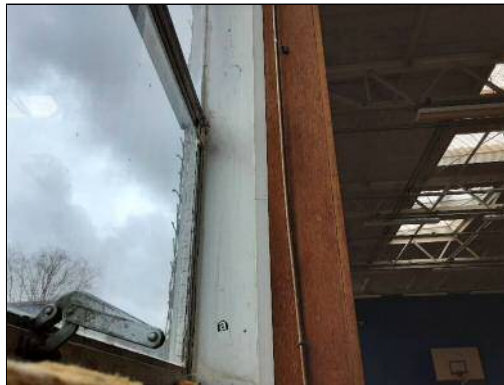
| Assessment details | | | | Comments | Photograph |
|---|---|---|---|---|---|
| Building | Block EFAG | Floor/ room | Ground Floor / 122 gym | Plastic coating to board, x14 columns at 7lm each. | |

| Assessment details | | | | Comments | Photograph |
|---|---|---|---|---|---|
| Identification | Identified | Condition | Good Condition | | |

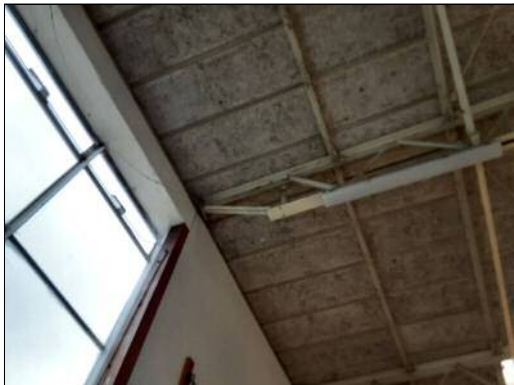
| Assessment details | | | | Comments | Photograph |
|---|---|---|---|---|---|
| Building | Block EFAG | Floor/ room | Ground Floor / 122 gym | No access to ceiling and high level areas (3.5m+) - high level access required | |

| Assessment details | | | | Comments | Photograph |
|---|---|---|---|---|---|
| Identification | Inaccessible (Presumed) | Condition | n/a | | |

| Assessment details | | | | Comments | Photograph |
|---|---|---|---|---|---|
| Action | Inspect Prior to Disturbance | | | | |

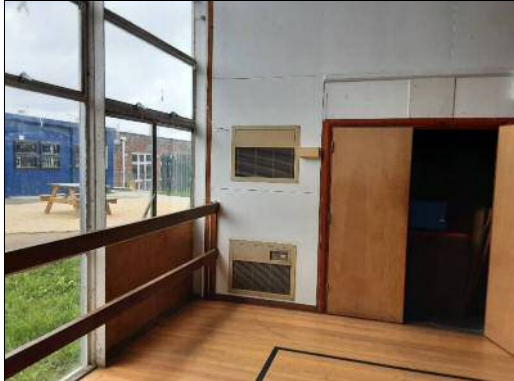
| Assessment details | | | | Comments | Photograph |
|---|---|---|---|---|---|
| Building | Block EFAG | Floor/ room | Ground Floor / 122 gym | No access within recessed wall heaters throughout - sealed units, live electrics, heaters fully operational, inaccessible rear doors to heaters | |

| Assessment details | | | | Comments | Photograph |
|---|---|---|---|---|---|
| Identification | Inaccessible (Presumed) | Condition | n/a | | |

| Assessment details | | | | Comments | Photograph |
|---|---|---|---|---|---|
| Action | Inspect Prior to Disturbance | | | | |

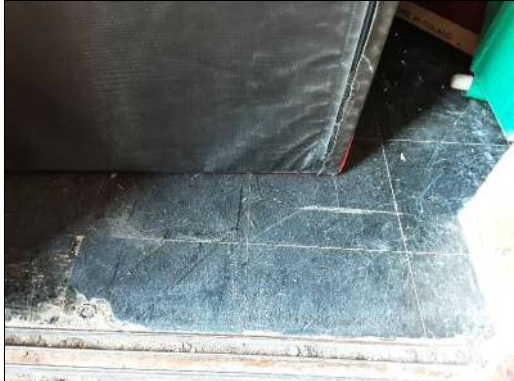
| Assessment details | | | | Comments | <div>Photograph</div> |
|---|---|---|---|---|---|
| Building | Block EFAG | Floor/ room | Ground Floor / 125 | | |

| Assessment details | | | | Comments | <div>Photograph</div> |
|---|---|---|---|---|---|
| Identification | Identified | Condition | Low Damage | | |

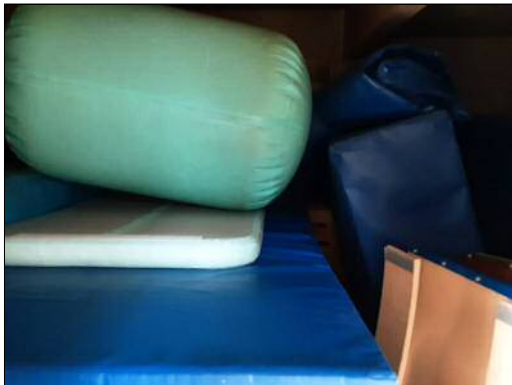
| Assessment details | | | | Comments | Photograph |
|---|---|---|---|---|---|
| Building | Block EFAG | Floor/ room | Ground Floor / 125 | No access to far reaches of store<br>- Stored equipment prevents access, visual inspection from doorway only | |

| Assessment details | | | | Comments | Photograph |
|---|---|---|---|---|---|
| Identification | Inaccessible (Presumed) | Condition | n/a | | |

| Assessment details | | | | Comments | Photograph |
|---|---|---|---|---|---|
| Action | Inspect Prior to Disturbance | | | | |

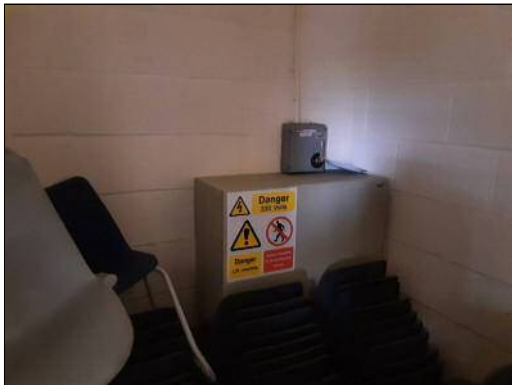
| Assessment details | | | | Comments | Photograph |
|---|---|---|---|---|---|
| Building | Block EFAG | Floor/ room | Ground Floor / 490 | No access to electrics throughout<br>- live services | |

| Assessment details | | | | Comments | Photograph |
|---|---|---|---|---|---|
| Identification | Inaccessible (Presumed) | Condition | n/a | | |

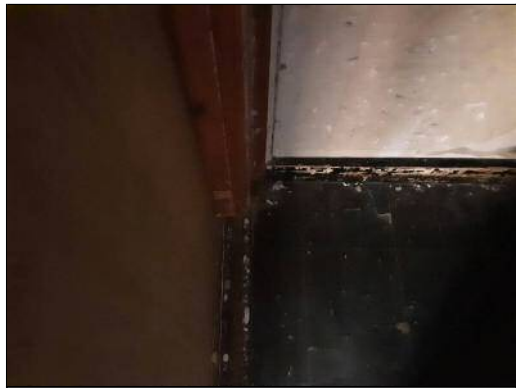
| Assessment details | | | | Comments | Photograph | |
|---|---|---|---|---|---|--|
| Building | Block EFAG | Floor/ room | Ground Floor / 117 and 124 | | | |

| Assessment details | | | | Comments | Photograph | |
|---|---|---|---|---|---|--|
| Identification | Strongly Presumed (338) | Condition | Low Damage | | | |
| Extent | 4m² | Asbestos Type | Chrysotile | | | |

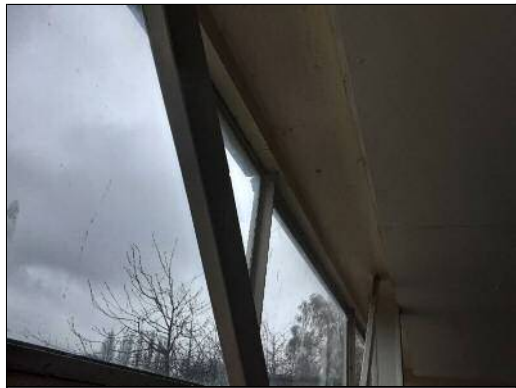
| Assessment details | | | | Comments | Photograph |
|---|---|---|---|---|---|
| Building | Block EFAG | Floor/ room | Ground Floor / 456 | | |

| Assessment details | | | | Comments | Photograph |
|---|---|---|---|---|---|
| Identification | Identified | Condition | Low Damage | | |

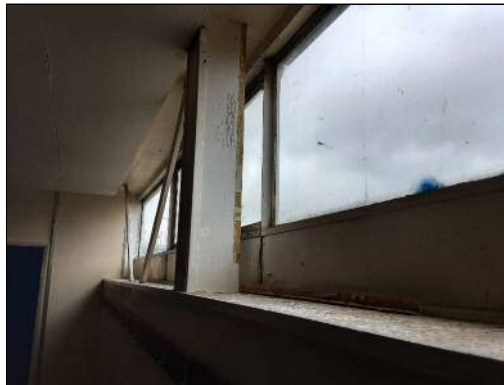
| Assessment details | | | | Comments | Photograph |
|---|---|---|---|---|---|
| Building | Block EFAG | Floor/ room | Ground Floor / 456 | X3 columns at 4lm each | |

| Assessment details | | | | Comments | Photograph |
|---|---|---|---|---|---|
| Identification | Identified | Condition | Low Damage | | |

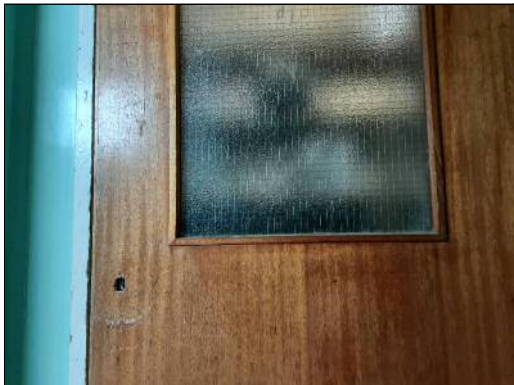
| Assessment details | | | | Comments | Photograph |
|---|---|---|---|---|---|
| Building | Block EFAG | Floor/ room | Ground Floor / 121 | No access - locked, no key available at time of survey | |

| Assessment details | | | | Comments | Photograph |
|---|---|---|---|---|---|
| Identification | Inaccessible (Presumed) | Condition | n/a | | |

| Assessment details | | | | Comments | Photograph |
|---|---|---|---|---|---|
| Action | Inspect Prior to Disturbance | | | | |

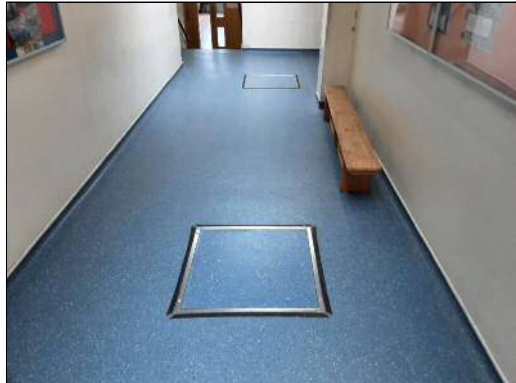
| Assessment details | | | | Comments | Photograph |
|---|---|---|---|---|---|
| Building | Block EFAG | Floor/ room | Ground Floor / 485 | No access within floor ducts throughout - confined space | |

| Assessment details | | | | Comments | Photograph |
|---|---|---|---|---|---|
| Identification | Inaccessible (Presumed) | Condition | n/a | | |

| Assessment details | | | | Comments | Photograph |
|---|---|---|---|---|---|
| Action | Inspect Prior to Disturbance | | | | |

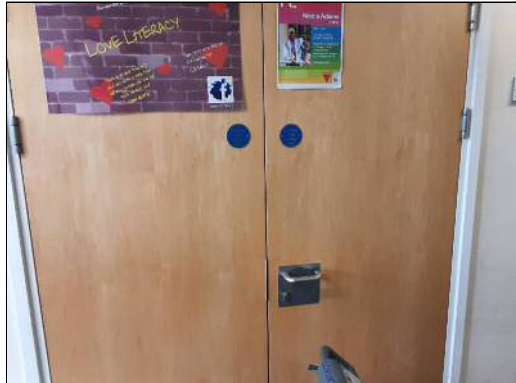
| Assessment details | | | | Comments | Photograph |
|---|---|---|---|---|---|
| Building | Block EFAG | Floor/ room | Ground Floor / 498A | No access to electrics - live services | |

| Assessment details | | | | Comments | Photograph |
|---|---|---|---|---|---|
| Identification | Inaccessible (Presumed) | Condition | n/a | | |

| Assessment details | | | | Comments | Photograph |
|---|---|---|---|---|---|
| Action | Inspect Prior to Disturbance | | | | |

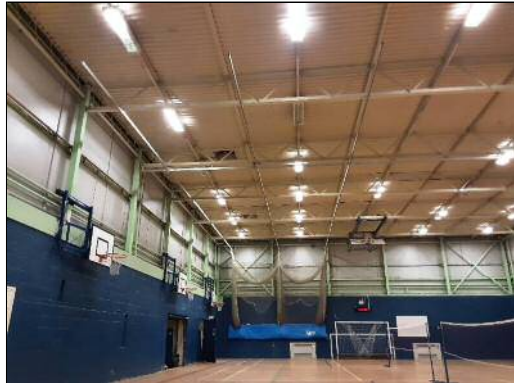
| Assessment details | | | | Comments | Photograph |
|---|---|---|---|---|---|
| Building | Block EFAG | Floor/ room | Ground Floor / 142 | No access to ceiling and high level areas (3.5m+) - high level access required | |

| Assessment details | | | | Comments | Photograph |
|---|---|---|---|---|---|
| Identification | Inaccessible (Presumed) | Condition | n/a | | |

| Assessment details | | | | Comments | Photograph |
|---|---|---|---|---|---|
| Action | Inspect Prior to Disturbance | | | | |

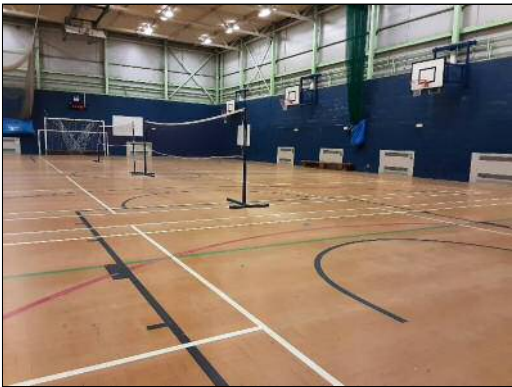
| Assessment details | | | | Comments | Photograph |
|---|---|---|---|---|---|
| Building | Block EFAG | Floor/ room | Ground Floor / 142 | No access within recessed wall heaters throughout - sealed units, live electrics, heaters fully operational, inaccessible rear doors to heaters | |

| Assessment details | | | | Comments | Photograph |
|---|---|---|---|---|---|
| Identification | Inaccessible (Presumed) | Condition | n/a | | |

| Assessment details | | | | Comments | Photograph |
|---|---|---|---|---|---|
| Action | Inspect Prior to Disturbance | | | | |

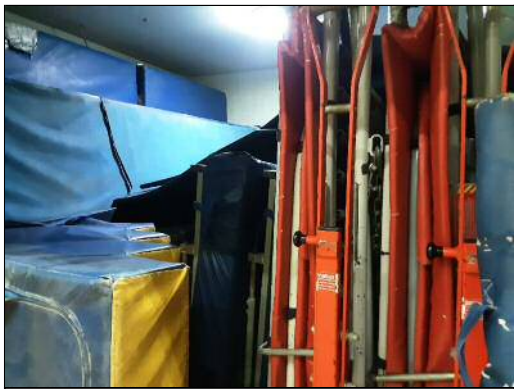
| Assessment details | | | | Comments | Photograph |
|---|---|---|---|---|---|
| Building | Block EFAG | Floor/ room | Ground Floor / 144 split stores | No access to far reaches of stores - stored equipment prevents access, visual inspection from doorway only | |
| Identification | Inaccessible (Presumed) | Condition | n/a | | |

| Assessment details | | | | Comments | Photograph |
|---|---|---|---|---|---|
| Action | Inspect Prior to Disturbance | | | | |

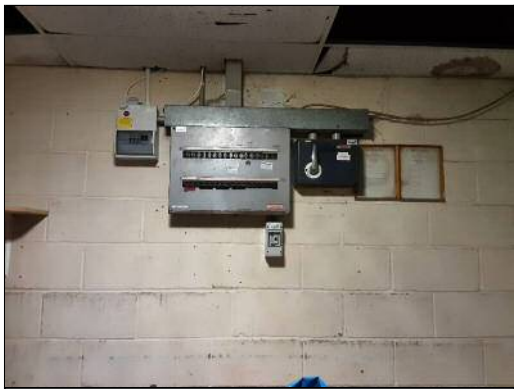
| Assessment details | | | | Comments | Photograph |
|---|---|---|---|---|---|
| Assessment no. | 0360 | Accessibility | | | |

| Assessment details | | | | Comments | Photograph |
|---|---|---|---|---|---|
| Building | Block EFAG | Floor/ room | Ground Floor / 144 split stores | No access to electrics - live services | |
| Identification | Inaccessible (Presumed) | Condition | n/a | | |

| Assessment details | | | | Comments | Photograph |
|---|---|---|---|---|---|
| Action | Inspect Prior to Disturbance | | | | |

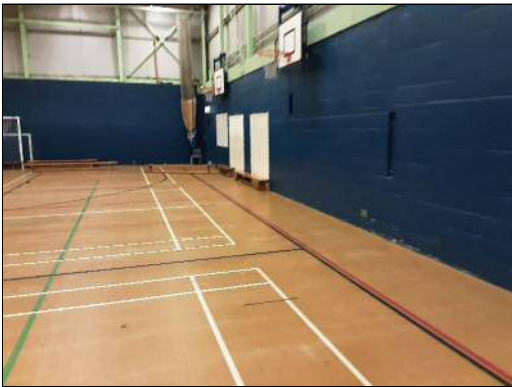
| Assessment details | | | | Comments | Photograph |
|---|---|---|---|---|---|
| Assessment no. | 0361 | Accessibility | | | |

| Assessment details | | | | Comments | Photograph |
|---|---|---|---|---|---|
| Building | Block EFAG | Floor/ room | Ground Floor / 142 | No access within 2 no. cupboards<br>- locked, no keys available at time of survey | |
| Identification | Inaccessible (Presumed) | Condition | n/a | | |

| Assessment details | | | | Comments | Photograph |
|---|---|---|---|---|---|
| Action | Inspect Prior to Disturbance | | | | |

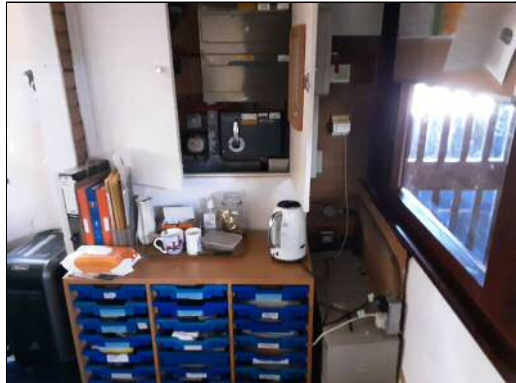
| Assessment details | | | | Comments | Photograph |
|---|---|---|---|---|---|
| Assessment no. | 0364 | Accessibility | | | |

| Assessment details | | | | Comments | Photograph |
|---|---|---|---|---|---|
| Building | Block EFAG | Floor/ room | Ground Floor / 343 | No access to electrics - live services | |
| Identification | Inaccessible (Presumed) | Condition | n/a | | |

| Assessment details | | | | Comments | Photograph |
|---|---|---|---|---|---|
| Action | Inspect Prior to Disturbance | | | | |

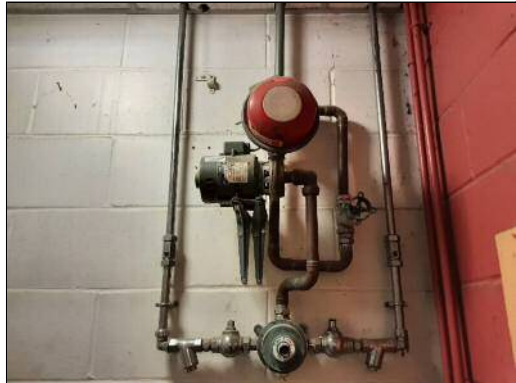
| Assessment details | | | | Comments | Photograph |
|---|---|---|---|---|---|
| Assessment no. | 0365 | Accessibility | Usually inaccessible or unlikely to be disturbed | | |

| Assessment details | | | | Comments | Photograph |
|---|---|---|---|---|---|
| Building | Block EFAG | Floor/ room | Ground Floor / 141 | | |
| Identification | Presumed | Condition | Low Damage | | |

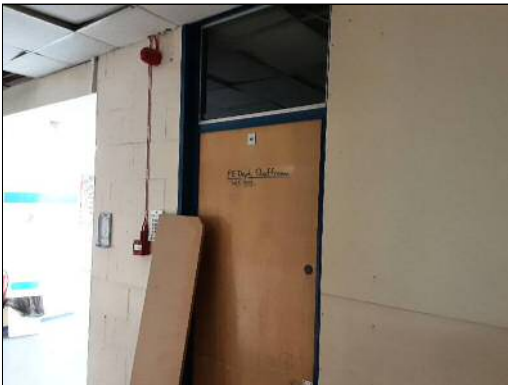
| Assessment details | | | | Comments | Photograph |
|---|---|---|---|---|---|
| Assessment no. | 0366 | Accessibility | | | |

| Assessment details | | | | Comments | Photograph |
|---|---|---|---|---|---|
| Building | Block EFAG | Floor/ room | Ground Floor / 134 | No access - locked, no key available at time of survey | |
| Identification | Inaccessible (Presumed) | Condition | n/a | | |

| Assessment details | | | | Comments | Photograph |
|---|---|---|---|---|---|
| Action | Inspect Prior to Disturbance | | | | |

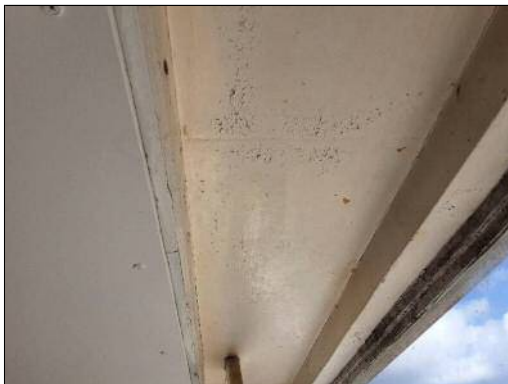
| Assessment details | | | | Comments | Photograph |
|---|---|---|---|---|---|
| Assessment no. | 0367 | Accessibility | Occasionally likely to be disturbed | | |

| Assessment details | | | | Comments | Photograph |
|---|---|---|---|---|---|
| Building | Block EFAG | Floor/ room | Ground Floor / 118 and 459 | | |
| Identification | Strongly Presumed (347) | Condition | Low Damage | | |

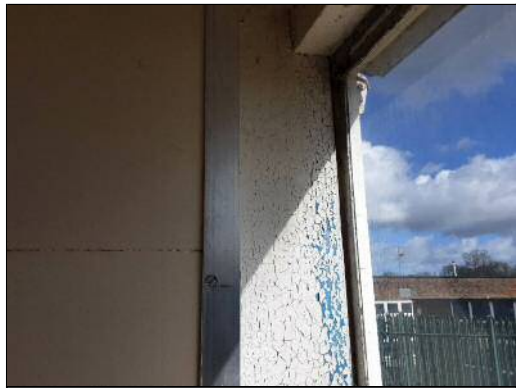
| Assessment details | | | | Comments | Photograph |
|---|---|---|---|---|---|
| Assessment no. | 0368 | Accessibility | Occasionally likely to be disturbed | | |

| Assessment details | | | | Comments | Photograph |
|---|---|---|---|---|---|
| Building | Block EFAG | Floor/ room | Ground Floor / 118 and 459 | X3 columns at 4lm each | |
| Identification | Strongly Presumed (348) | Condition | Low Damage | | |

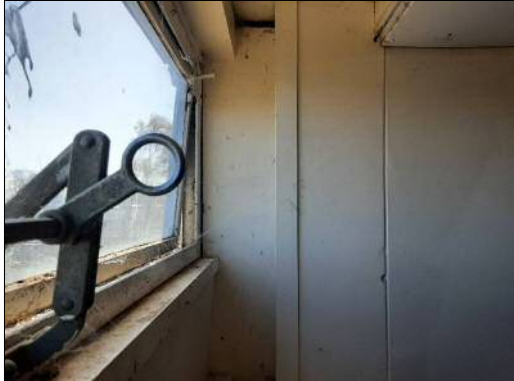
| Assessment details | | | | Comments | Photograph |
|---|---|---|---|---|---|
| Assessment no. | 0371 | Accessibility | Occasionally likely to be disturbed | | |

| Assessment details | | | | Comments | Photograph |
|---|---|---|---|---|---|
| Building | Block EFAG | Floor/ room | 1st Floor / 127 | | |
| Identification | Identified | Condition | Low Damage | | |

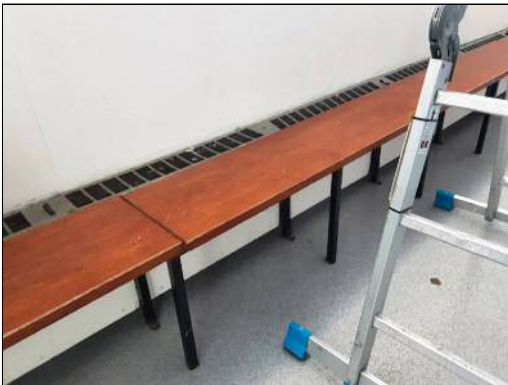
| Assessment details | | | | Comments | Photograph |
|---|---|---|---|---|---|
| Assessment no. | 0372 | Accessibility | | | |

| Assessment details | | | | Comments | Photograph |
|---|---|---|---|---|---|
| Building | Block EFAG | Floor/ room | 1st Floor / 127 | No access to heaters - live services | |
| Identification | Inaccessible (Presumed) | Condition | n/a | | |

| Assessment details | | | | Comments | Photograph |
|---|---|---|---|---|---|
| Action | Inspect Prior to Disturbance | | | | |

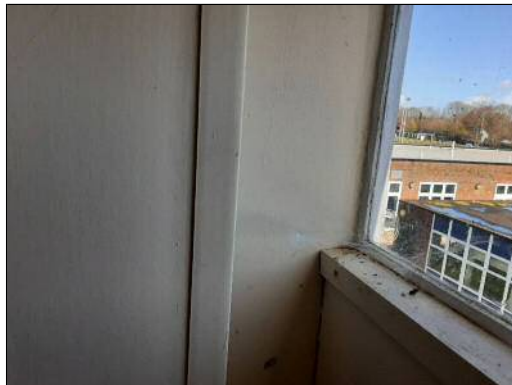
| Assessment details | | | | Comments | Photograph |
|---|---|---|---|---|---|
| Assessment no. | 0373 | Accessibility | Occasionally likely to be disturbed | | |

| Assessment details | | | | Comments | Photograph |
|---|---|---|---|---|---|
| Building | Block EFAG | Floor/ room | 1st Floor / 128 | | |
| Identification | Strongly Presumed (371) | Condition | Low Damage | | |

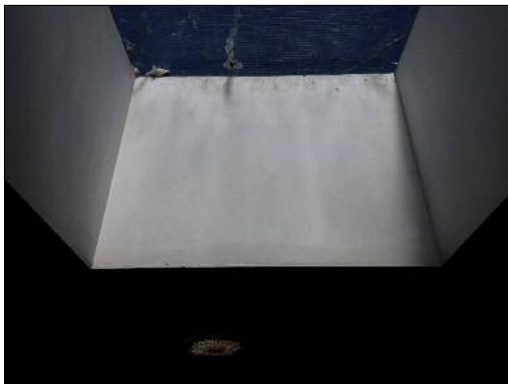
| Assessment details | | | | Comments | Photograph |
|---|---|---|---|---|---|
| Assessment no. | 0374 | Accessibility | Occasionally likely to be disturbed | | |

| Assessment details | | | | Comments | Photograph |
|---|---|---|---|---|---|
| Building | Block EFAG | Floor/ room | 1st Floor / 129 | | |
| Identification | Strongly Presumed (371) | Condition | Low Damage | | |

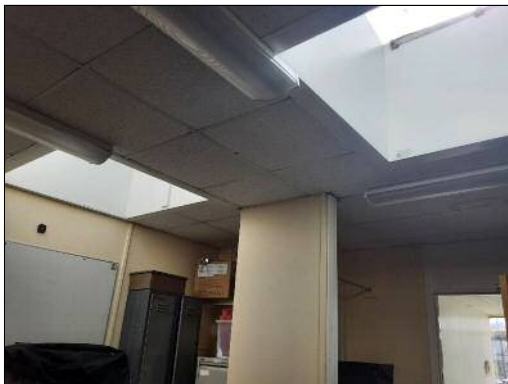
| Assessment details | | | | Comments | Photograph |
|---|---|---|---|---|---|
| Assessment no. | 0375 | Accessibility | Occasionally likely to be disturbed | | |

| Assessment details | | | | Comments | Photograph |
|---|---|---|---|---|---|
| Building | Block EFAG | Floor/ room | 1st Floor / 759 | | |
| Identification | Strongly Presumed (371) | Condition | Low Damage | | |

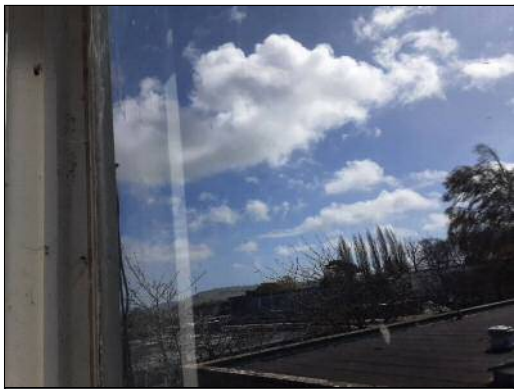
| Assessment details | | | | Comments | Photograph |
|---|---|---|---|---|---|
| Assessment no. | 0376 | Accessibility | Occasionally likely to be disturbed | | |

| Assessment details | | | | Comments | Photograph |
|---|---|---|---|---|---|
| Building | Block EFAG | Floor/ room | 1st Floor / 121 stair | X3 1m each side of large window | |
| Identification | Strongly Presumed (371) | Condition | Low Damage | | |
