## Verification Report

Former Sony Facility  
Southwater  
Horsham  
RH13 9YT

June 2026

000440032.0002.0001

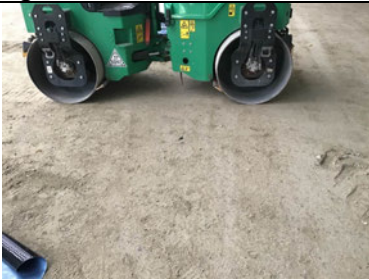
Evidence of the well rolled fine aggregate substrate that the membrane is being laid upon during the installation.

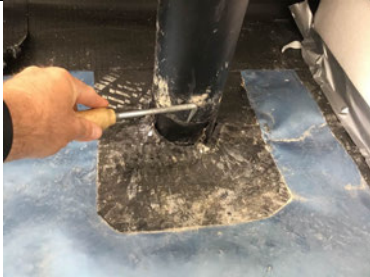
Probe testing a pipe penetration detail.

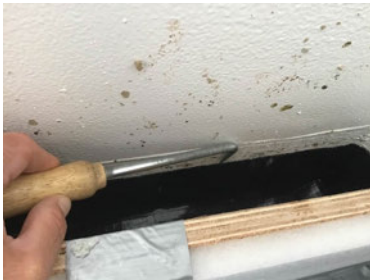
Probe testing a steel stanchion detail.

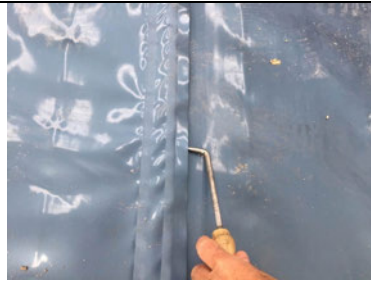
Probe testing an auto welded membrane lap.

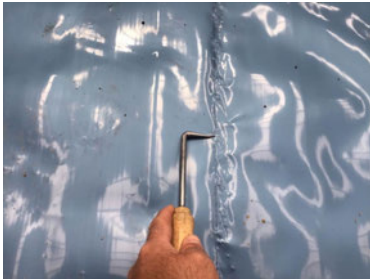
Probe testing all hand welded membrane laps.

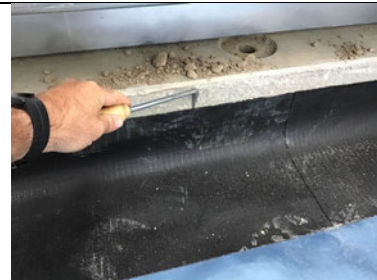
Probe testing the heat sealed perimeter curb stone detailing.

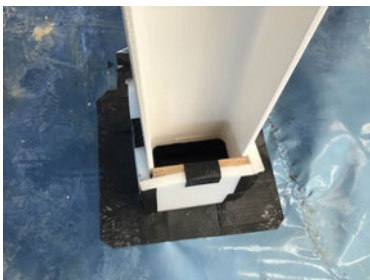
A restricted inspection took place of the steel stanchions due to miothene being in place at the time of our inspection.

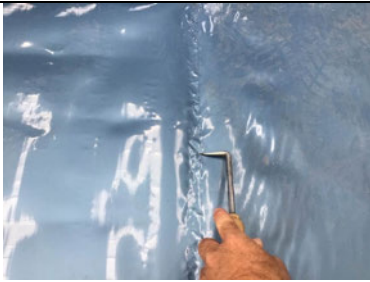
Probe testing a hand welded membrane lap.

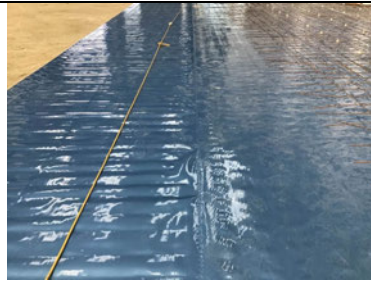
Overview of a hand welded membrane lap.

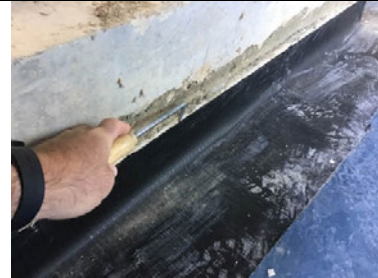
Probe testing all retro fit detailing.

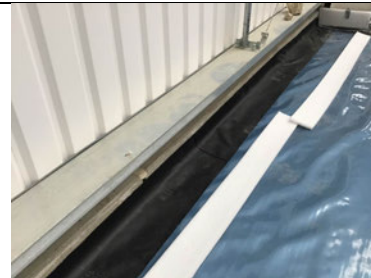
Overview of the perimeter termination detailing to the concrete curb stone.

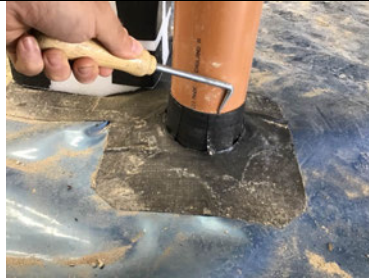
Probe testing a typical pipe penetration detail.

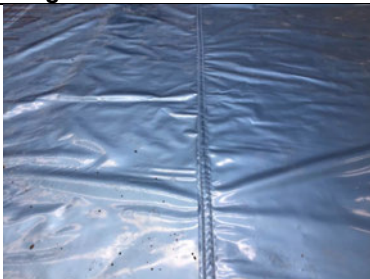
A typical auto welded membrane lap.

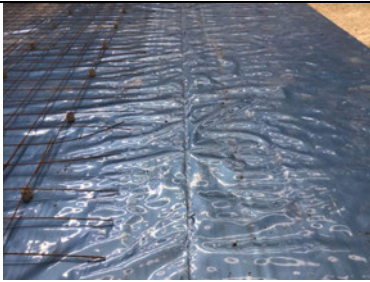
Overview of a hand welded membrane lap.

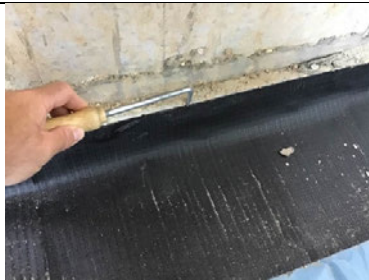
Probe testing the retro fit detailing to the base of the concrete stairs.

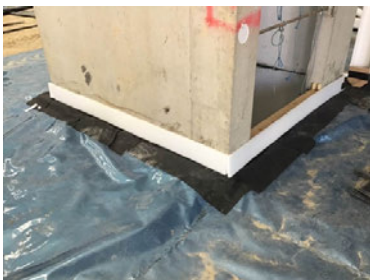
The lift pit detailing had been covered with miothene at the time of our inspection.

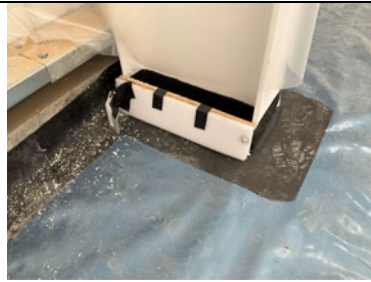
Restricted inspection to steel stanchions.

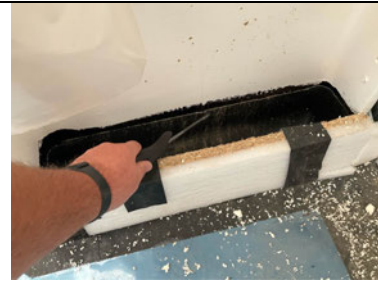
Probe testing to steel stanchion were possible.

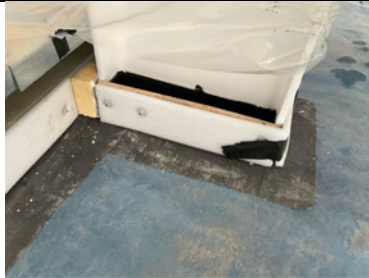
Restricted inspection to steel  
stanchion detailing.

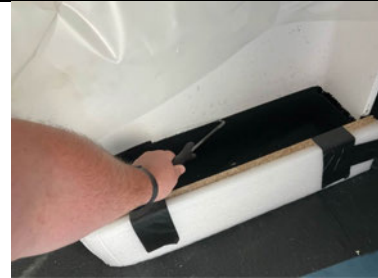
Probe testing to restricted steel  
stanchion.

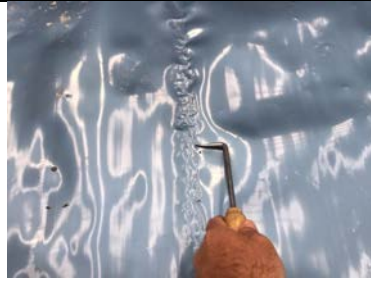
Probe testing a hand welded membrane lap.

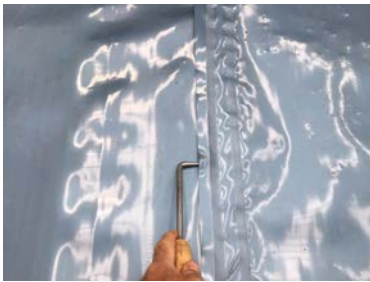
Probe testing all auto welded membrane laps.

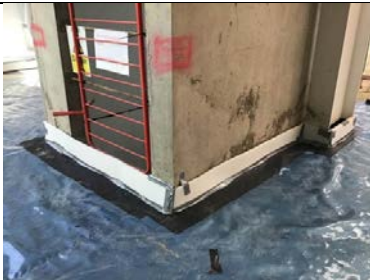
Miothene was placed around the lift pit at the time of our inspection.

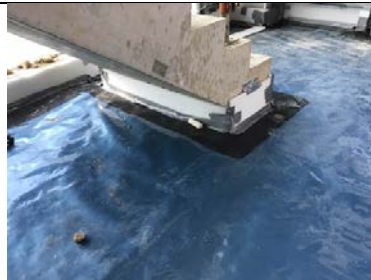
Miothene was placed around the base of the stairs at the time of our inspection.

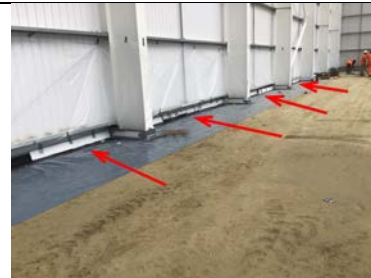
Miothene covering the perimeter detailing.

has been covered with miothene prior to our inspection.

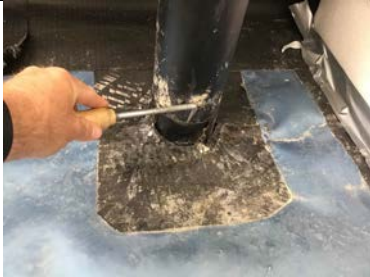
Probe testing a pipe penetration detail.

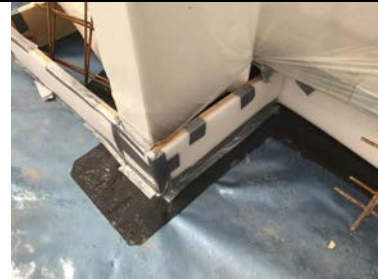
Steel stanchion covered with miothene at the time of our inspection.

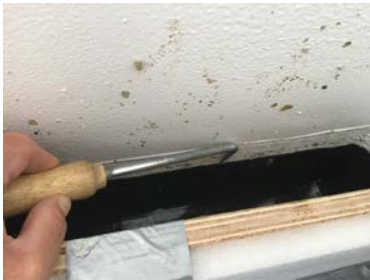
Probe testing a steel stanchion detail.

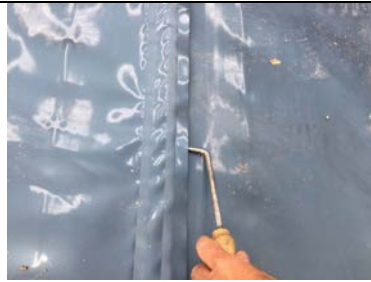
Probe testing an auto welded membrane lap.

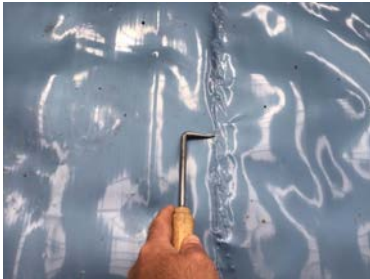
Probe testing all hand welded membrane laps.

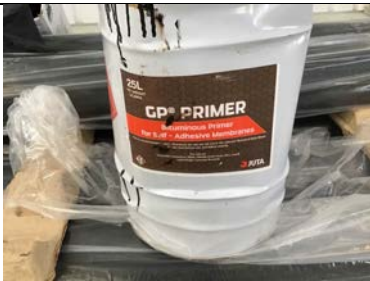
Evidence of the Juta GP Bitumen Primer that has been applied to the concrete prior to the detailing.

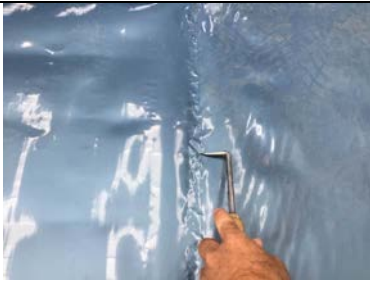
Probe testing a hand welded membrane lap.

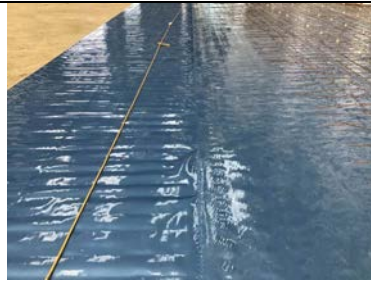
Overview of a hand welded membrane lap.

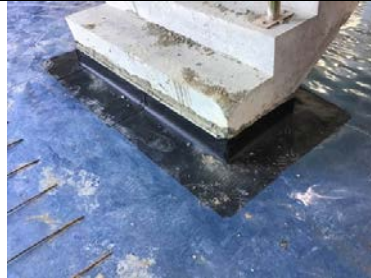
Overview of the detailing to the base of the concrete stair core.

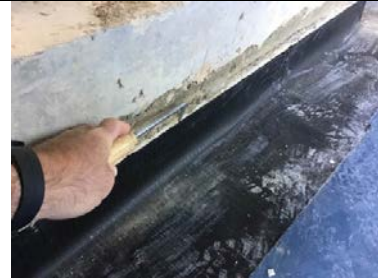
Probe testing all retro fit detailing.

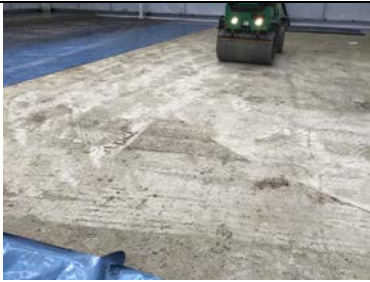
Evidence of the rolling machine used on the sand blinded substrate prior to the install of the gas membrane.

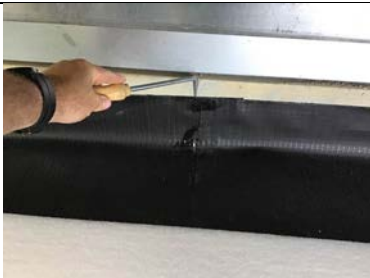
Probe testing the perimeter termination detailing.

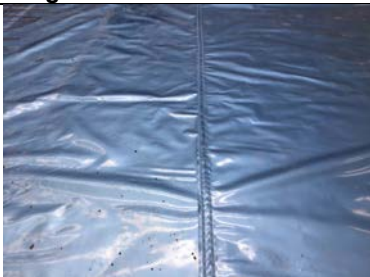
A typical auto welded membrane lap.

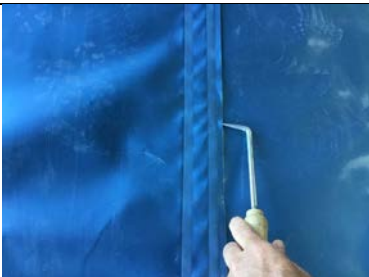
Probe testing the auto welded membrane lap.

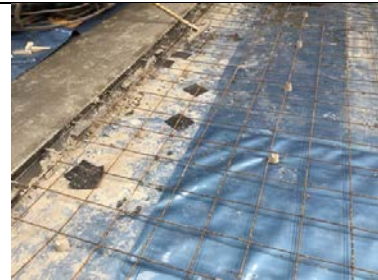
UK Membranes carried out their own CQA repairs as the pour progressed.

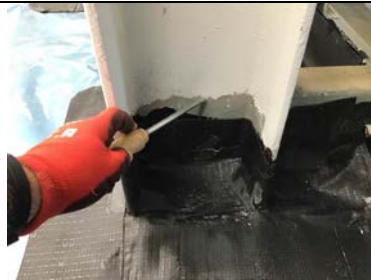
Probe testing a steel stanchion detail in unit 1.

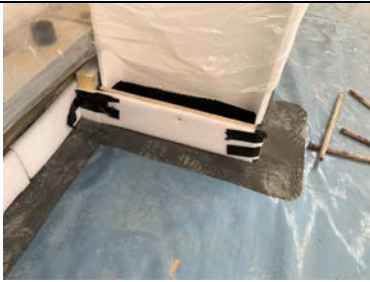
Restricted inspection to steel stanchion details.

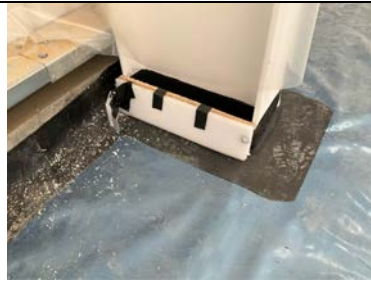
Restricted inspection to steel stanchions.

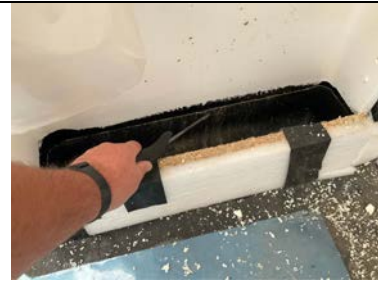
Probe testing to steel stanchion were possible.

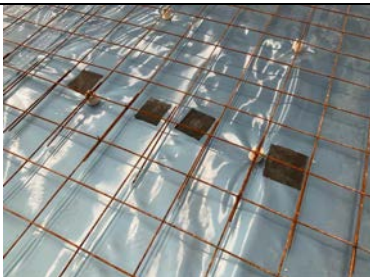
Installers own CQA patch repairs using Juta GP1 SAM.

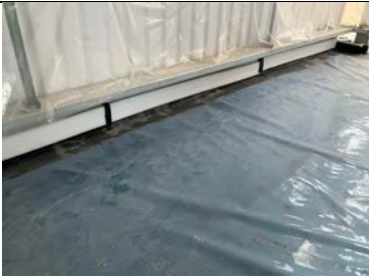
Restricted inspection of the retrofit termination detailing to the perimeter cladding rail.

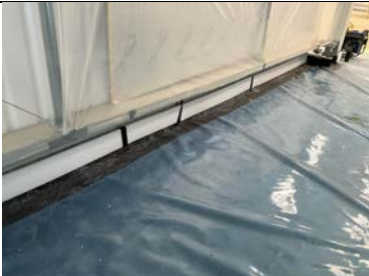
Overview of the restricted inspection to the retrofit

termination along perimeter  
cladding rail.

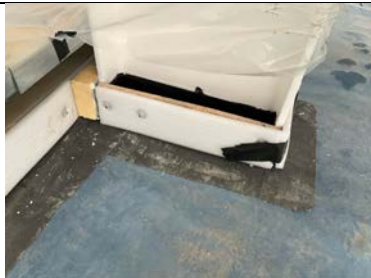
Restricted inspection to steel  
stanchion detailing.

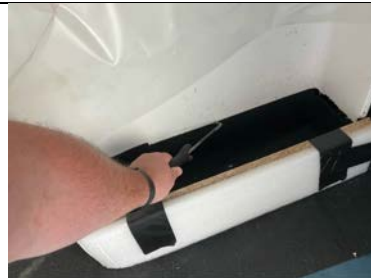
Probe testing to restricted steel  
stanchion.

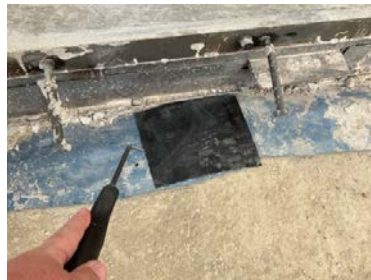
Probe testing to patched repaired armoured joint pin holes.

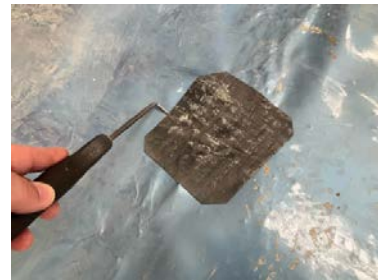
Probe testing to installers own CQA patch repair.
