### DRAINAGE CCTV REPORT

# CCTV survey report

**Project Name** – Novartis site Horsham - CCTV Survey

**Project Number** – 60950

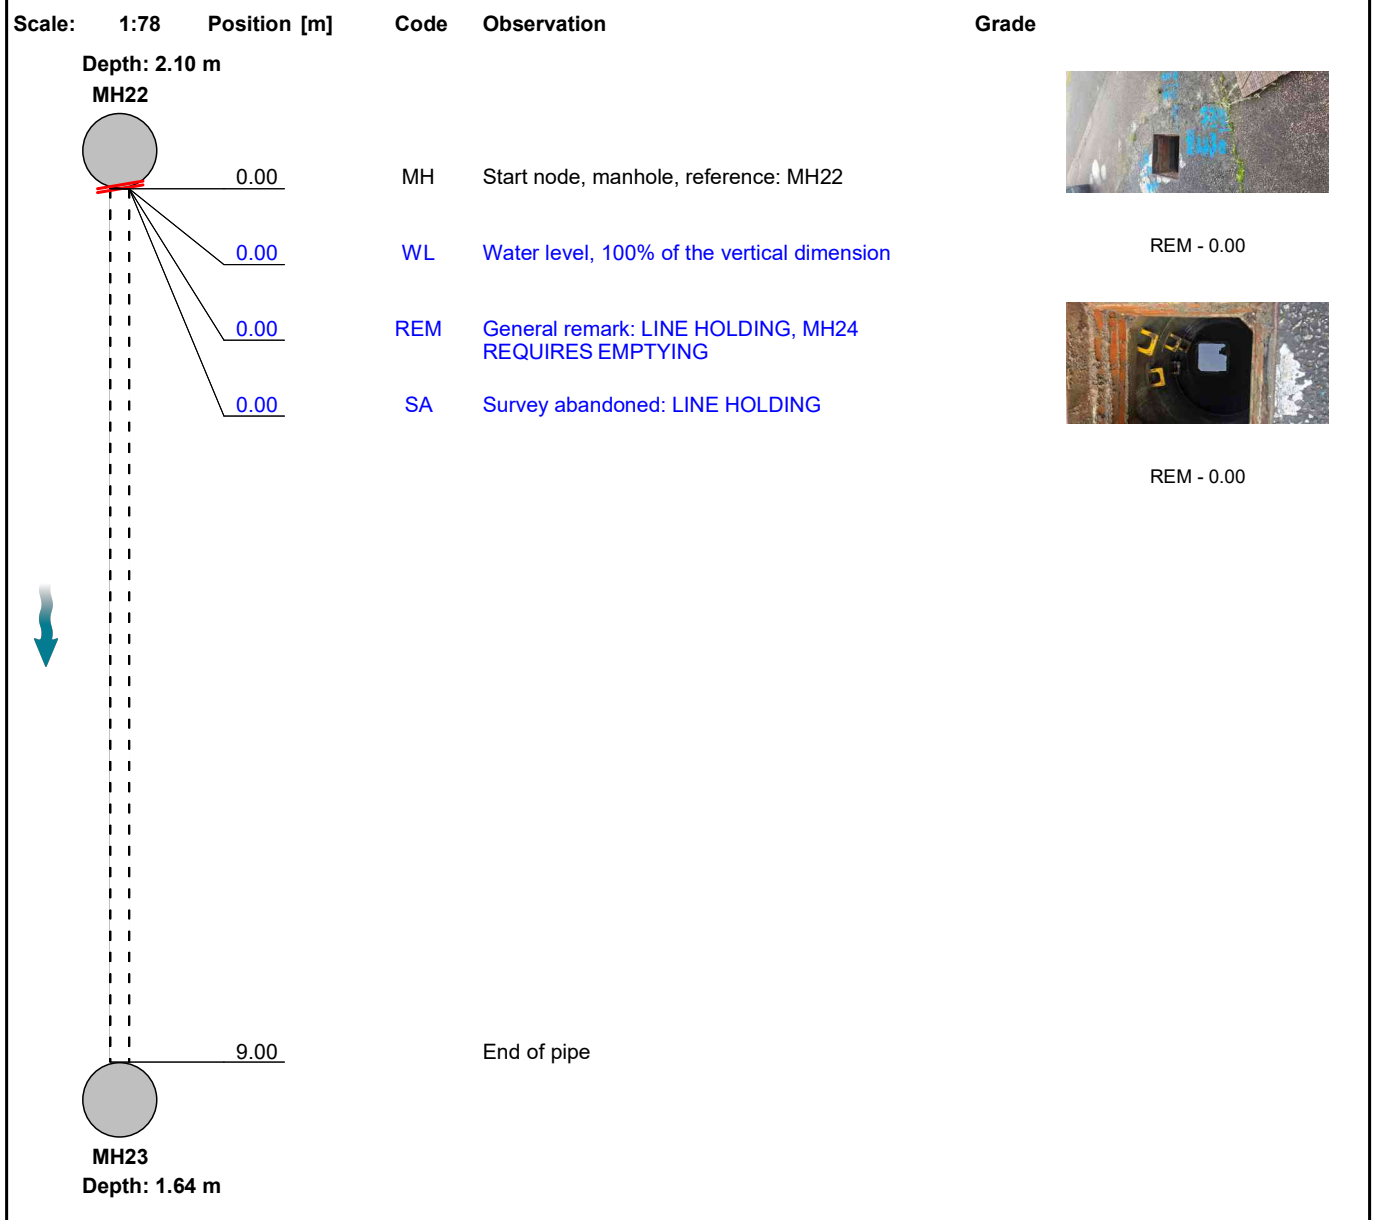
| <b>Comments:</b> | LINE HOLDING FROM INTERCEPTOR - MH24 | | | | |

| <b>Recommendations:</b> | INTERCEPTOR REQUIRES EMPTYING TO CLEAN | | | | |

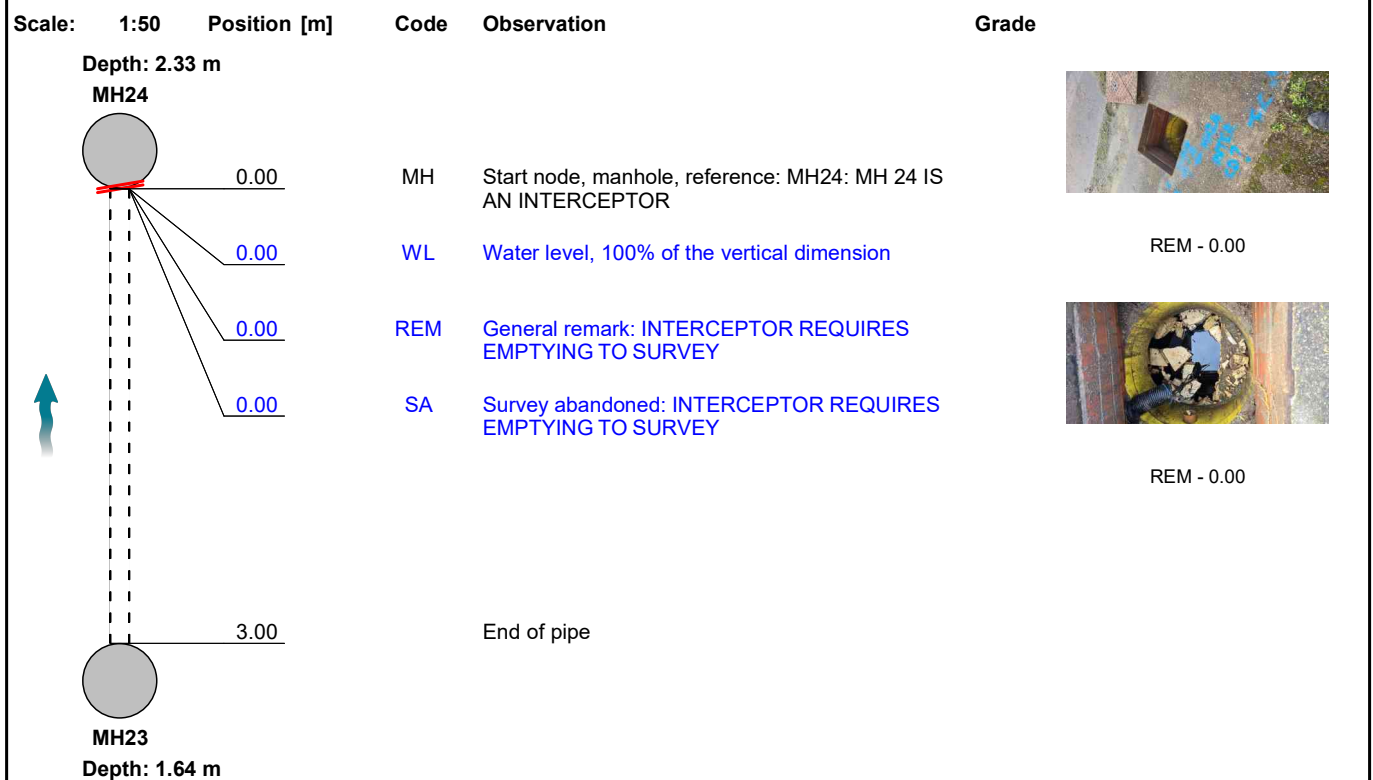
| <b>Comments:</b> | REQUIRES SUCKING OUT TO SURVEY | | | | |

| <b>Recommendations:</b> | REQUIRES SUCKING OUT TO EMPTY | | | | |

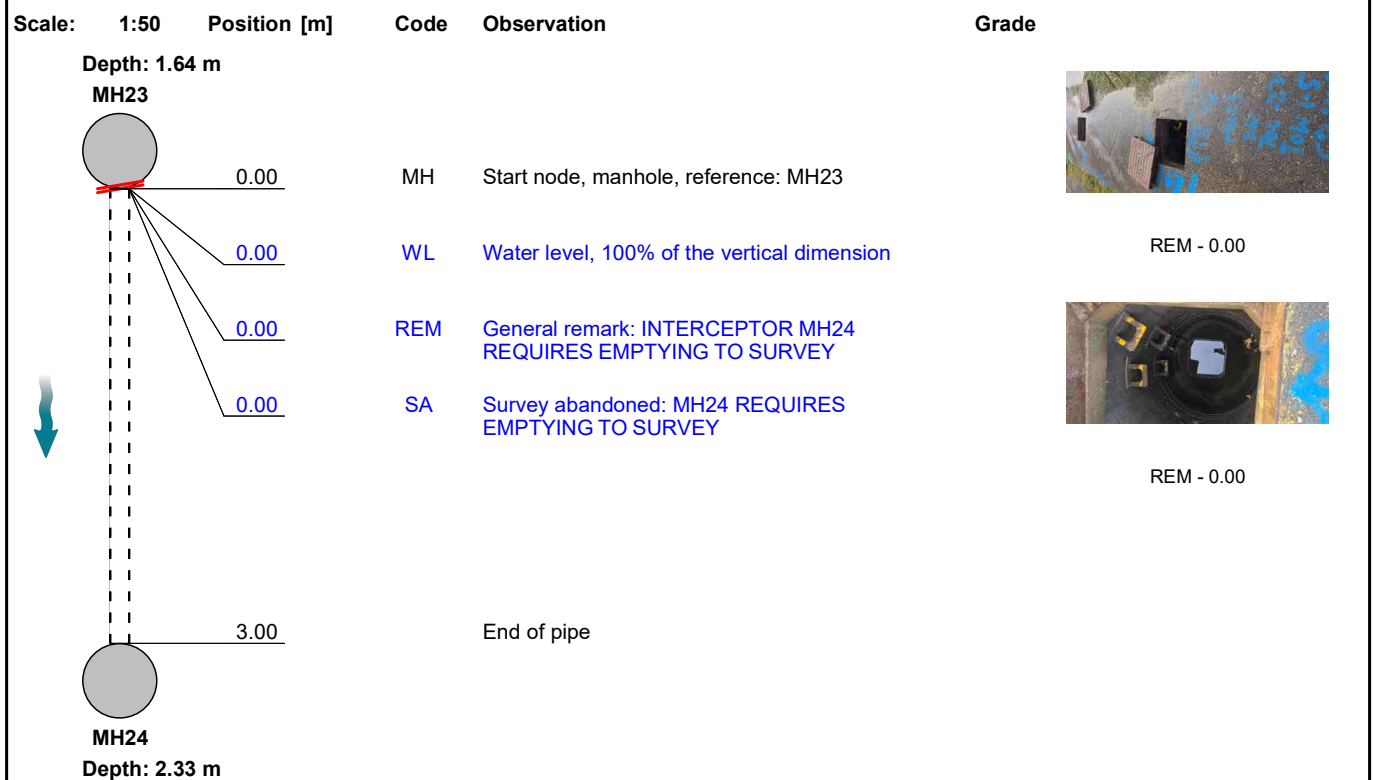
| <b>Comments:</b> | INTERCEPTOR - MH24 REQUIRES EMPTYING TO SURVEY | | | | |

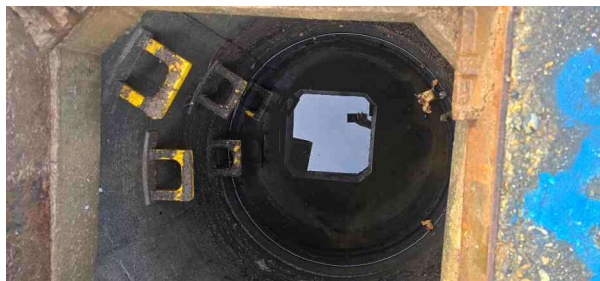
MH23X\_6dcffdca-c3d8-4f4e-adff-02b165a218c5\_20241125\_100841.jpg, 00:00:03, 0.00 m  
 General remark, INTERCEPTOR MH24 REQUIRES EMPTYING TO SURVEY

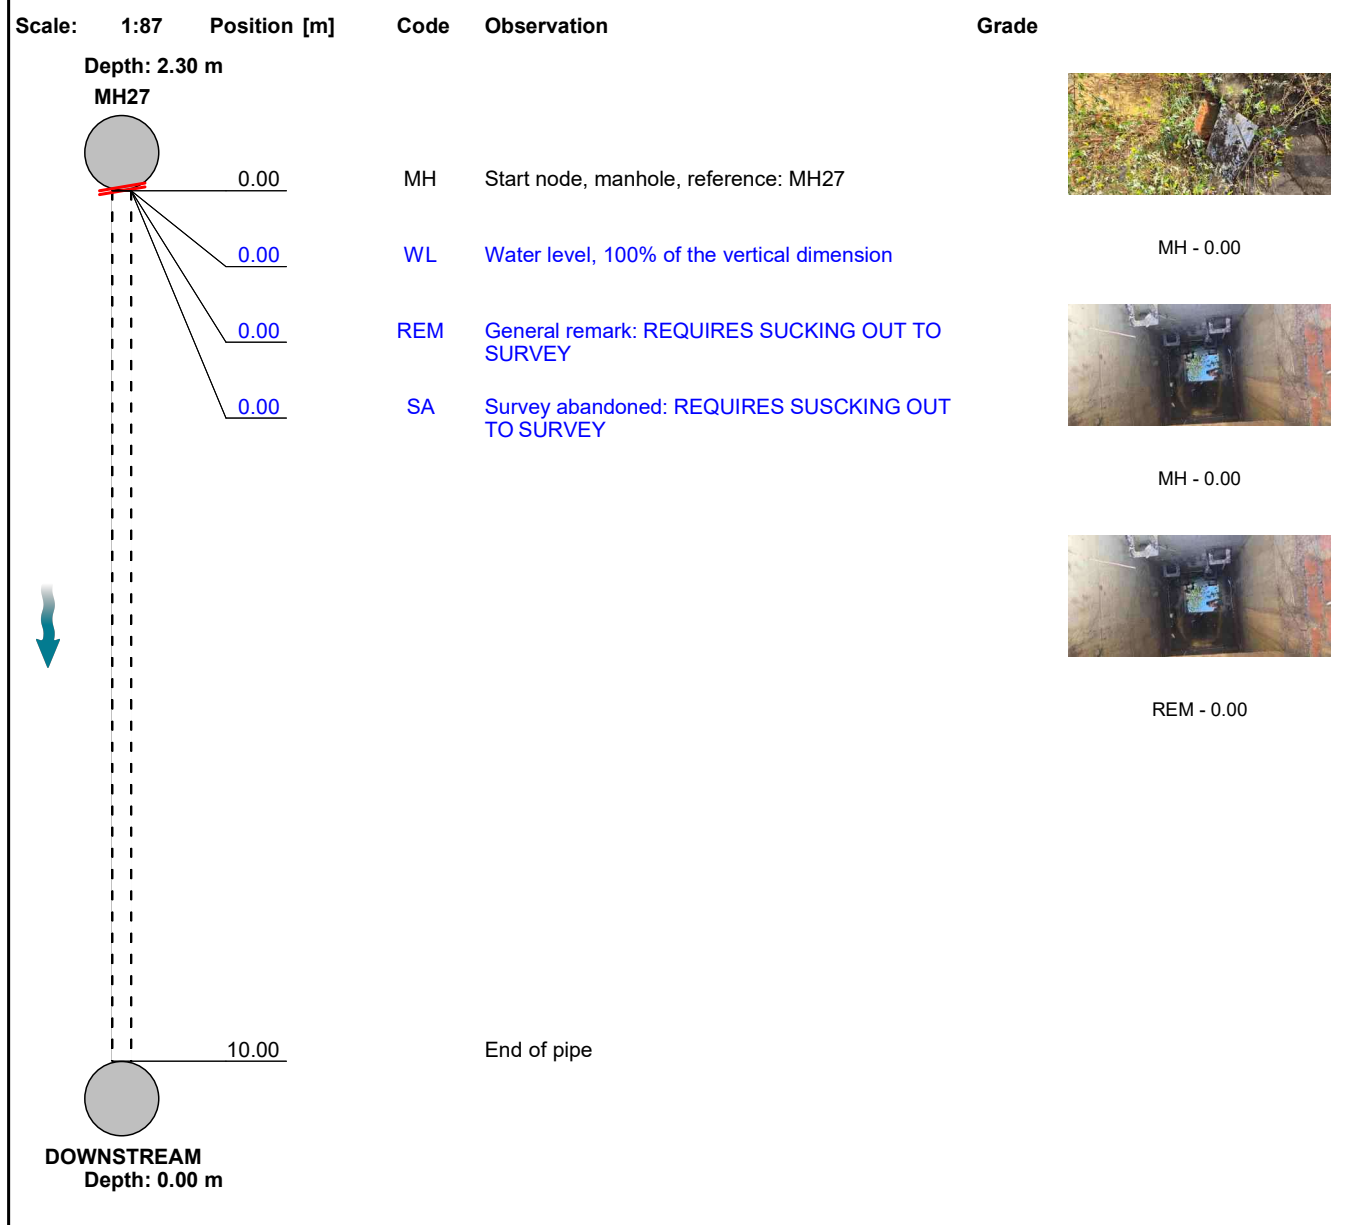
| <b>Comments:</b> | LINE HOLDING WATER, REQUIRES SUCKING OUT TO SURVEY | | | | |

| <b>Recommendations:</b> | REQUIRES SUCKING OUT | | | | |

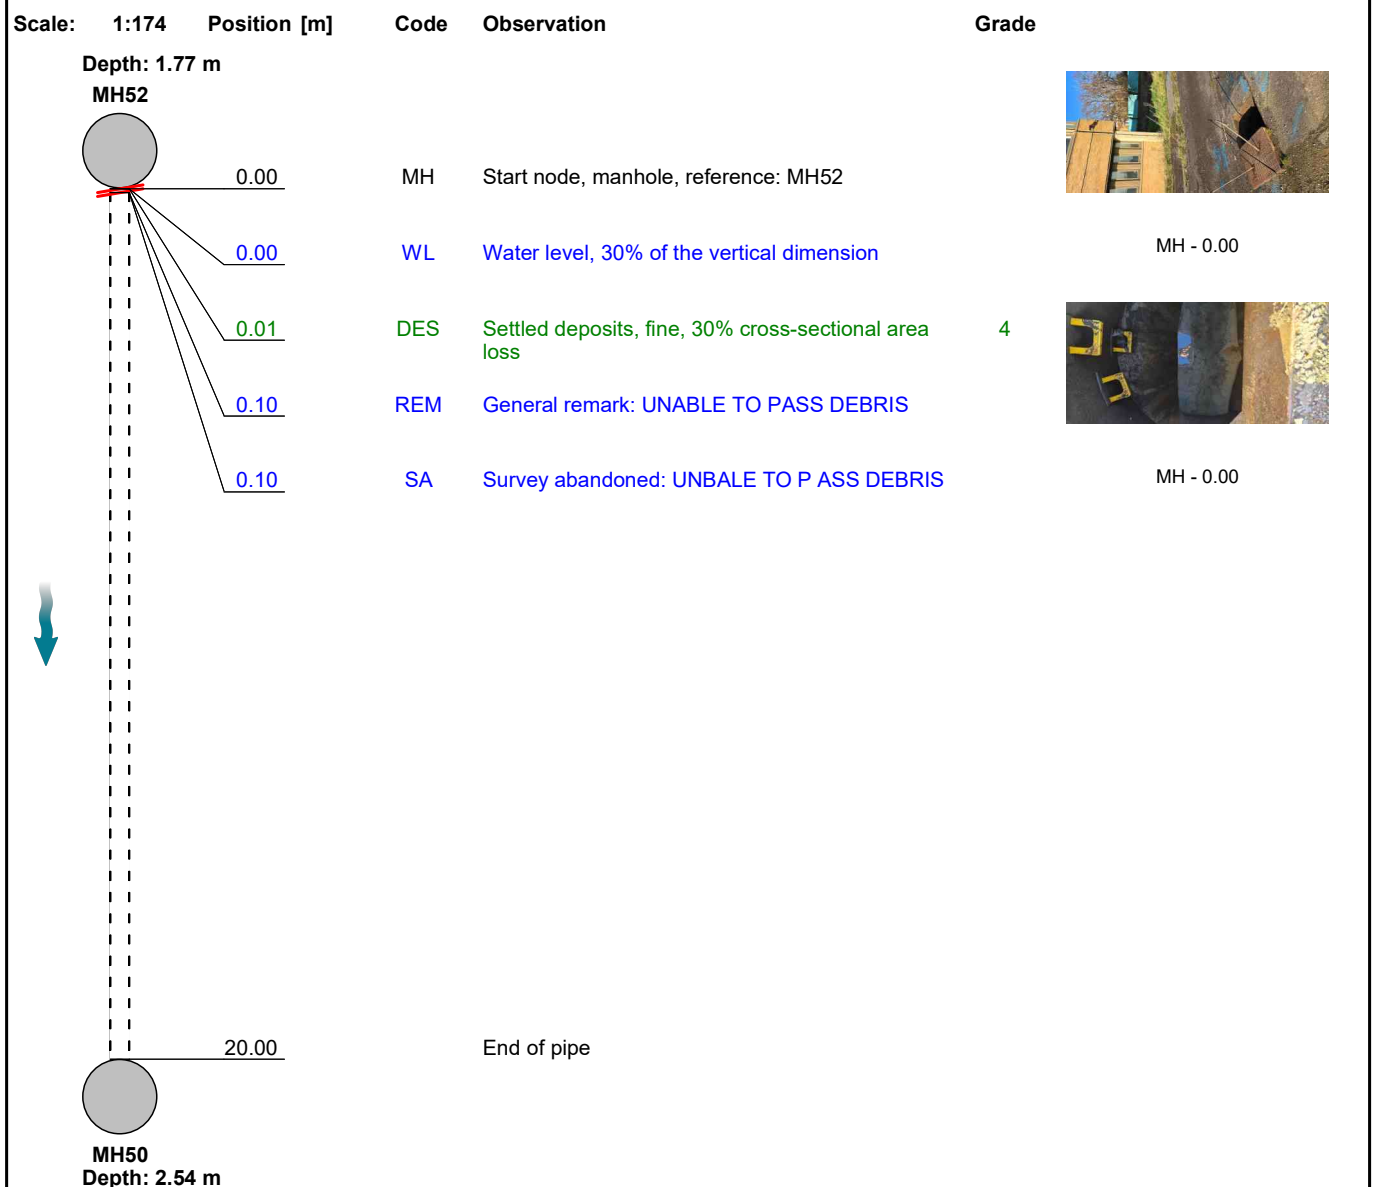
| <b>Comments:</b> | REQUIRES HEAVY JETTING TO SURVEY | | | | |

| <b>Recommendations:</b> | REQUIRES HEAVY JETTING | | | | |

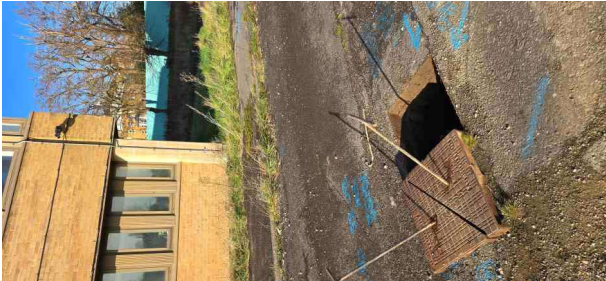
MH61X\_e9efd8cd-0511-4080-8fd8-b2573383b329\_20241125\_135532.jpg, 00:00:01, 0.00 m  
 Start node, manhole, reference: MH52

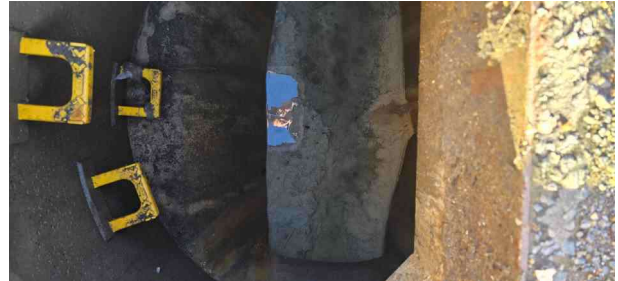
MH61X\_449bec40-dc47-42f4-b402-821d3b46e9b5\_20241125\_135540.jpg, 00:00:01, 0.00 m  
 Start node, manhole, reference: MH52

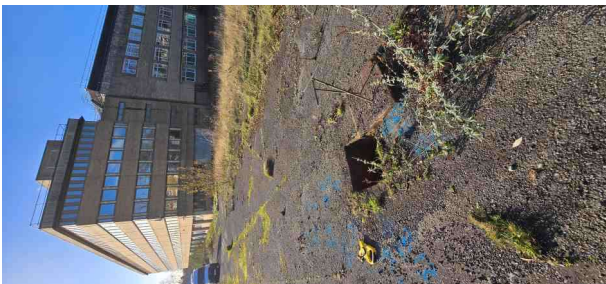
MH61X\_272adc5c-e3b7-4cf9-9421-c9fd14ab4772\_20241125\_135430.jpg, 00:03:38, 32.41 m  
 Finish node, manhole, reference: MH61

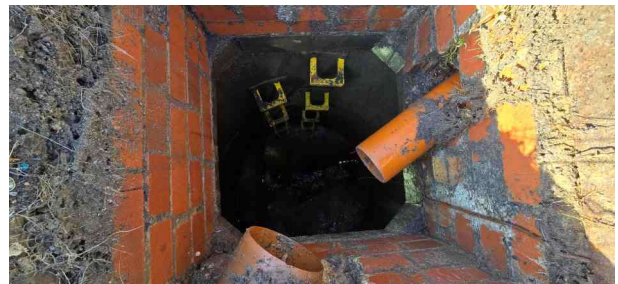
MH61X\_95386cbb-045a-4908-ae61-5f8a9d181394\_20241125\_135443.jpg, 00:03:38, 32.41 m  
 Finish node, manhole, reference: MH61

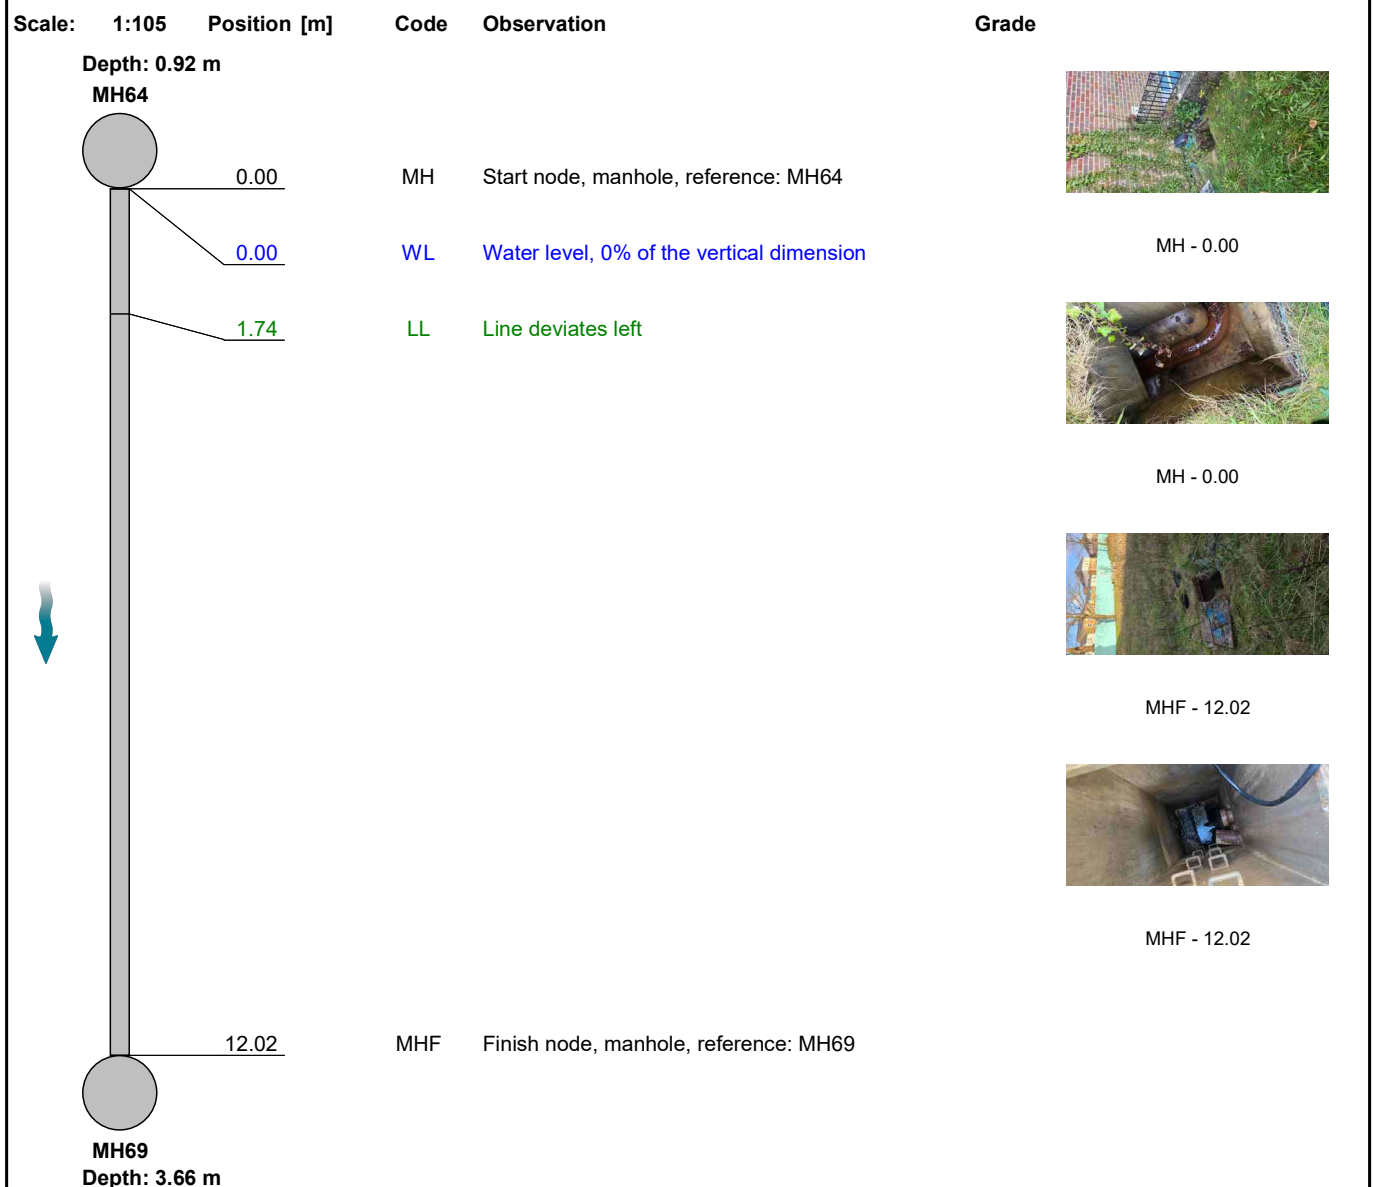
| Comments: | SURVEY COMPLETE | | | | |

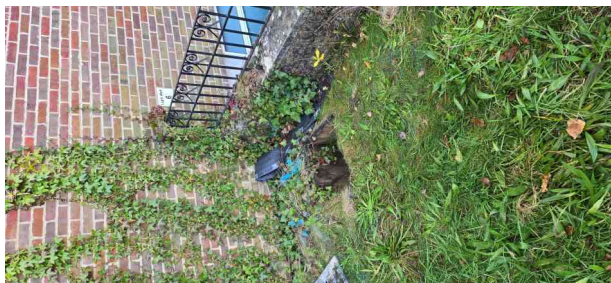
MH64X\_c13aa89b-c7d0-4460-9c15-158c411df083\_20241125\_142620.jpg, 00:00:01, 0.00 m  
 Start node, manhole, reference: MH64

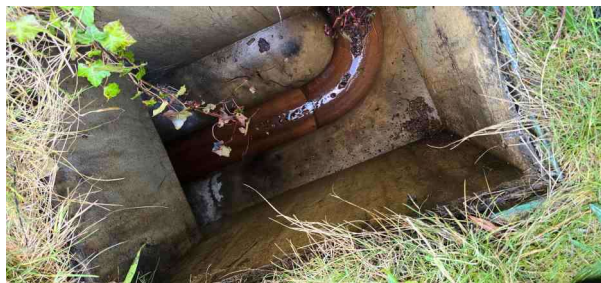
MH64X\_d5373b3c-21a3-474c-b060-ec25bf1d1ca6\_20241125\_142625.jpg, 00:00:01, 0.00 m  
 Start node, manhole, reference: MH64

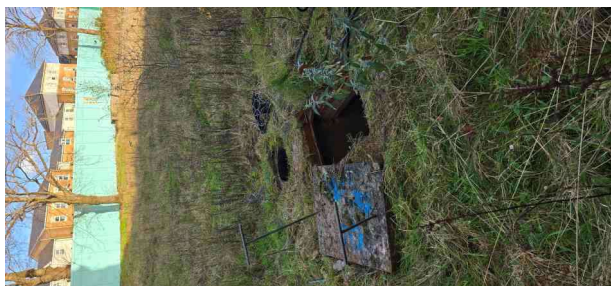
MH64X\_d30f4c3b-6a8c-4047-97a1-0165e4aa9c35\_20241125\_142601.jpg, 00:00:50, 12.02 m  
 Finish node, manhole, reference: MH69

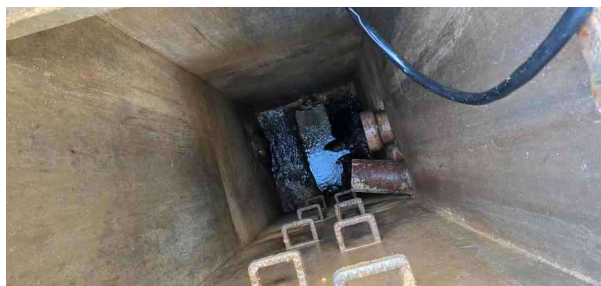
MH64X\_b008573f-6747-4f00-aa6c-8ff2cf7564c6\_20241125\_142612.jpg, 00:00:50, 12.02 m  
 Finish node, manhole, reference: MH69

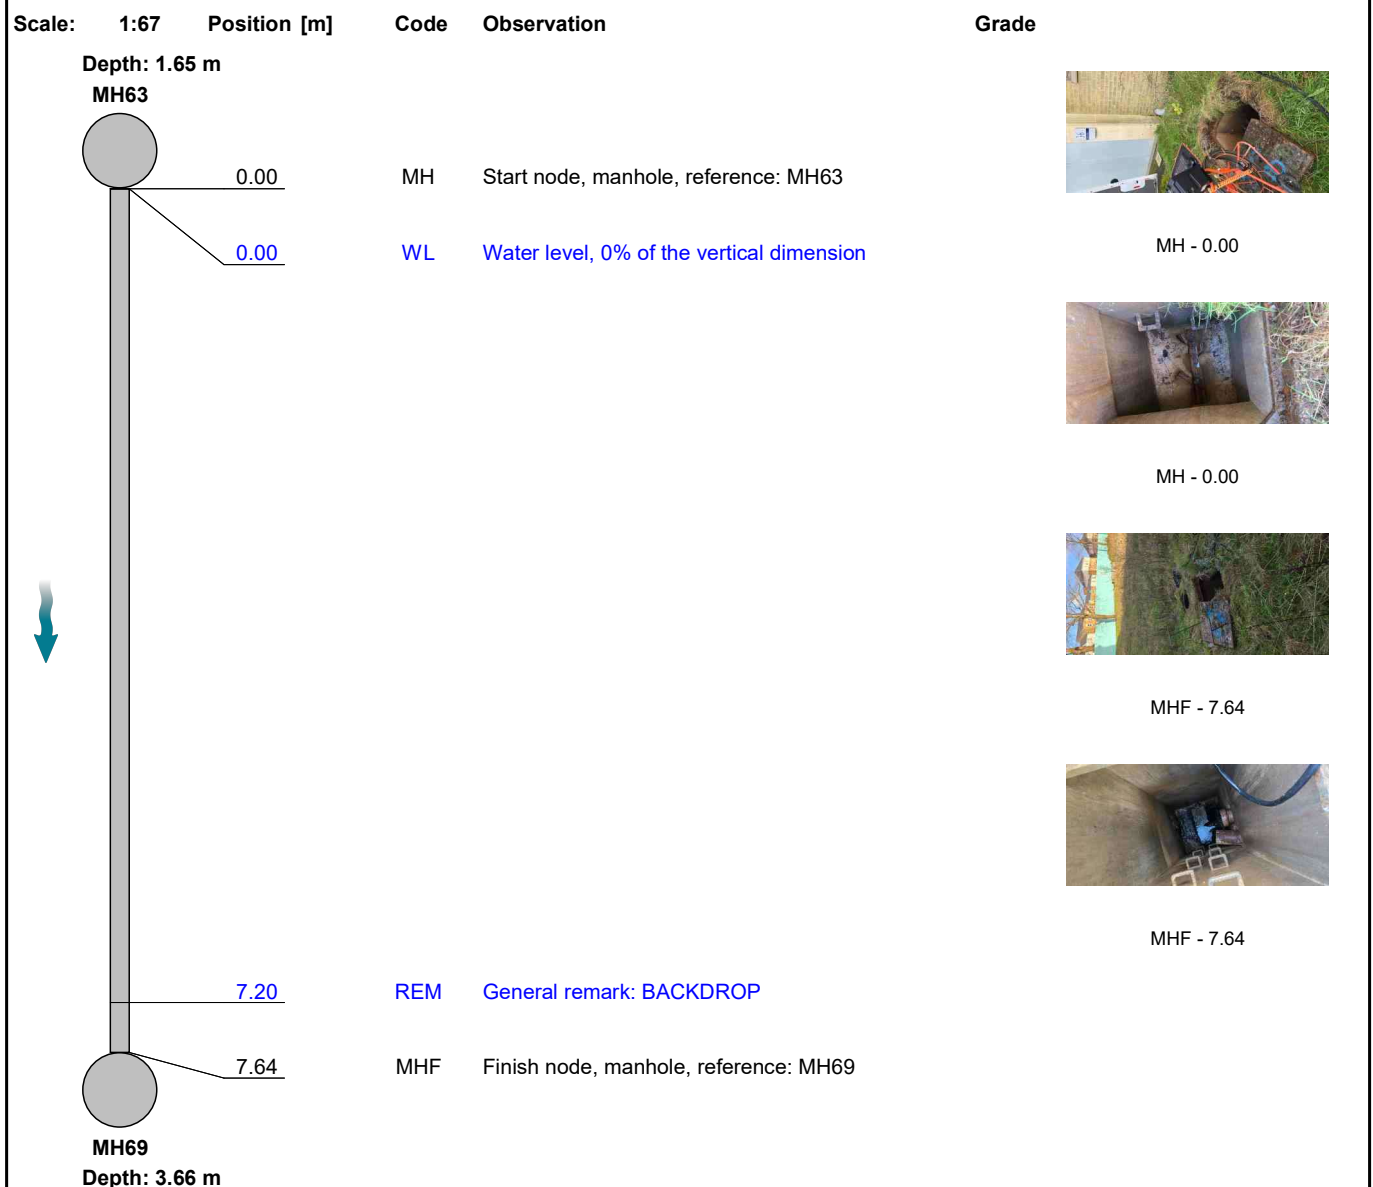
| Comments: | SURVEY COMPLETE | | | | |

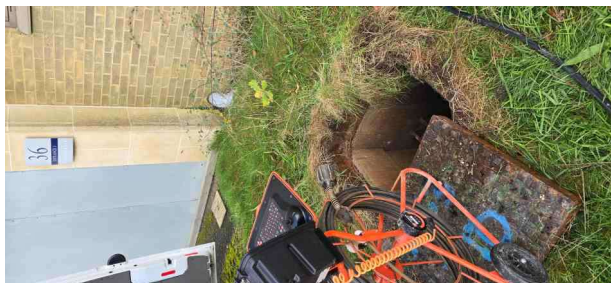
MH63X\_84e43519-7d21-40aa-bcb9-b75b2af84fb4\_20241125\_142650.jpg, 00:00:01, 0.00 m  
 Start node, manhole, reference: MH63

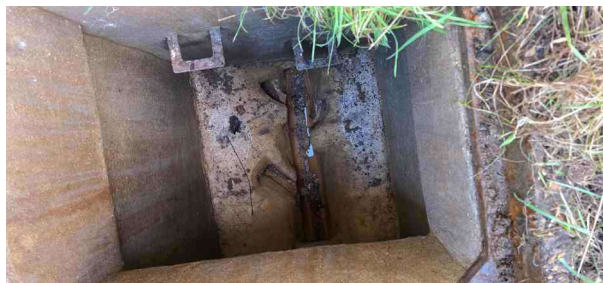
MH63X\_f4076f48-0765-4e20-82e3-76d467fc6afd\_20241125\_142655.jpg, 00:00:01, 0.00 m  
 Start node, manhole, reference: MH63

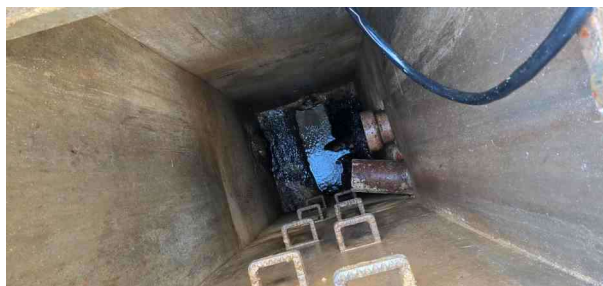
MH63X\_fc3eee03-1a09-4fa9-a55e-c192e3ece00d\_20241125\_142804.jpg, 00:00:41, 7.64 m  
 Finish node, manhole, reference: MH69

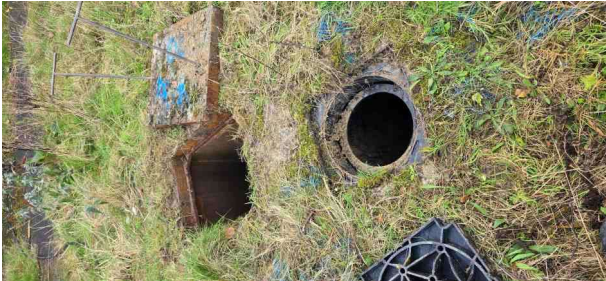
MH70X\_952ce354-e7cf-4cab-a660-69bb7fe629e2\_20241125\_142811.jpg, 00:00:01, 0.00 m  
 Start node, manhole, reference: MH70

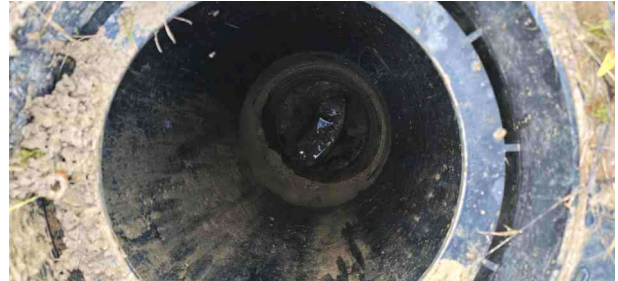
MH70X\_16ffa554-662e-4a19-806b-834db8797b30\_20241125\_142815.jpg, 00:00:01, 0.00 m  
 Start node, manhole, reference: MH70

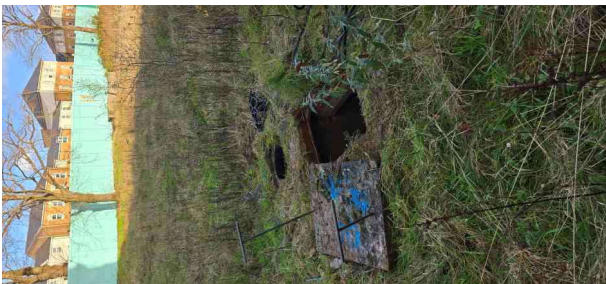
MH70X\_70be9e61-a083-4eb8-9561-a24162f15128\_20241125\_142836.jpg, 00:00:26, 0.50 m  
 Finish node, manhole, reference: MH69

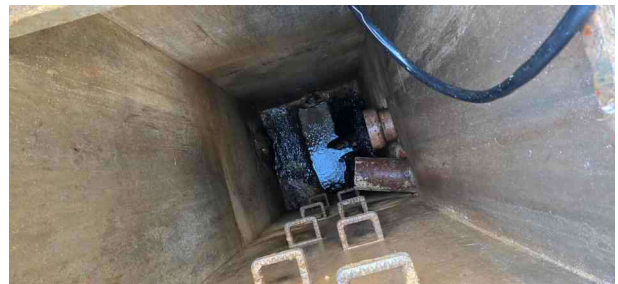
MH70X\_482b3a68-3968-4f9b-934f-2755644c4826\_20241125\_142839.jpg, 00:00:26, 0.50 m  
 Finish node, manhole, reference: MH69

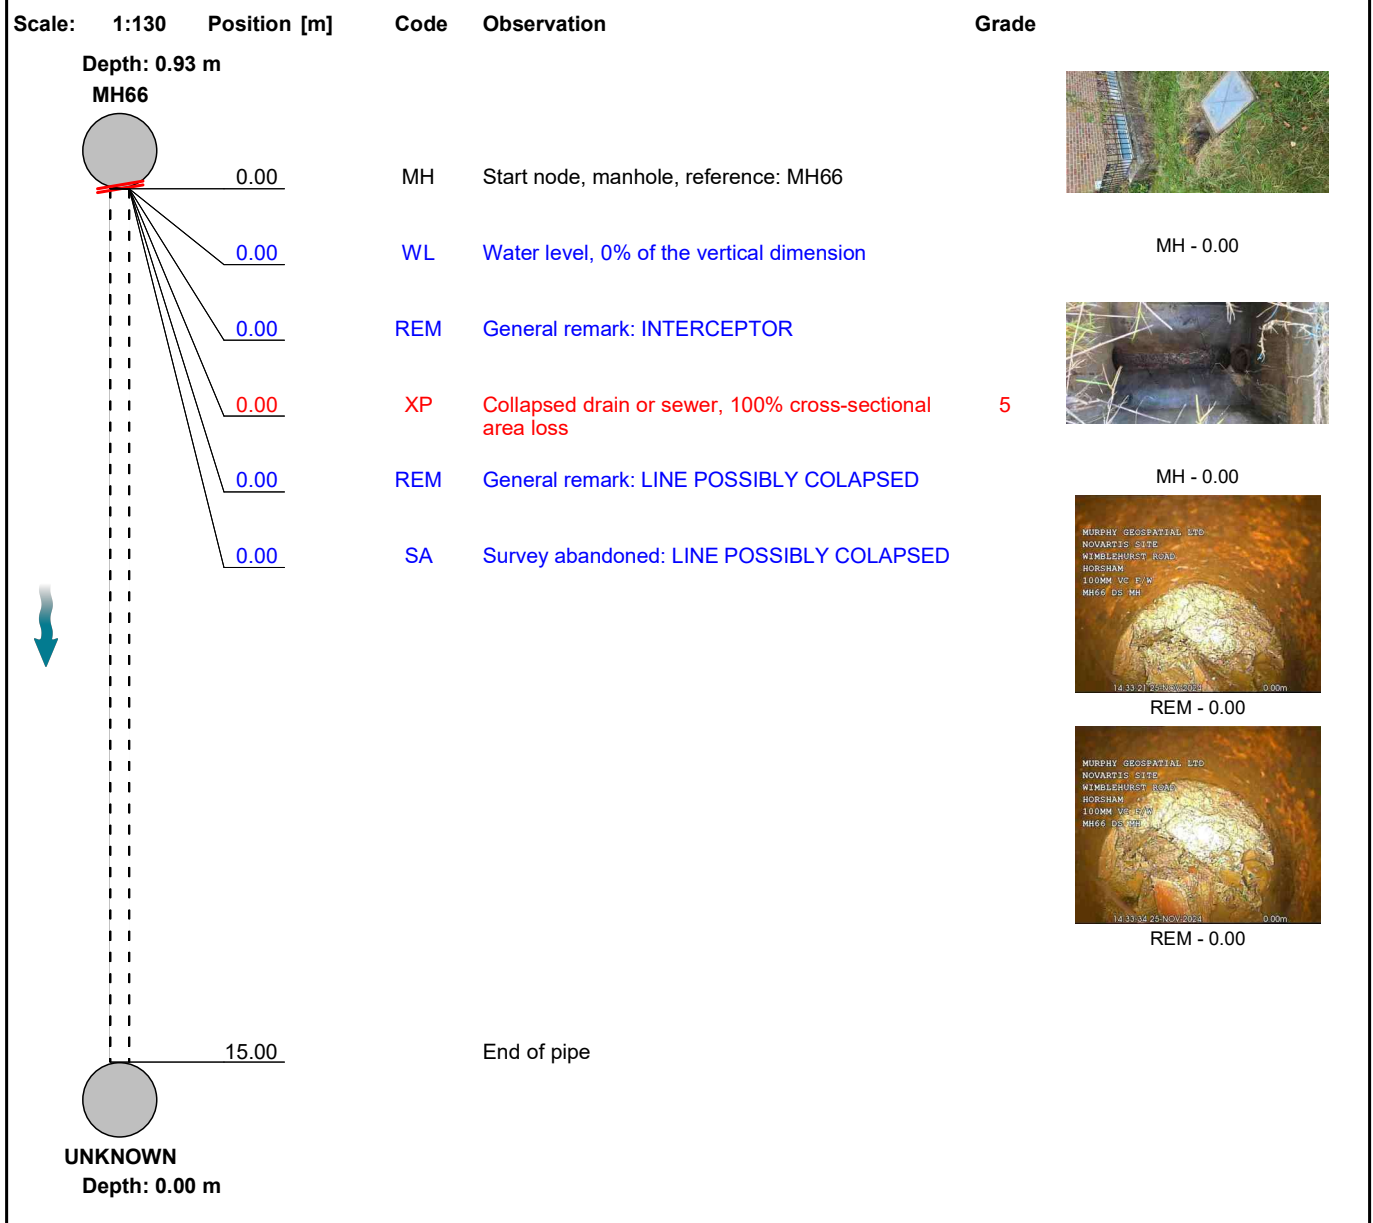
| <b>Comments:</b> | LINE POSSIBLY COLLAPSED | | | | |

| <b>Recommendations:</b> | LINE REQUIRES DIG UP TO REPAIR | | | | |

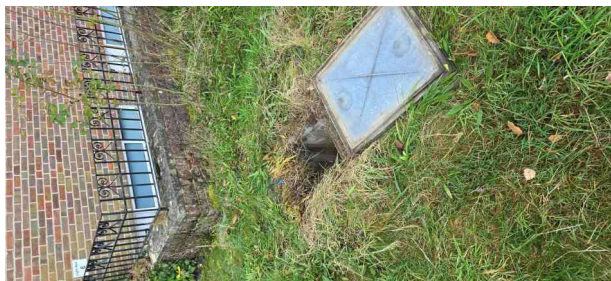
MH66X\_af767249-9a80-4ee8-a502-89d04811b755\_20241125\_143053.jpg, 00:00:01, 0.00 m  
 Start node, manhole, reference: MH66

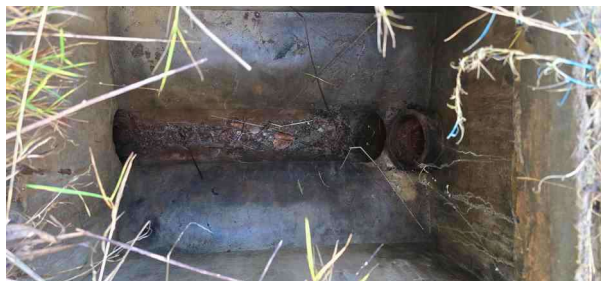
MH66X\_2dc65504-d53d-443b-888b-a4185d0b8c0d\_20241125\_143058.jpg, 00:00:01, 0.00 m  
 Start node, manhole, reference: MH66

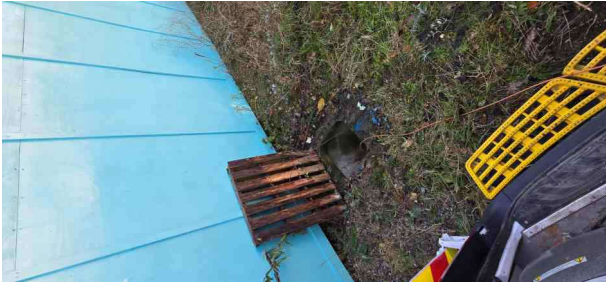
X\_2586be45-4d85-47f3-9d48-08431449bb65\_20241125\_144824.jpg, 00:00:01, 0.00 m  
 Start node, manhole, reference: MH92

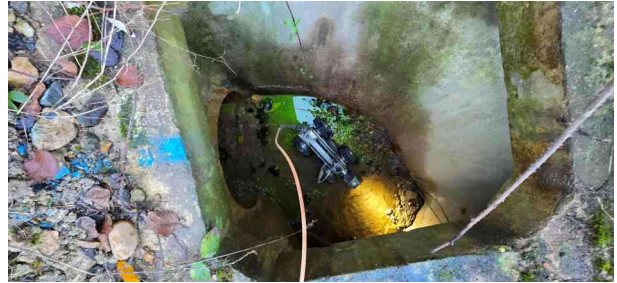
X\_eef80fef-569a-412d-a87a-84c72ef6bb35\_20241125\_144828.jpg, 00:00:01, 0.00 m  
 Start node, manhole, reference: MH92

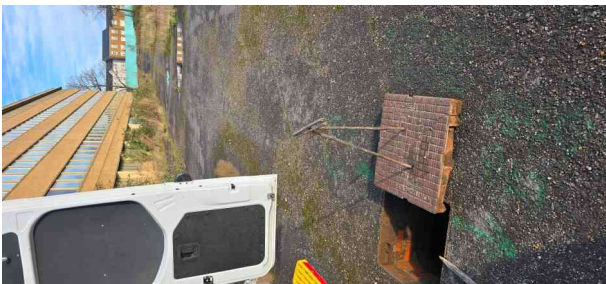
MH33X\_2ca10918-82b4-4f2f-bf51-7afa06732a2f\_20241125\_145333.jpg, 00:03:02, 29.66 m  
 Finish node, manhole, reference: MH33

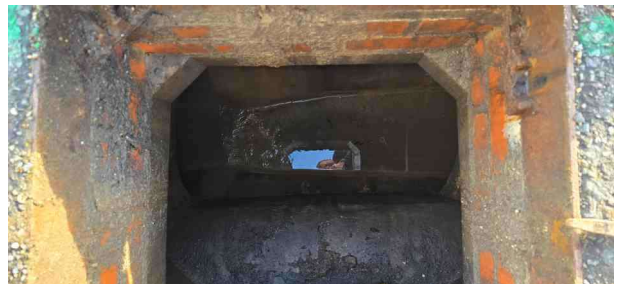
MH33X\_115bf01f-265c-4dc9-b4e9-34a2b1cad7e3\_20241125\_145344.jpg, 00:03:02, 29.66 m  
 Finish node, manhole, reference: MH33
