## HERITAGE IMPACT ASSESSMENT

**Property Address:** Park Farm House, Wheatsheaf Road, Woodmancote,  
Henfield, West Sussex, BN5 9BA

**Report Date:** 6<sup>th</sup> September 2024

**Prepared by** Richard Pocock MSc MRICS

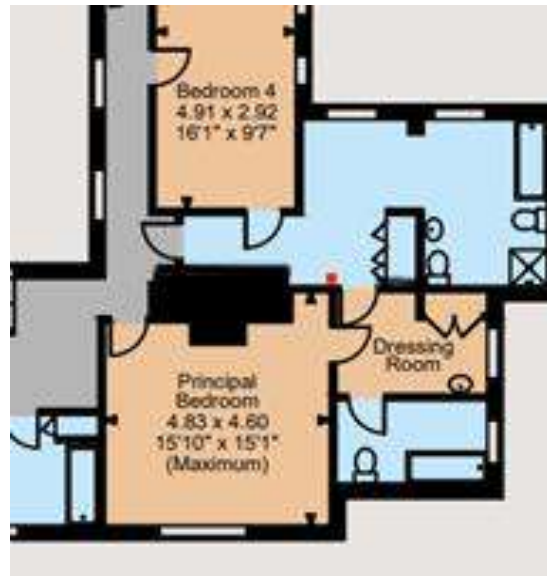
The bay post is located in the position shown as a red dot in the image below:

The reason for implying such importance to this post is that it is, after inspection, the only suspected in-situ surviving element from pre circa 1620-30.

It is suspected of remaining in situ due to the post's orientation in relation to the fireplace. The roof structure above is most certainly later and should the post have been re-used out of situ to support this structure, then the jowl swelling at the top of the post to take a tease tenon joint for a spanning tie beam would have been oriented 90 degrees clockwise for the purpose of supporting the span of the butt purlin roof tie above. The fact that it is not rotated and that the roof was rather roughly placed above this post in this position against the fireplace strongly suggests that the post was already in existence adjacent to the fireplace structure before the roof and surrounding fabric was added and was merely utilised to allow for the present arrangement. Not only this, but it suggests that the building on the site may have been either L shaped from the outset or had a fireplace axially along the back wall instead of the current lateral arrangement. (However, not enough of the mortise arrangement extending from the back of this post could be seen to assess likely options in this regard).

What is fascinating about the post is that it shows distinct evidence of severe fire damage. Views into the surrounding wall lining was limited, but what can be seen is scorching and the loss by burning of parts of a lateral mortise joint.

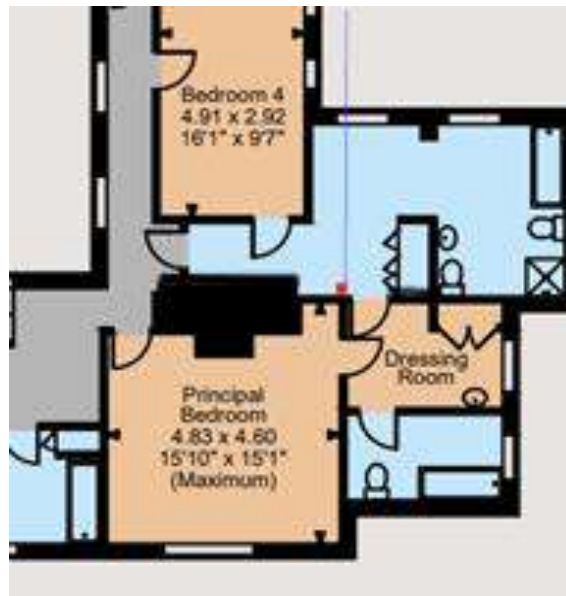
Furthermore, the post is out of alignment with the remaining bay posts of the current south wall of the house and it is clear from the mortise evidence that the building must have extended in this line to the east. The image overleaf shows the alignment compared to the south wall with a blue line extending:

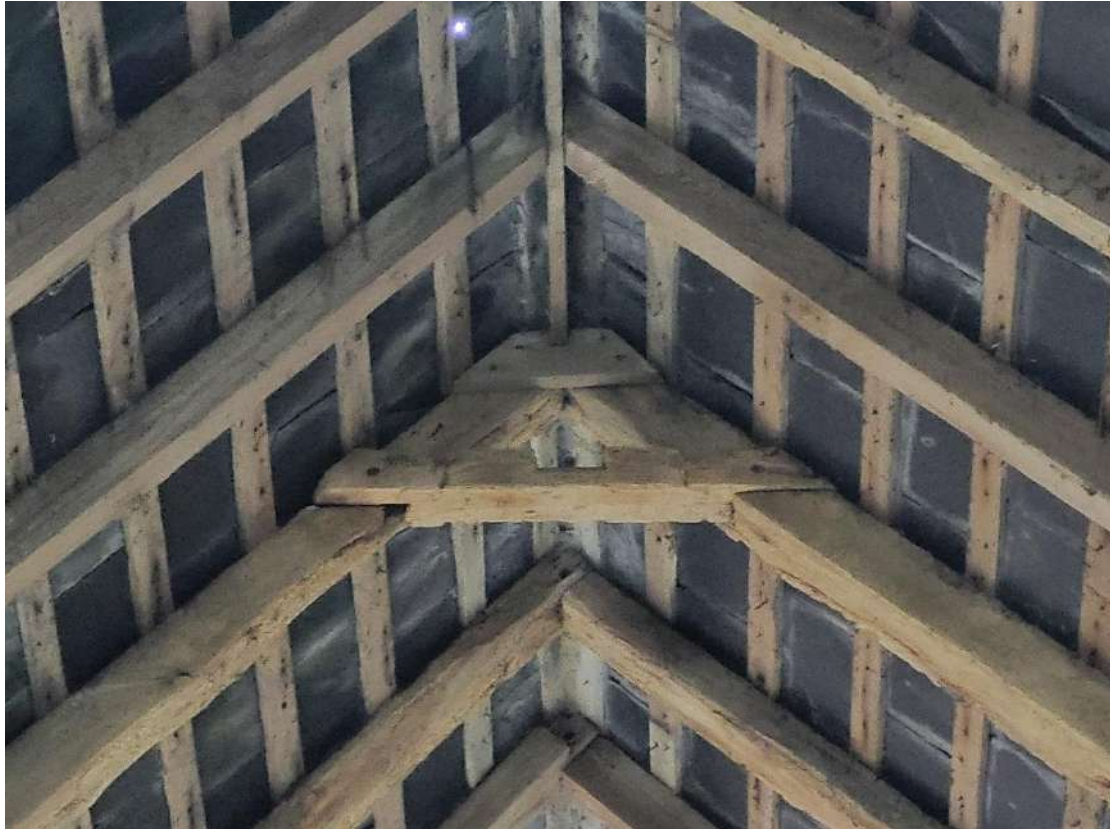
As noted above, the barn was originally in four bays. The fifth bay to the west was added in the 19<sup>th</sup> century. The roof in this bay has a ridge board and the end wall is masonry. The original jack rafter collar for what was evidently a half-hipped terminal can be seen midway along the fourth bay roof apex.
