**From:** Alex Smith [REDACTED]  
**Sent:** 07 August 2026 15:22  
**To:** Sam.Whitehouse  
**Cc:** [REDACTED]  
**Subject:** DISC/26/0217 - Former Fire Station, Hurst Road, Horsham - Conditions 5 & 6  
**Attachments:** C-36677 The Old Fire Station RH12 2ND Asbestos Demolition Report.pdf; 253128B Final Phase 2 Investigation Report.pdf

## Asbestos Demolition Report

The Old Fire Station  
Hurst Road  
Horsham  
RH12 2ND

Reference: C-36677

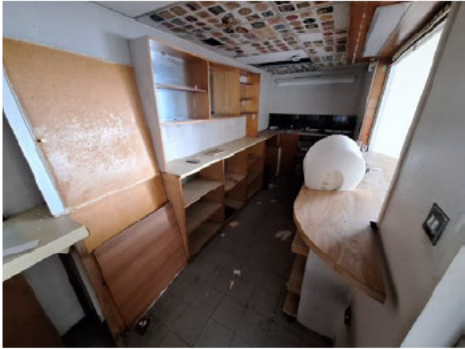
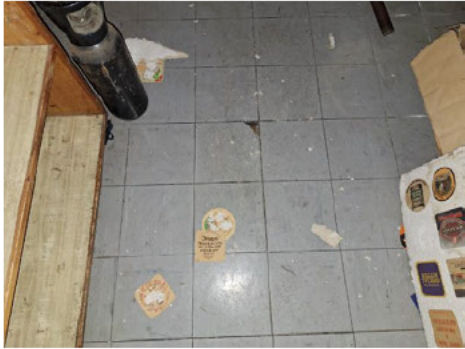
| Comments | <p>Metal sheeted roof, cellulose tiled suspended ceiling, plasterboard walls with a woodchip covering, concrete floor with floortiles.</p> <p>Timber door and frame.</p> <p>Unlagged copper and plastic pipework.</p> <p>Steel and timber beams within ceiling void.</p> <p>Bonded to concrete</p> | | | | |

| Recommendation | No action required | | | | |

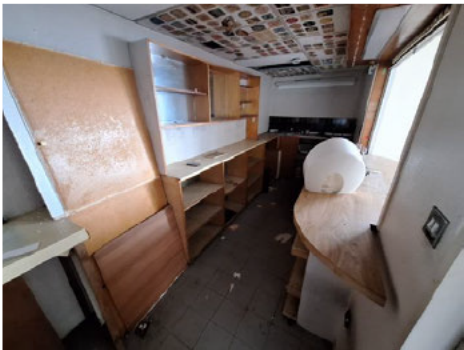
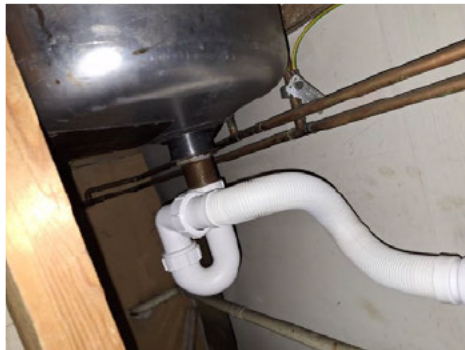
| Comments | Metal sheeted roof, cellulose tiled suspended ceiling, plasterboard walls with a woodchip covering, concrete floor with floortiles.<br>Timber door and frame.<br>Unlagged copper and plastic pipework.<br>Bonded to metal | | | | |

| Recommendation | No action required | | | | |

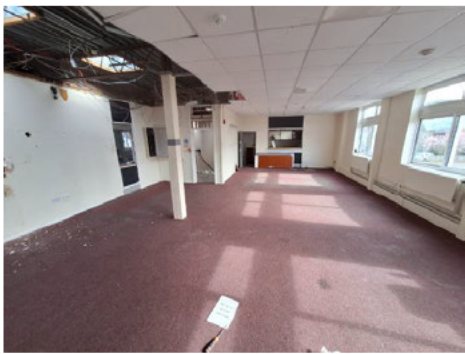
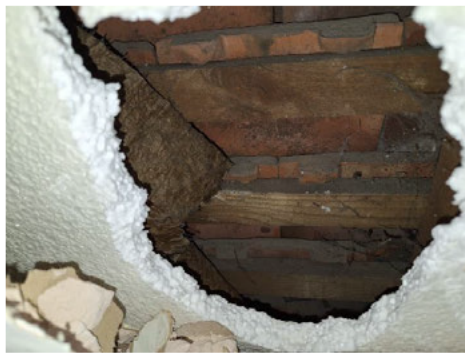
| Comments | <p>Metal sheeted roof, cellulose tiled suspended ceiling, plasterboard walls with a woodchip covering, concrete floor with carpet.</p> <p>Concrete beams.</p> <p>Timber doors and frames.</p> <p>Foamlagged copper pipework.</p> <p>Plasterboard door header panels.</p> <p>Bagged MMMF and cotton insulation within ceiling void.</p> <p>Nailed to timber</p> | | | | |

| Recommendation | No action required | | | | |

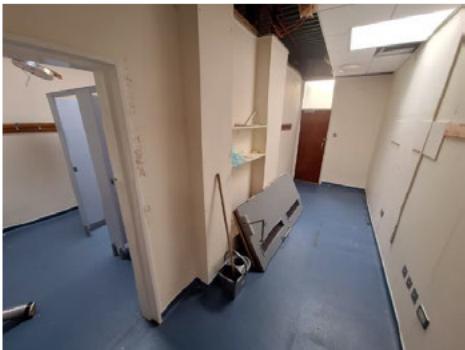
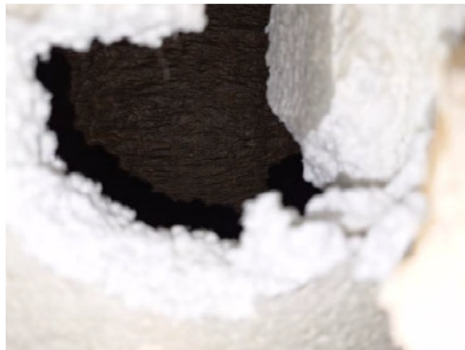
| Comments | <p>Metal sheeted roof, cellulose tiled suspended ceiling, plasterboard walls with a woodchip covering, concrete floor with linoleum.</p> <p>Steel frame.</p> <p>Timber doors and frames.</p> <p>Plastic lagged copper pipework.</p> <p>Timber door header panels.</p> <p>Timber boxing.</p> <p>MMMF insulation within ceiling void.</p> <p>Nailed to timber</p> | | | | |

| Recommendation | No action required | | | | |

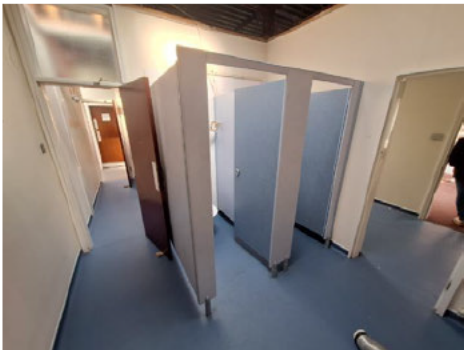
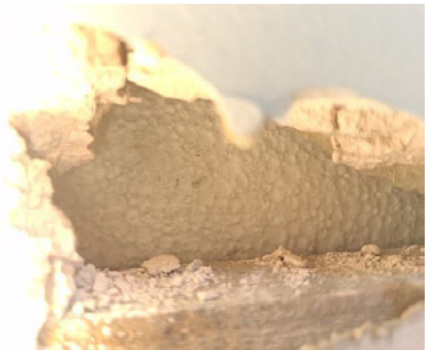
| Comments | <p>Metal roof, suspended ceiling had been removed, plasterboard walls, concrete floor with linoleum.</p> <p>Timber doors and frames.</p> <p>Plastic lagged copper pipework.</p> <p>Ceramic toilet cisterns with plastic soil pipes.</p> <p>Timber boxing.</p> <p>Nailed to timber</p> | | | | |

| Recommendation | No action required | | | | |

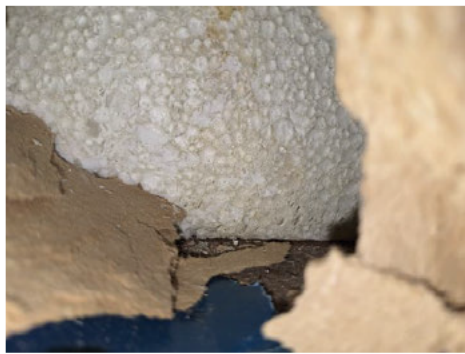
| Comments | <p>Metal sheeted roof, cellulose tiled suspended ceiling, plasterboard walls, concrete floor with carpet.</p> <p>Timber door and frame.</p> <p>Plastic lagged copper pipework.</p> <p>Plasterboard door header panel.</p> <p>Bagged MMMF and cotton insulation within ceiling void.</p> <p>Nailed to timber</p> | | | | |

| Recommendation | No action required | | | | |

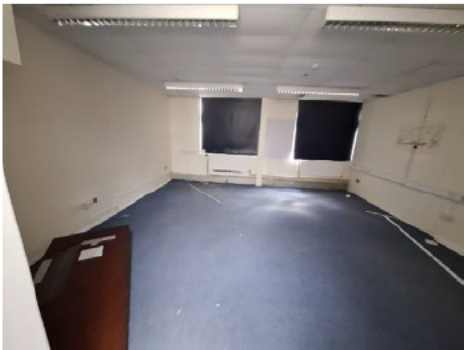
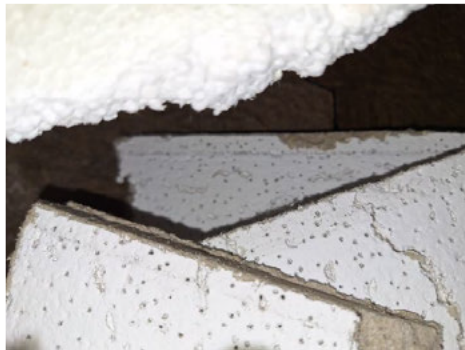
| Comments | <p>Metal sheeted roof, cellulose tiled suspended ceiling, plasterboard walls, concrete floor with carpet.</p> <p>Timber door and frame.</p> <p>Plastic lagged copper pipework.</p> <p>Plasterboard door header panel.</p> <p>Bagged MMMF and cotton insulation within ceiling void.</p> <p>Nailed to timber</p> | | | | |

| Recommendation | No action required | | | | |

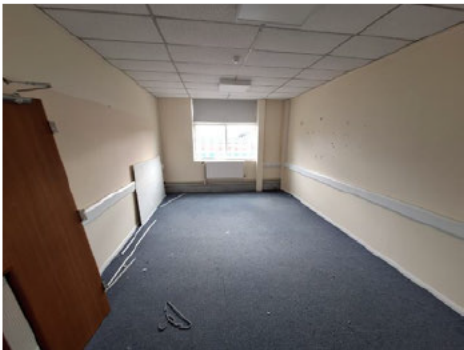
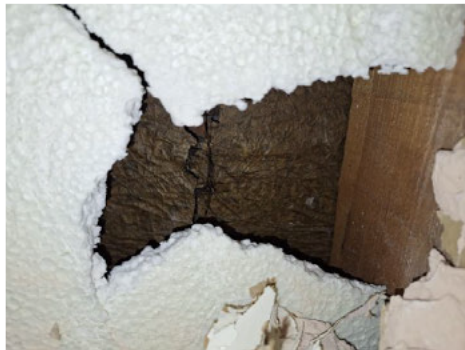
| Comments | <p>Metal sheeted roof, cellulose tiled suspended ceiling, plasterboard walls, concrete floor with carpet.</p> <p>Timber door and frame.</p> <p>Plastic lagged copper pipework.</p> <p>Plasterboard door header panel.</p> <p>Bagged MMMF and cotton insulation within ceiling void.</p> <p>Nailed to timber</p> | | | | |

| Recommendation | No action required | | | | |

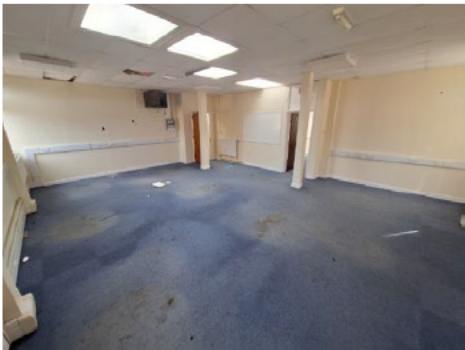
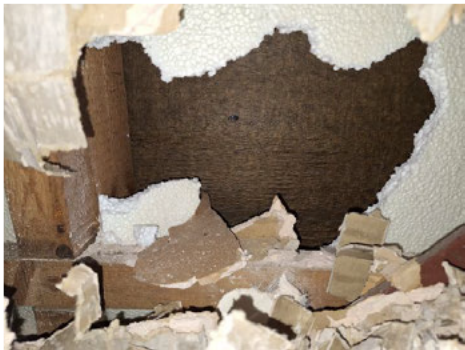
| Comments | <p>Metal sheeted roof, cellulose tiled suspended ceiling, plasterboard walls, concrete floor with carpet.</p> <p>Timber door and frame.</p> <p>Plastic lagged copper pipework.</p> <p>Timber door header panel.</p> <p>Bagged MMMF and cotton insulation within ceiling void.</p> <p>Bitumen felt and polystyrene within wall cavities.</p> <p>Plastic flue pipe within plasterboard boxing.</p> <p>Nailed to timber</p> | | | | |

| Recommendation | No action required | | | | |

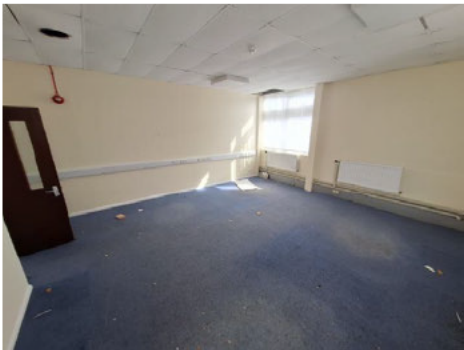
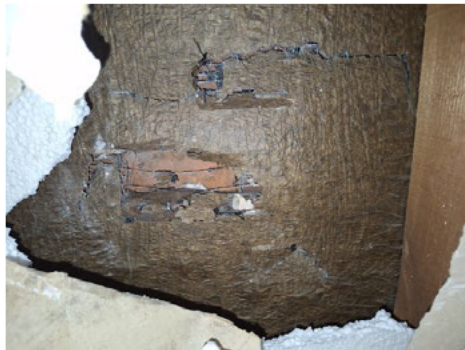
| Comments | <p>Metal sheeted roof, cellulose tiled suspended ceiling, plasterboard walls, concrete floor with carpet.</p> <p>Timber door and frame.</p> <p>Plastic lagged copper pipework.</p> <p>Timber door header panel.</p> <p>Bagged MMMF and cotton insulation within ceiling void.</p> <p>Metal ducting.</p> <p>Bitumen felt and polystyrene within wall cavities.</p> <p>Nailed to timber</p> | | | | |

| Recommendation | No action required | | | | |

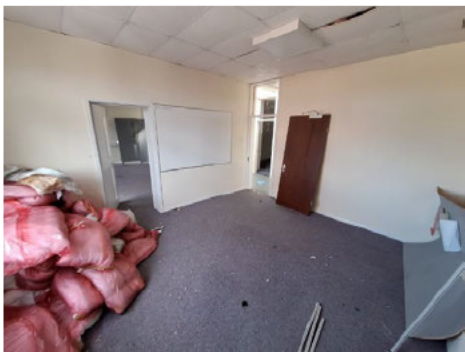
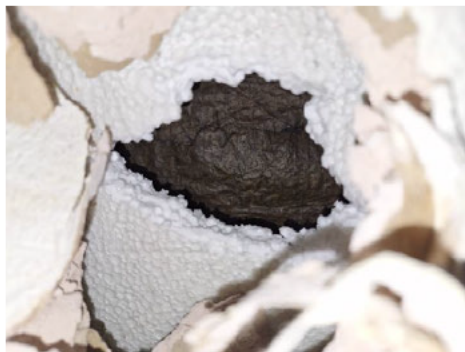
| Comments | <p>Metal sheeted roof, cellulose tiled suspended ceiling, plasterboard walls, concrete floor with carpet.</p> <p>Timber door and frame.</p> <p>Plastic lagged copper pipework.</p> <p>Timber door header panel.</p> <p>Bagged MMMF and cotton insulation within ceiling void.</p> <p>Metal ducting</p> <p>Nailed to timber</p> | | | | |

| Recommendation | No action required | | | | |

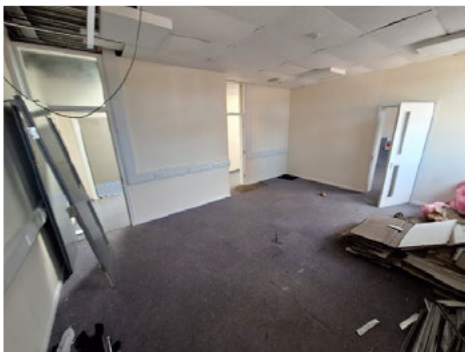
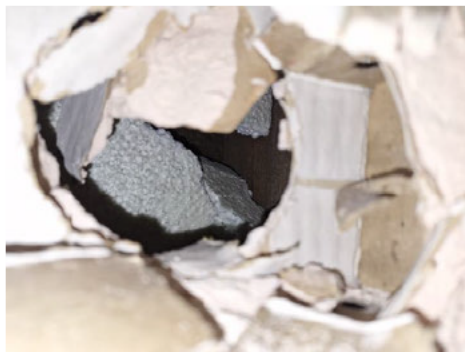
| Comments | <p>Metal sheeted roof, cellulose tiled suspended ceiling, plasterboard walls, concrete floor with carpet.</p> <p>Timber door and frame.</p> <p>Plastic lagged copper pipework.</p> <p>Glass door header panel.</p> <p>Bagged MMMF and cotton insulation within ceiling void.</p> <p>Metal ducting</p> <p>Nailed to timber</p> | | | | |

| Recommendation | No action required | | | | |

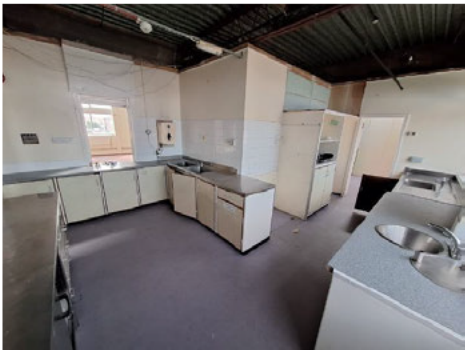
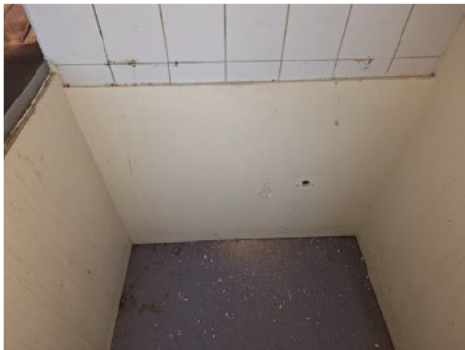
| Comments | <p>Metal roof, suspended ceiling has been removed, plasterboard walls with a ceramic covering, concrete floor with linoleum.</p> <p>Timber doors and frames.</p> <p>Unlagged copper pipework.</p> <p>Steel frame.</p> <p>Nailed to timber</p> | | | | |

| Recommendation | No action required | | | | |

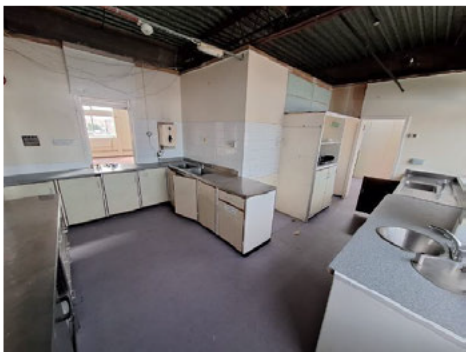
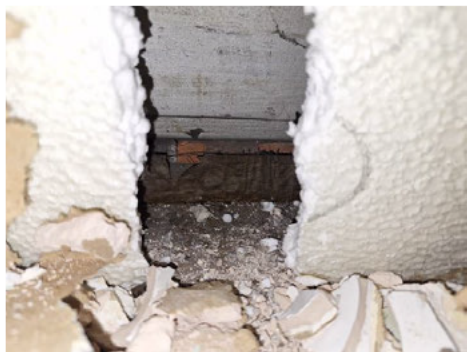
| Comments | <p>Metal roof, suspended ceiling has been removed, plasterboard walls with a ceramic covering, concrete floor with linoleum.</p> <p>Timber doors and frames.</p> <p>Unlagged copper pipework.</p> <p>Steel frame.</p> <p>Nailed to timber</p> | | | | |

| Recommendation | No action required | | | | |

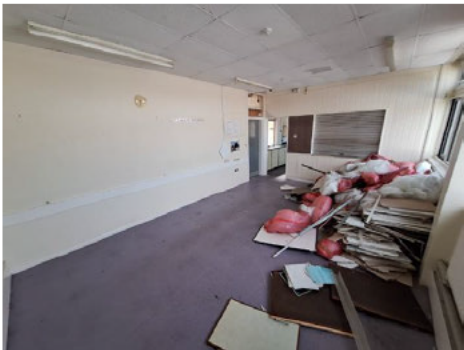
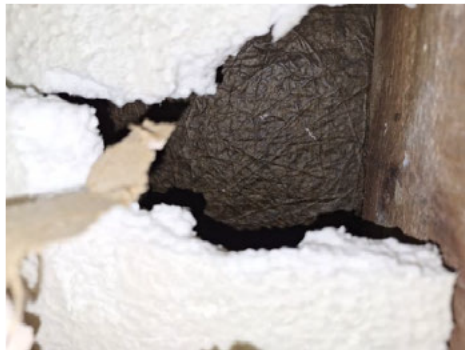
| Comments | <p>Metal sheeted roof, cellulose tiled suspended ceiling, plasterboard walls with a woodchip covering, concrete floor with linoleum</p> <p>Timber door and frame.</p> <p>Plastic lagged copper pipework.</p> <p>Door header panels have been removed.</p> <p>Bagged MMMF and cotton insulation within ceiling void.</p> <p>Metal ducting</p> <p>Nailed to timber</p> | | | | |

| Recommendation | No action required | | | | |

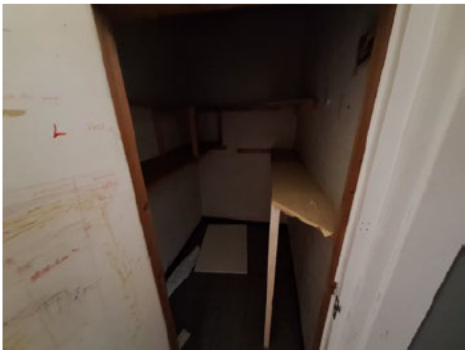
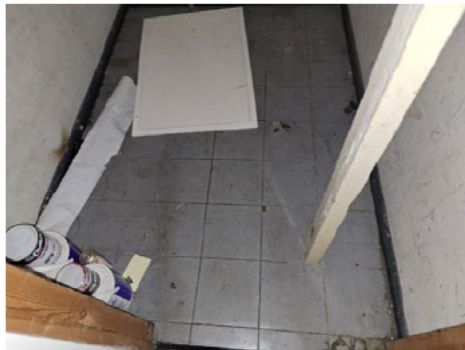
| Comments | Metal sheeted roof, timber tiled suspended ceiling, plasterboard walls, concrete floor with vinyl floortiles.<br>Timber door and frame.<br>Plastic flue pipes.<br>Bonded to concrete | | | | |

| Recommendation | No action required | | | | |

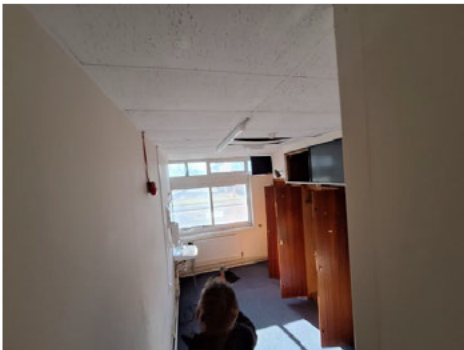
| Condition | Good Condition | | 0 | | |
| Comments | Cellulose tiled suspended ceiling, plasterboard walls, concrete floor with vinyl floortiles beneath carpet.<br>Timber door and frame.<br>Timber window sill.<br>Plastic lagged metal pipework.<br>Metal ducting.<br>Bonded to concrete | | | | |

| Recommendation | <b>Remove - NON-Licensed Material Removal by an asbestos contractor. This material is not licensed however may still be notifiable to the HSE prior to removal works taking place. All works must conform to the Control of Asbestos Regulations 2012.</b> | | | | |

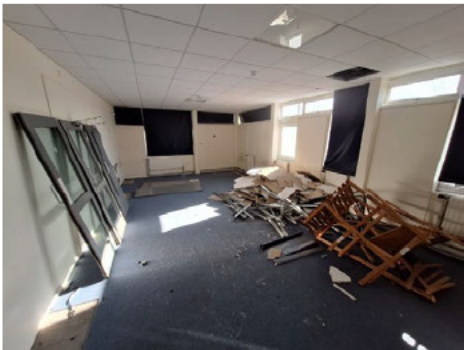
| Condition | Good Condition | | 0 | | |
| Comments | Cellulose tiled suspended ceiling, plasterboard walls, concrete floor with vinyl floortiles beneath carpet.<br>Timber door and frame.<br>Timber window sill.<br>Timber door header panel.<br>Plastic lagged metal pipework.<br>Metal ducting.<br>Bonded to concrete | | | | |

| Recommendation | Remove - NON-Licensed Material Removal by an asbestos contractor. This material is not licensed however may still be notifiable to the HSE prior to removal works taking place. All works must conform to the Control of Asbestos Regulations 2012. | | | | |

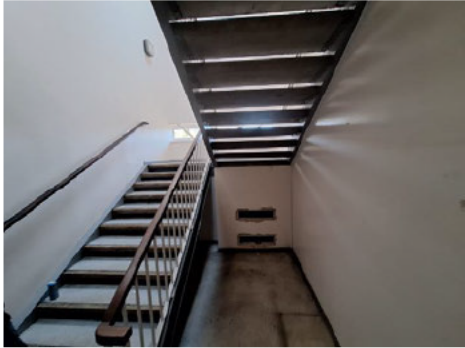
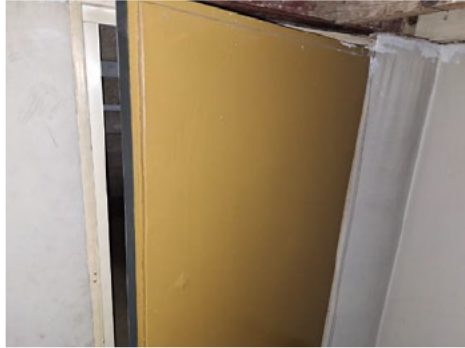
| Condition | Good Condition | | 0 | | |
| Comments | Cellulose tiled suspended ceiling, plasterboard walls, concrete floor with vinyl.<br>Timber doors and frames.<br>Steel beams.<br>Concrete stairs.<br>Screwed to timber | | | | |

| Recommendation | <b>Remove - Licensed Material Removal by a licensed asbestos contractor. This material is licensed therefore is subject to a 14 notification to the HSE prior to removal works taking place. All works must conform to the Control of Asbestos Regulations 2012.</b> | | | | |

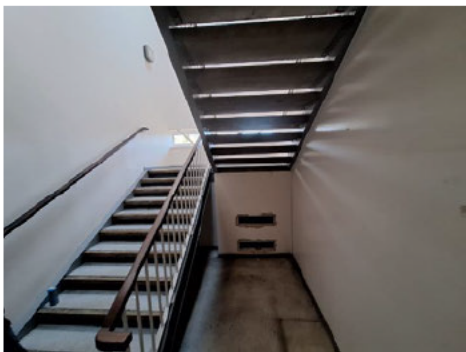
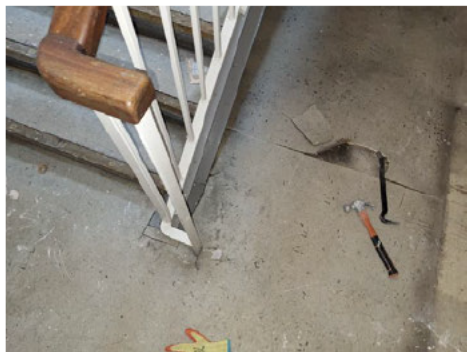
| Comments | Cellulose tiled suspended ceiling, plasterboard walls, concrete floor with vinyl.<br>Timber doors and frames.<br>Steel beams.<br>Concrete stairs.<br>Bonded to concrete | | | | |

| Recommendation | No action required | | | | |

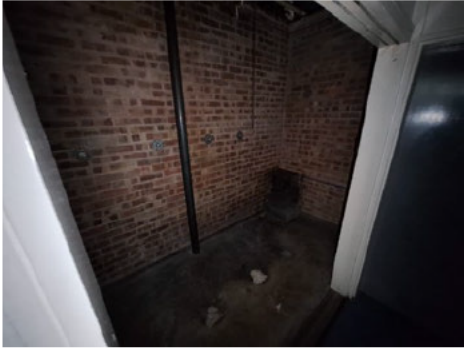
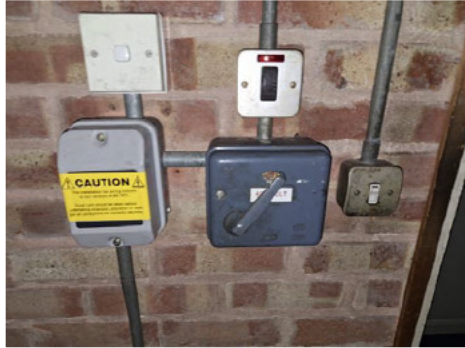
| Condition | Good Condition | | 0 | | |
| Substrate | Enclosed within | Accessibility | Low | | |
| Comments | Steel beams, brick walls, concrete floor.<br>Ceiling has been removed.<br>Enclosed within | | | | |

| Recommendation | <b>Inaccessible Items / Strongly Presumed Inaccessible item. Isolation, access and sampling will be required prior to any works which may disturb the presumed item.</b> | | | | |

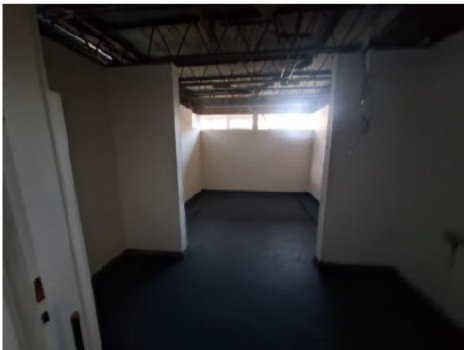
| Condition | Low Damage | | 1 | | |
| Substrate | Bonded to concrete | Accessibility | Medium | | |
| Comments | Steel beams, ceiling tiles have been removed, plasterboard walls, concrete floor with linoleum.<br>Timber door frame.<br>Plasterboard beam cladding.<br>MMMF lagged copper pipework within ceiling void.<br>Bonded to concrete | | | | |

| Recommendation | <b>Remove - NON-Licensed Material Removal by an asbestos contractor. This material is not licensed however may still be notifiable to the HSE prior to removal works taking place. All works must conform to the Control of Asbestos Regulations 2012.</b> | | | | |

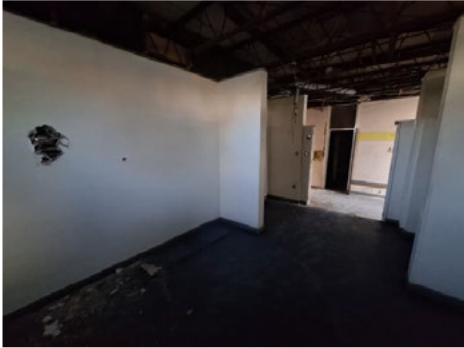
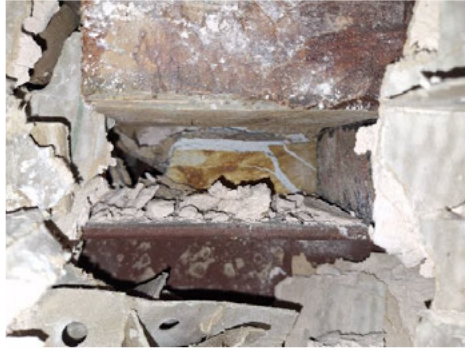
| Condition | High Damage | | 3 | | |
| Substrate | Nailed to timber | Accessibility | High | | |
| Comments | Steel beams, ceiling tiles have been removed, plasterboard walls, concrete floor with linoleum.<br>Timber door frame.<br>Plasterboard beam cladding.<br>MMMF lagged copper pipework within ceiling void.<br>Nailed to timber | | | | |

| Recommendation | <b>Remove - Licensed Material Removal by a licensed asbestos contractor. This material is licensed therefore is subject to a 14 notification to the HSE prior to removal works taking place. All works must conform to the Control of Asbestos Regulations 2012.</b> | | | | |

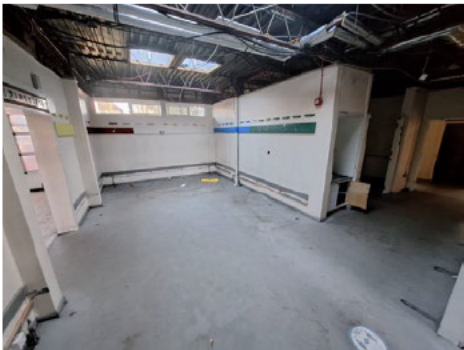
| Condition | Low Damage | | 1 | | |
| Substrate | Nailed to timber | Accessibility | High | | |
| Comments | Metal roof, steel beams, ceiling tiles have been removed, plasterboard walls, concrete floor with linoleum.<br>Timber door frame.<br>Plasterboard beam cladding.<br>MMMF lagged copper pipework within ceiling void.<br>Metal ducting<br>Insulating board within timber boxing.<br>Nailed to timber | | | | |

| Recommendation | <b>Remove - NON-Licensed Material Removal by an asbestos contractor. This material is not licensed however may still be notifiable to the HSE prior to removal works taking place. All works must conform to the Control of Asbestos Regulations 2012.</b> | | | | |

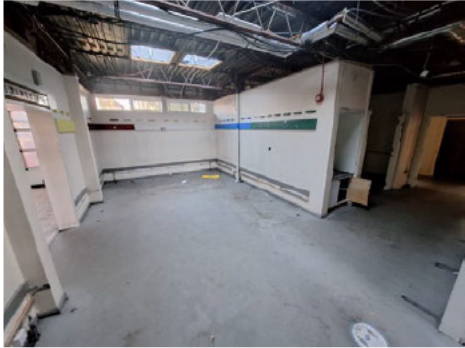
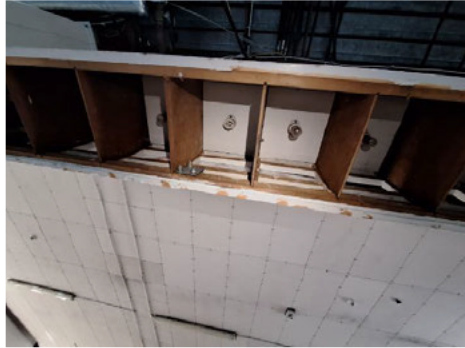
| Condition | Good Condition | | 0 | | |
| Substrate | Nailed to timber | Accessibility | Medium | | |
| Comments | Metal roof, steel beams, ceiling tiles have been removed, plasterboard walls, concrete floor with linoleum.<br>Timber door frame.<br>Plasterboard beam cladding.<br>MMMF lagged copper pipework within ceiling void.<br>Metal ducting<br>Insulating board within timber boxing.<br>Nailed to timber | | | | |

| Recommendation | <b>Remove - Licensed Material Removal by a licensed asbestos contractor. This material is licensed therefore is subject to a 14 notification to the HSE prior to removal works taking place. All works must conform to the Control of Asbestos Regulations 2012.</b> | | | | |

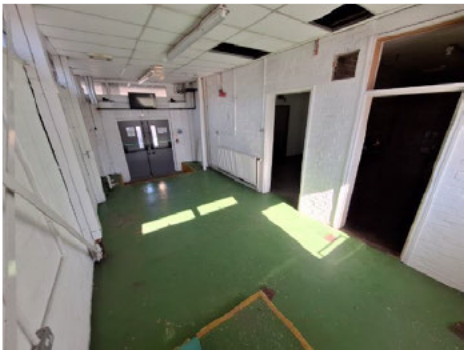
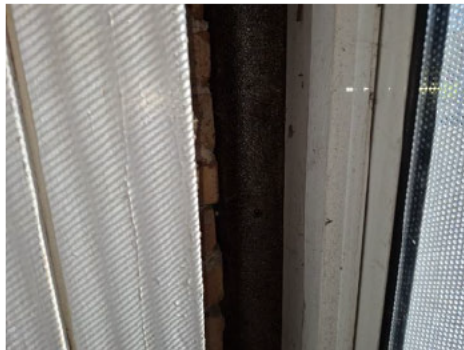
| Condition | Low Damage | | 1 | | |
| Substrate | Bonded to brick | Accessibility | Medium | | |
| Comments | Concrete ceiling with a cellulose tiled suspended ceiling, brick walls, concrete floor.<br>Timber doors and frames.<br>Metal ducting.<br>Steel beams.<br>Plastic and MMMF lagged copper pipework.<br>Bonded to brick | | | | |

| Recommendation | <b>Remove - NON-Licensed Material Removal by an asbestos contractor. This material is not licensed however may still be notifiable to the HSE prior to removal works taking place. All works must conform to the Control of Asbestos Regulations 2012.</b> | | | | |

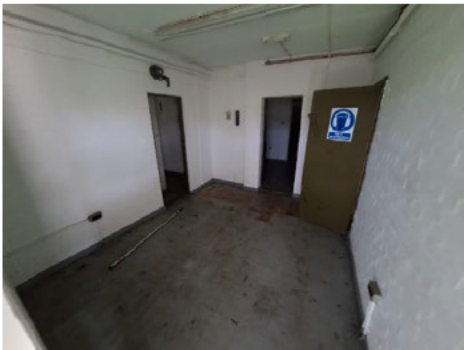
| Condition | Low Damage | | 1 | | |
| Substrate | Bonded to concrete | Accessibility | High | | |
| Comments | Concrete ceiling, brick walls, concrete floor with thermoplastic floortiles<br>Metal doors and frames.<br>Unlagged copper pipework.<br>Bonded to concrete | | | | |

| Recommendation | <b>Remove - NON-Licensed Material Removal by an asbestos contractor. This material is not licensed however may still be notifiable to the HSE prior to removal works taking place. All works must conform to the Control of Asbestos Regulations 2012.</b> | | | | |

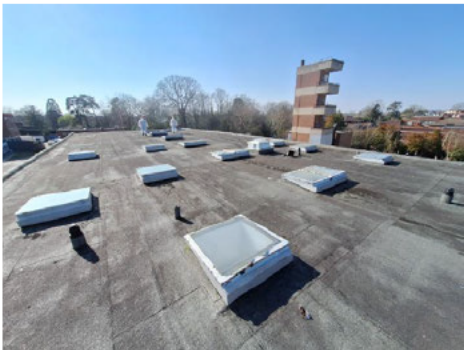
| Condition | Good Condition | | 0 | | |
| Substrate | Bonded to metal | Accessibility | Low | | |
| Comments | Bitumen flat roof, brick walls, skylights, plastic flue pipes, lead flashing.<br>Bonded to metal | | | | |

| Recommendation | <b>Remove - NON-Licensed Material Removal by an asbestos contractor. This material is not licensed however may still be notifiable to the HSE prior to removal works taking place. All works must conform to the Control of Asbestos Regulations 2012.</b> | | | | |

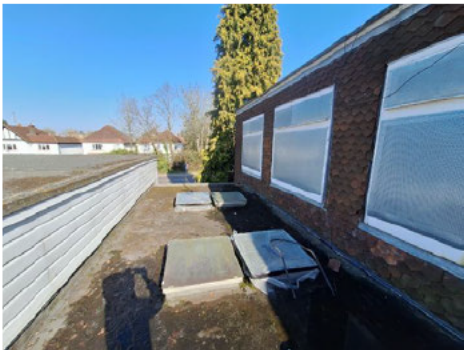
| Condition | Low Damage | | 1 | | |
| Substrate | Bonded to brick | Accessibility | Low | | |
| Comments | Bonded to brick | | | | |

| Recommendation | Remove - NON-Licensed Material Removal by an asbestos contractor. This material is not licensed however may still be notifiable to the HSE prior to removal works taking place. All works must conform to the Control of Asbestos Regulations 2012. | | | | |

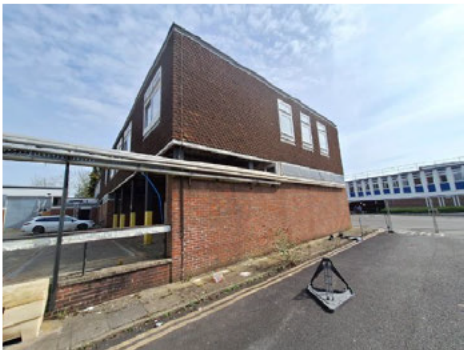
| Condition | Good Condition | | 0 | | |
| Substrate | Bonded to brick | Accessibility | High | | |
| Comments | <p>Flat roof, brick walls with upvc and clay tiled cladding, concrete floor.</p> <p>Steel and timber beams.</p> <p>Metal and timber doors and frames.</p> <p>Upvc and timber window frames.</p> <p>Timber cladding.</p> <p>Metal ducting.</p> <p>Metal roll down doors.</p> <p>Lead flashing</p> <p>Metal sheets covering doors.</p> <p>Bonded to brick</p> | | | | |

| Recommendation | <b>Remove - NON-Licensed Material Removal by an asbestos contractor. This material is not licensed however may still be notifiable to the HSE prior to removal works taking place. All works must conform to the Control of Asbestos Regulations 2012.</b> | | | | |
