# GeoShield Verification Report 1

GEO105886

Kilnwood Vale 3E  
Off Illett Way  
Faygate  
Horsham  
RH12 0AJ

Plots 583, 584, 585, 594, 595, 596 & 597 - Full Line Out

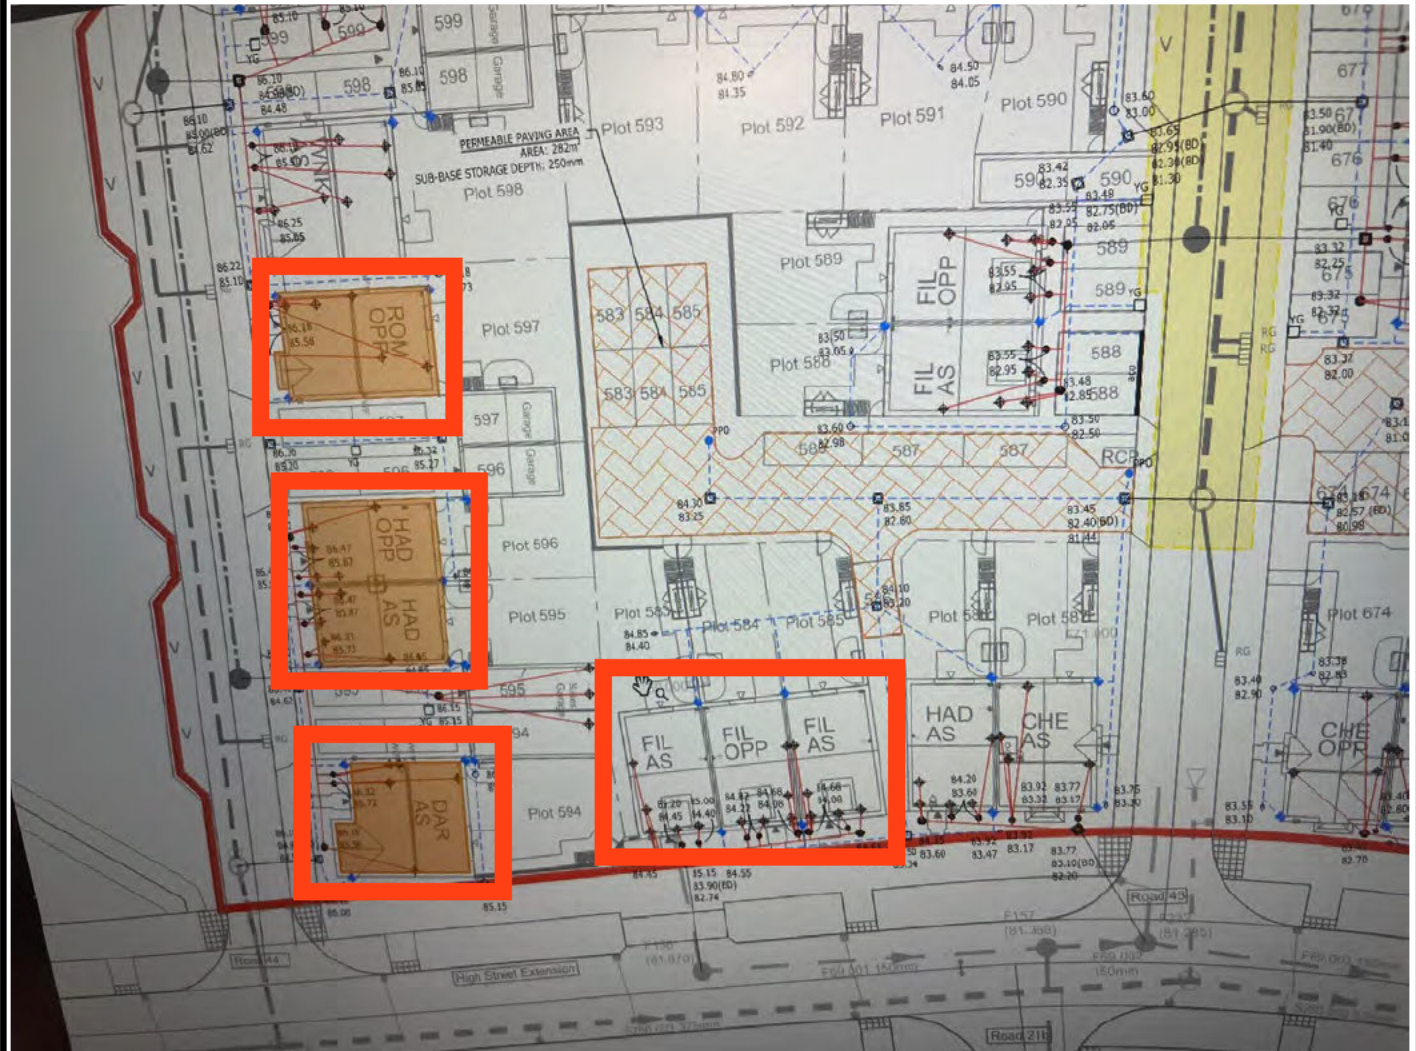
The photograph above shows a plan layout of the site. The areas highlighted in red show Plots 583, 584, 585, 594, 595, 596 & 597 where the verification inspection took place on site today.
