# GeoShield Verification Report 2

GEO105886

Kilnwood Vale 3E  
Off Illett Way  
Faygate  
Horsham  
RH12 0AJ

Plots 586, 587 & 599 - Full Line Out

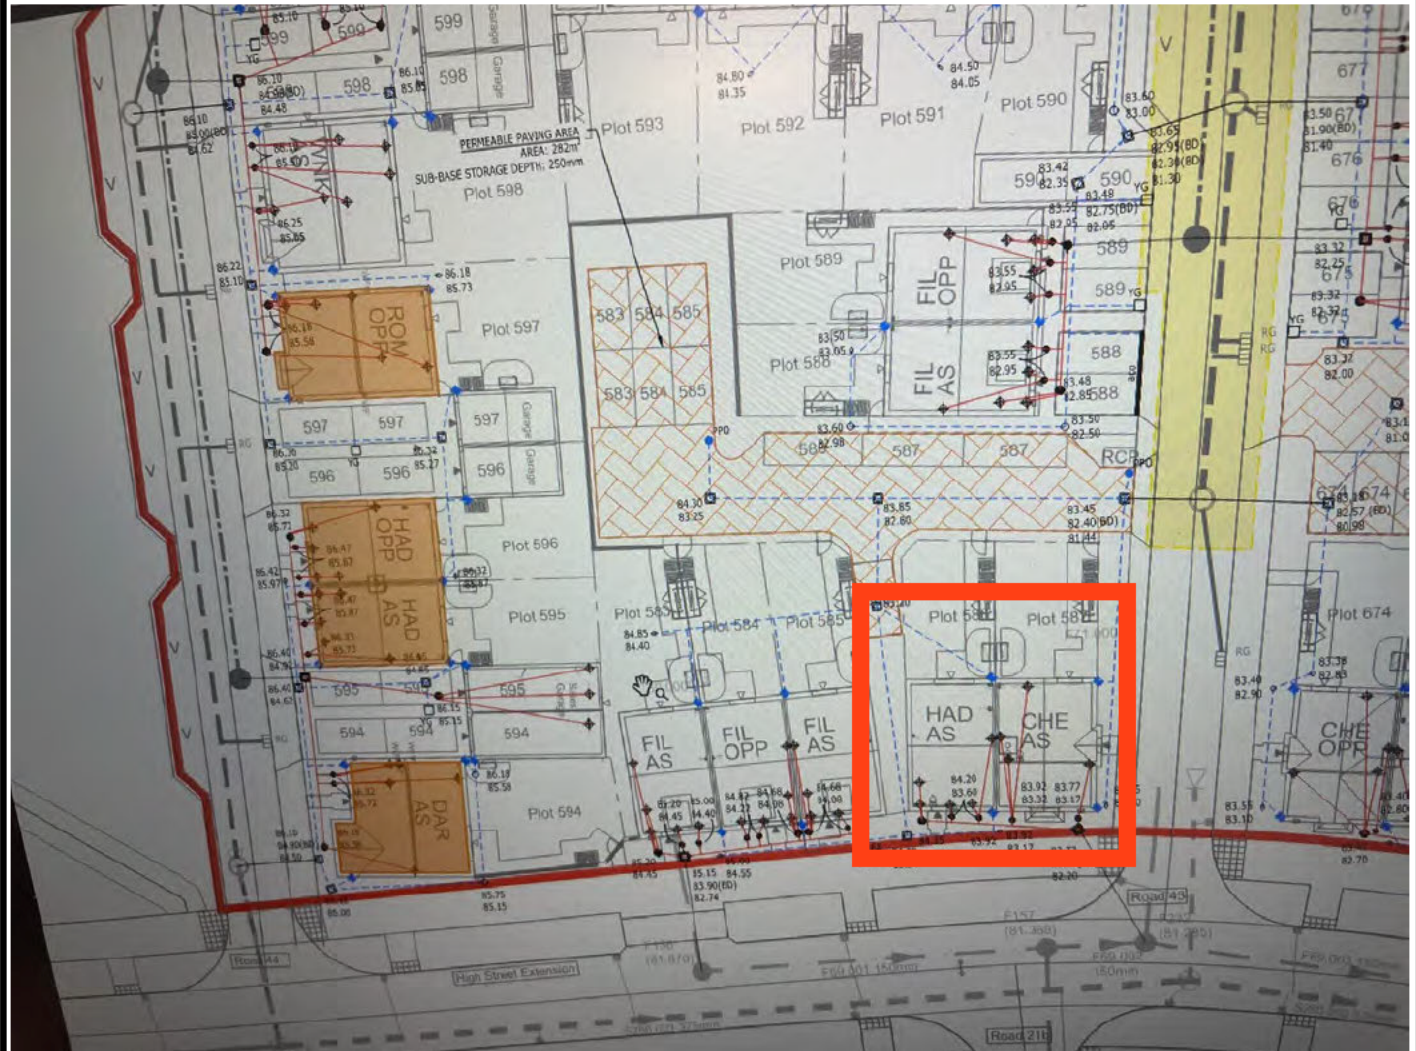
The photograph above shows a plan layout of the site. The areas highlighted in red show Plots 586 & 587 where the verification inspection took place on site today.

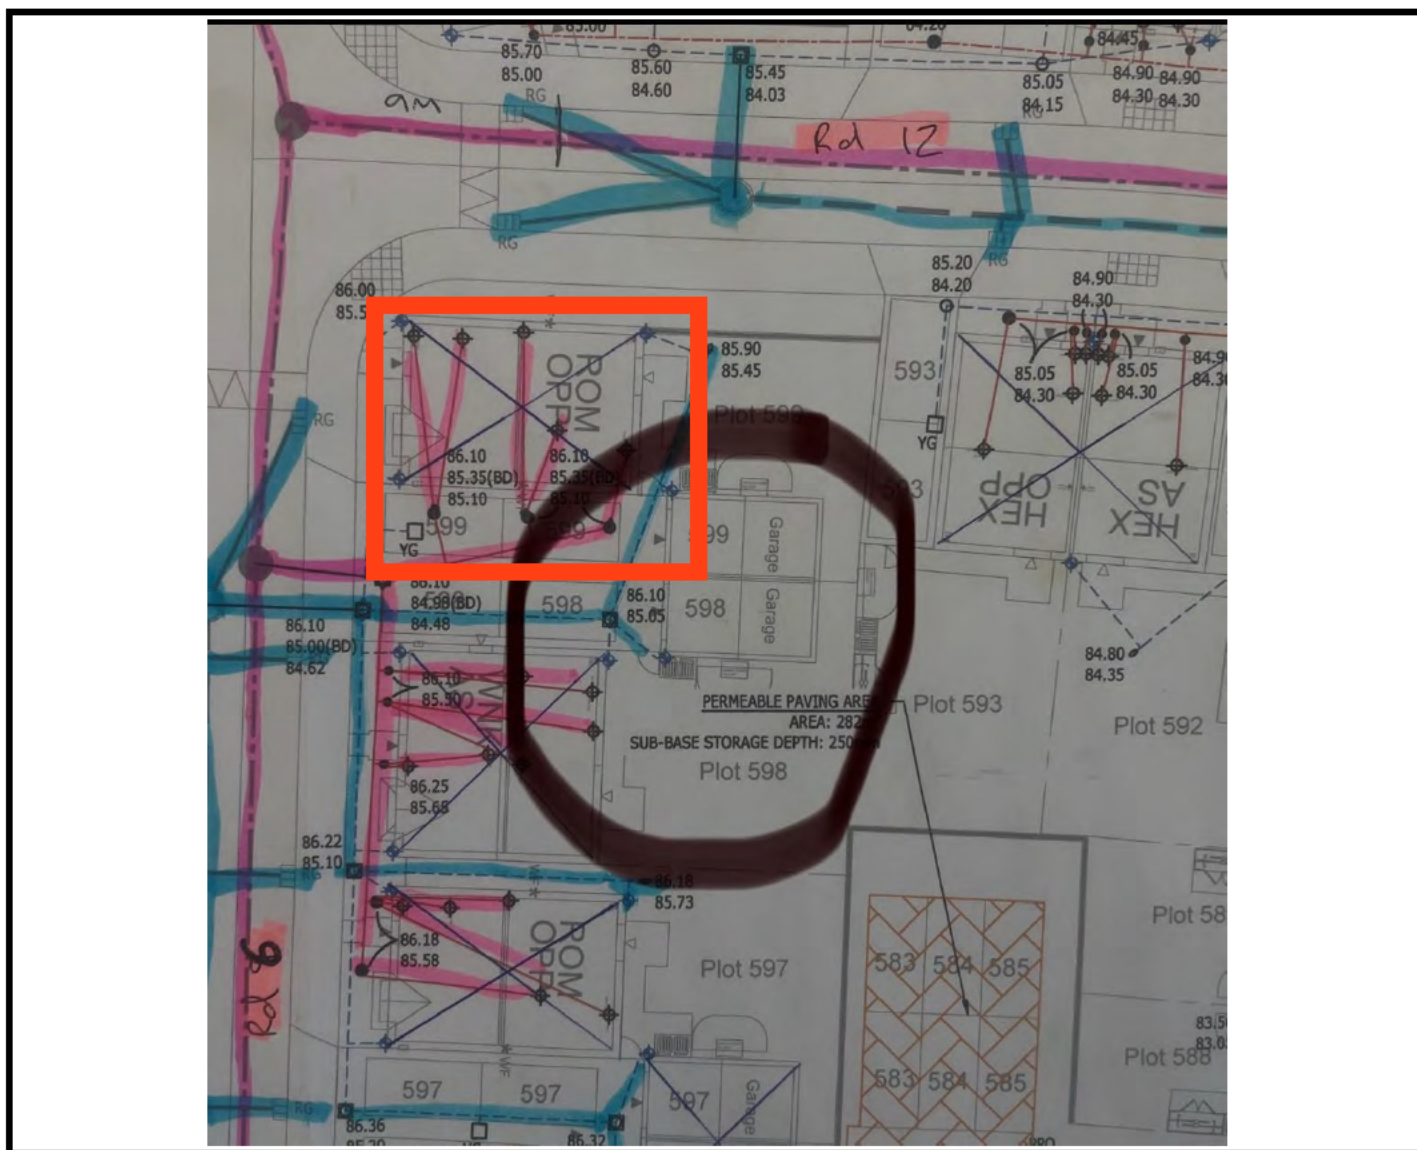
The photograph above shows a plan layout of the site. The area highlighted in red shows Plot 599 where the verification inspection took place on site today.
