# GeoShield Verification Report 4

GEO105886

Kilnwood Vale 3E  
Off Illett Way  
Faygate  
Horsham  
RH12 0AJ

Plots 588, 589 & 598 - Full Line Out

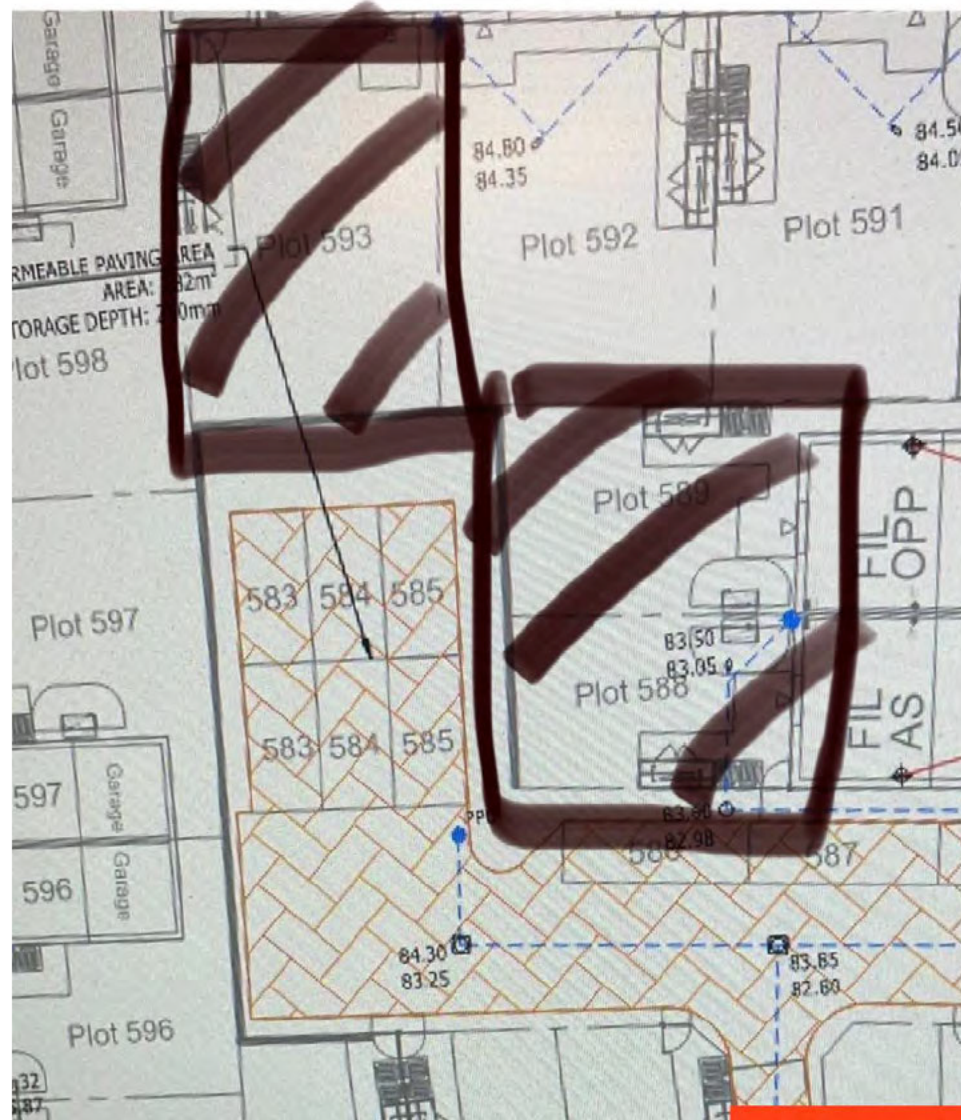
## VERIFICATION LAYOUT

The photograph above shows a plan layout of the site. The areas highlighted show Plots 588, 589 & 598 where the verification inspection of the JUTA GP1 Gas Barrier complete line out installation took place.

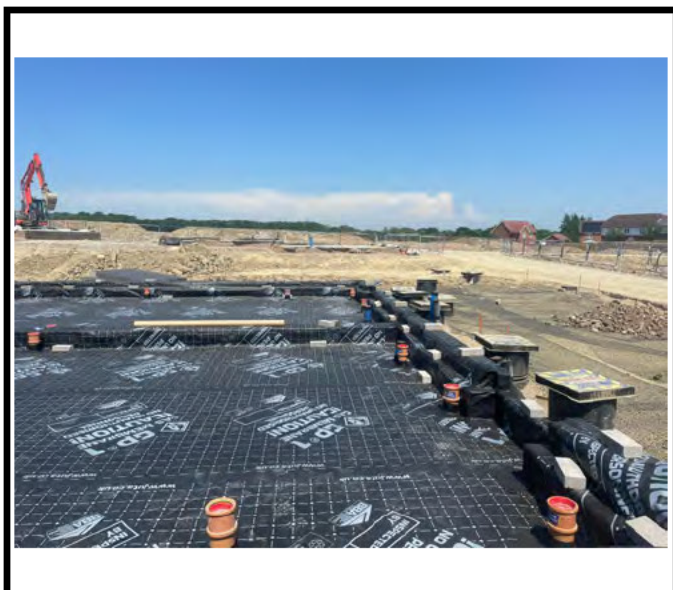
An overview of the plots.
