## Hampers lane re-pollard of willow

### Pollard willow

Site\*  
Hampers Lane to public footpath Foot Bridge

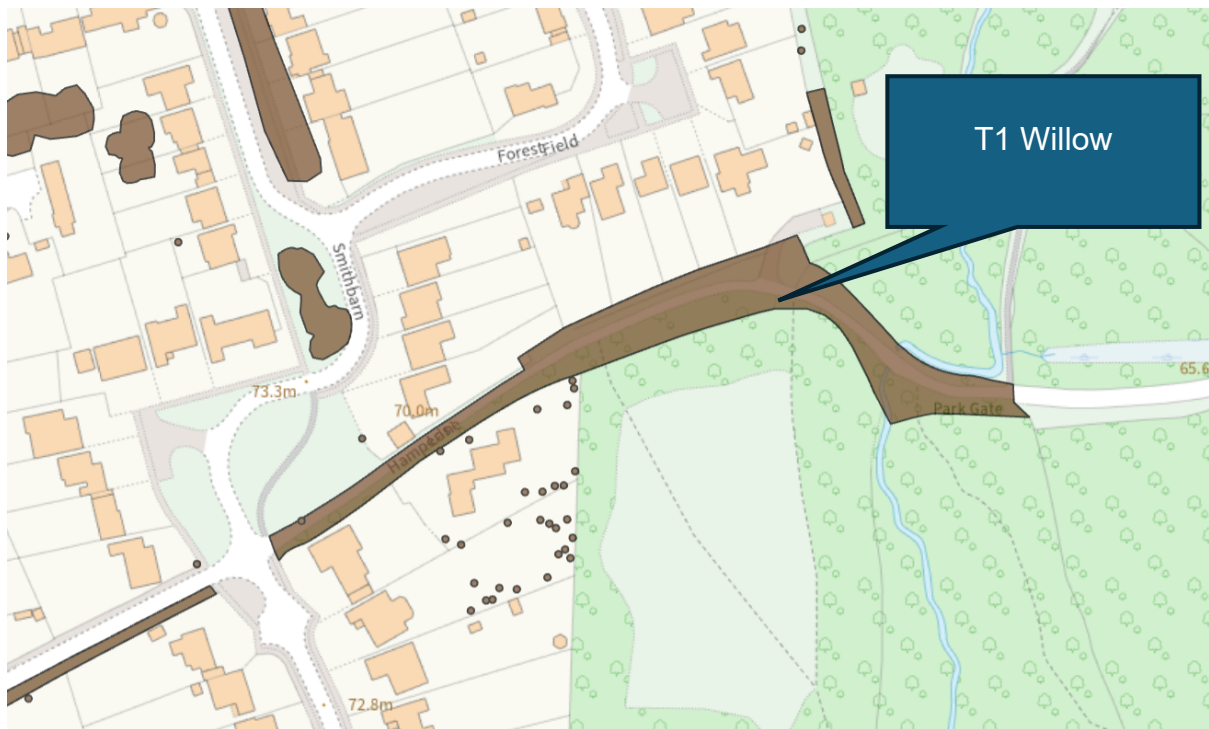
Inspectors notes : "23.1.26 leaning over road, historic pollard with decay on lower tension side of stem... (repollard) 1m below previous pollard points
