HORSHAM DISTRICT COUNCIL CONSULTATION

TO:	Horsham District Council – Planning Dept
LOCATION:	Land East of Mousdell Close Rectory Lane Ashington
DESCRIPTION:	Erection of 74 dwellings with associated access, parking and landscaping.
REFERENCE:	DC/25/1327
RECOMMENDATION:	Advice/ Modification/ More information
SUMMARY OF COMMENTS & RECOMMENDATION: The proposed development, as supported by the submitted Arboricultural Impact Assessment (AIA), Arboricultural Method Statement (AMS) and Tree Protection Plans (TPP), however, concerns are raised with incursions into Root Protection Areas (RPAs), and poor spatial relationships between retained trees and new dwellings, which are likely to impact on existing trees and give rise to future pressure for robust surgery works, or in the worst case their removal.

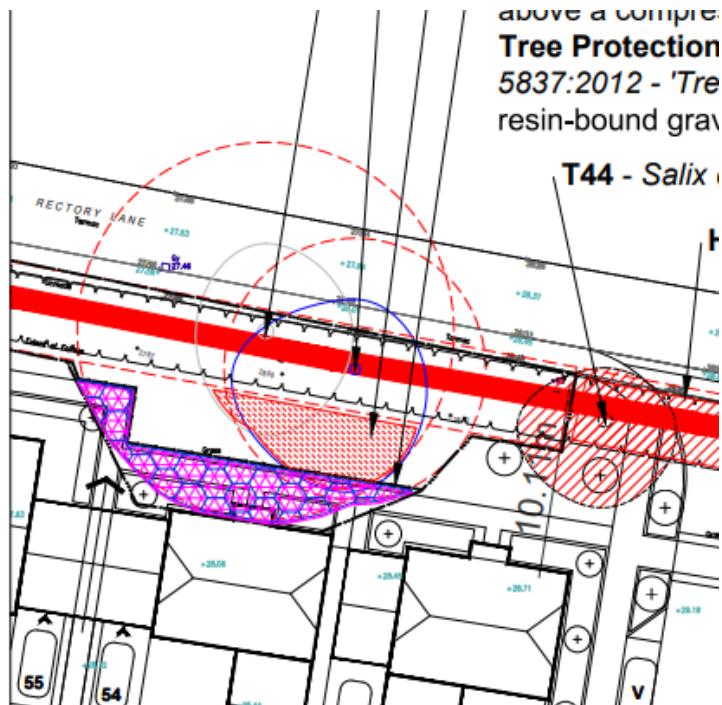
Furthermore, the RPAs for T42 (Sycamore) and T43 (Oak) have been plotted as standard circular areas extending beneath Rectory Lane, which is best described as being an inhospitable rooting environment. Rooting is therefore more likely concentrated southwards within the site and potentially beneath Unit 54. The current circular RPAs for both trees do not reflect this, and consequently, in my opinion, underestimate the potential impact of the proposed development and its associated infrastructure on T42 and T43. The RPA for these trees needs to be amended to better consider the long-standing relationship that T42 and T43 will have had with the engineered road to the north, and the impact this will have had on any significant root development in this area under the road, and with the site.

BS5837:2012, Paragraph 4.6.2 advises, - The RPA for each tree should initially be plotted as a circle centred on the base of the stem. Where pre-existing site conditions or other factors indicate that rooting has occurred asymmetrically, a polygon of equivalent area should be produced. Modifications to the shape of the RPA should reflect a soundly based arboricultural assessment of likely root distribution.

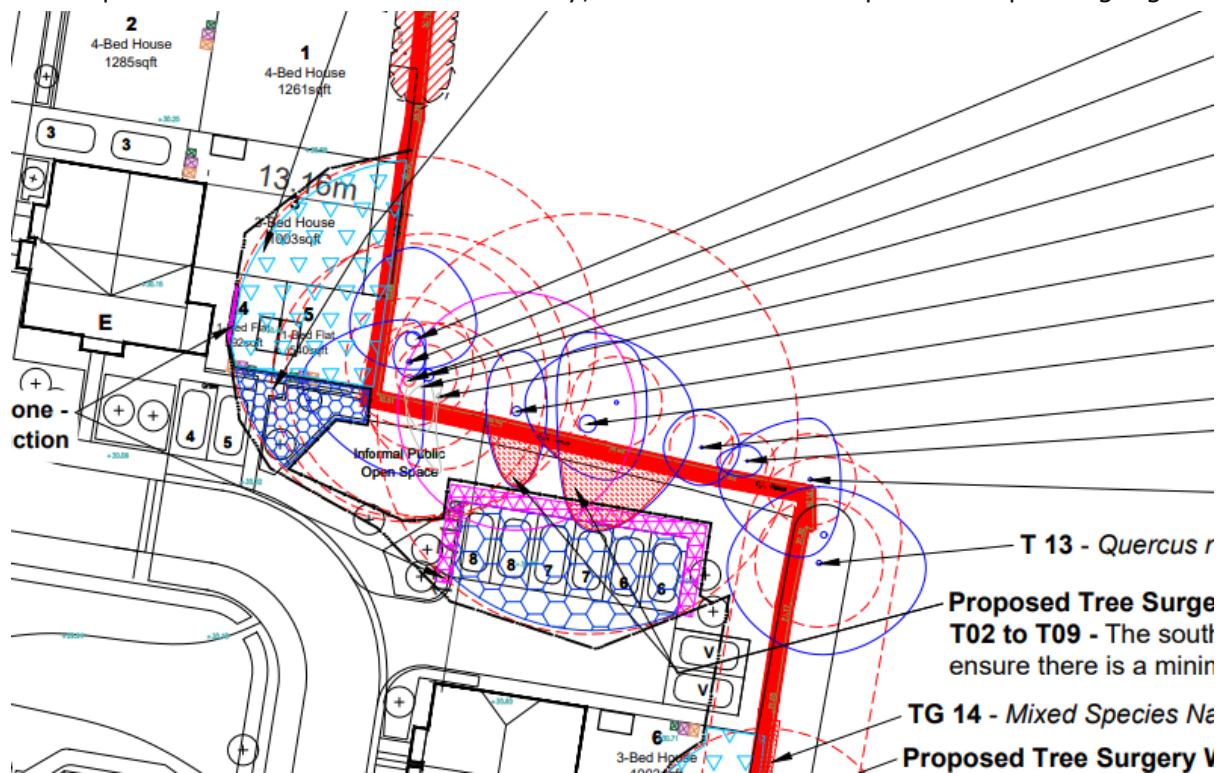
The proposed development encroaches on the Root Protection Areas (RPAs) of several off-site trees, as shown on the plan below. Although these trees are of limited individual quality, collectively they form an important visual and screening feature for the adjacent property, making their retention desirable for the adjacent property. Construction activity within the RPAs has the potential to adversely affect tree health through soil compaction, root damage, or changes to ground levels. The use of above-ground construction techniques in this area would be necessary, as the AIA and tree protection plan highlights.
