6.2 STABLE BLOCK

6.2.12 EXISTING FACADE IMPROVEMENTS

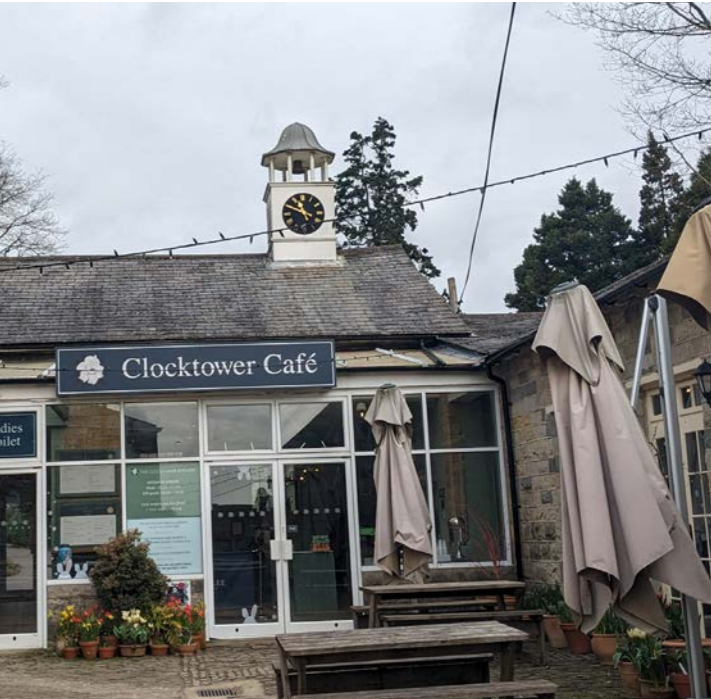
Existing Clocktower Café

Upon entering the existing courtyard, the most notable facade is the modern uPVC lean to structure situated below the clocktower which appears very out of context and inappropriate in a heritage setting.

It is likely that the lean to roof would have originally have been tiled, then later replaced with a corrugated metal sheeting and finally in recent history refurbished as part of the cafe as a translucent perspex roof to allow light to penetrate into the cafe.

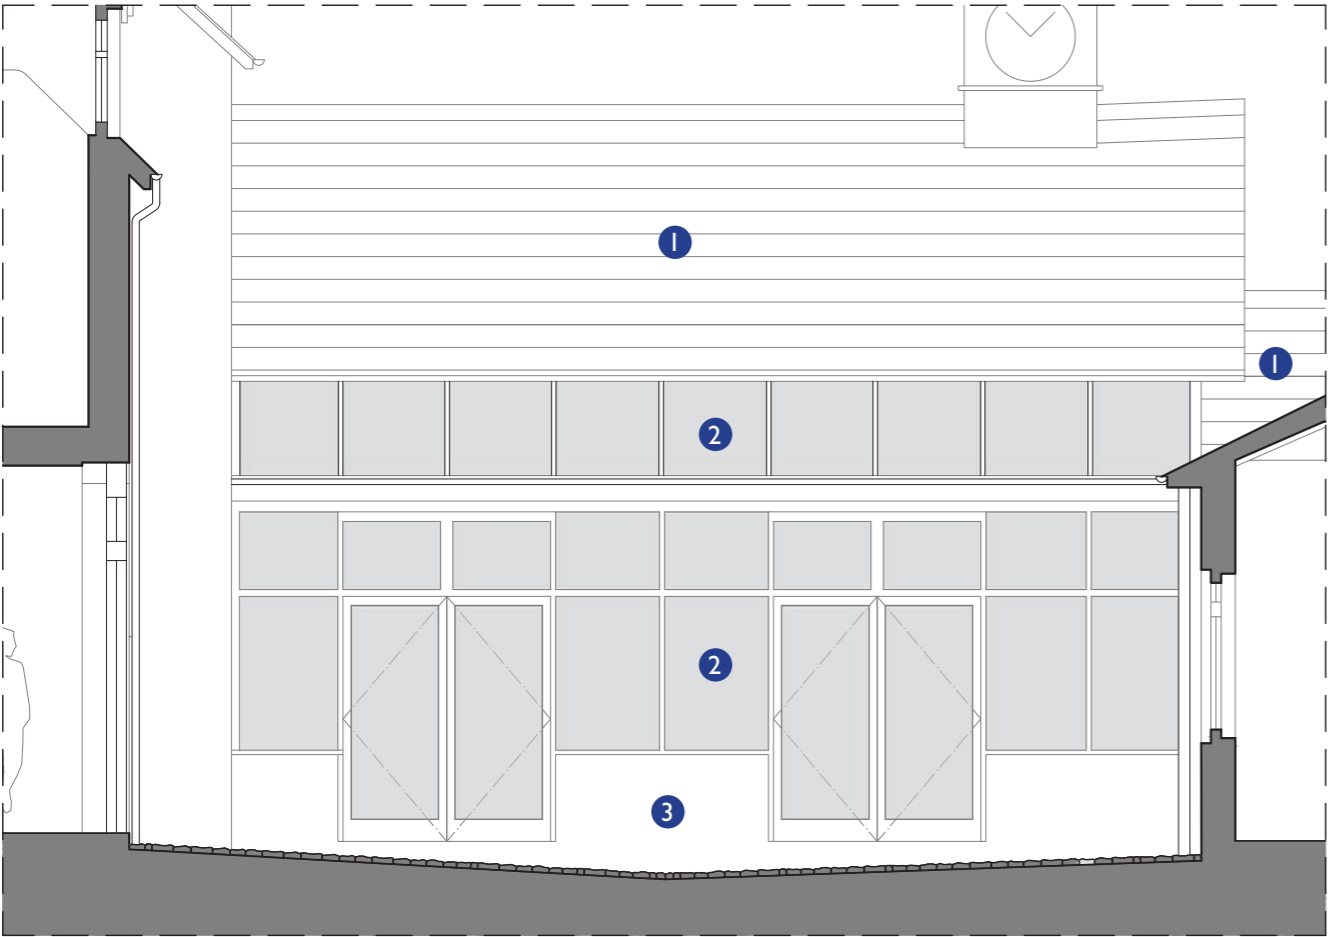
Existing Courtyard Section

- Key:
- 1 Existing slate roof
  - 2 Existing uPVC facade and roof
  - 3 Existing stone base
  - 4 New warm slate roof with conservation rooflights
  - 5 New black painted metal rainwater goods to match existing
  - 6 Proposed painted timber boarding to match existing historic timber
  - 7 Proposed stepped lead gutters
  - 8 New glazed timber doors to match adjacent existing doors

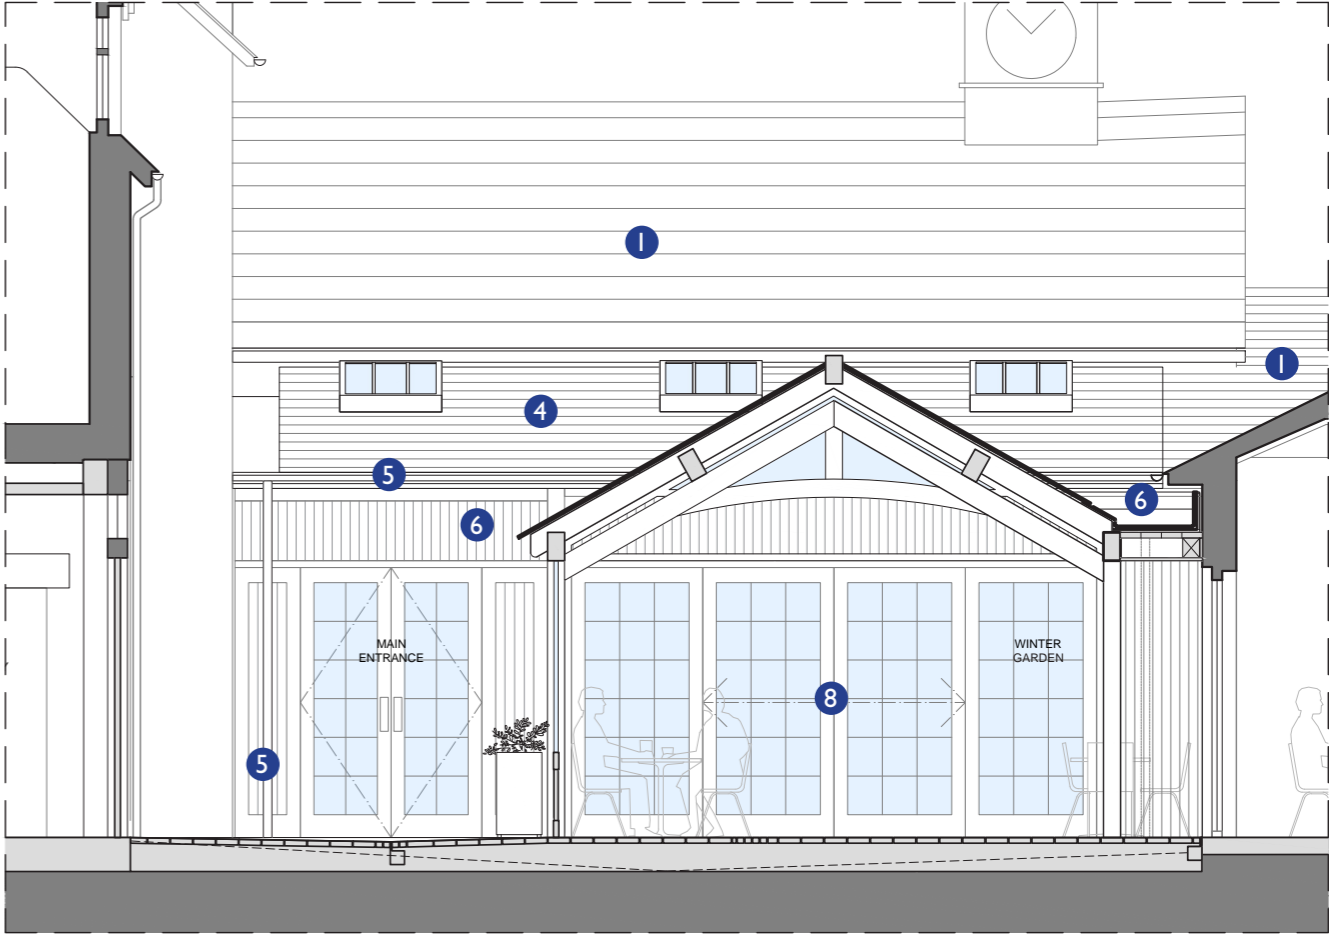
Proposed Courtyard Section

The perspex roof is not in keeping with the character of the Stable Block, and now the kitchen is proposed to be located under the clocktower; there is a lessened requirement for natural light deep into the plan. It is therefore proposed to install a slate roof with discreet conservation rooflights to allow light into the entrance area, and situated so as to retain the historic timber structure still present.

The existing facade has unsympathetic proportions, with UPVC doors and side panels with a natural stone plinth. It is proposed to reconstruct the facade in traditional painted timber doors with glazing bars, which will be in-keeping with the other courtyard elevations.

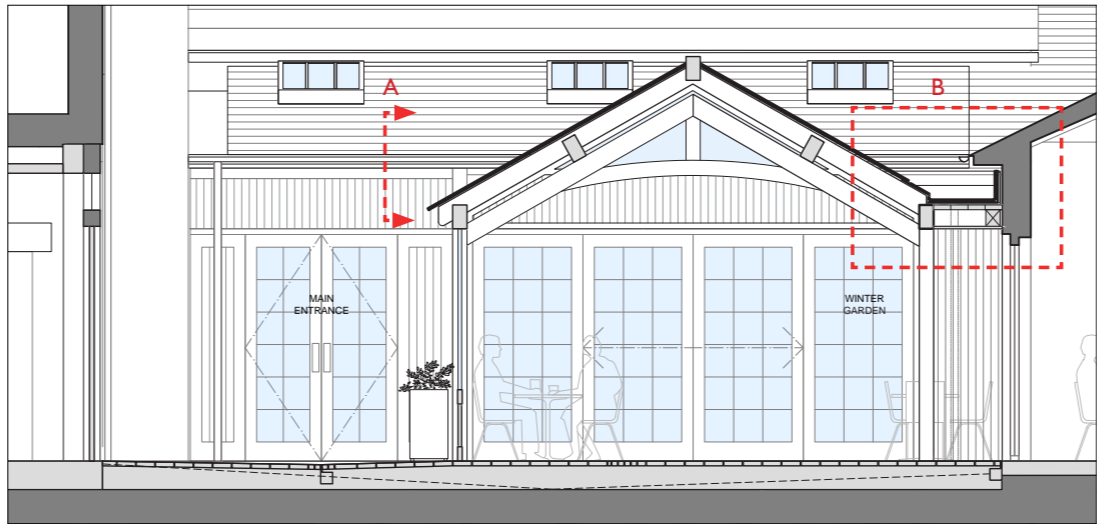
Section through proposed winter garden

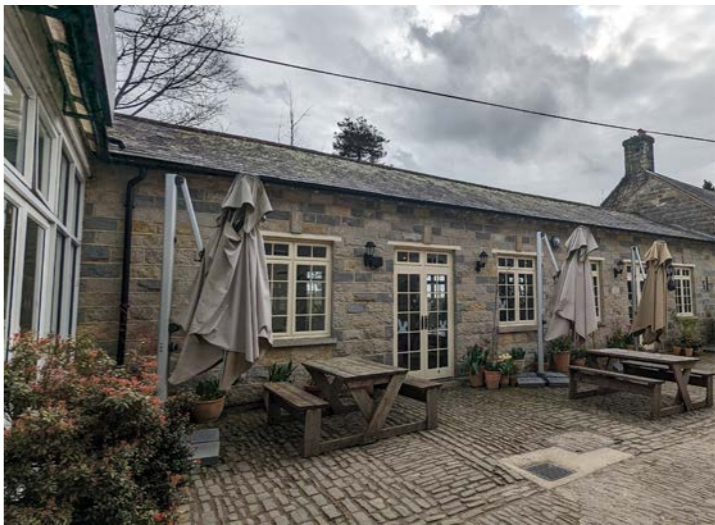
Existing Stable Block (non original facade)

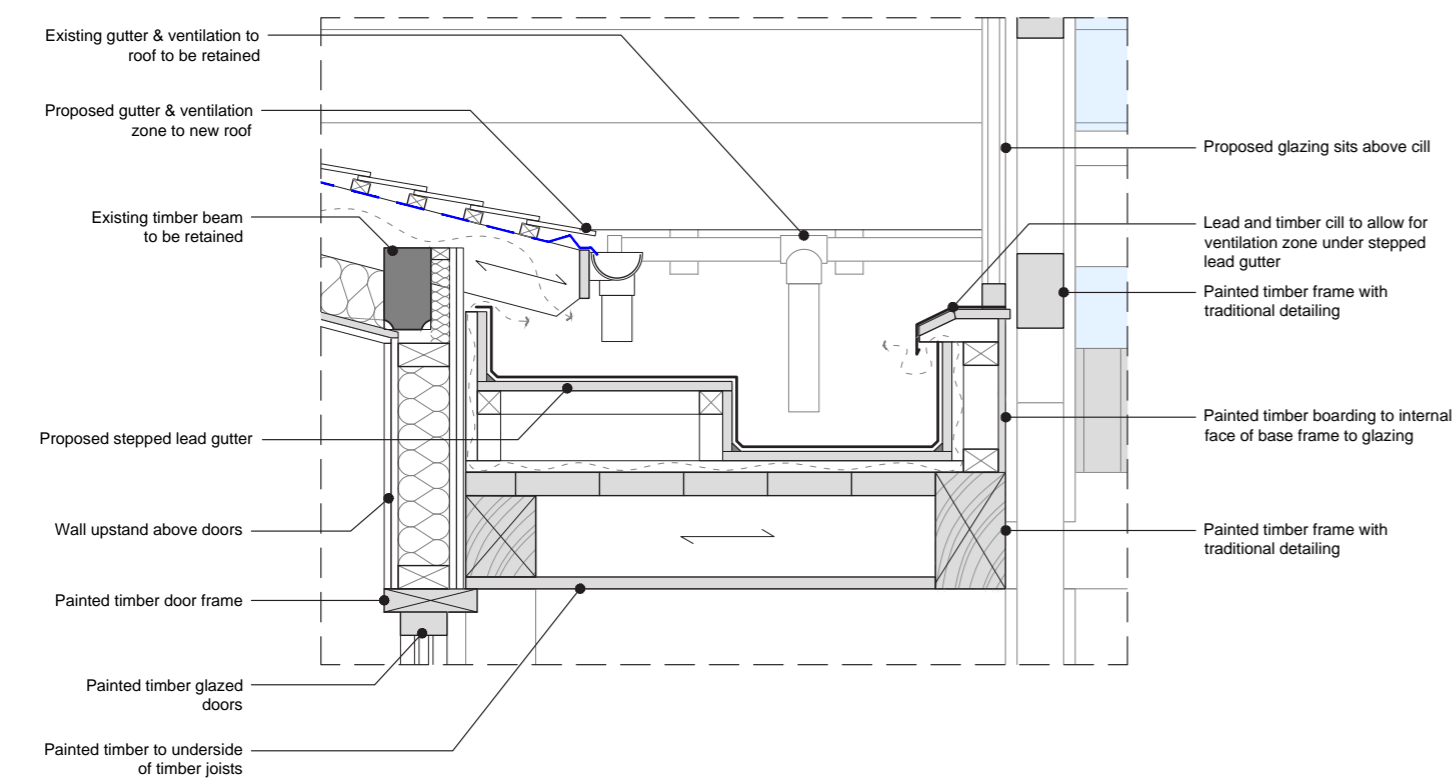
Detail section extract of proposed abutment A

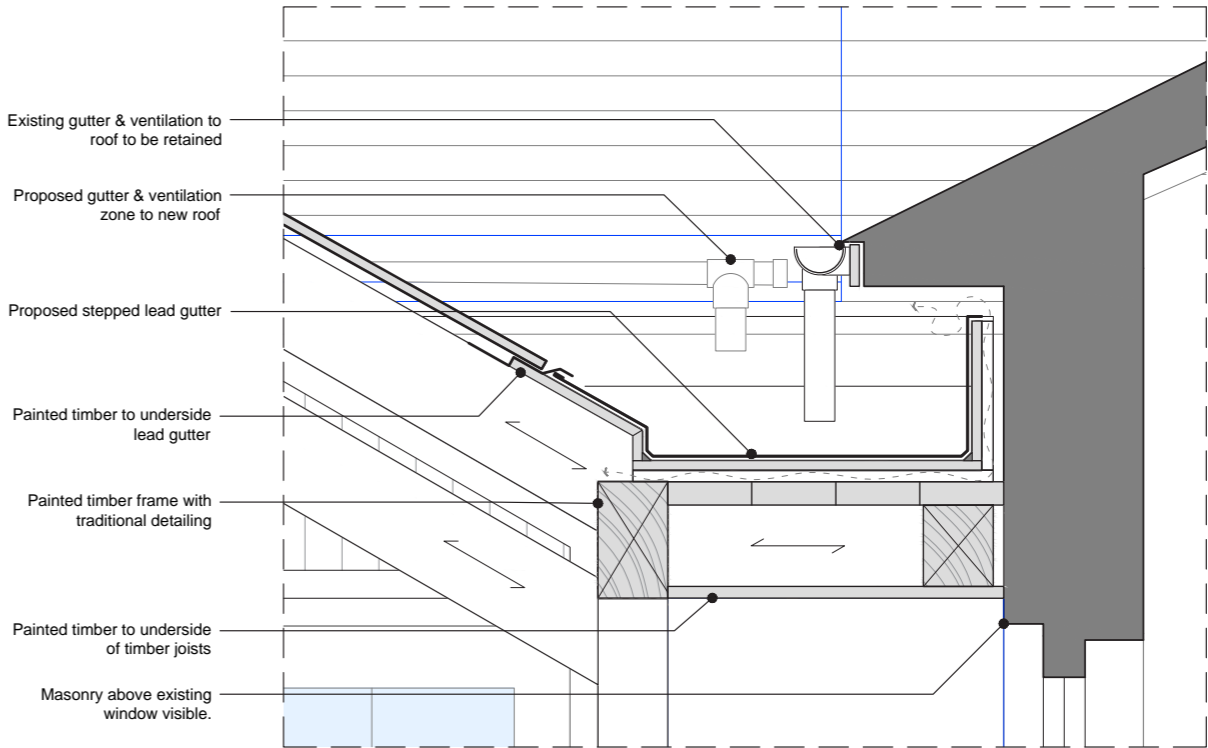
Detail section extract of proposed abutment B

The connection along the long side of the stable block takes place below the existing eaves, both to retain the existing ventilation of the historic fabric (from beneath the eaves board) and so that the proposed extension appears secondary and subservient to the original form. This connection is shown in detail B.

As outlined in the previous page, the existing perspex lean to extension is being replaced with a slate roof with conservation rooflights. The connection to the existing building is replicating the existing condition with the perspex roof, whereby there will be a traditional leaded detail from the existing roof eaves to the to the new roof form, as demonstrated in detail B.
