## HERITAGE IMPACT ASSESSMENT

**Property Address:** Park Farm House, Wheatsheaf Road, Woodmancote,  
Henfield, West Sussex, BN5 9BA

**Report Date:** 6<sup>th</sup> September 2024

**Prepared by** Richard Pocock MSc MRICS

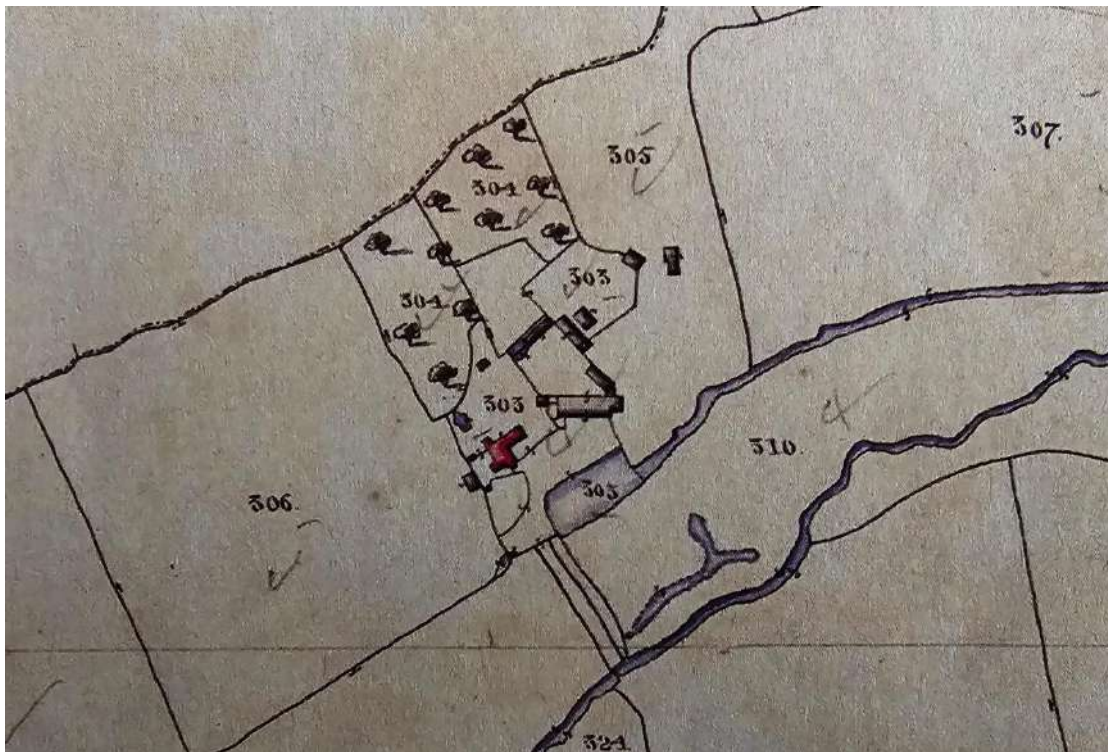
Tithe Map  
1845

The tithe map of 1845 is the earliest map that the property is depicted upon that can reasonably be located. The property is denoted with the farmhouse in red and the remaining farm buildings in shaded black/blue. What is evident immediately is the L shaped outline of the farmhouse, before the sizeable 1930s wings were added, together with the original southern alignment of the property in general. There is also little suggestion of the property access, as no trackway is depicted passing through field 305, though the two outbuildings in this field (and boundary of 303) suggest that the access always passed through this way north.

The barn and its northern return are shown, along with the open farmyard to the north, surrounded by farm buildings. The land north of the house is shown as garden/light woodland, but with surrounding fields as arable/other farmland.

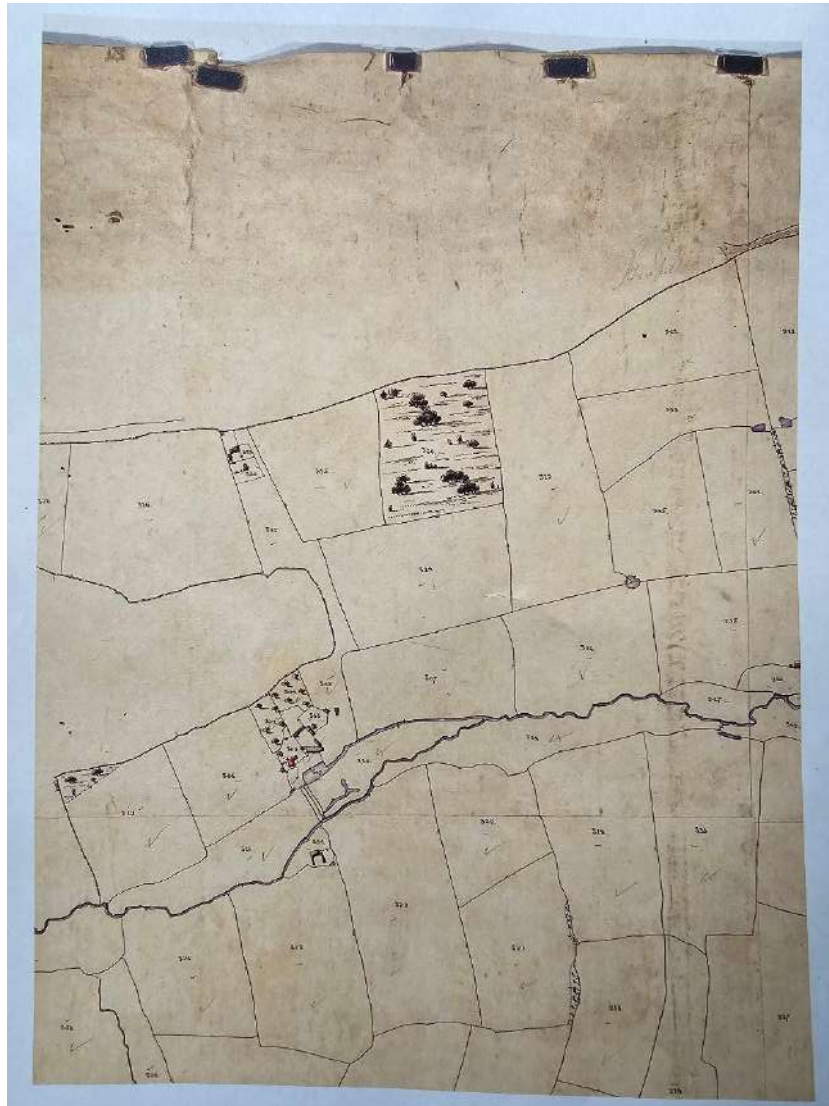
The image below shows the farm in its wider context in 1845 and apportionment shows that all but one of the fields below were owned and farmed by Park Farm at the time that the tithe was taken. The farm also owned the cluster of barns shown to the south of the main farm. These still exist as a private property and are no longer part of the estate.

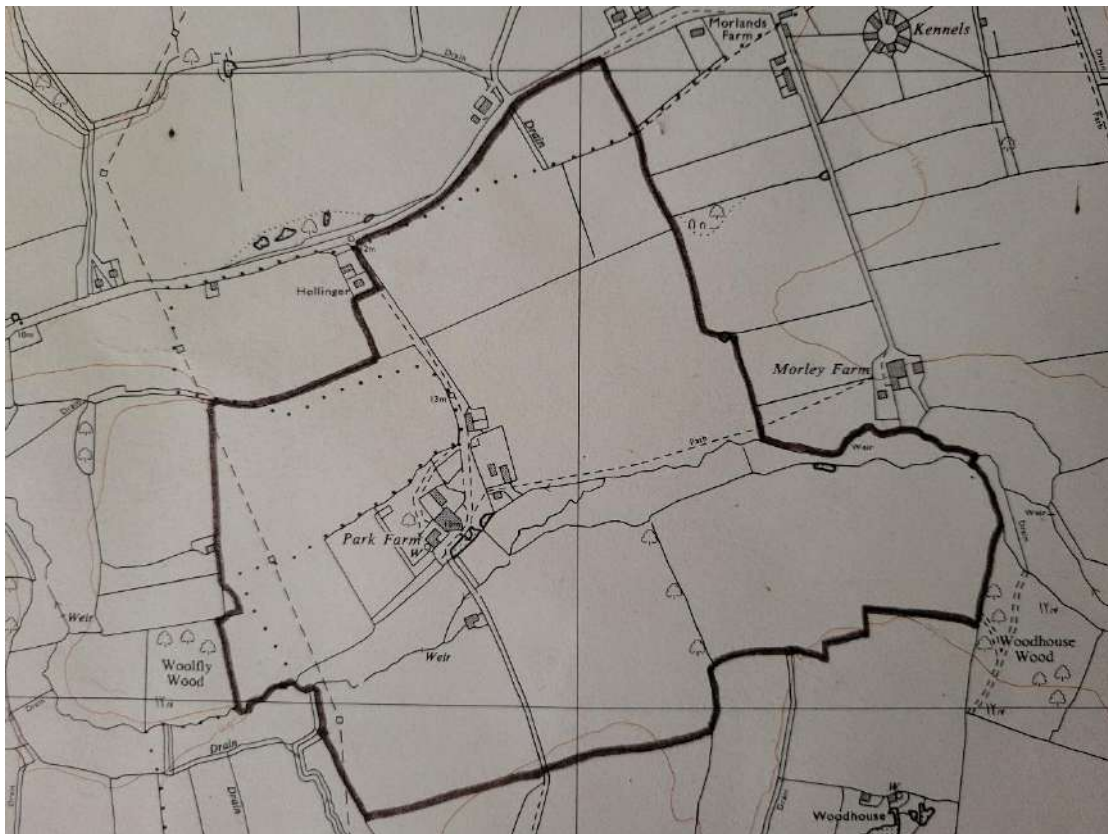
Comparing that to a later post mid 20<sup>th</sup> century landholding map (below) suggests that the farm maintained much of this land right up until recently.

There are also some notable differences, with at least one of the large western field systems north of the house not being assigned to the farm in 1845, but forming part of its landholding in the 20<sup>th</sup> century.

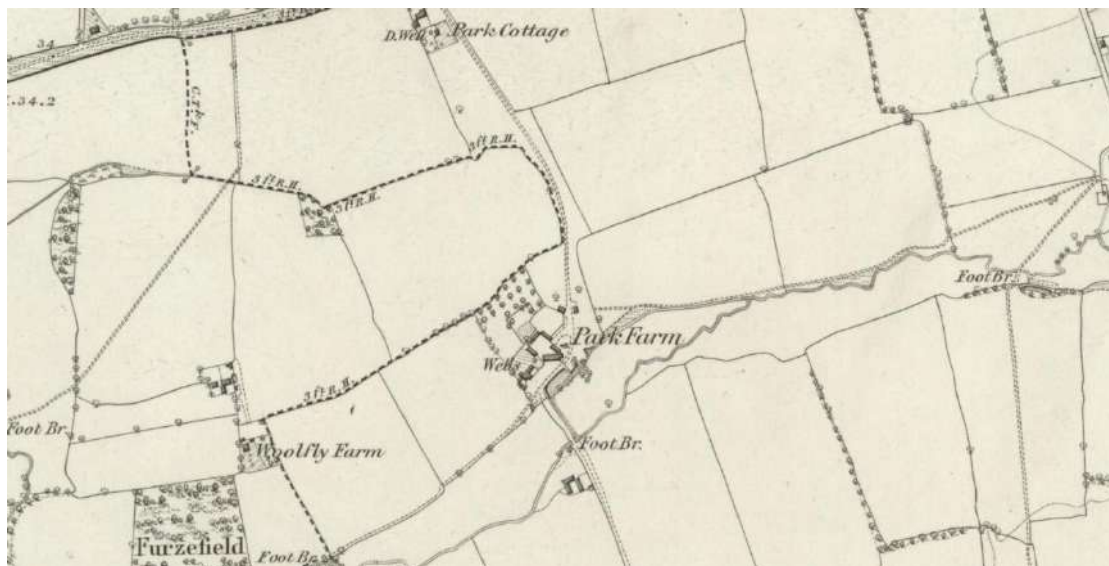
The 1874 the map depicts the farm in situ, but with a very slight change of shape to the farmhouse in that the 145 map suggests a small projection to the south west that no longer survives. These were often lean to arrangements and there is no surviving present physical evidence of what this might have been.

Furthermore, the outbuildings are slightly different with an outbuilding shown to the east of the main farmyard being no longer in existence in 1874, but with the presently surviving stable unit (below) now having been built within that intervening 30 years.

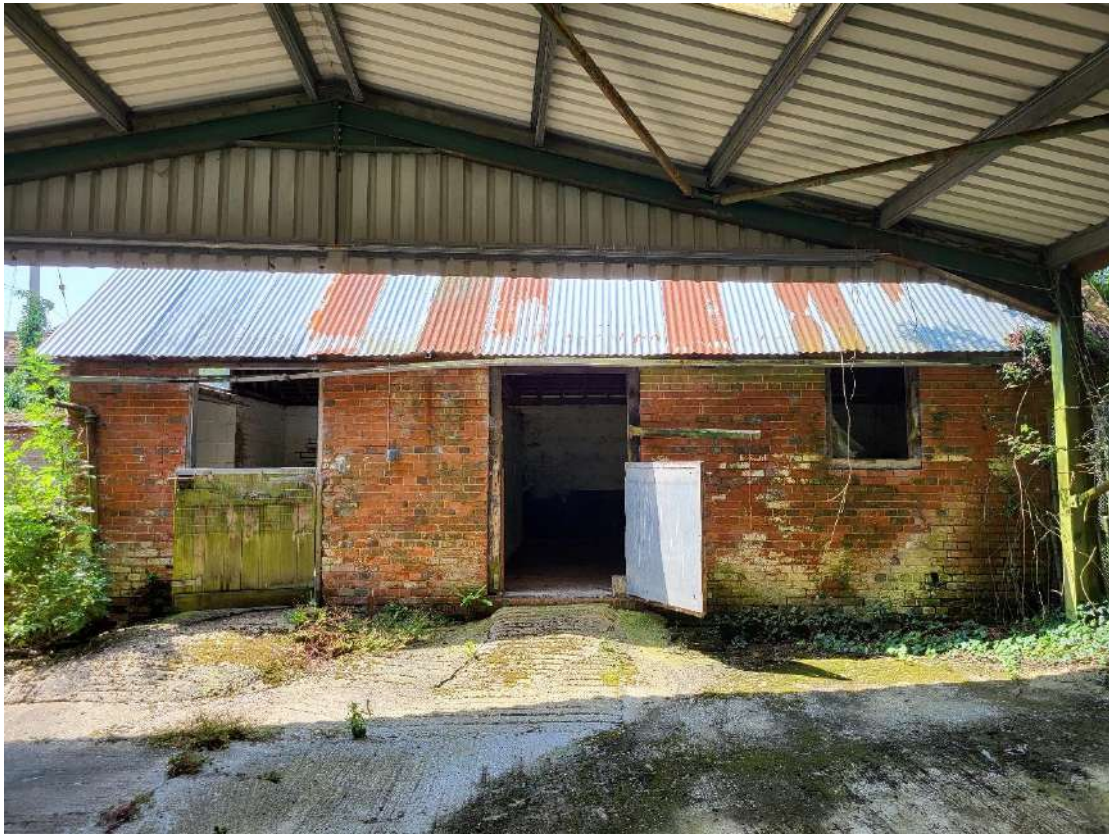
This outbuilding can then be fairly accurately dated.

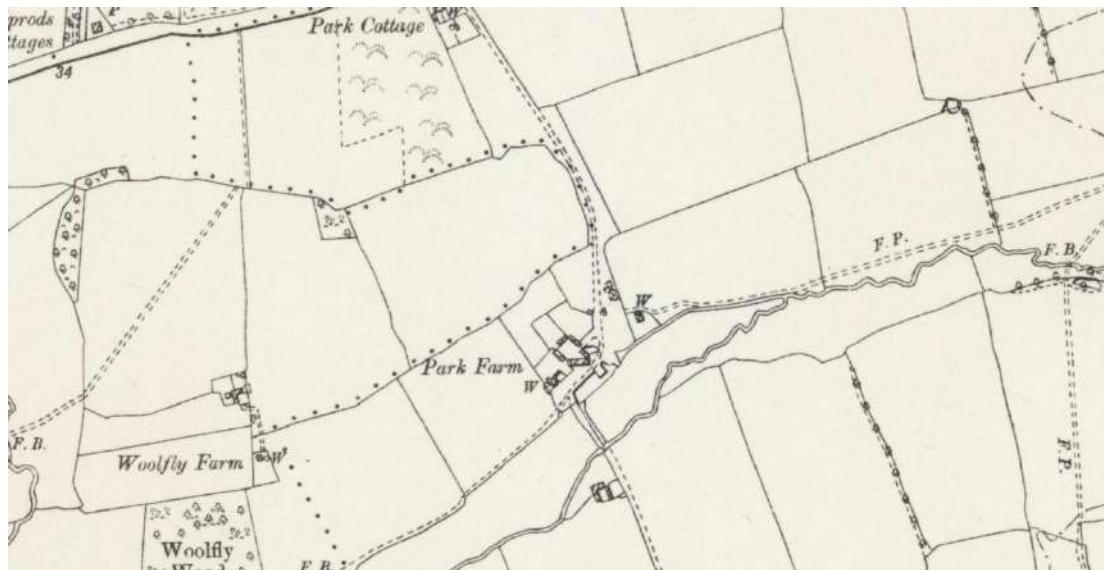
1896

By 1896, there is little evident change to the outline appearance and arrangement of the farm, apart from the typical matter of less detail and a suggestion that the wooded areas north of the house has somewhat been cleared by this date.

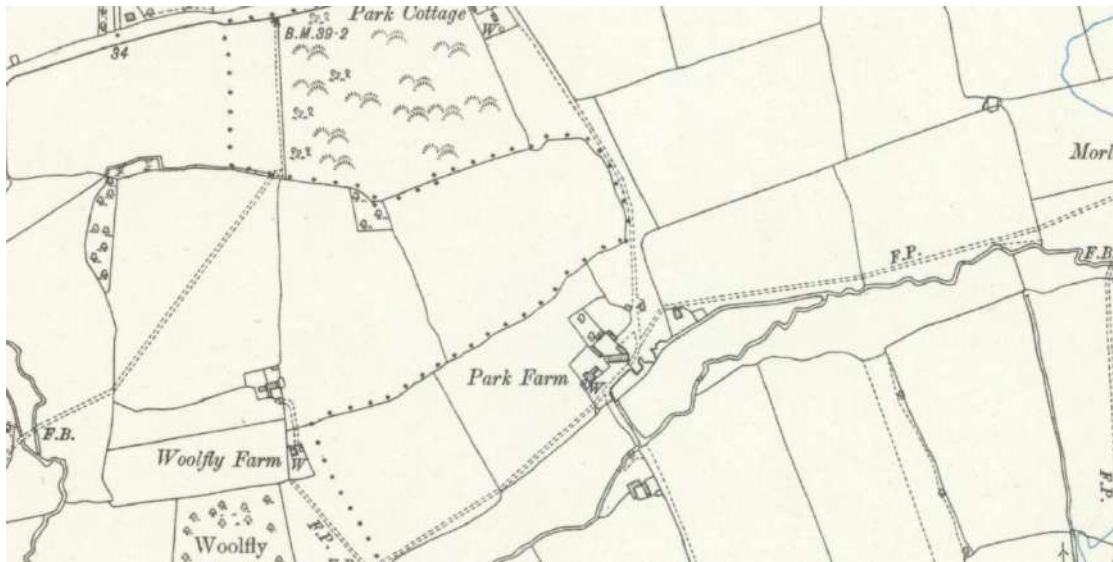
1909

By 1909, those fields/garden areas north of the house had been reduced a little and would seem to have now been a more formalised garden.

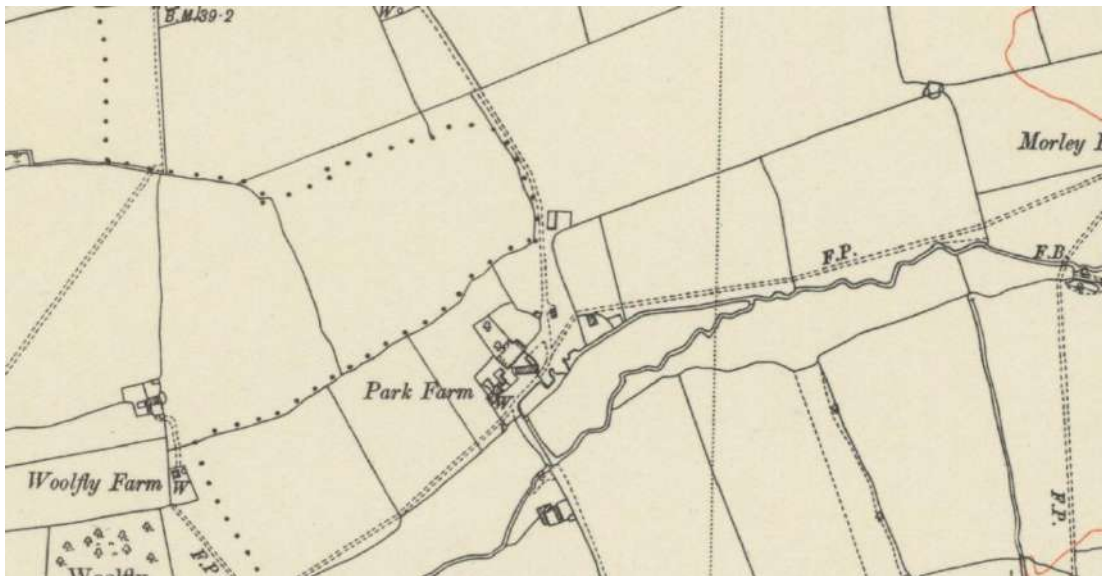
1946

By 1946, the sizeable north wings had been added, changing the shape of the building considerably, though the farmyard remained broadly unchanged – the infill farm buildings that presently cover the farmyard centre still to be added at this date.

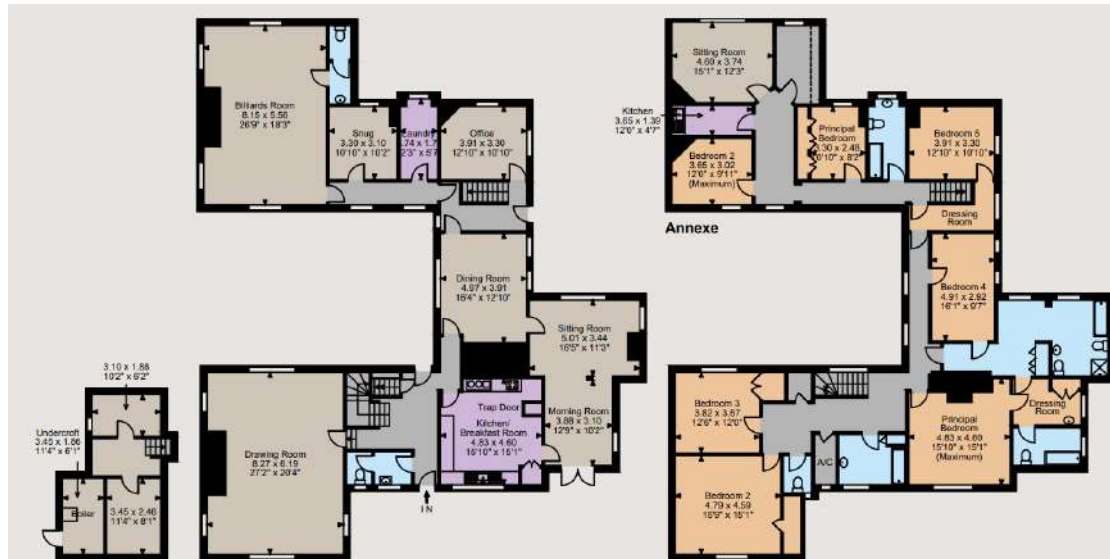
The below ground floor internal plan has been attached for reference, with a due note that the cellar is depicted mirrored and should be the other way around.

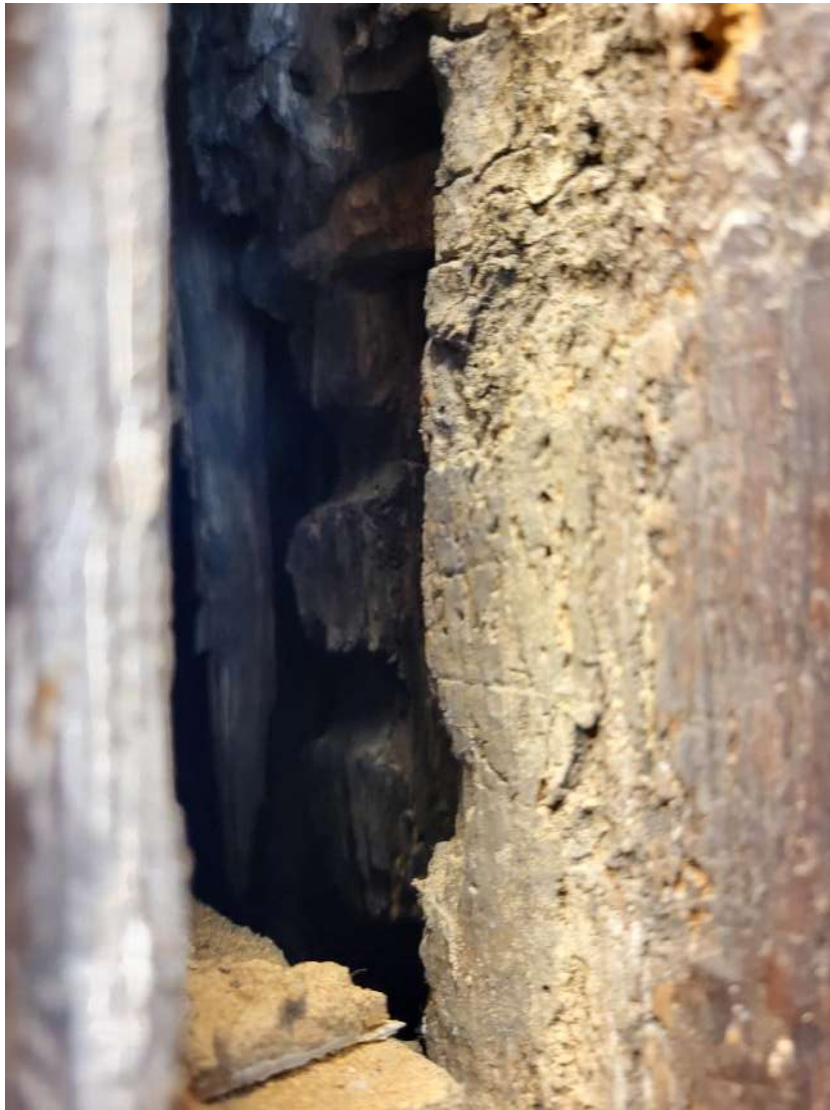
What is fascinating about the post is that it shows distinct evidence of severe fire damage. Views into the surrounding wall lining was limited, but what can be seen is scorching and the loss by burning of parts of a lateral mortise joint.

Given this and other evidence from the re-used timber around the house, it would be reasonable to assume that this earlier building suffered a severe fire. This has a bearing upon Phase 2 of the building's life, as with reasonable continuation of occupation, one can suggest that the fire must have taken place around the end of the first quarter of the 17<sup>th</sup> century, requiring a wholesale rebuilding of the house.

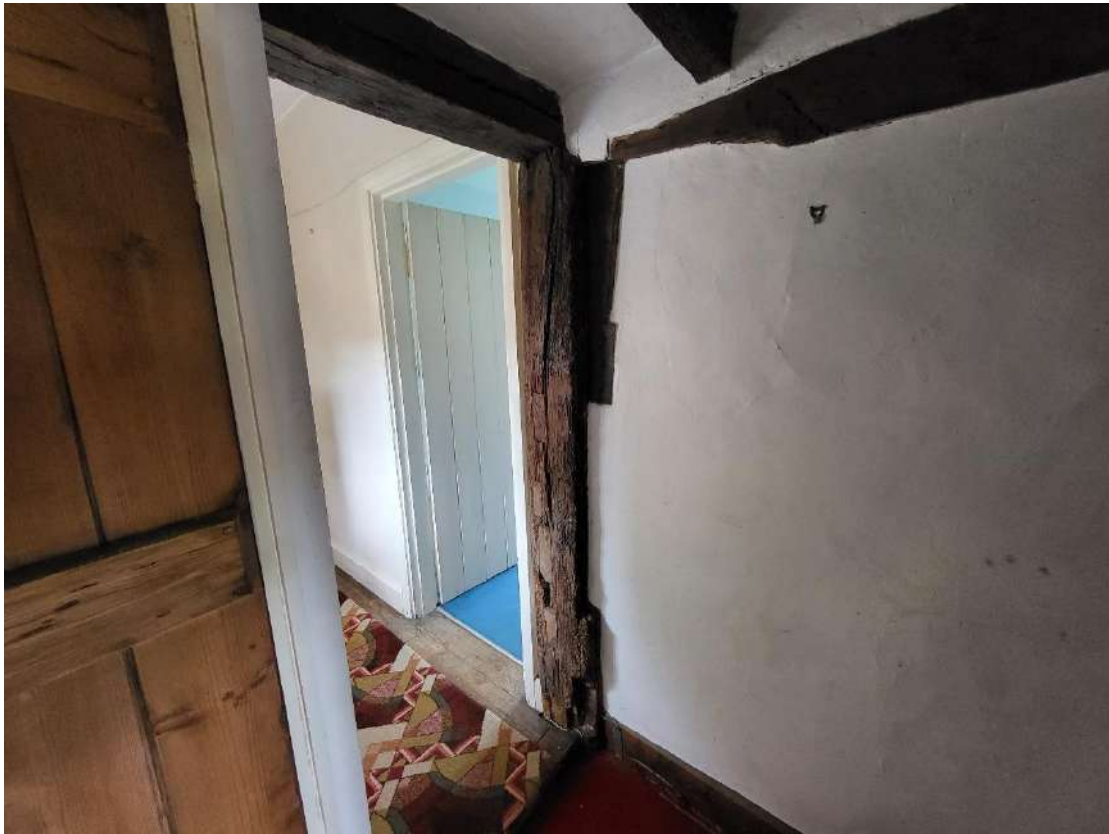
The fact that the property would seem to have been entirely rebuilt after the fire, would certainly explain the lack of other in situ evidence and also the state of some of the re-used elements of timber in the later frame. Some of these are earlier bay posts, scorched and with considerable mortise damage.

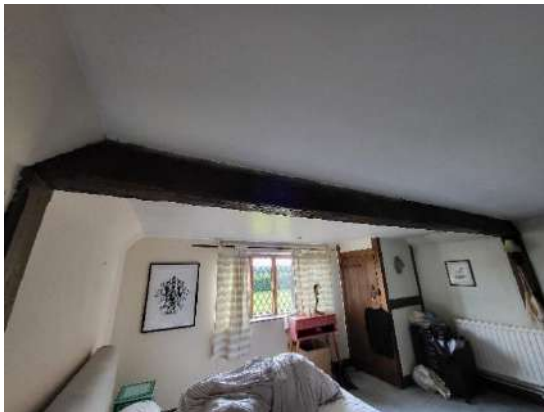
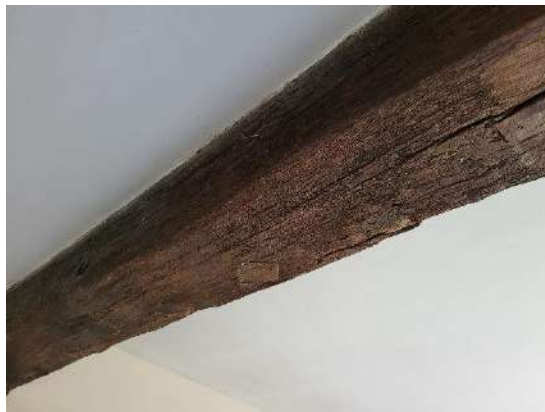
The spanning beam in the master bedroom is also re-used out of situ and can be identified as what was a section of wall plate (complete with former mullion window cut outs).

This section of timber indeed could be misleading, as it is installed in such a way as to possibly suggest that it was the end wall of the original building. However, there are certain signs that this is not the case. The position of the window cut outs is wrong, there is a brace position centrally (something that would only be seen on a face wall in that position, not an end wall). Furthermore, the position of the studs does not equate to an end wall and the post ends are not mortised for suitable connective joints of the era. Therefore, it fits far better with interpretation as a section of face wall wallplate, repurposed in this position. However, this end of the house poses some issues in relation to sequencing, as will be outlined below in the section 'Phase 3'.

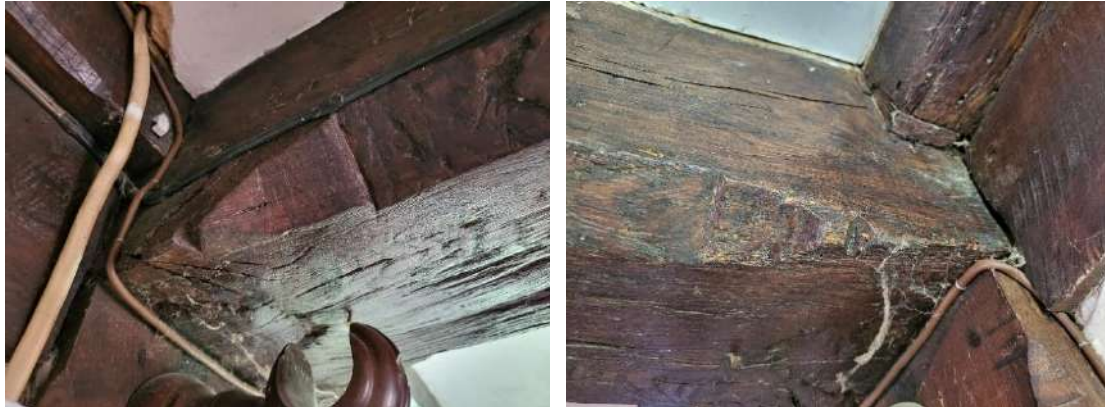
The re-building of the house seems to have come around the first quarter of the 17<sup>th</sup> century onwards. Indeed, assessment of individual decorative features in what would have been the high end parlour suggest a date of past 1620 in relation to stop carving (below).

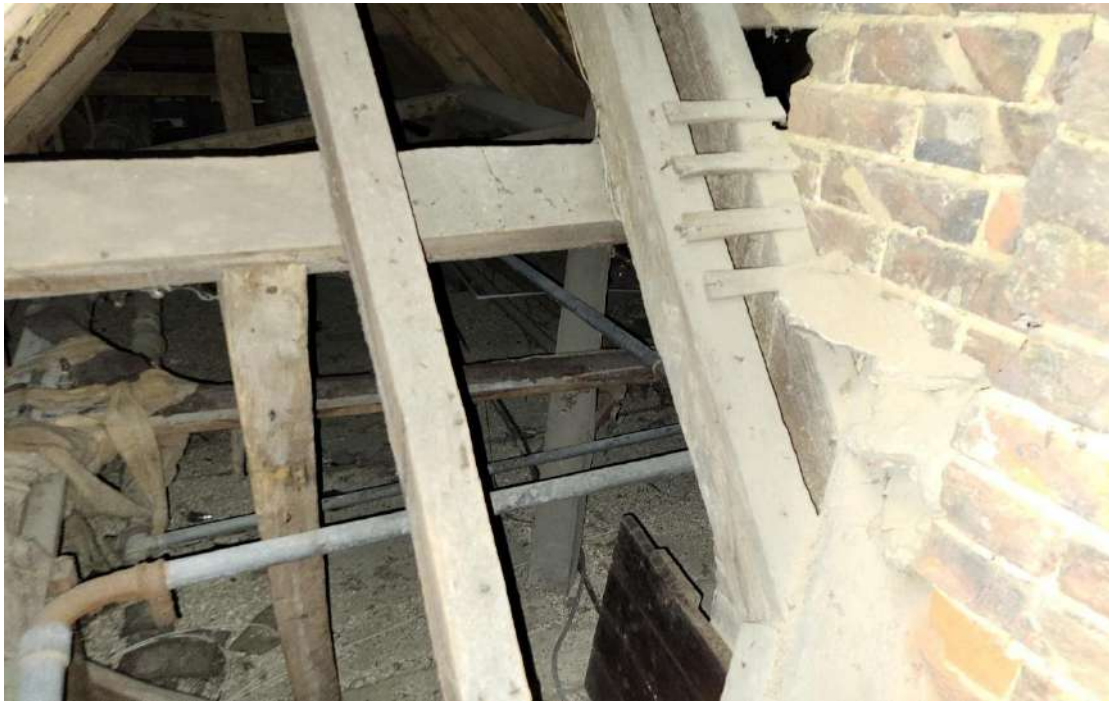
The roof had a fully hipped terminal built close to the existing stack, part of which remains in situ under later roof framing for the 'office' end of the building.

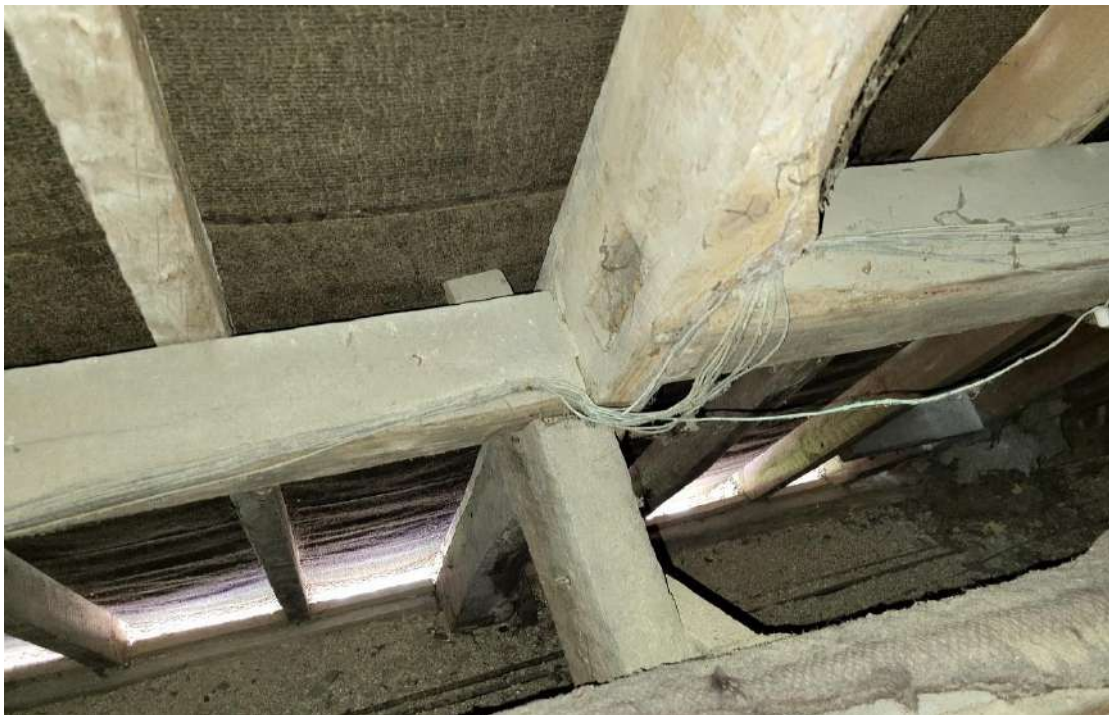
The roof is a butt purlin example with collared rafters. There have been later repairs (some collars are refitted with a ridge board, purlin replacement has occurred in places and also some rafters are replaced). However, the roof remains in situ virtually complete. The roof is interesting in that there are sections of both inline and staggered butt purlin, though quite clearly from the same phase.

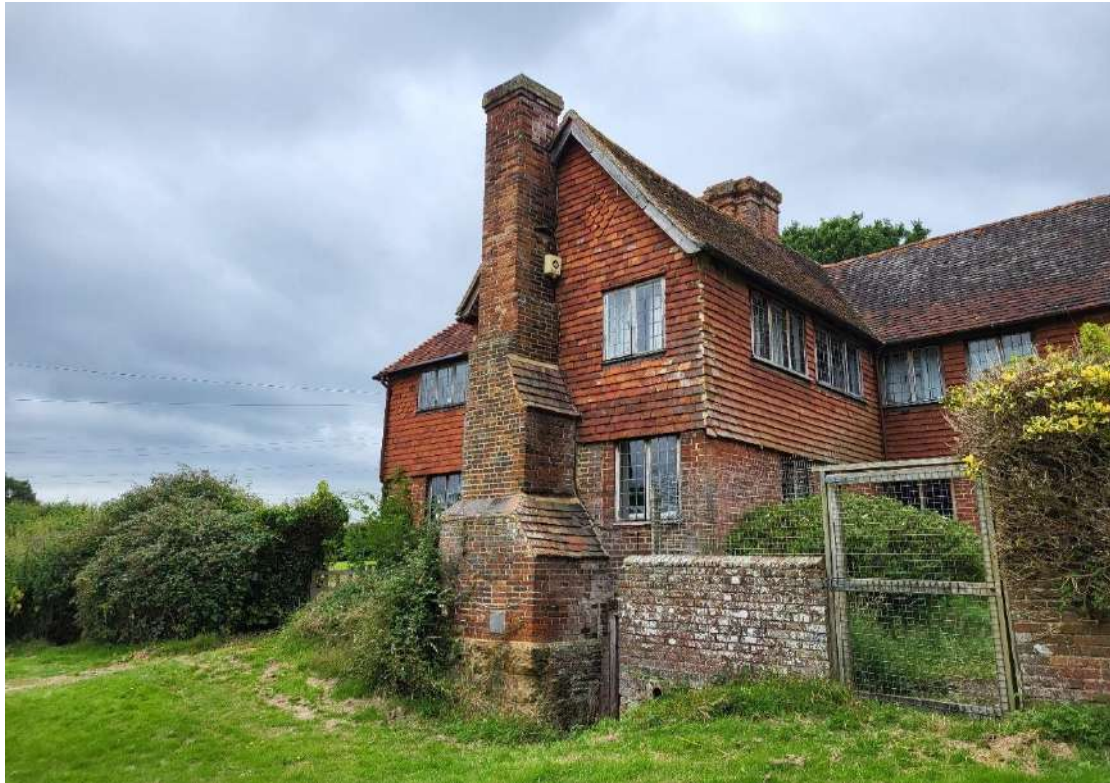
The frame is consistent in its layout and construction and shows the building as an 'L' shaped house from the outset. The parlour end chimney stack structure, with its stone footings also dates from this period, though with some later rebuilding.

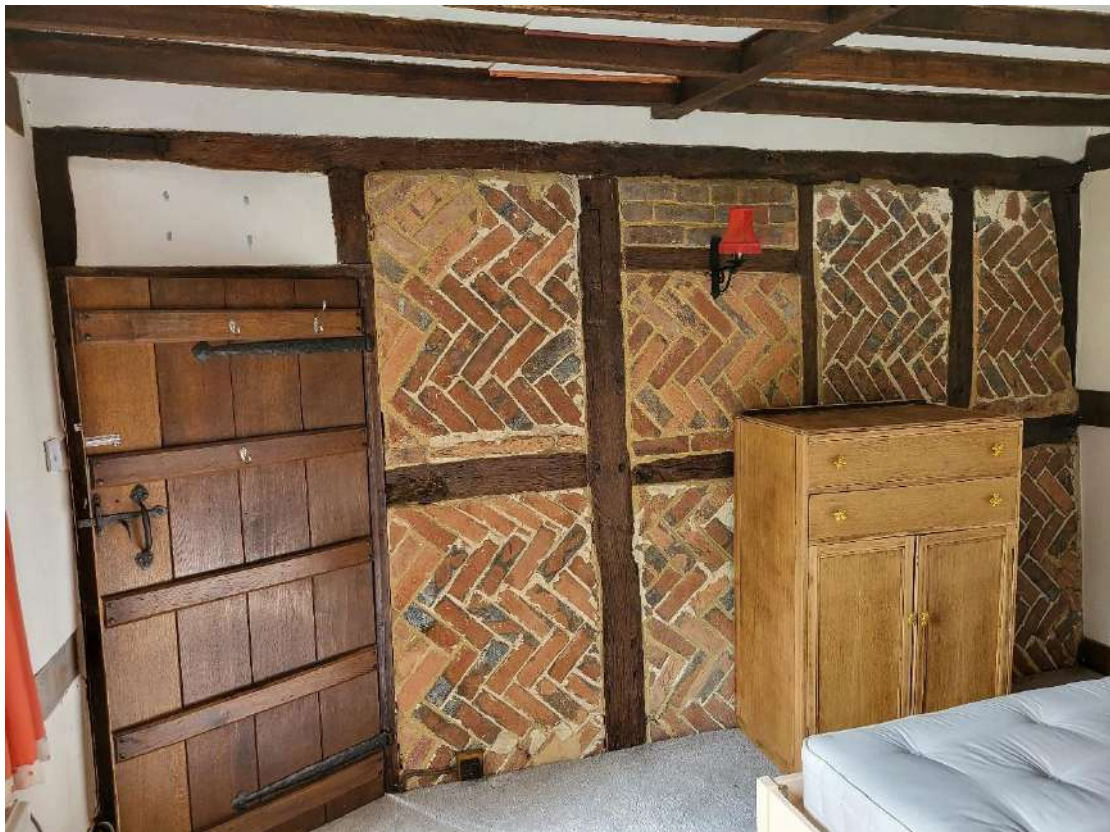
Wall framing is large square panels, and the herringbone infill panelling is likely to be original to this phase in this instance, rather than a later addition.

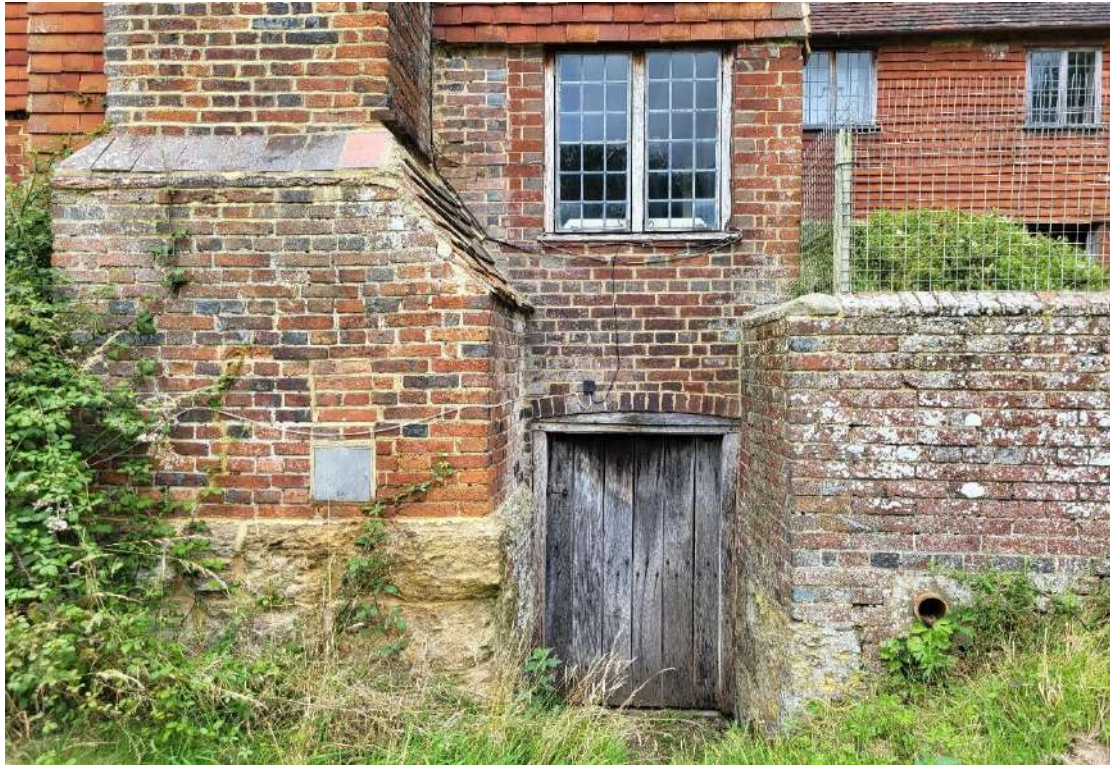
The small cellar under the projecting parlour end is also original to this phase, though largely rebuilt internally and also facing masonry has been replaced above. The entry door is early to mid 20<sup>th</sup> century.

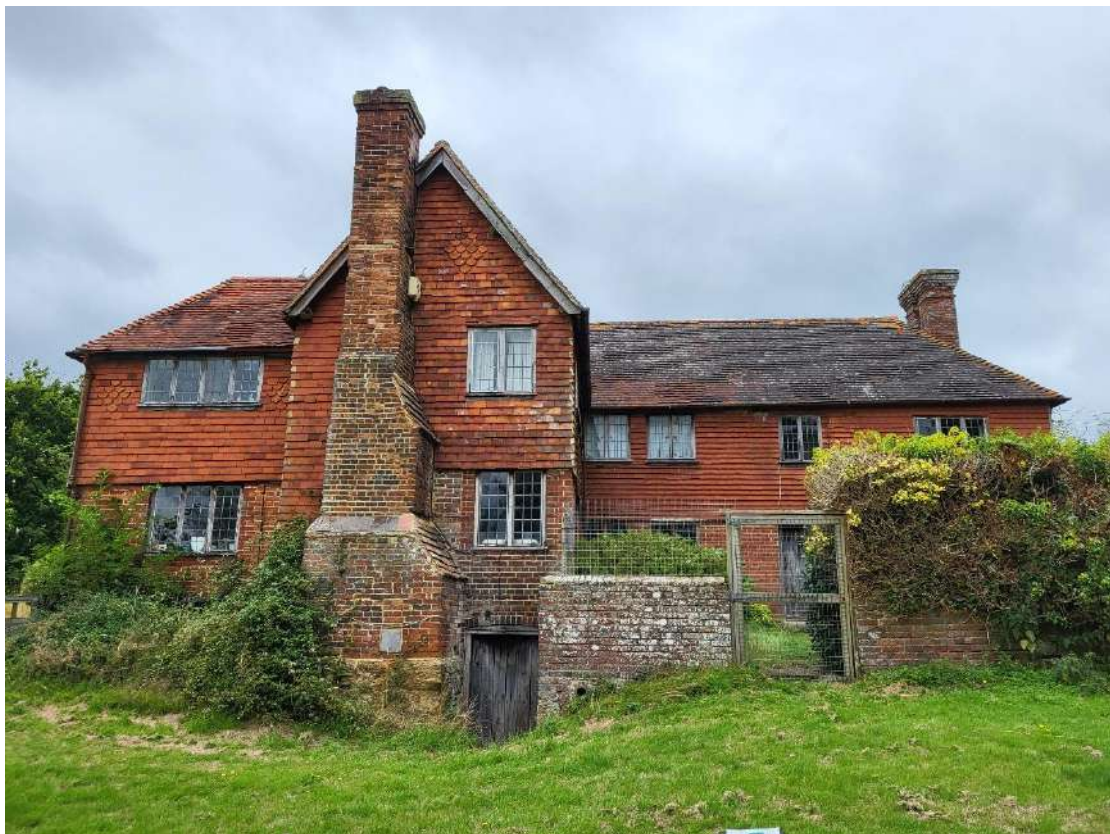
This Phase 2 house stood on slightly rising ground facing approximately south and this was the primary façade.

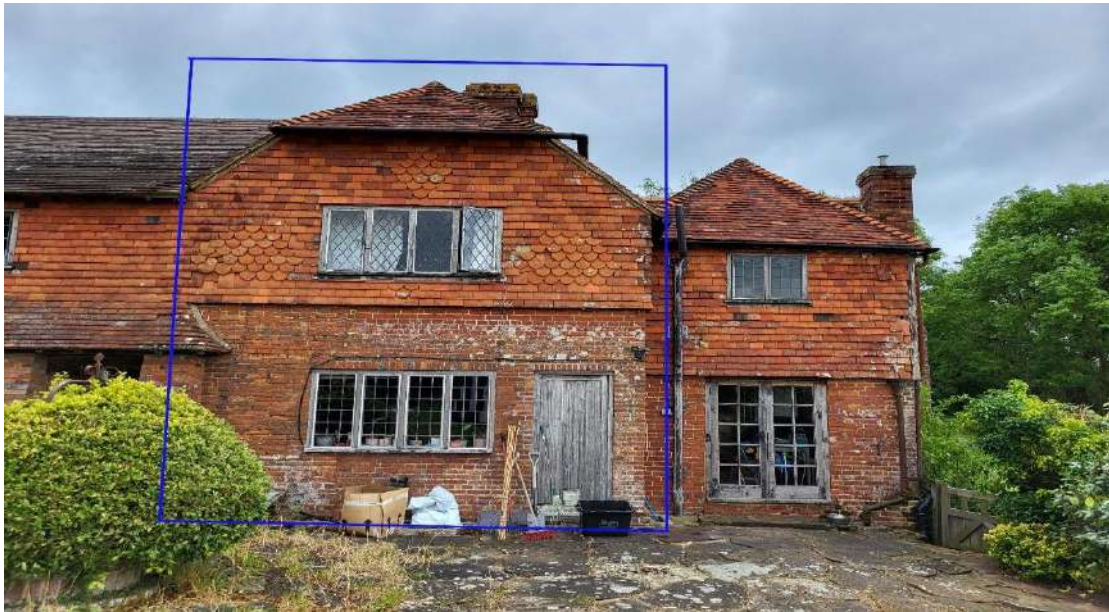
The present projection depicted in the blue box below is dated on a date stone to 1726 and the wall masonry certainly suggests that this is broadly accurate.

The re-used material within may have been taken from a pre-existing structure. However, this is conjectural and leads to questions about where the present re-used timber material used within came from, if not from the Phase 1 house.

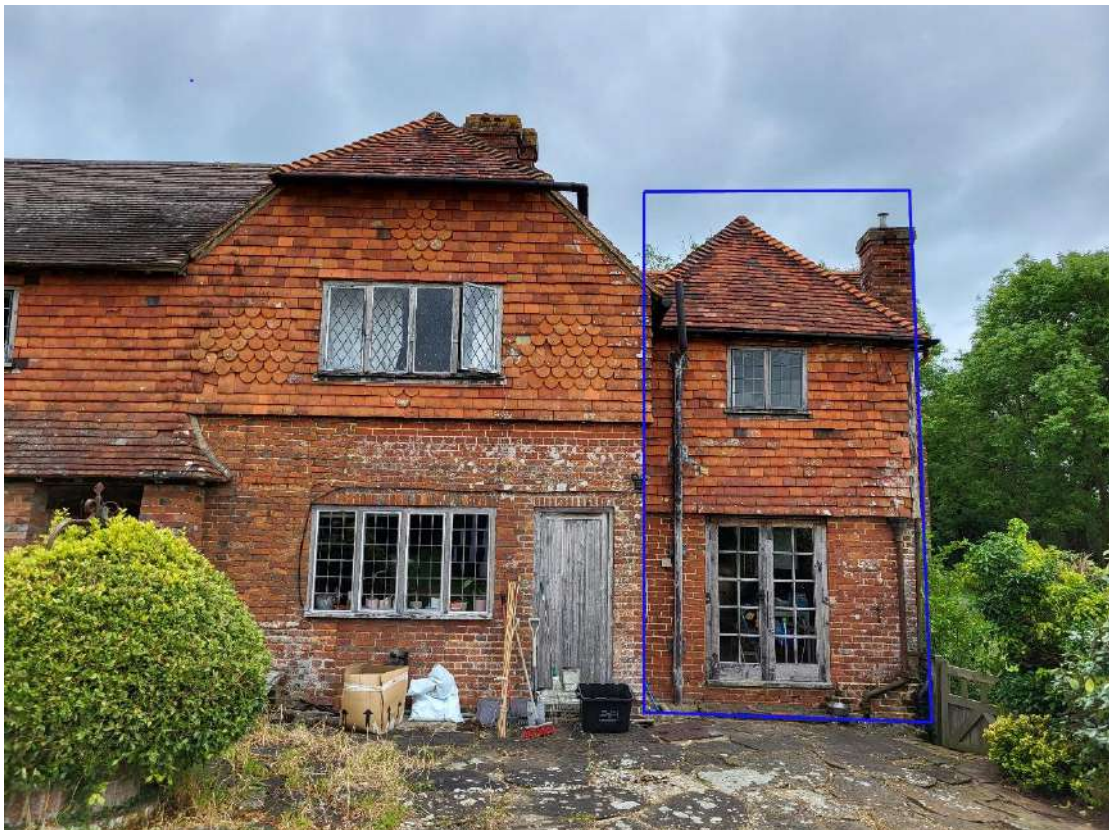
Mapping layout, though not always totally accurate, suggests that the extension infill in the south western corner is a probable very late 19<sup>th</sup> century addition – though it may replace a smaller lean-to arrangement covering a cellar entry.

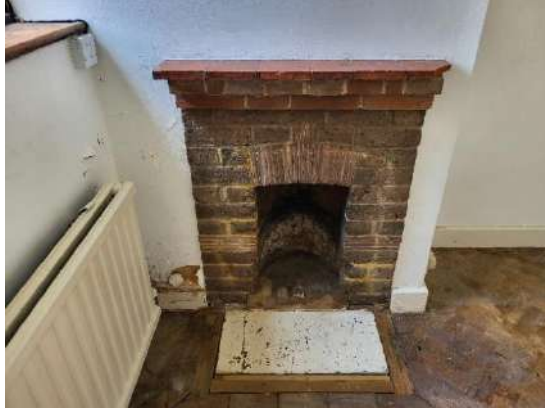
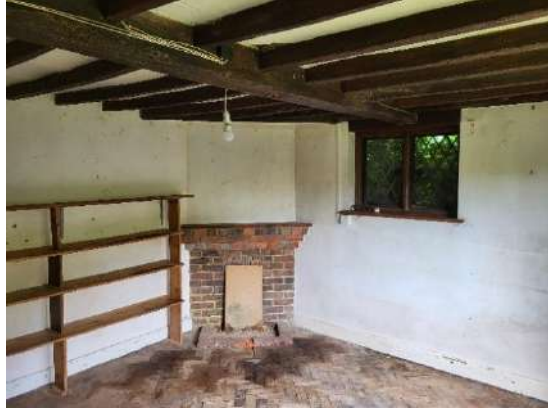
The 1930s extension was built as a pastiche, so no historic material exists within it. However, these parts are still protected by the listing and are indicative and representative of their era. So, ceiling fabrication, fireplaces, wall finishes and other decorative elements are to be considered of evidential value in this case and should not be considered any the less important in respect of significance.

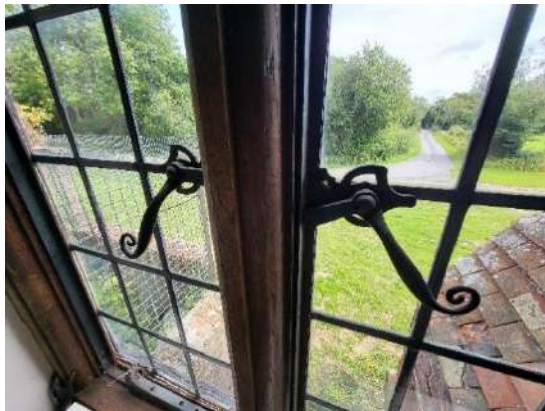
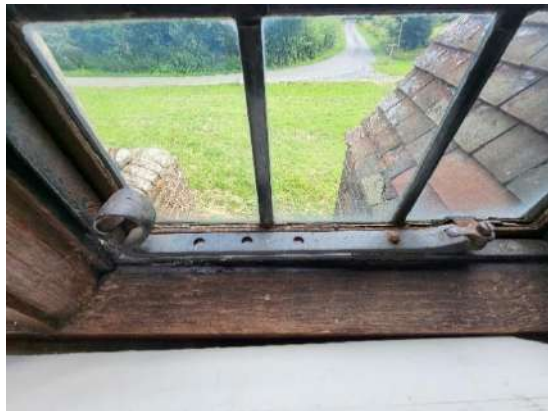
Fenestration almost certainly dates from this period and was extended to the entire house to provide a suited match around the building (thus unfortunately losing any older fenestration that may have existed in the process). Nonetheless, the fenestration that now exists is well observed and is of a sort that would not have been out of place in a mid to later 17<sup>th</sup> century house. The fenestration, despite its 1930s date, remains a key feature of this building.

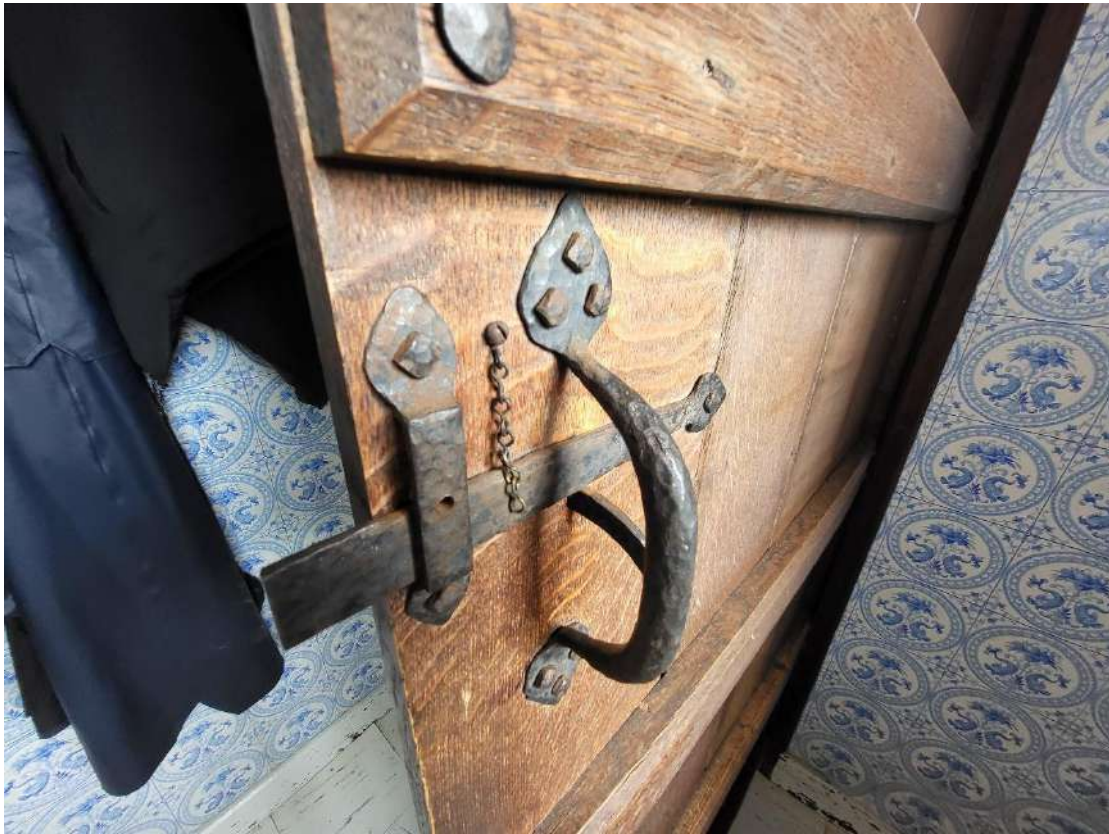
Other internal joinery is also of similar importance, for instance the various braced doors and also door furniture surviving from the 1930s refurbishment.
