From: Tom Dixon [REDACTED]  
Sent: 20 April 2026 13:42  
To: Sophie.Moore [REDACTED]  
Subject: RE: DISC/26/0061 - Old Clayton Boarding Kennels

I've since had a reply from our Geo Engineer, see below. If you could review with others and confirm agreement, before returning discharge for this condition.

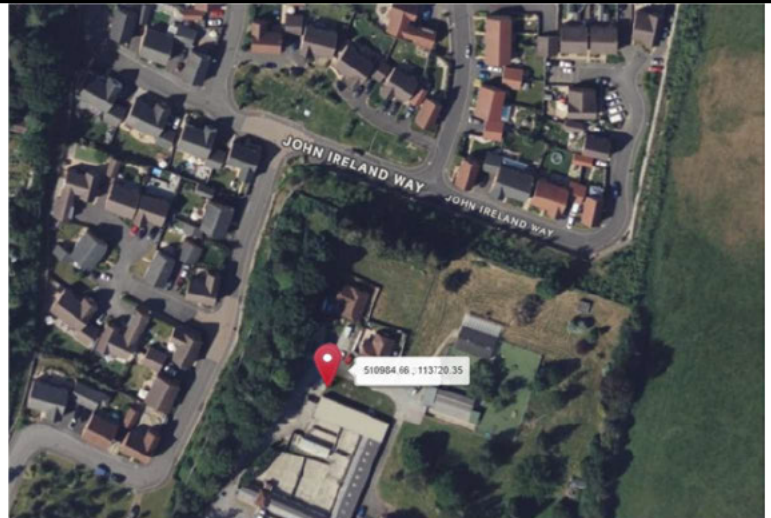
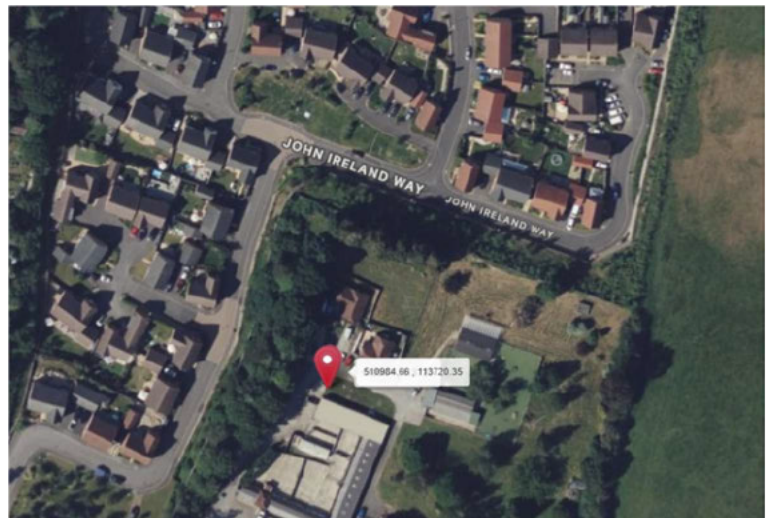
for WS109, locations have been plotted for the borehole(s) and shown on the plan below:

Comparing this location with the proposed development plan shown below, the location of WS109 is under the footprint of the care home.

| Item | EPO Comment | Response |
|---|---|---|
| 2 | <i>We note the comment in relation to location WS109 – 'During the setting out of the of the site, it was determined that the hotspot</i> | <p>When reviewing the logs contained in the original Ground Investigation report, the Omnia Phase I-II Geo-Environmental Site Assessment Report referenced A11530/1.2, dated April 2022 and using the co-ordinates</p> |

*fell under the footprint of the proposed care home. As a result the area would no longer pose a risk to end users'. From revisiting the borehole location plan in the site investigation report (a copy of which is provided below) and lining up this location with an o?site reference point, notably the existing residential dwellings to the west of the site, we are however not entirely convinced that location WS109 now falls under the footprint of the proposed care home. On the assumption that the below locations are accurate, WS109 lines up with the eastern corner of 3 John Ireland Way which, from reviewing the proposed plan, which puts WS109 to the south of the main care home building.*
