## **DEMOLITION SURVEY**

Project No J000102 - Survey Date 10 Jul 2025 to 16 Jul 2025

Ingfield Manor School

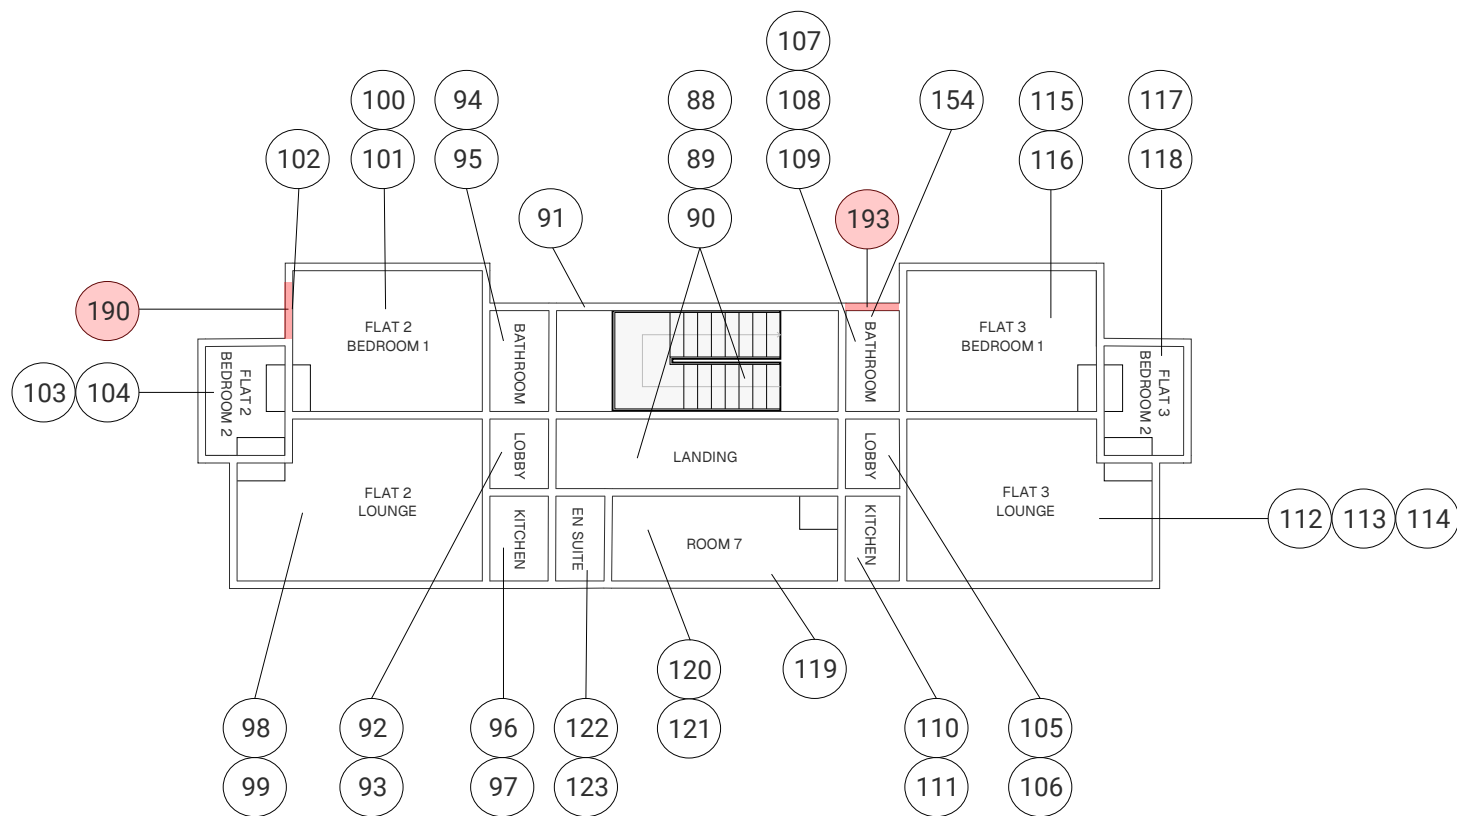
| Site :<br>Ingfield Manor School, Five Oaks, Billingshurst, RX14 9AX | Plan Key :<br><div><div></div> POSITIVE<br/><div></div> NEGATIVE<br/><div></div> NO ACCESS</div> | Job No :<br>J000102 | Date :<br>09 July 2025 | <div> APTHORP ASBESTOS<br/>MANAGEMENT LTD</div> |

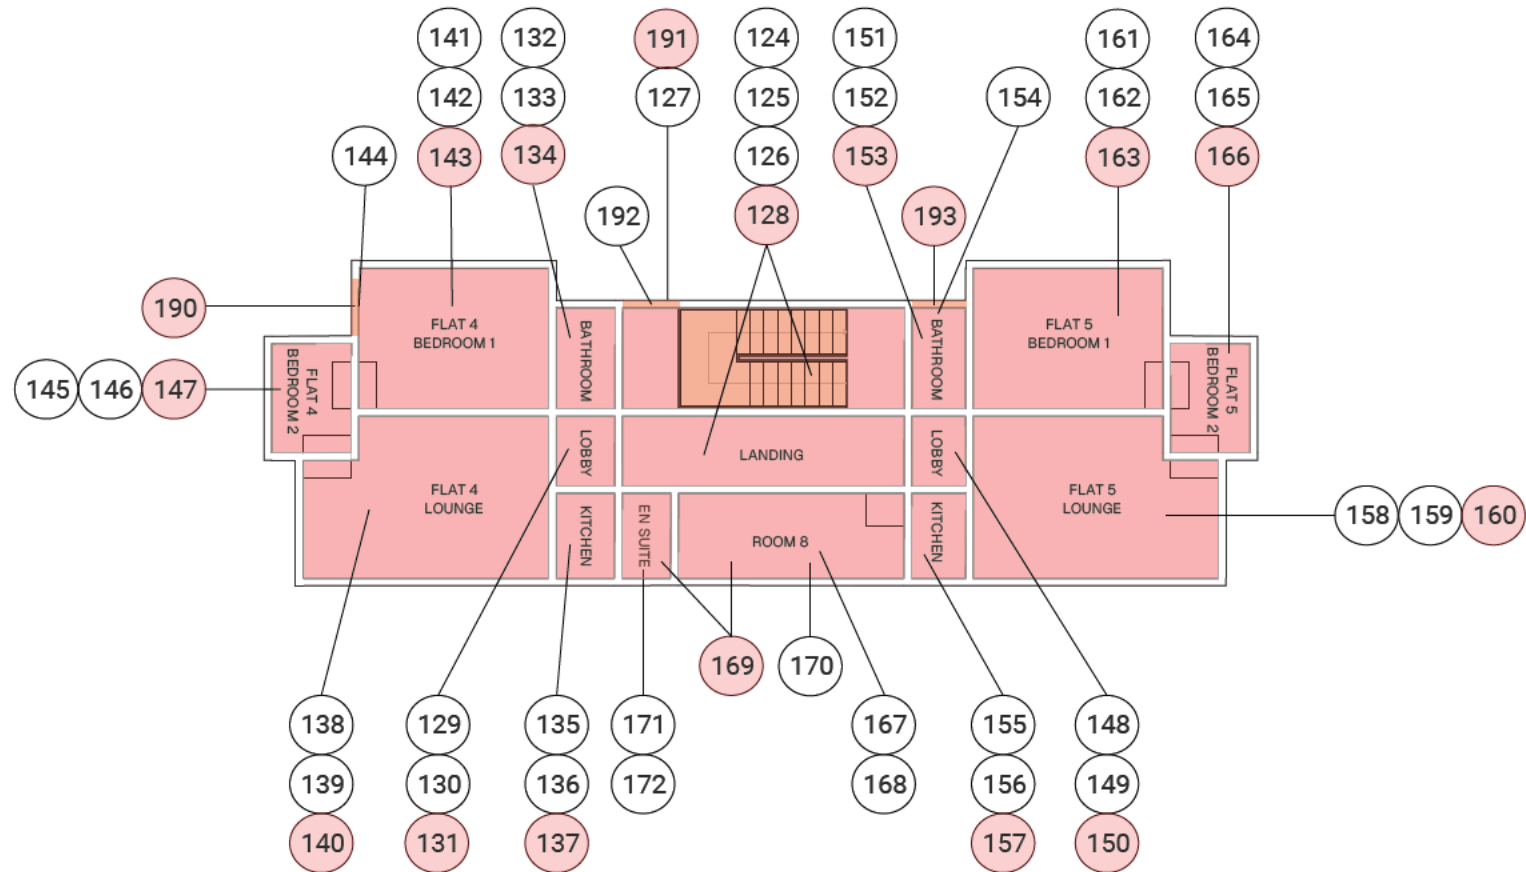
| Site : | Ingfield Manor School, Five Oaks, Billingshurst, RX14 9AX | Plan Key :<br><div><div></div> POSITIVE<br/><div></div> NEGATIVE<br/><div></div> NO ACCESS</div> | Job No :<br>J000102 | Date :<br>09 July 2025 | <div> APTHORP ASBESTOS<br/>MANAGEMENT LTD</div> |

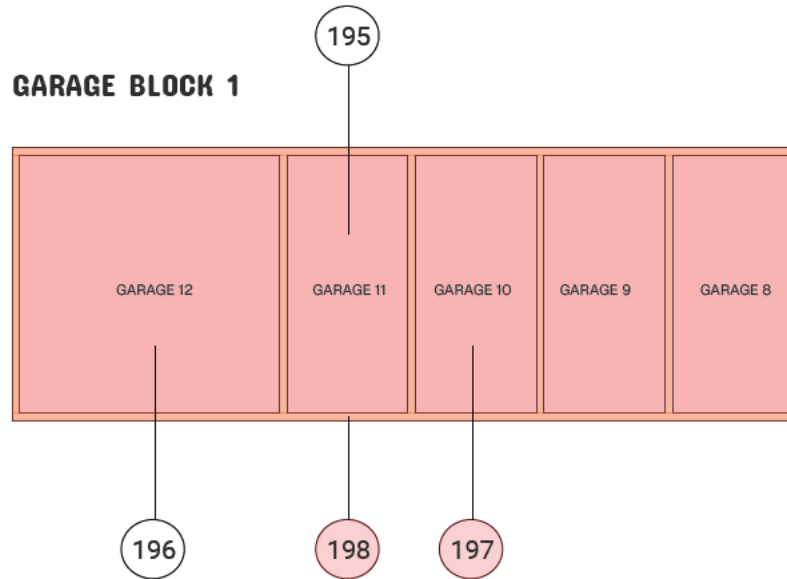
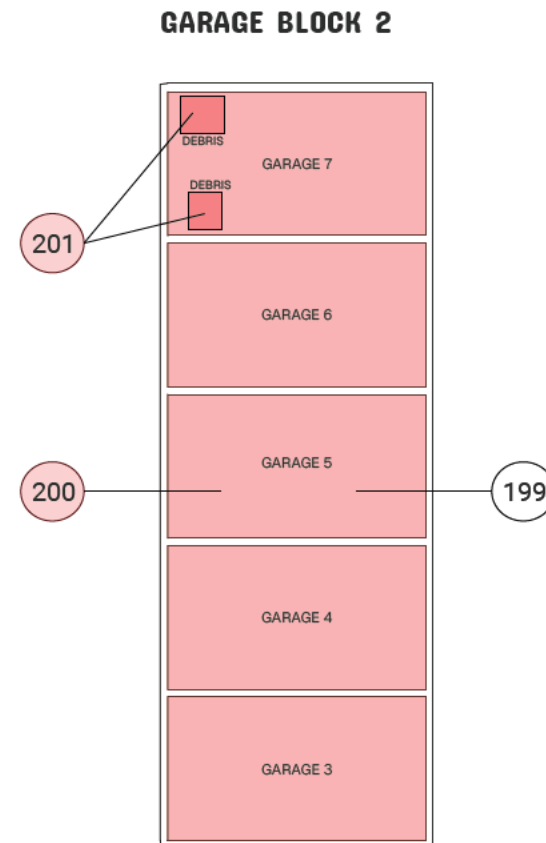
| Site :<br>Ingfield Manor School, Five Oaks, Billingshurst, RX14 9AX | Plan Key :<br><div><div></div> POSITIVE<br/><div></div> NEGATIVE<br/><div></div> NO ACCESS</div> | Job No :<br>J000102 | Date :<br>09 July 2025 | <div> APTHORP ASBESTOS<br/>MANAGEMENT LTD</div> |
