## Optera Structural Solutions

### SOW OPT-9697 Agreement to install a root barrier for Innovation Group/LV

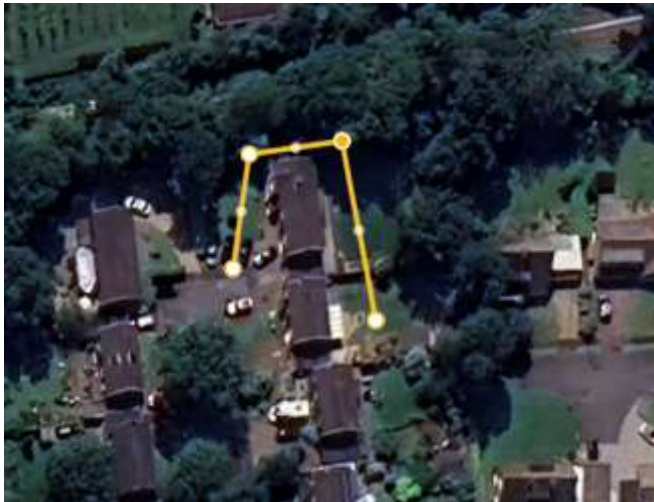
Aerial plan indicating proposed 66m length and alignment of barrier.

| Specifications of Barrier | | | | | |
|---|---|---|---|---|---|
| Barrier Type | length | Max Root Depth from SI | Minimum depth to be achieved with barrier | Distance between tree / Vegetation and barrier | shortest distance between barrier and foundation |
| Copper | 66m | 2.1 | 4.0m | 4.5m | 1m |

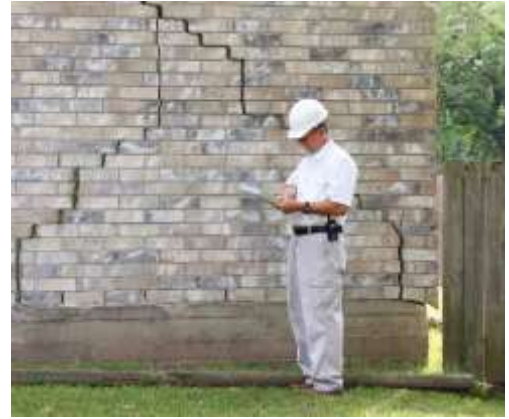
The barrier will be positioned between the offending tree(s) and the affected part of the building, and will be installed to a depth designed to cut the tree(s) roots between the tree and the foundations; the act of excavation severs the roots, causing any roots beneath the foundations to wither and die. This prevents the tree(s) from extracting moisture from the clay supporting the foundations, allowing the clay to rehydrate and recover their natural moisture levels. Naturally, there is a period of time required for the recovery process to take place, but repairs can typically be undertaken shortly after the installation is complete.

To ameliorate tree-root induced clay-shrinkage subsidence, the first option is generally removal of the implicated tree(s). However, where the tree(s) cannot be felled, for whatever reason, the next option would be to sever the roots between the tree and the property and form a barrier to prevent reestablishment of the roots.

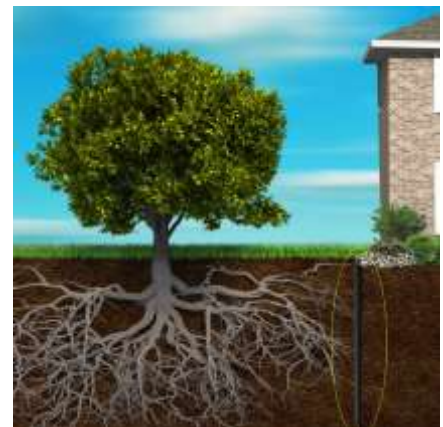
The moisture content of a clay soil tends to vary with depth. Closer to the surface there can be relatively large changes in soil moisture content between summer and winter as a result of evaporation from the ground surface, the drying effect of the Sun and general vegetation, including grasses. Such variations are normally confined to the upper 1m of the ground. However, where trees are growing within influencing distance of a building, then the soil moisture profiles will fluctuate much more widely through the seasons and to a much greater depth; in response, soil volume changes are amplified, and consequential building movements will be far greater.

Trees are known to cause clay soils to shrink by drawing water through their roots, predominantly during the Spring and Summer months. The shrinkage results in both vertical and horizontal ground movement that, when transmitted to a building's foundations, cause damage to the building's structure. The amount of shrinkage depends on the type of clay soil, the type and size of vegetation, and on weather patterns.

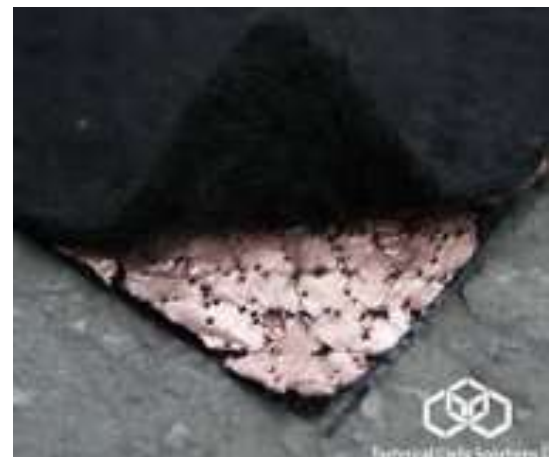
The bio-root barrier is strong and flexible, with very high tear resistance, as well as being water-permeable, thus allowing the natural movement of water through the ground without impediment. The Copper contained within the core of the membrane also acts as a chemical repellent to the roots without constituting a hazard to plants or animals. The Copper foil securely bonded within the porous geotextile membrane, releases Copper ions into the adjacent soil by forming Copper Carbonate (verdigris); these signal adverse conditions to any roots growing towards the barrier, preventing a proliferation of roots close to the barrier. The levels of Copper generated do not constitute a burden on the eco-system or impact groundwater quality.

Outdated, impervious barriers divert rather than stop roots and may prevent the movement of groundwater causing unintended consequences. The use of Optera's permeable barrier stops roots both by forming a physical impenetrable obstacle and by acting as a chemical inhibitor to the reestablishment of roots.

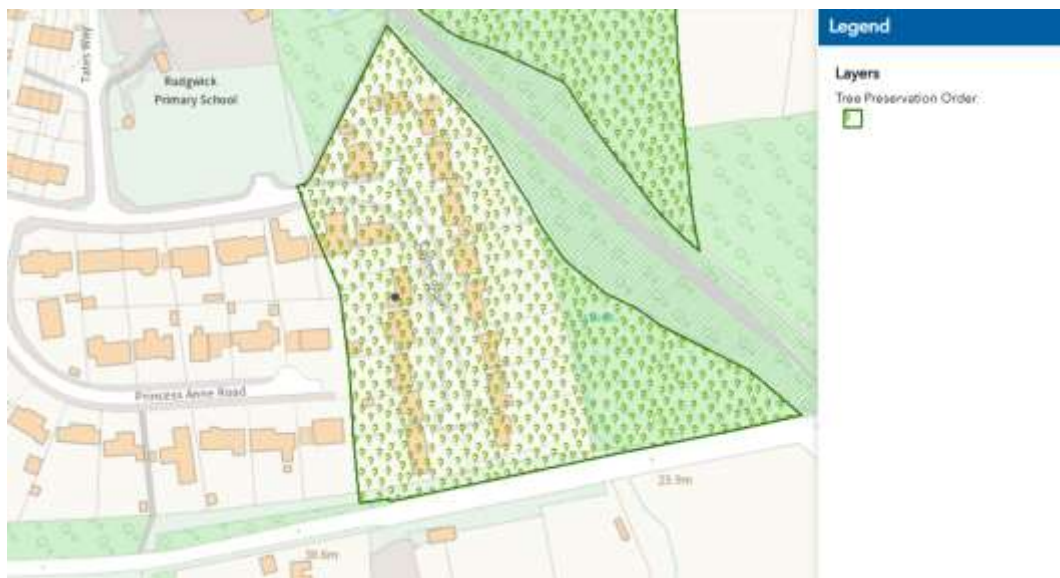
## TPO Status

Based upon Horsham District Council GIS maps, the implicated trees are protected and a root severance application will be necessary on this occasion.
