## HORSHAM DISTRICT COUNCIL CONSULTATION

| <b>LOCATION:</b> | Coombe Cottage Church Road Mannings Heath |
| <b>DESCRIPTION:</b> | Erection of a two storey 4 bedroom dwelling with associated parking and landscaping |
| <b>REFERENCE:</b> | DC/26/0088 |

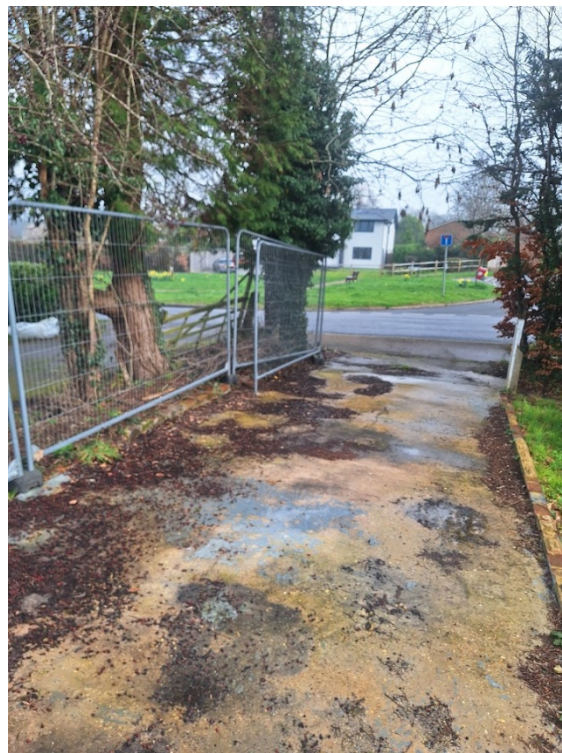
Additionally, the removal of the old garage/shed slab foundation to allow for the proposed new access will negatively impact two possibly off-site trees that may be located within the grounds of the neighbouring property, **Ingleside**, and would likely result in their rapid decline and removal. This is due to the location of the trees and the likelihood that their roots lie directly beneath the existing concrete slab. As the trees in question appear to fall outside the applicant's ownership, this should be confirmed.

I note that the Ash at the front of the property is shown on the Hard and Soft Landscaping Scheme, but the conifers are not.

Retaining the existing slab and installing any new surfacing on top of it would help mitigate this risk. Failing this, the Ash and the conifers would need to be removed to allow the new access to be built as proposed. Neither of the trees are specimens of particular merit, and their removal could be compensated for with new tree planning at the front of the property subject to confirmation on their ownership.
