## **Arboricultural Impact Assessment**

### **& Method Statement:**

Land off Crawley Road  
Faygate  
West Sussex  
RH12 4RU

Ref: jwmb/rpt4/landoffcrawleyrd/AIAAMS

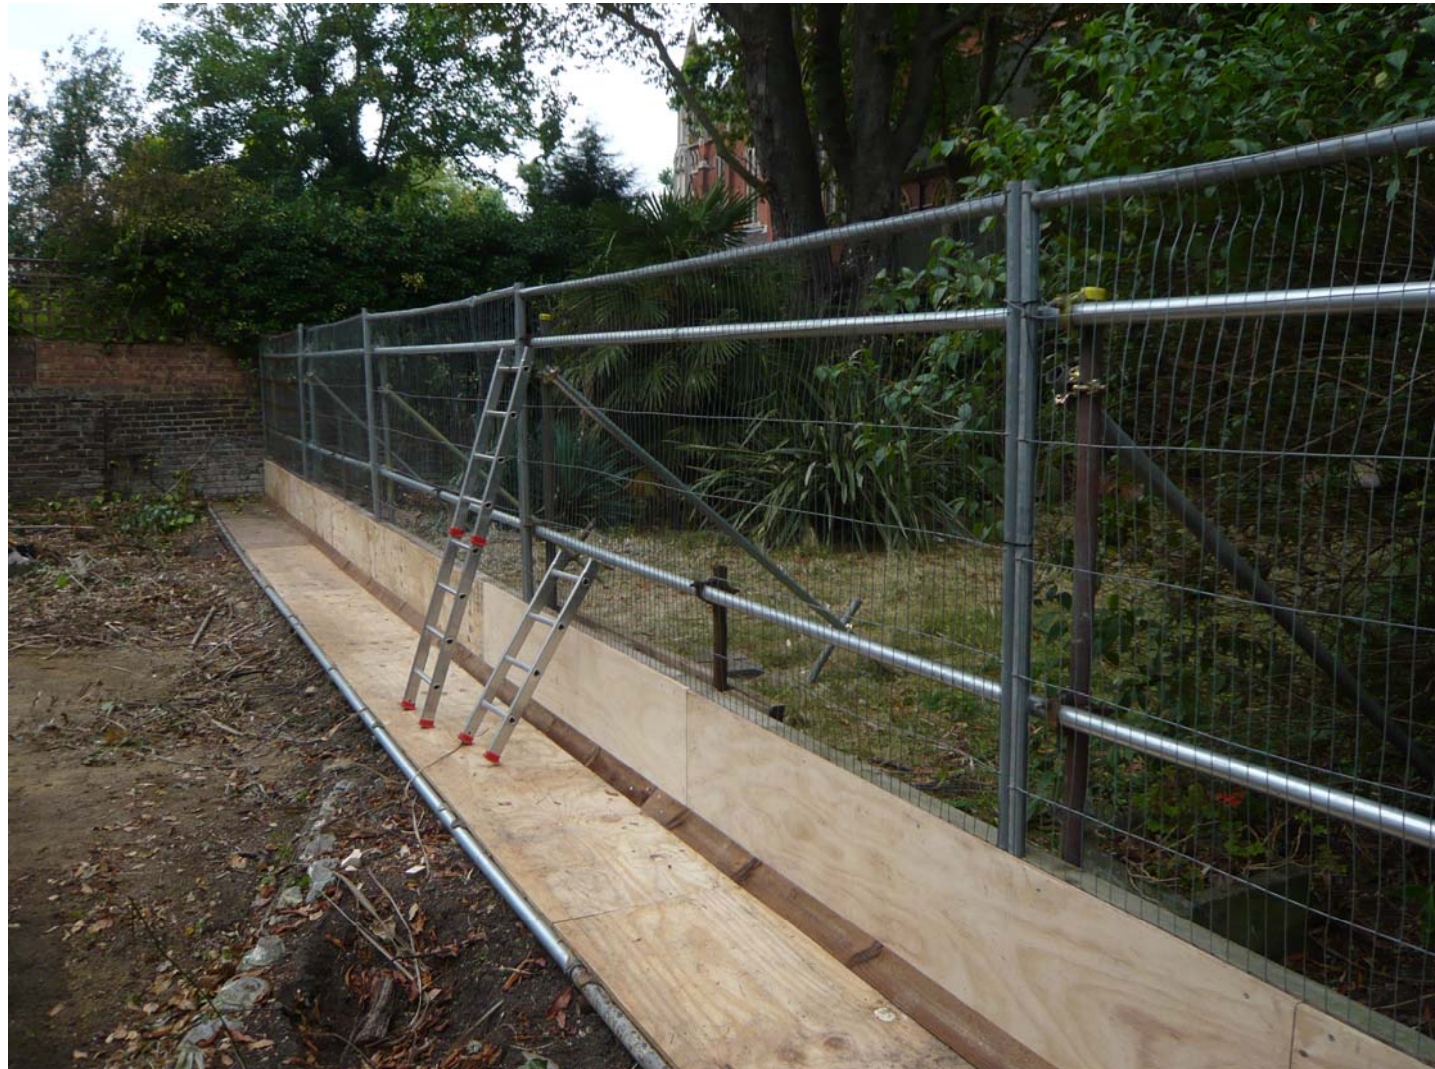
Illustrative example of strengthened tree RPA ground protection set forward of protective barrier.

An adaptation of BS 5837: 2005 Trees in Relation to Construction (Figure 3.)

Installation by Tree Projects 2008.
