## HORSHAM DISTRICT COUNCIL CONSULTATION

| <b>LOCATION:</b> | Phases 2 and 3 Land at Wellcross Farm Broadbridge Heath |
| <b>DESCRIPTION:</b> | Application for Approval of Details Reserved by Condition 2 (Construction Management Plan), <sup>3</sup> (borehole to meet Private Water Supplies), <sup>4</sup> (Private Water Supply Management Plan), <sup>5</sup> (finished floor levels and external ground levels) and 7 (underground services) to approved application DC/24/0205 Reserved matters application pursuant to condition 5 of outline planning permission DC/19/1897 for the provision of phases 2 and 3 of Land at Wellcross Farm to provide a continuing care retirement community with 94 units of accommodation (C2), with access, infrastructure, open space, landscaping and associated works including an onsite borehole water supply). |
| <b>REFERENCE:</b> | DISC/26/0012 & DISC/26/0013 |

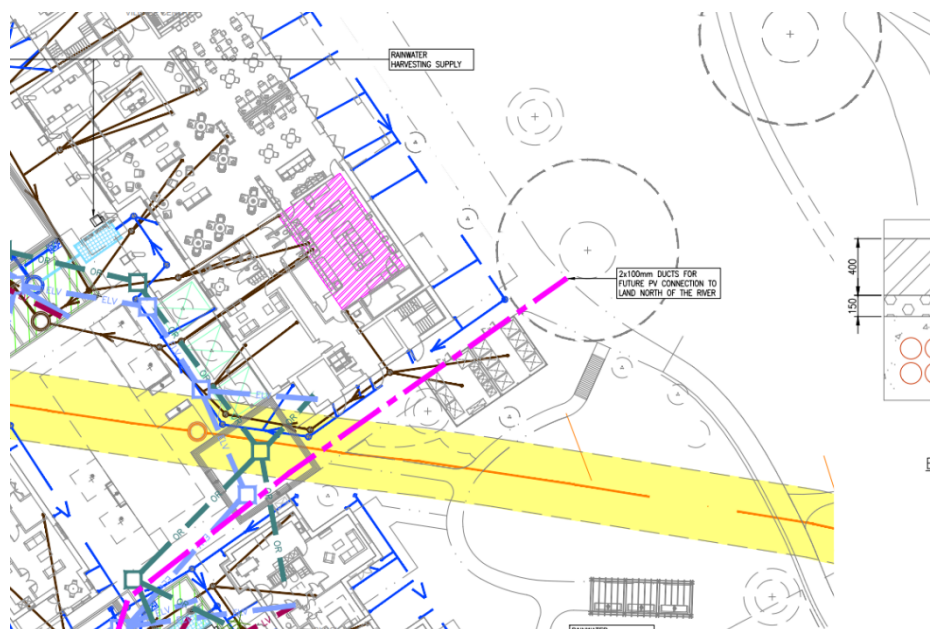
Accordingly, amendments should be sought to the route of the service runs to ensure that they do not encroach within the RPA of tree T31, and outside of the RPA, of the unknown tree in the above image taken from Electrical & Electrical Services Drawing No. 1163-ESD-XX-00-DR-XX-P2-1001.

One potential solution would be to relocate the service runs further north, outside the RPA of T31, and outside of the RPA, of the unknown tree in the above image. If this is not
