| CONSULTEE | COMMENT | RESPONSE |
|---|---|---|
| HDC EHO<br>19/12/2023 | <b>Geo-Environmental Desk Study Report</b> | |
| | <b>Geo-Environmental Ground Investigation Report</b> | |

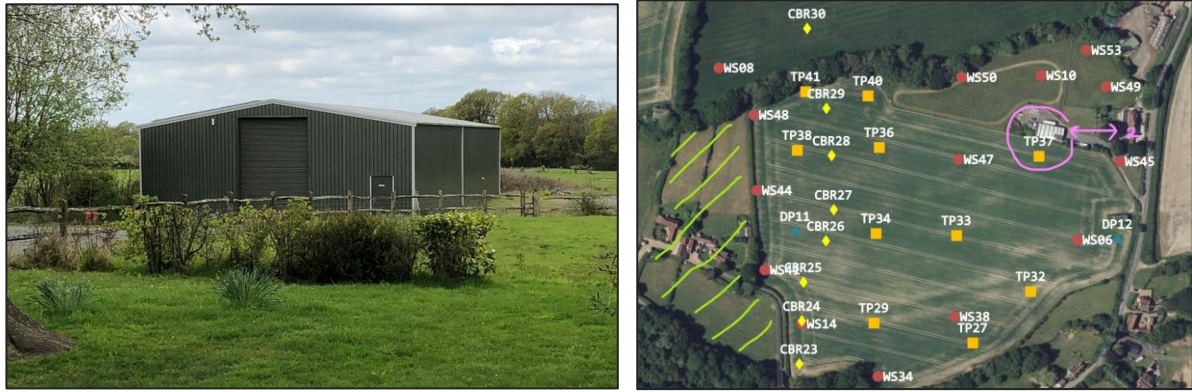
| CONSULTEE | COMMENT | RESPONSE |
|---|---|---|
| | <p>2. Given the above we would be grateful for some comments on fluctuations of the carbon dioxide at this location and the likely source of the elevated carbon dioxide.</p> | <p>The two images below show the location of WS40 in the top right (NE) corner of the field and this is away from the developed part of the sports hub so no risk to end users.</p> |

| CONSULTEE | COMMENT | RESPONSE |
|---|---|---|
| | 1. From reviewing Appendix B 'Groundwater/Ground Gas Monitoring Assessment', in particular the results for location WS40, we note that during the monitoring on 16.06.22, 29.06.22 and 14.07.22 carbon dioxide levels were consistently above 5%v/v, the level above which consideration should be given to increasing to CS2. The carbon dioxide results then drop to 0.0-0.1%v/v during the monitoring on 27.07.22 before rising to a maximum of 4.6%v/v during the monitoring on 10.08.22. We also note however that the response zone for WS40 was in the natural ground and we are not aware of any sources of ground gas in close proximity to WS40. | <p>No potential sources of ground gases were identified at the location of WS40, or within the surrounding area of the sports pitch's location. Although a maximum carbon dioxide reading of 5.7% with a maximum flow of 0.1% at Pit location WS40. The calculated hazardous gas flow for WS40 was 0.0057l/hr falling within CS/1.</p> <p>Regardless of this, no structures are planned within this area of the sports pitches. The initial elevated concentrations were likely caused by the rewetting of dry soils which is often accompanied by a pulse in carbon dioxide concentrations through microbial mineralisation.</p> |
