## HORSHAM DISTRICT COUNCIL CONSULTATION

| <b>LOCATION:</b> | Coombe Cottage Church Road Mannings Heath |
| <b>DESCRIPTION:</b> | Erection of a two storey 4 bedroom dwelling with associated parking and landscaping |
| <b>REFERENCE:</b> | DC/26/0088 |

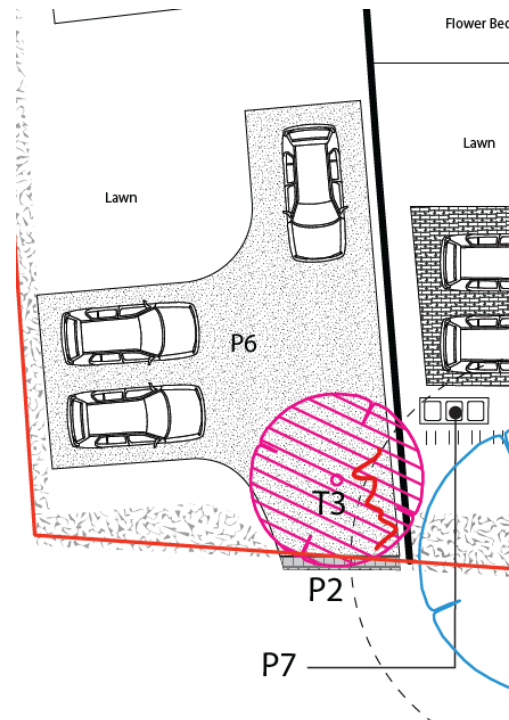
At present, it is apparent that new parking bay and bin storage area would fall within the yew tree's root protection area (RPA).

As such, it is recommended that the two parking bays to the north of the yew, along with the bin store, be relocated further within the site to maintain an appropriate distance of approximately 6m from the tree's base. And tree protection fencing (TPF) would be

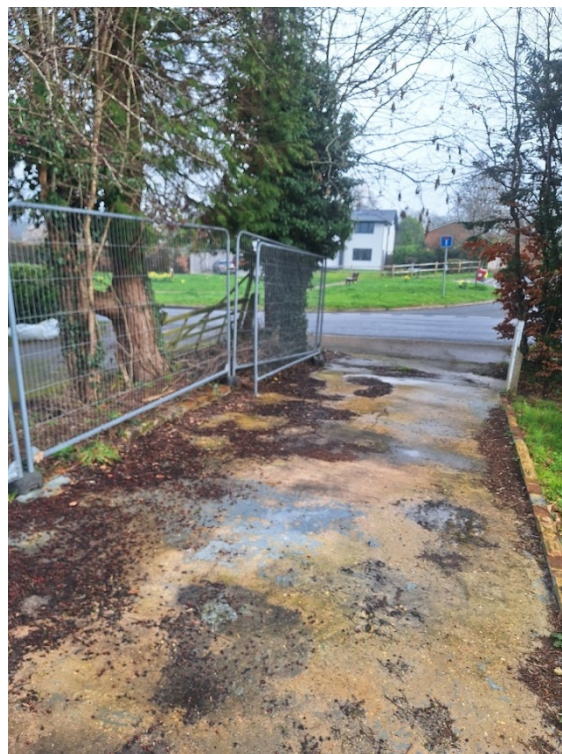
Additionally, the removal of the old garage/shed slab foundation to allow for the proposed new access will negatively impact two possibly off-site trees that may be located within the grounds of the neighbouring property, **Ingleside**. This is due to the location of the trees and the likelihood that their roots lie directly beneath the existing concrete slab. As the trees in question appear to fall outside the applicant's ownership, this should be confirmed.

I note that the Ash at the front of the property is shown on the Hard and Soft Landscaping Scheme, but the conifers are not.

Retaining the existing slab and installing any new surfacing on top of it would help mitigate this risk. Failing this, the Ash and the conifers would need to be removed to allow the new access to be built as proposed. Neither of the trees are specimens of particular merit, and their removal could be compensated for with new tree planning at the front of the property.
