## Optera Structural Solutions

### SOW 20498 Agreement to install a root barrier for Direct Line Group.

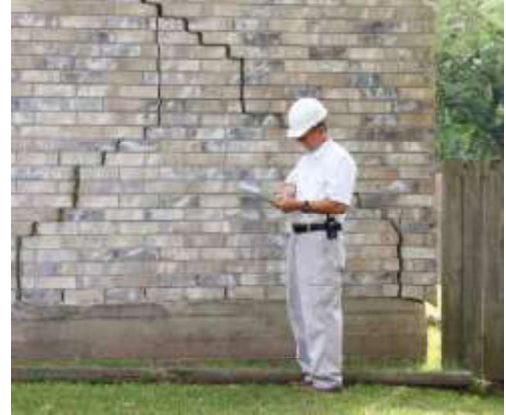
The barrier will be positioned between the offending tree(s) and the affected part of the building, and will be installed to a depth designed to cut the tree(s) roots between the tree and the foundations; the act of excavation severs the roots, causing any roots beneath the foundations to wither and die. This prevents the tree(s) from extracting moisture from the clay supporting the foundations, allowing the clay to rehydrate and recover their natural moisture levels. Naturally, there is a period of time required for the recovery process to take place, but repairs can typically be undertaken shortly after the installation is complete.

To ameliorate tree-root induced clay-shrinkage subsidence, the first option is generally removal of the implicated tree(s). However, where the tree(s) cannot be felled, for whatever reason, the next option would be to sever the roots between the tree and the property and form a barrier to prevent reestablishment of the roots.

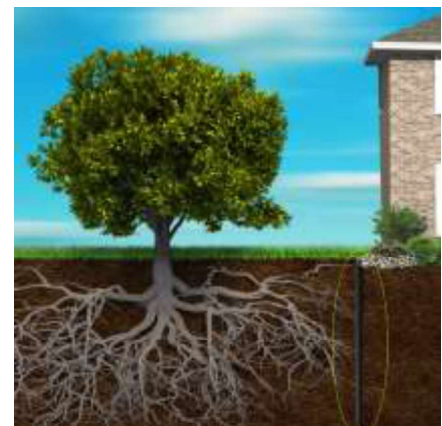
Trees are known to cause clay soils to shrink by drawing water through their roots, predominantly during the Spring and Summer months. The shrinkage results in both vertical and horizontal ground movement that, when transmitted to a building's foundations, cause damage to the building's structure. The amount of shrinkage depends on the type of clay soil, the type and size of vegetation, and on weather patterns.

The moisture content of a clay soil tends to vary with depth. Closer to the surface there can be relatively large changes in soil moisture content between summer and winter as a result of evaporation from the ground surface, the drying effect of the Sun and general vegetation, including grasses. Such variations are normally confined to the upper 1m of the ground. However, where trees are growing within influencing distance of a building, then the soil moisture profiles will fluctuate much more widely through the seasons and to a much greater depth; in response, soil volume changes are amplified, and consequential building movements will be far greater.

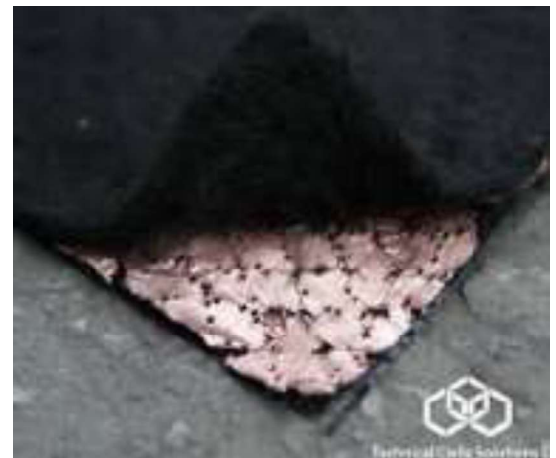
The bio-root barrier is strong and flexible, with very high tear resistance, as well as being water-permeable, thus allowing the natural movement of water through the ground without impediment. The Copper contained within the core of the membrane also acts as a chemical repellent to the roots without constituting a hazard to plants or animals. The Copper foil securely bonded within the porous geotextile membrane, releases Copper ions into the adjacent soil by forming Copper Carbonate (verdigris); these signal adverse conditions to any roots growing towards the barrier, preventing a proliferation of roots close to the barrier. The levels of Copper generated do not constitute a burden on the eco-system or impact groundwater quality.

Outdated, impervious barriers divert rather than stop roots and may prevent the movement of groundwater causing unintended consequences. The use of Optera's permeable barrier stops roots both by forming a physical impenetrable obstacle and by acting as a chemical inhibitor to the reestablishment of roots.

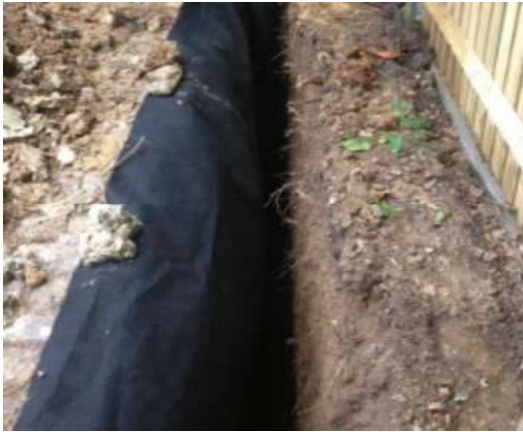
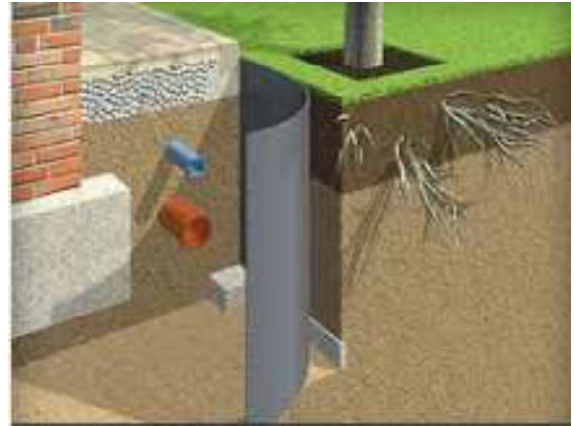
Following installation of the root barrier, the trench may be backfilled with 20mm single sized stone, alternatively, and dependent upon site conditions, backfilling could be done with as-dug material, which would be placed and compacted with a plate-compactor mounted on the excavator arm. In specific circumstances, we may also use no-fines concrete on the structure side of the shield.

Some degree of surface settlement can be experienced following completion, where this happens, Optera will return to top-up the trench; typically this occurs within the first six months of installation.
