## HORSHAM DISTRICT COUNCIL CONSULTATION

| <b>LOCATION:</b> | Phases 2 and 3 Land at Wellcross Farm Broadbridge Heath |
| <b>DESCRIPTION:</b> | Application for Approval of Details Reserved by Condition 2 (Construction Management Plan), <sup>3</sup> (borehole to meet Private Water Supplies), <sup>4</sup> (Private Water Supply Management Plan), <sup>5</sup> (finished floor levels and external ground levels) and 7 (underground services) to approved application DC/24/0205 Reserved matters application pursuant to condition 5 of outline planning permission DC/19/1897 for the provision of phases 2 and 3 of Land at Wellcross Farm to provide a continuing care retirement community with 94 units of accommodation (C2), with access, infrastructure, open space, landscaping and associated works including an onsite borehole water supply). |
| <b>REFERENCE:</b> | DISC/26/0012 & DISC/26/0013 |

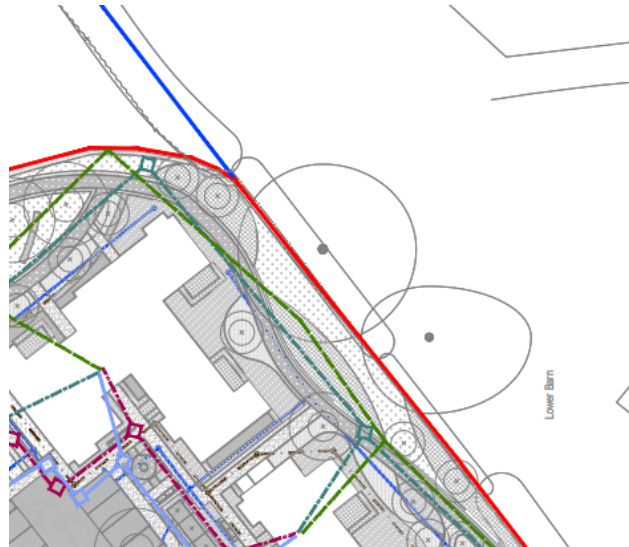
If the new services are installed using an open-trench method, the historically greenfield nature of the site and the absence of physical constraints that would have limited root development to the northwest of the tree indicate a high likelihood that trenching works would result in substantial root severance and long-term damage to T31.

| <p>One arboricultural concern identified in the supporting documents accompanying the approval of details reserved by Condition 7 of the approved application DC/24/0205 relates to the route of the underground service pipes. These are proposed to pass through the Root Protection Area (RPA) of the off-site oak, T31, as numbered on the Tree Removal Plan Drawing No. 1164-KC-XX-YTREE-TRP01 Rev B that supported application DC/19/1897, as shown on the Electrical &amp; Electrical Services Drawing No. 1163-ESD-XX-00-DR-XX-P2-1001.</p> <p>In addition, concerns are raised regarding the proposed landscaping works and associated land level changes in the area to the northwest of the off-site oak trees T30 and T31, as numbered on the Tree Removal Plan Drawing No. 1164-KC-XX-YTREE-TRP01 Rev B that supported application DC/19/1897.</p> | |

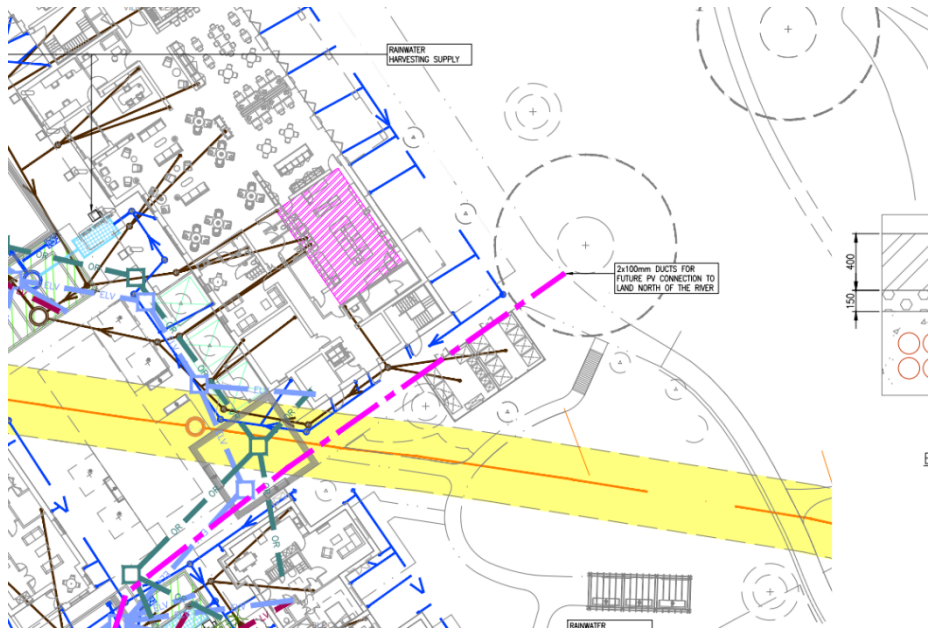
Accordingly, amendments should be sought to the route of the service runs to ensure that they do not encroach within the RPA of tree T31, and outside of the RPA, of the unknown tree in the above image taken from Electrical & Electrical Services Drawing No. 1163-ESD-XX-00-DR-XX-P2-1001.

One potential solution would be to relocate the service runs further north, outside the RPA of T31, and outside of the RPA, of the unknown tree in the above image. If this is not considered feasible, trenchless installation methods should be employed, such as thrust boring or impact moling.

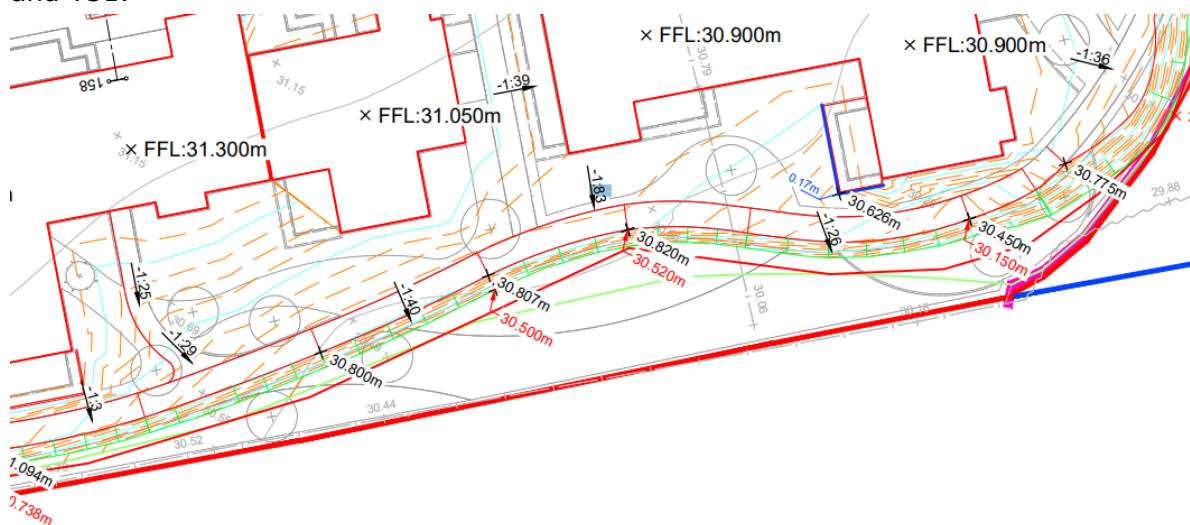
Further concerns are also raised in relation to the proposed landscaping works and associated land level changes in the area to the northwest of off-site trees T30 and T31, both oaks. Given the lack of detail on how the works would be completed without resulting in direct construction damage or indirect post-development harm, including root damage and soil compaction, these proposals are considered problematic. Please seek confirmation on the exact extent of the level changes and landscaping works within the RPA of T30, and T31.
