Site: Land North of The Rise, Littleworth Lane,  
Prepared by: Joe Hitchman  
Approved by: Neil Jaques  
Date: 27 August 2026

### 1.0 Document Purpose

1.1 This document has been prepared in response to comments raised by West Sussex County Council (WSCC) in their capacity as Lead Local Flood Authority (LLFA) raised on 20<sup>th</sup> July 2026 in response to a discharge of condition 13 of planning approval DC/22/0301 (approved on appeal APP/Z3825/W/23/3324144). The full LLFA response is included within **Appendix A** of this document.

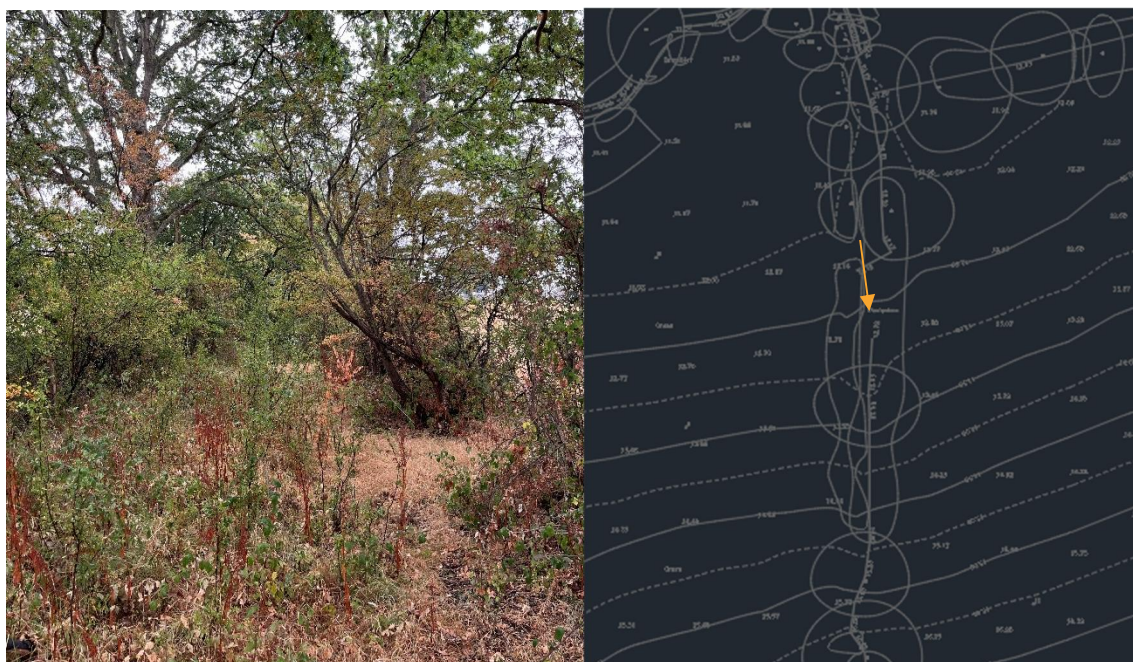
- 5.1 In response to receiving this comment, we attended the site to more fully investigate the potential existence of a watercourse at this location. However, we could only observe the tree line, and it does not appear that a ditch exists at this location. Certainly, there is no connection, including piped from the central corridor of trees to the wider watercourse network. Please see image taken from site below.

Figure 2: Photo taken on site, right image indicating location and direction of photo taken
