## HORSHAM DISTRICT COUNCIL CONSULTATION

| <b>LOCATION:</b> | Phases 2 and 3 Land at Wellcross Farm Broadbridge Heath |
| <b>DESCRIPTION:</b> | Application for Approval of Details Reserved by Condition 2 (Construction Management Plan), <sup>3</sup> (borehole to meet Private Water Supplies), <sup>4</sup> (Private Water Supply Management Plan), <sup>5</sup> (finished floor levels and external ground levels) and 7 (underground services) to approved application DC/24/0205 Reserved matters application pursuant to condition 5 of outline planning permission DC/19/1897 for the provision of phases 2 and 3 of Land at Wellcross Farm to provide a continuing care retirement community with 94 units of accommodation (C2), with access, infrastructure, open space, landscaping and associated works including an onsite borehole water supply). |
| <b>REFERENCE:</b> | DISC/26/0012 & DISC/26/0013 |

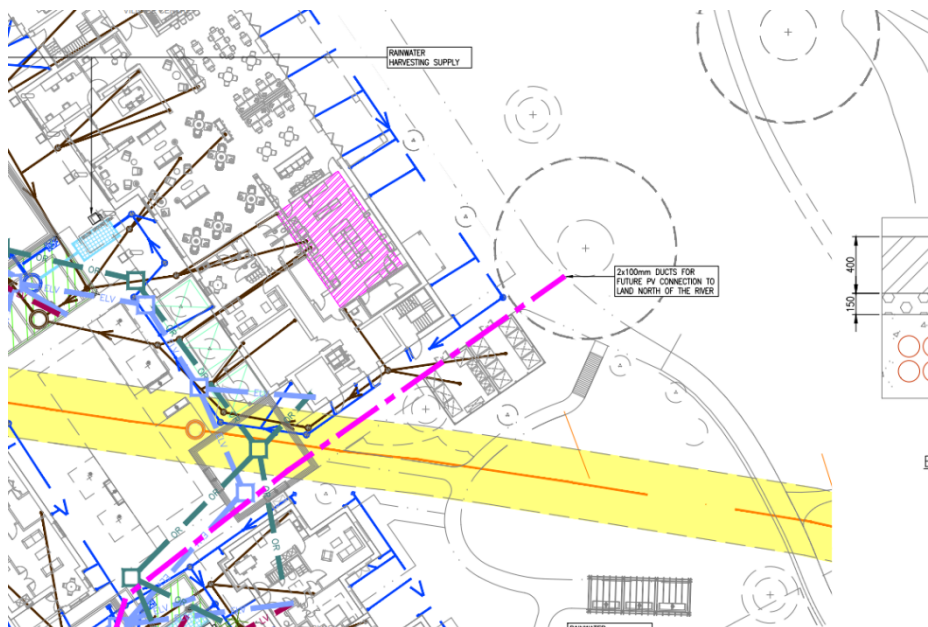
Accordingly, amendments should be sought to the route of the service runs to ensure that they do not encroach within the RPA of tree T31, and outside of the RPA, of the unknown tree in the above image taken from Electrical & Electrical Services Drawing No. 1163-ESD-XX-00-DR-XX-P2-1001. [Concerns addressed.](#)

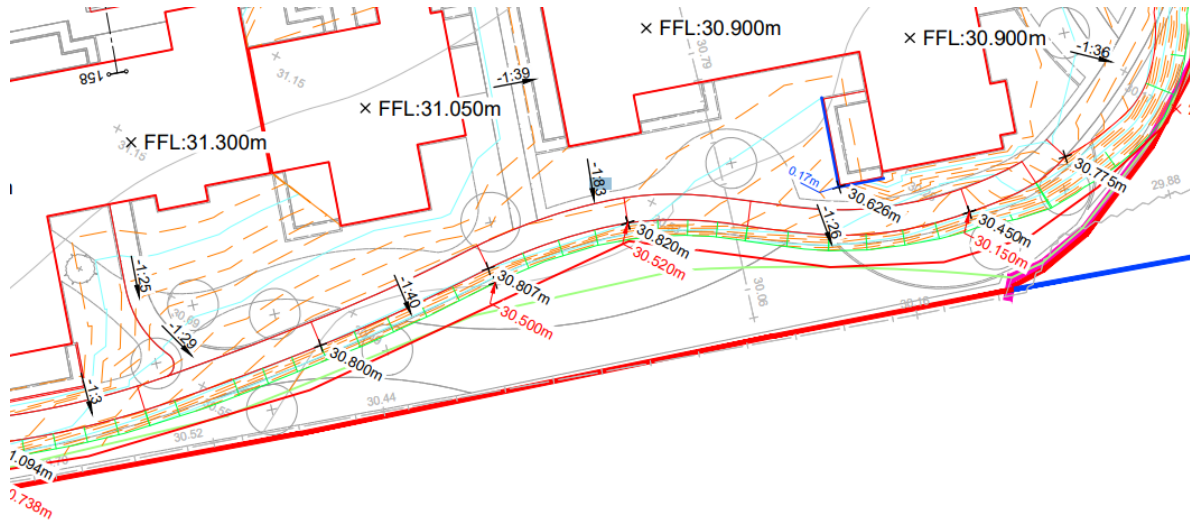
Further concerns are also raised in relation to the proposed landscaping works and associated land level changes in the area to the northwest of off-site trees T30 and T31, both oaks. Given the lack of detail on how the works would be completed without resulting in direct construction damage or indirect post-development harm, including root damage and soil compaction, these proposals are considered problematic. Please seek confirmation on the exact extent of the level changes and landscaping works within the RPA of T30, and T31. [Concerns addressed.](#)
