**Bottings Farmhouse**

**Design and Access Statement**

**And Heritage Statement**

**To accompany a Householders Planning Permission and Listed Building Consent Application for; Relaying Roof, Replacement Windows and Doors, and Internal Alterations to a Grade II Listed Building**

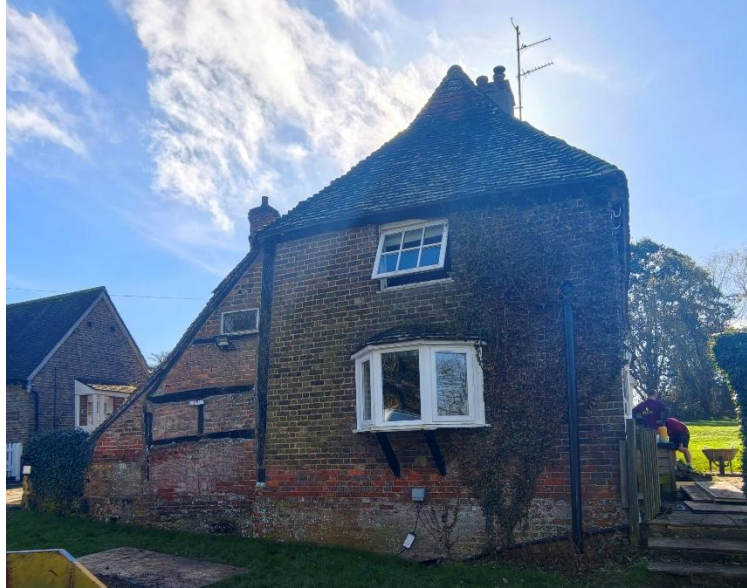
The northern elevation displays the original northern end of the long-range to the right-hand side, where the eastern aisle can be seen through the retained exposed timbers and now extends down into a catslide roof. The walls are finished in brick in Flemish bond in a variety of modern brown/red bricks under a square clay tile roof with Sussex hip. The timber frame and softer brick has become heavily eroded due to the use of cementitious render to point the brickwork and fill around the original timber frame.

Windows are a mixture of C21st timber framed double glazed casements, with single horizontal bars and square lights, and include a projecting bay window to the northern end of the range.

Fig 12: photo of the existing north elevation, northern end of long range

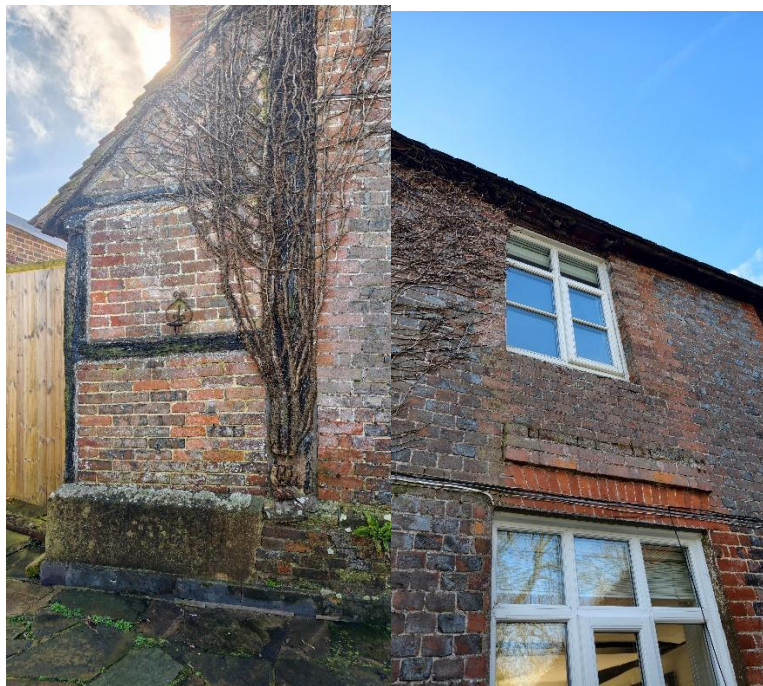
To the left-hand side, the C16th range is seen projecting to the east under a gable ended roof with square clay tiles. This element is finished in blue brick headers with some red brick quoining to the windows and includes a chimney to the eastern end finished in modern brick in stretcher bond between an exposed timber frame.

Fig 13: photo of the existing north elevation, eastern range

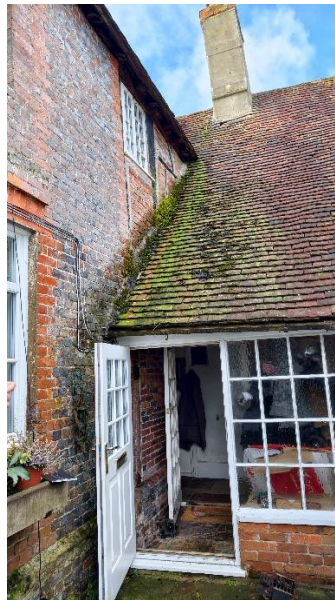
Shows to the right-hand side, the northern end of the long range with square clay tile roof dropping to a catslide, with a modern timber framed front door located at the depth of the original arcade. C18th fixed glazing panel retained. Red brick is laid in stretcher bond. Lack of leadwork and drainage is causing significant damage to the fabric along the abutment with the eastern range.

Fig 14: photo of the existing east elevation, entrance porch

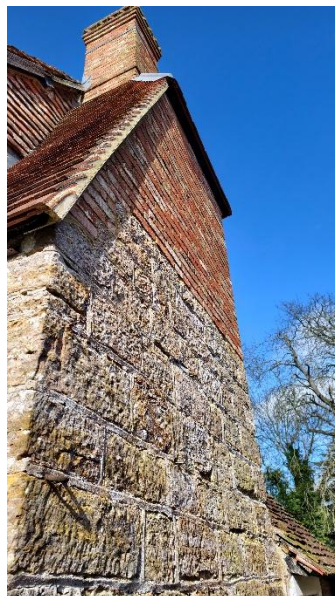
Centrally the eastern outshot is dominated by the chimney stack finished with a stone base and brickwork at first floor level. Due to lack of gutters the wall has over time become heavily saturated, this paired with the used of cementitious render to repoint the stonework has caused heavy erosion of the stonework.

Fig 15: photo of the existing east elevation, eastern chimney

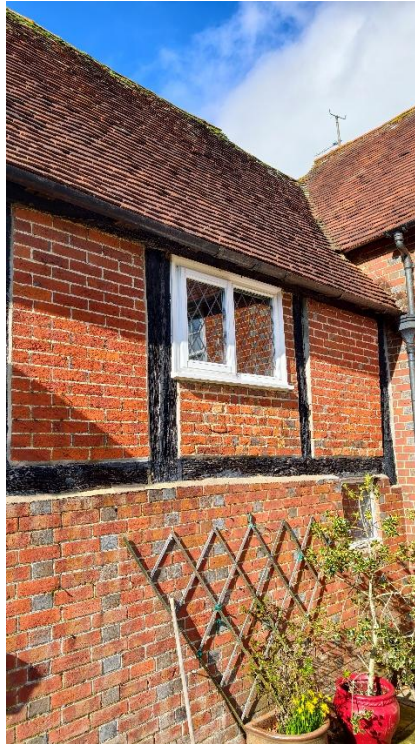
To the left-hand side, the southern end of the long-range shows brickwork in Garden Wall bond at ground floor level and modern brick infill in stretcher bond with exposed timber framing to first floor. Roof is finished in square clay tile, re-laid in the 1980's, resulting in a crisp pitch with the patina and undulations concealed by the new rafters.

Fig 16: photo of the existing east elevation, southern end of long range

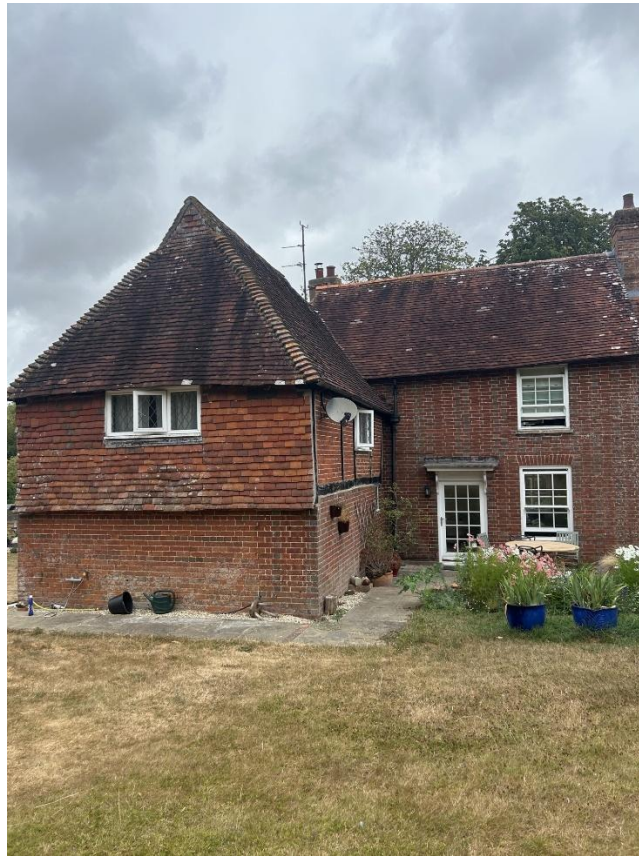
The southern elevation shows the south end of the long-range with brickwork in Flemish bond at ground floor level and clay tile hanging to first floor to the left-hand side, and the eastern range projecting to the right-hand side with red brick finish in Flemish bond with blue brick detailing. Materials are modern alterations most likely completed during the 1980s at the time of roof repair works.

Fig 17: photo of the existing south elevation, southern end of long range

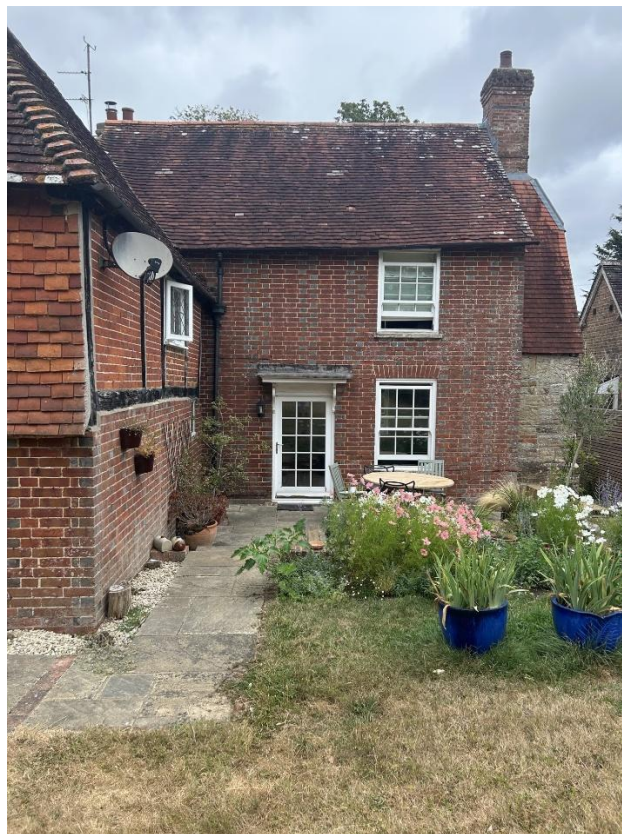
To the furthest right-hand side, the chimney stack is seen finished in stone and clay tile hanging to the eastern range. The eastern range is finished in red brick with blue header bricks in a sort of Garden Wall bond.

Fig 18: photo of the existing south elevation, eastern range

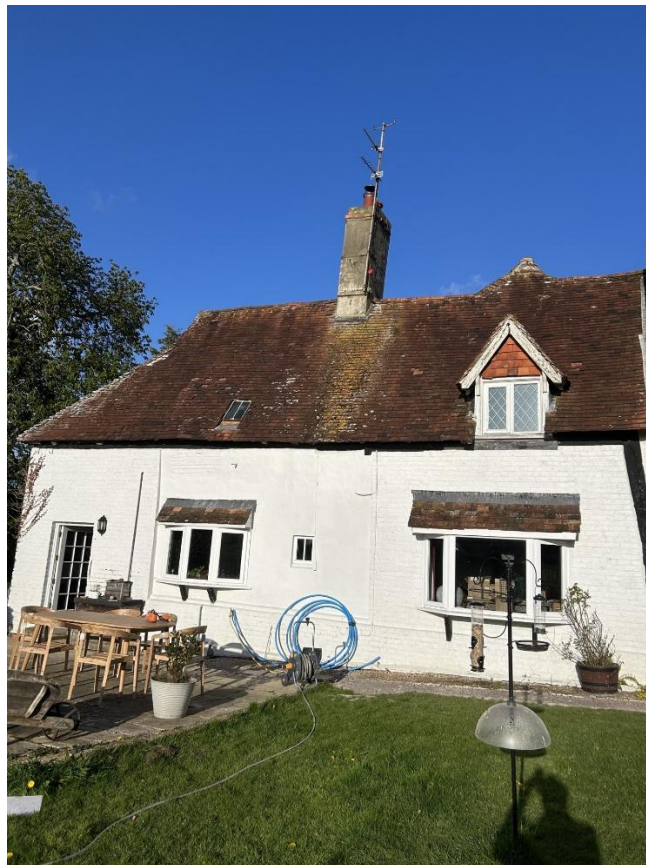
The northern elevation demonstrates the full length of the north to south long-range, with the change in roof heights and pitches clearly visible differentiating the two stages of development. The walls are finished in brick with a white paint finish, with exposed timber framing to the southern two bays. The roof is finished in square clay tiles with Sussex hip to north and south ends.

Windows are a mixture of timber C21st casements, with clear, square, and diamond leaded lights, and include two projecting bay windows to the northern end of the range.

Fig 19: photo of the existing west elevation, northern end of range

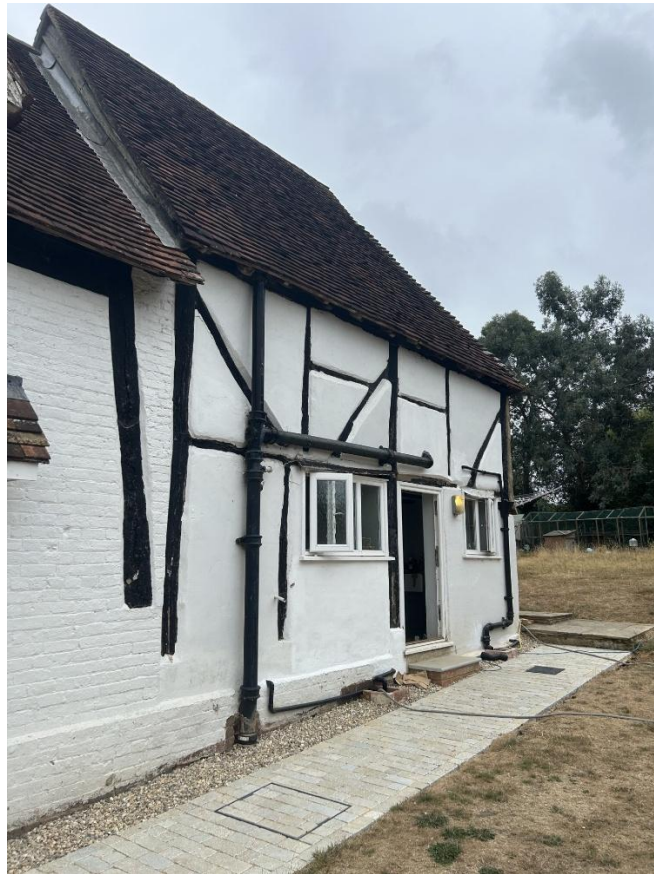
Fig 20: photo of the existing west elevation, southern end of range

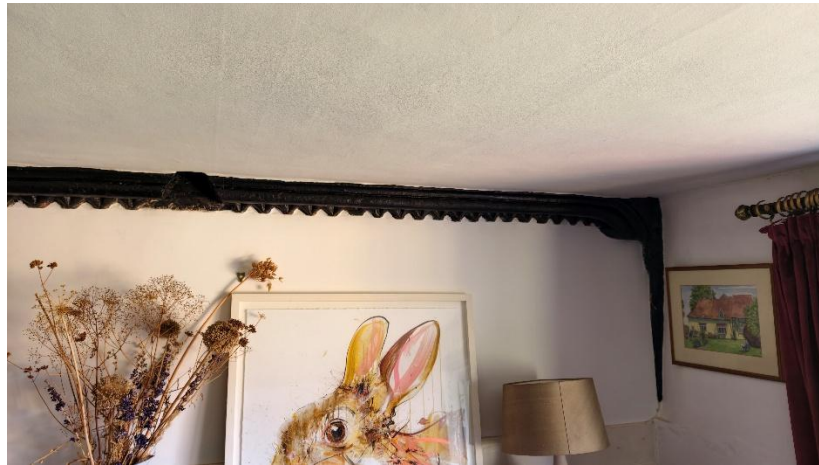
- 4.9 A decorated dais beam above a planked screen is noted by Annabelle Hughes as being of Architectural and Historical interest, with hollow chamfer and roll mould with a line of dog tooth carving which runs the length of the beam within the sitting room. This detail is usually seen in stone around arches of Norman churches. Dog tooth decoration was used between 1160-1260, meaning the four earliest bays at Bottings Farmhouse are of great significance in early surviving vernacular buildings in Sussex.

Fig 21: Dog tooth decoration in the sitting room

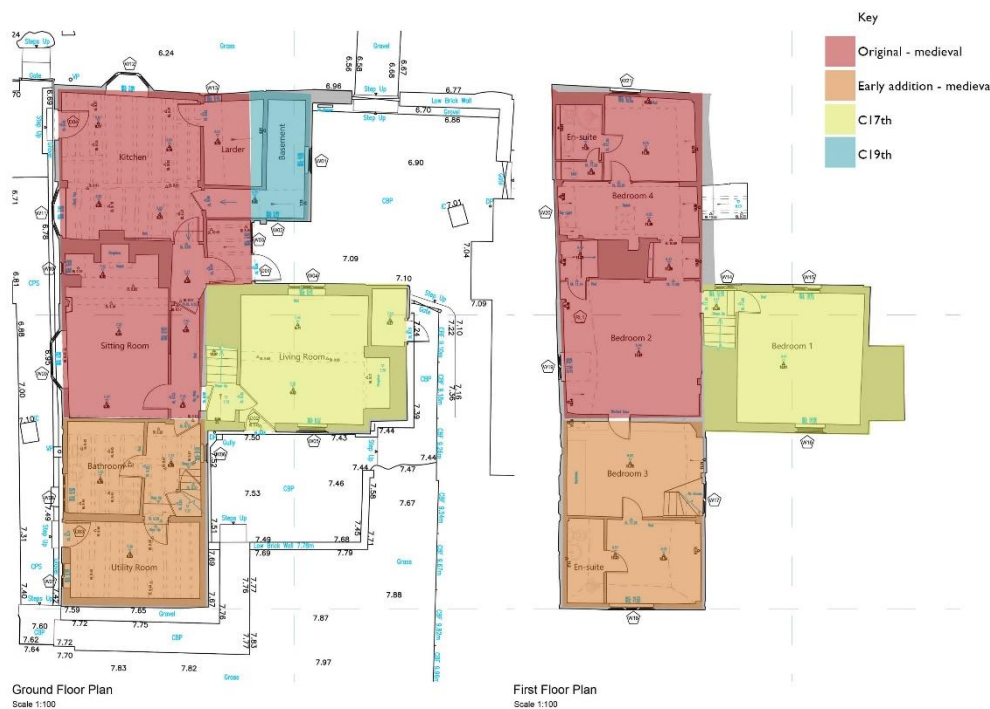
Fig 23: Existing Floor Plan showing Historic Development

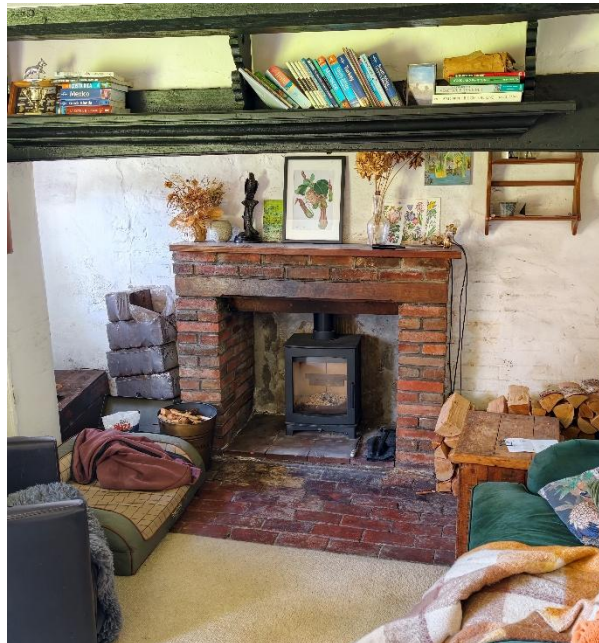
The proposal includes the removal of modern fireplace surround within inglenook fireplace and the removal of modern partition wall within sitting room. Both alterations restore the original form and legibility of the sitting room and Historic core of the house.

Fig 25: Modern fire surround within inglenook

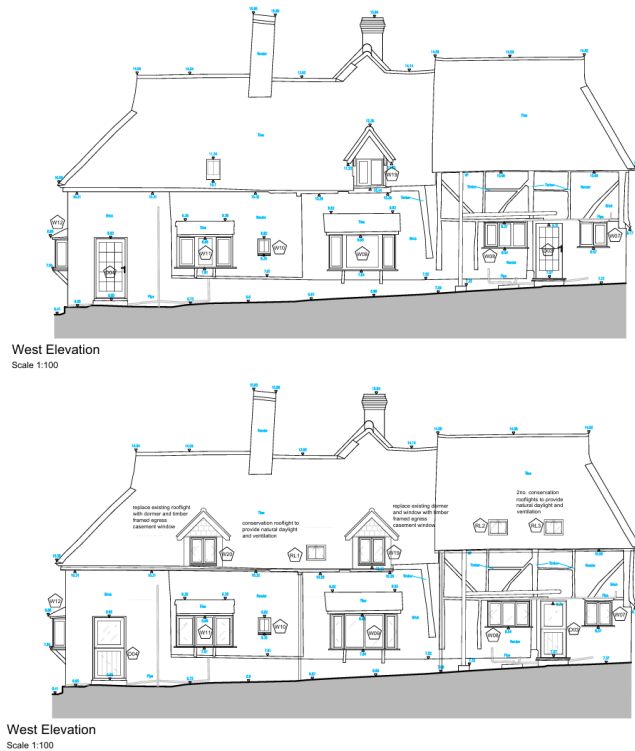
Fig 29: Existing and proposed west elevation

1. Replacement of the modern C21st windows with Heritage double glazed flush casements. Replacement doors with stable doors to Kitchen and Utility rooms.
2. Installation of Heritage Conservation rooflights, between the existing rafters to be retained as existing.
3. Installation of dormer window and replacement of existing dormer window, which is in poor condition to match.
4. Localised raking out of cementitious render which has eroded the Historic fabric, and replacement in lime render.
5. Installation of cast aluminium rainwater pipes and gutters.
