**Land South of Smugglers Lane,  
Barns Green, Horsham**

**Arboricultural Implications Assessment and  
Method Statement**

**Revision C**

| <b>File reference</b> | 25-1907-Report-C |

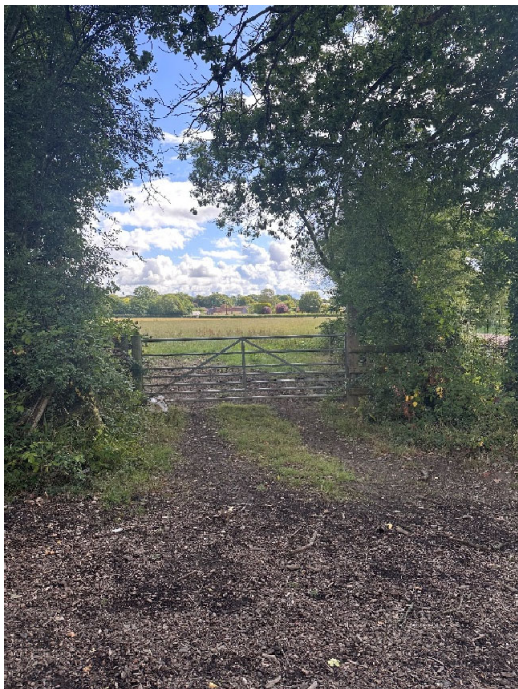
The proposed access path through the RPA of T26 and ASNW buffer zone utilises an existing access point, historically used for agricultural purposes.

Figure 1: Existing agricultural access viewed from bridleway

The proposed path ensures permeability of the layout in the interests of good planning and urban design. Using the proposed location negates the need to remove sections of
