AN ARCHAEOLOGICAL INTERPRETIVE STUDY FOR  
BARROW HILL FARMHOUSE, BARROW HILL, HENFIELD,  
WEST SUSSEX, BN5 9DN.

Report number: ASL 358-25

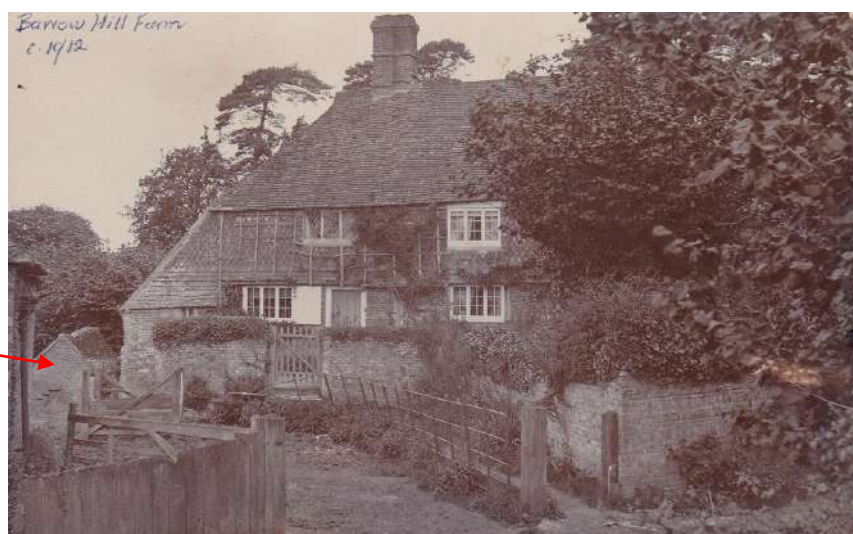
**Plate 1. Photograph of the front of the Farmhouse in 1912.**

- 2.12 A community web-site for Henfield<sup>5</sup> shows some information about the farmstead, with an early photograph from 1912 (Plate 1) clearly depicting the front of the building facing onto the road, with a gateway and fenced pathway leading to a gated, low brick enclosed front garden area. A separate wooden barred farm gate leads to the farm yard in-between the agricultural building and the house. The top half of the elevation is tile hung and only a small window can be seen in the southern outshot, although the garden wall hides the lower part of the structure. A diamond leaded light casement window can be seen at first floor level whilst the others have been replaced with timber casements with glazing bars. The small pigsty to the south is in a dilapidated condition by this point in time.

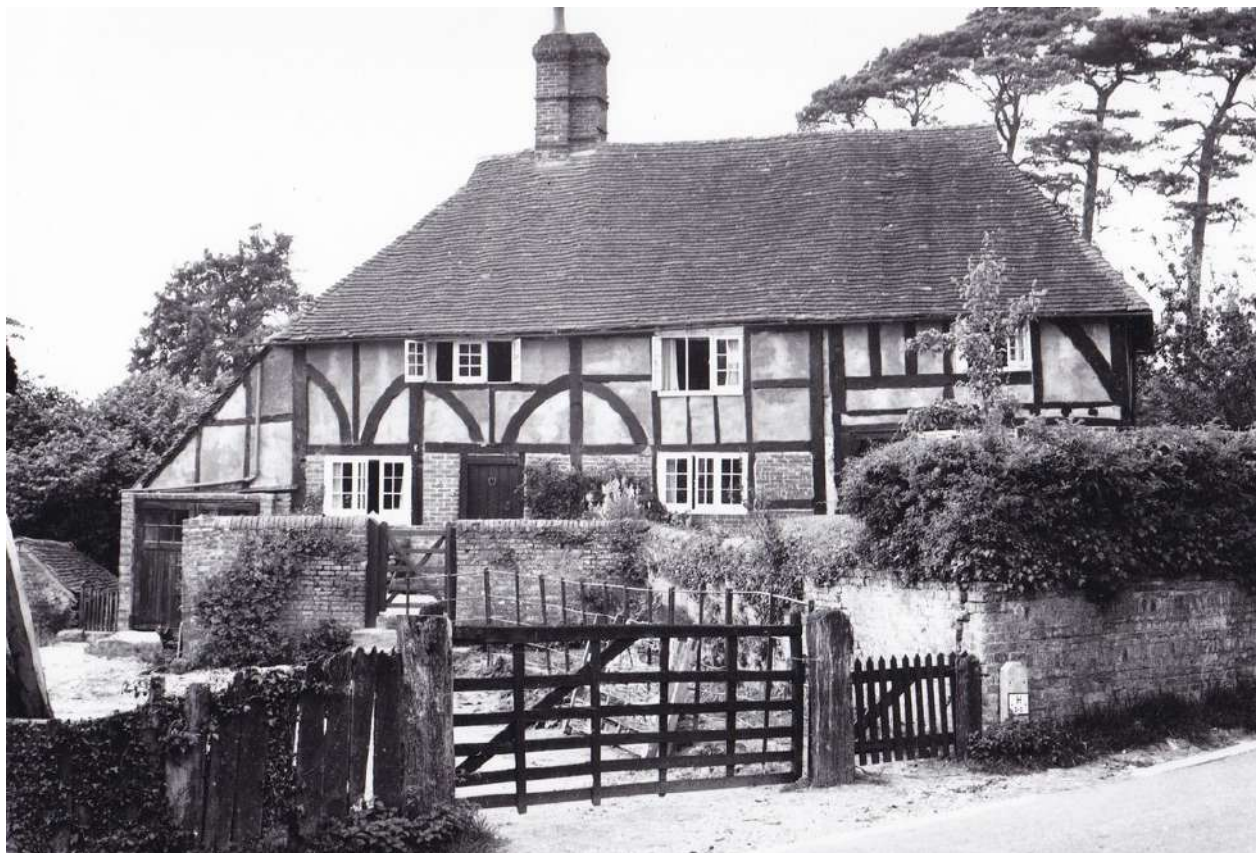
**Plate 2. Photograph of the front of the Farmhouse after the removal of the tile hanging in 1965.**

- 2.13 A photograph taken in 1965 (Plate 2) shows the tile hanging removed and the leaded light window replaced by a matching casement window. The pigsty is still extant and new garden gates have been introduced along with a double-width garage door in the southern outshot.

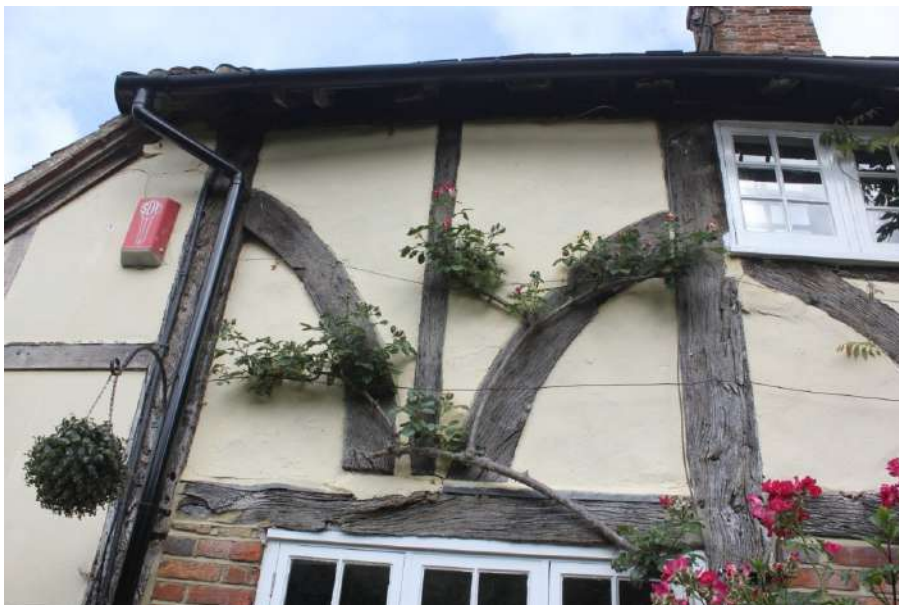
**Plate 3. The steeply curved braces in the east side of Bay 1.**

The wall design is of large panel construction, with curved foot bracing which is unusually steeply curved in places, particularly in the east face of the narrow Bay 1 (Plate 3).

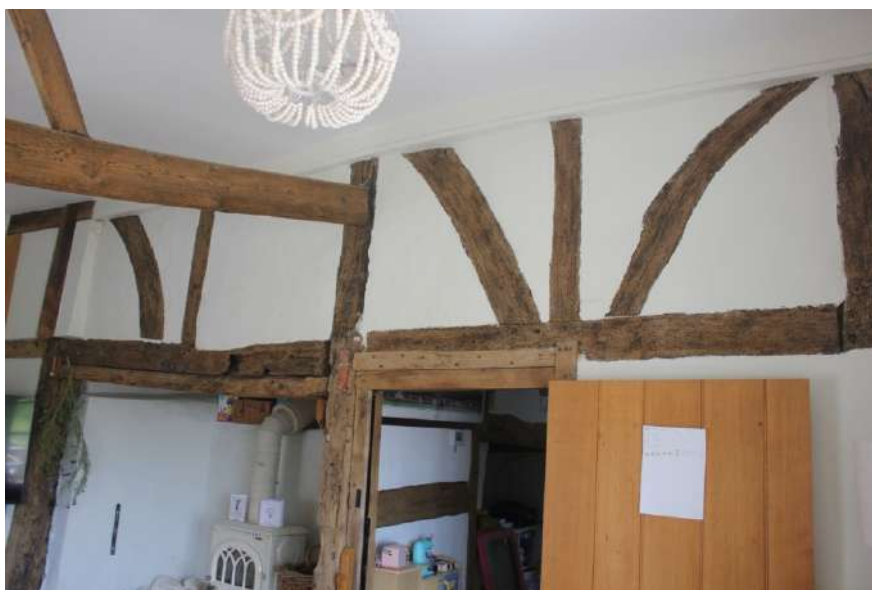
**Plate 4. The curved bracing the west side of Bay 1.**

This is matched in the west rear side (Plate 4).

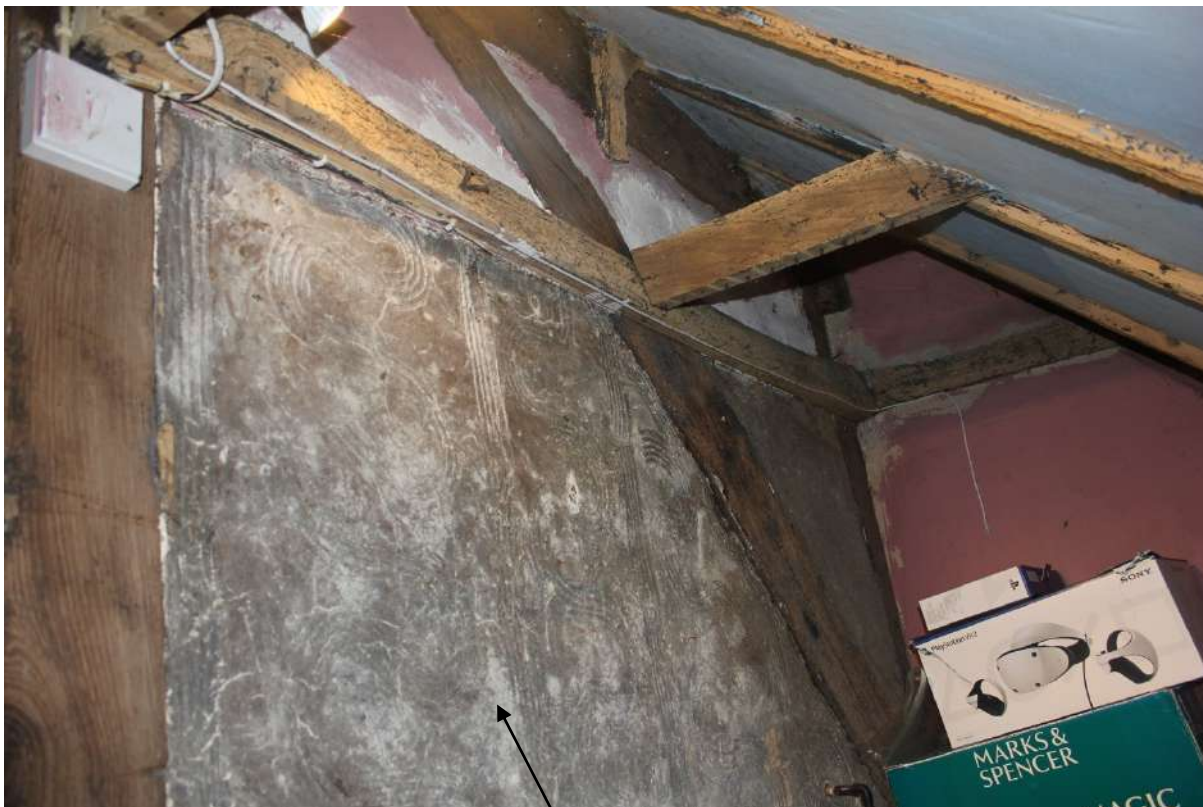
**Plate 5. Comb decorated daub under the paintwork in the south side of Truss A.**

Some original wattle and daub panels survive *in-situ* both externally and internally, with some comb decoration present inside, which appears as simple serpent trails in this period (Plate 5) but is slightly different in the ensuing period.

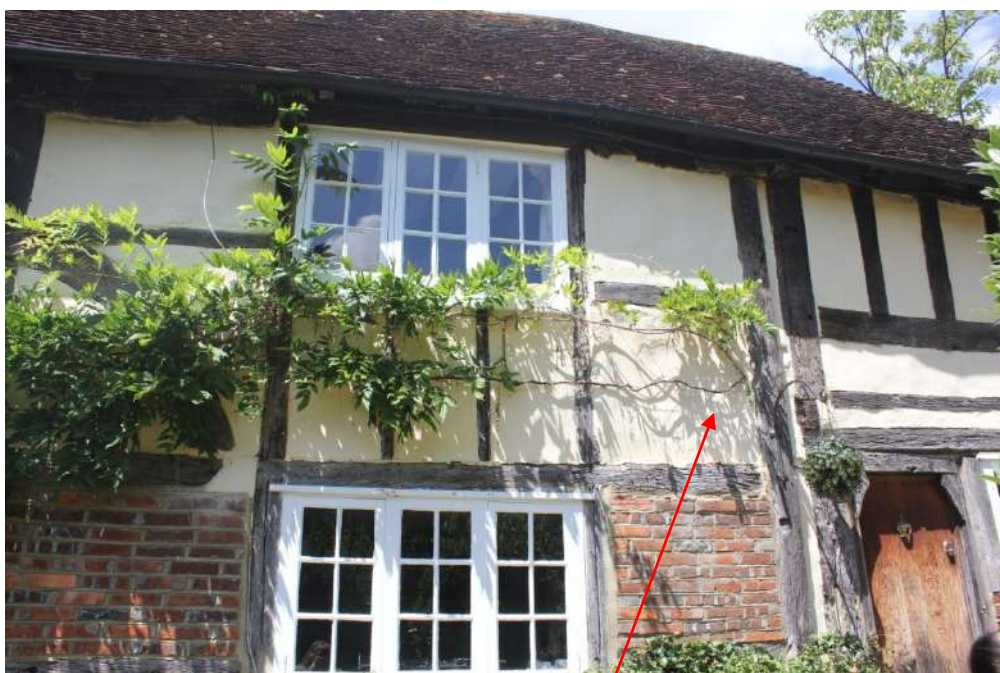
**Plate 6. Missing foot brace next to the location of the former hall window.**

The southern wall within the outshot is also decorated in this manner, which is further proof that a contemporary outshot was present from the outset. There has been some re-arrangement of the curved bracing to the north side of the hall window, where the additional Truss D has been inserted (Plate 6). In general, the pegs used in the frame construction are 25mm for the structural elements and 22mm for non-structural partitions etc.

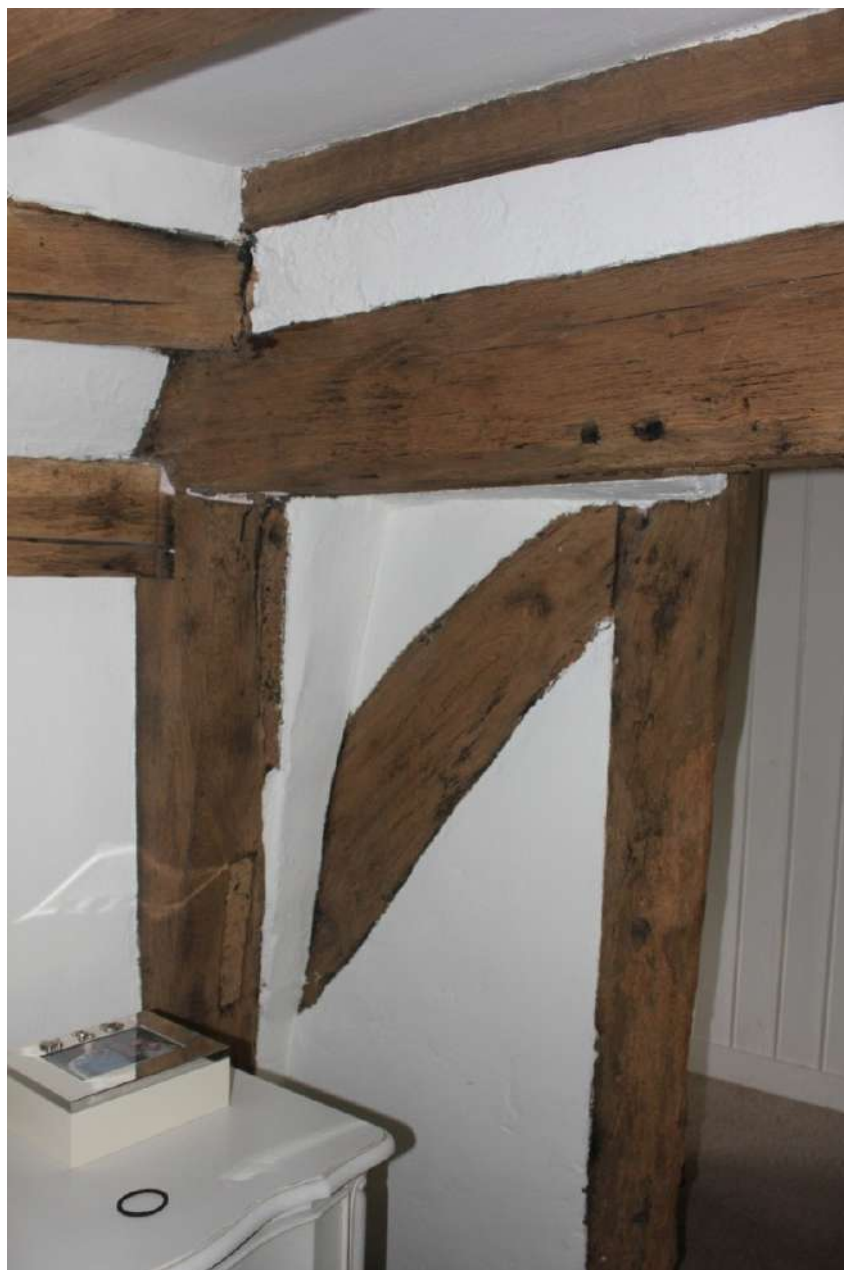
**Plate 7. No principal rafters jointed into the tiebeam of Truss D.**

Truss D is rather anomalous in that there is no surviving mid-tiebeam and the top of the truss does not have principal rafters or a collar. However, it has been seen elsewhere that there are no principal rafters as this is a common rafter roof where the rafters are not jointed into the top of the tiebeams by means of conventional teasel tenon joints, but instead are jointed to the wallplate to the side of the posts, as a form of intermediate truss. This truss has been interpreted as an inserted frame which was needed to support the end of the structure when the Period A1 structure was demolished, prior to the construction of the Period B cross wing. The braces appear to be inserted as an afterthought on both sides (Plates 7 and 8) as these are not directly tenoned to the posts and there is a second wallplate inserted above Post D (done during Period C).

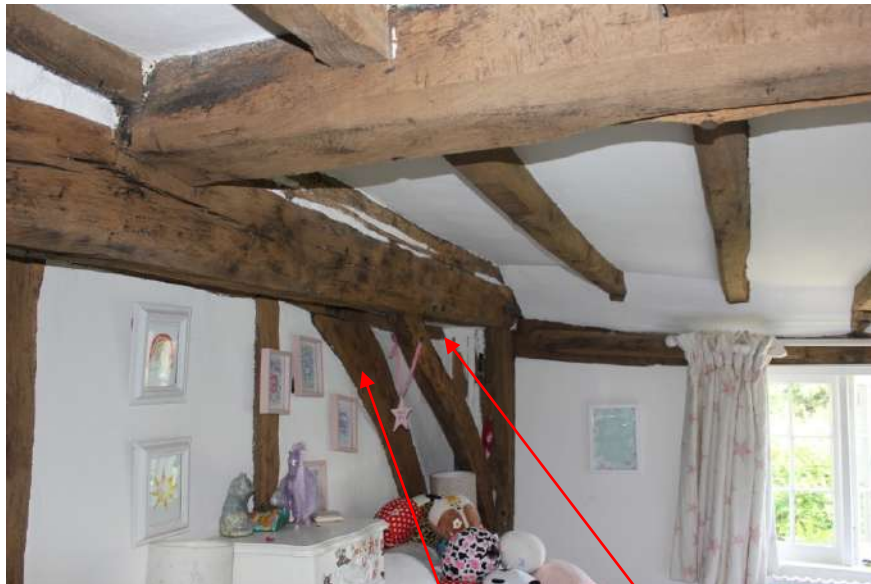
**Plate 8. Two frames evident where the inserted Truss D meets the braced wallplate of the Period B attachment.**

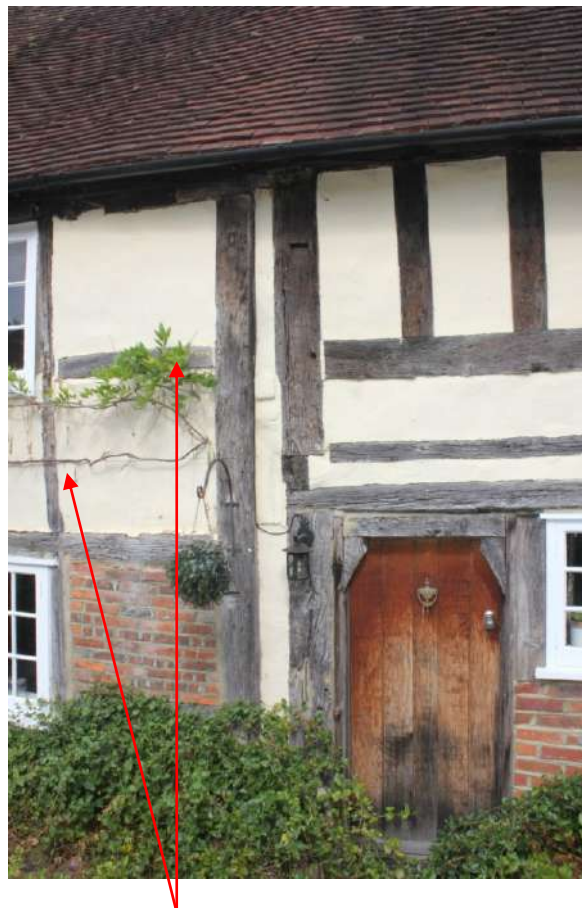
**Plate 9. Re-set timbers infilling the former hall window to the east.**

There is evidence for a full height hall window on the east side of Bay 3 to the north, suggesting this was the high end (Plate 9). However, there is no evidence for an opposing window on the west side where only a central interval post exists. There is no peg hole evidence for either the mullions, jambs or rails.

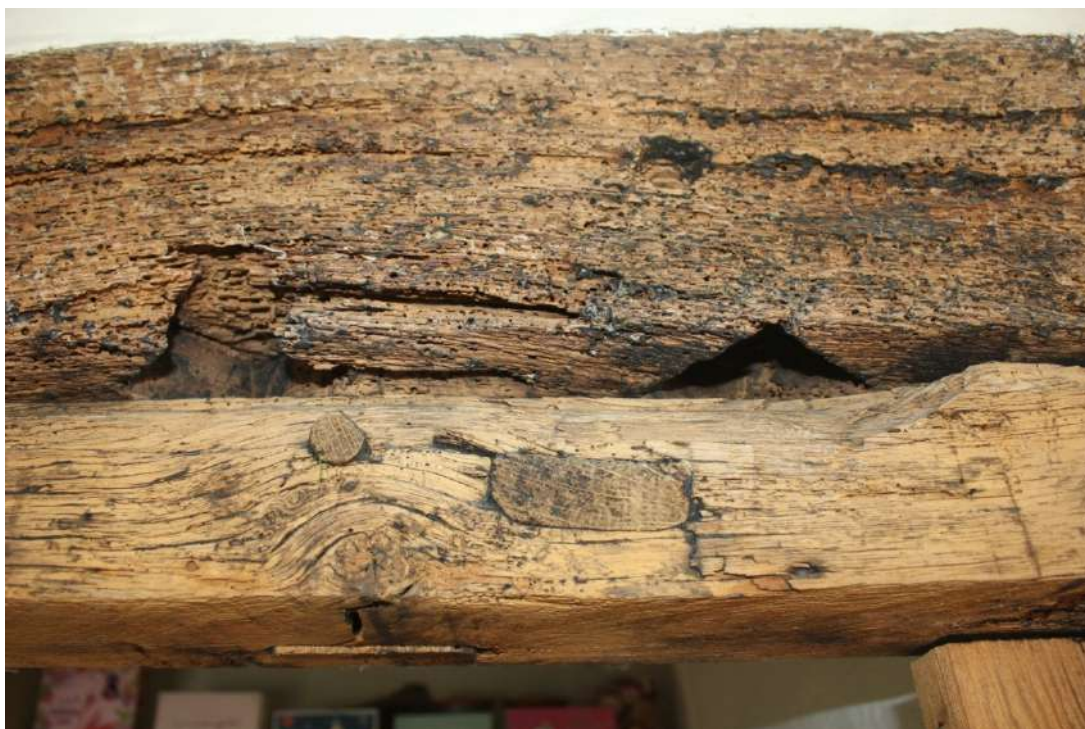
**Plate 10. Empty diamond shaped mullions in the soffit of the side girt in the far south side of Bay 2.**

There were two opposing windows next to the cross passage doors (since removed) which is very un-conventional. The base of the side girt here reveals the diamond set empty window mullion mortices (Plate 10: 6cm square) with a rebate for a sliding shutter, although this is external which would normally be internal. There is what appears to be a shutter groove on the underside of the side girt above this window, but it a shutter here would be blocked by the jamb so it is more likely to be groove for staves for the wattle and daub. In addition, there is peg hole evidence a first floor window in Bay 2, above this window on the west side which was not matched opposite, as there are curved foot braces in this wall. The first floor window would have measured 1.01m wide x 78cm high. This was fixed to the north side of Post B.

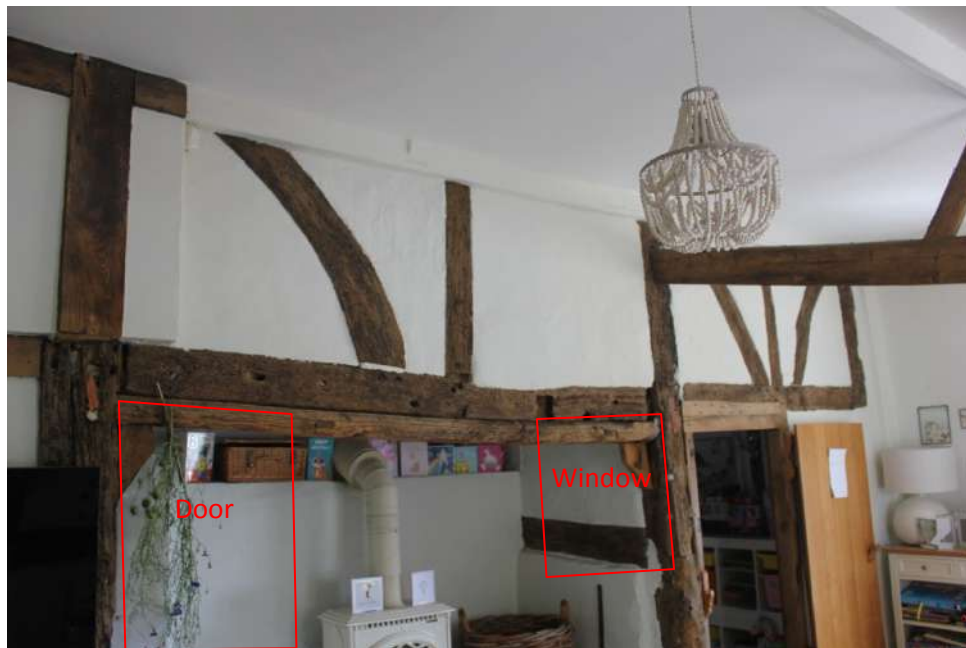
Plate 11. The west side of Bay 2 with removed features outlined in red.

Bay 2 had a ground floor cross passage with two opposing doorways positioned in the bay nearer the hall, rather than the furthest point from the hall which is not the norm. The west doorway is no longer present but the peg hole and mortice evidence for the jambs is still evident and it measured 1.04m wide which was positioned against the southern side of Post C (Plate 11). The existing door in the main entrance to the east is in the original location (Plate 12).

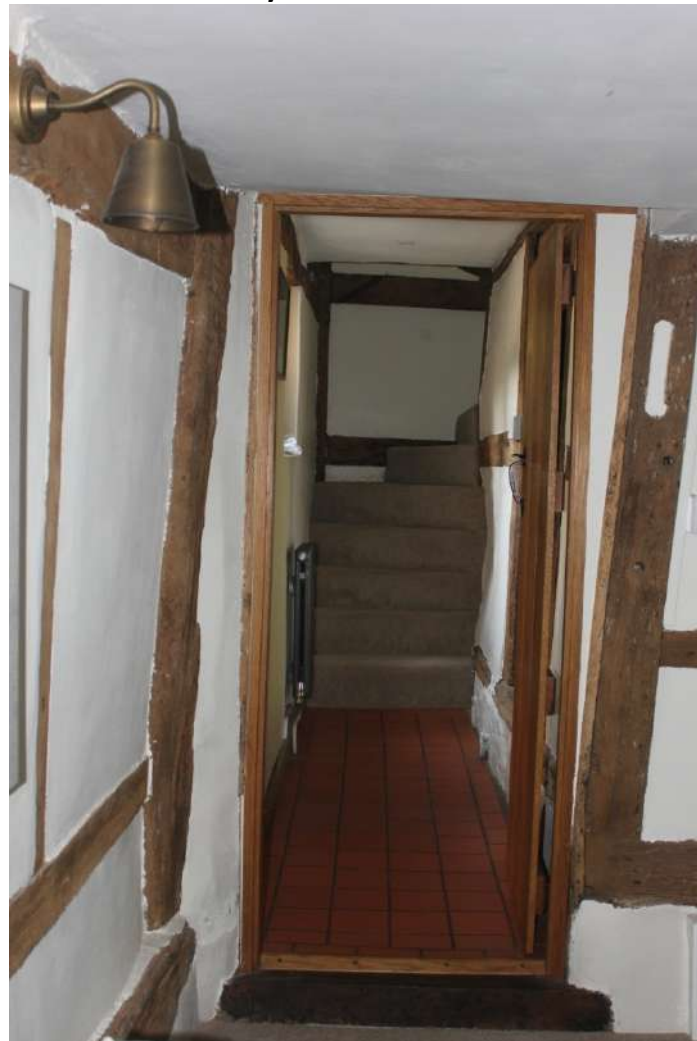
Plate 12. Modern doorway in likely original door from the hall ranged into the replaced Period A1 range.

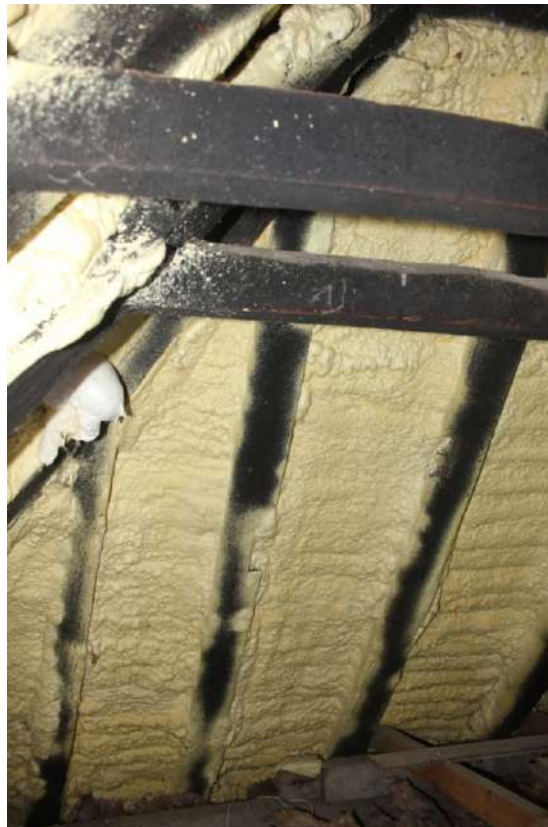
**Plate 14. Heavily sooted roof space in Bay 1.**

There was no chimney during this period, but an open kitchen hearth at ground floor level within the east side of Bay 1, with a hall hearth in Bay 3. The roof above Bay 1 is heavily soot stained (Plate 14), more so than the soot staining within the hall bay, although the roof has been entirely replaced here. There are some surviving clues, with some of the rafters next to Truss C heavily stained underneath the later applied daub. However, it is also possible that some of the soot staining belongs to another building, as the roof timbers are re-used, as discussed further below.

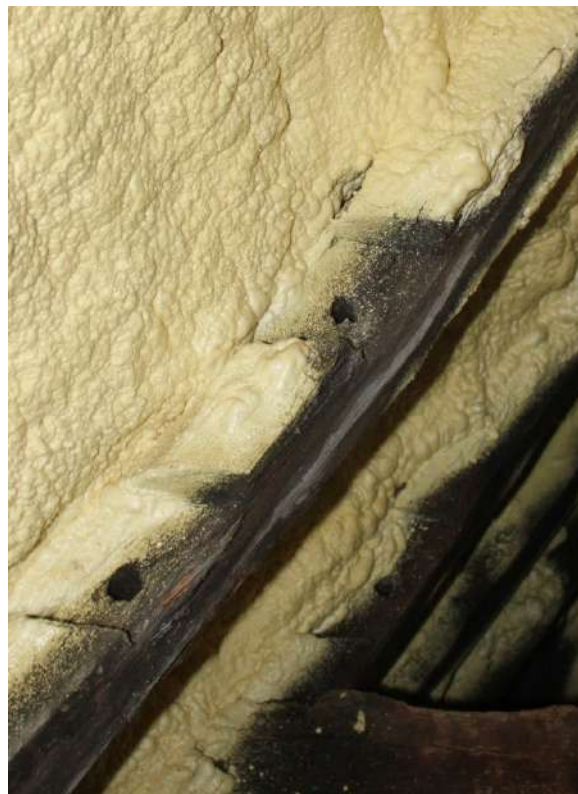
**Plate 15. Two phases of missing collars in the Bay 1 roof, both equally sooted.**

Re-used timbers do impede the interpretation, although the higher, empty mortices for the original collars of the donor building were also heavily soot stained (Plate 15), which is proof that this bay had an open hearth.

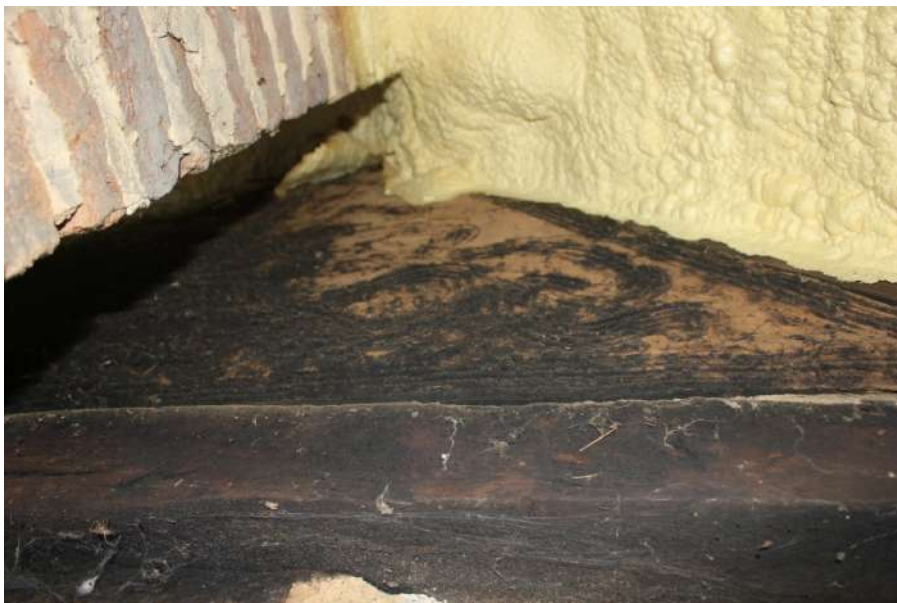
**Plate 16. Later sooted infill panel above the collar in the open Truss C.**

The Period A2 roof consists of common paired collars and rafters, also referred to as a *sans purlin* roof. However, it has been re-built, although some of the rafters are re-used from elsewhere as discussed above, with an earlier set of collar mortices present and daubed panels which are also soot stained (Plate 16). It appears that the re-used rafters came from a donor building and are *in-situ* for this frame, due to the heavy levels of sooting so a lot of the roof is original.

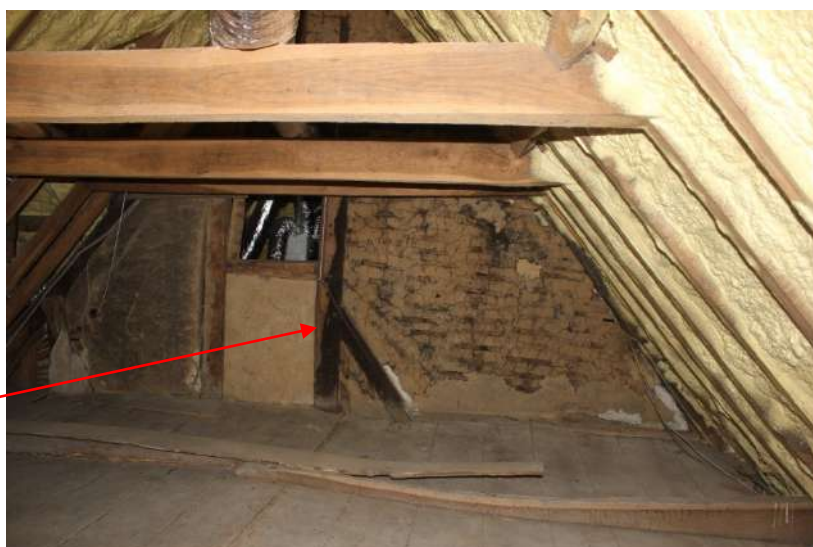
Soot stained  
crown post and  
cut end of collar  
purlin

**Plate 17. Period D roof replacement in Bay 3 only, which is not soot stained.**

The roof structure was replaced during two separate phases; firstly during Period B when the east-west range was replaced and secondly during Period D, but only in Bay 3 only for reasons unknown. The over-sailing roof was constructed when the Period B east-west range replaced the earlier range. This must have also contained a hall as the re-used collar purlin and crown post are soot stained on the north side of the partition here (Plate 17).

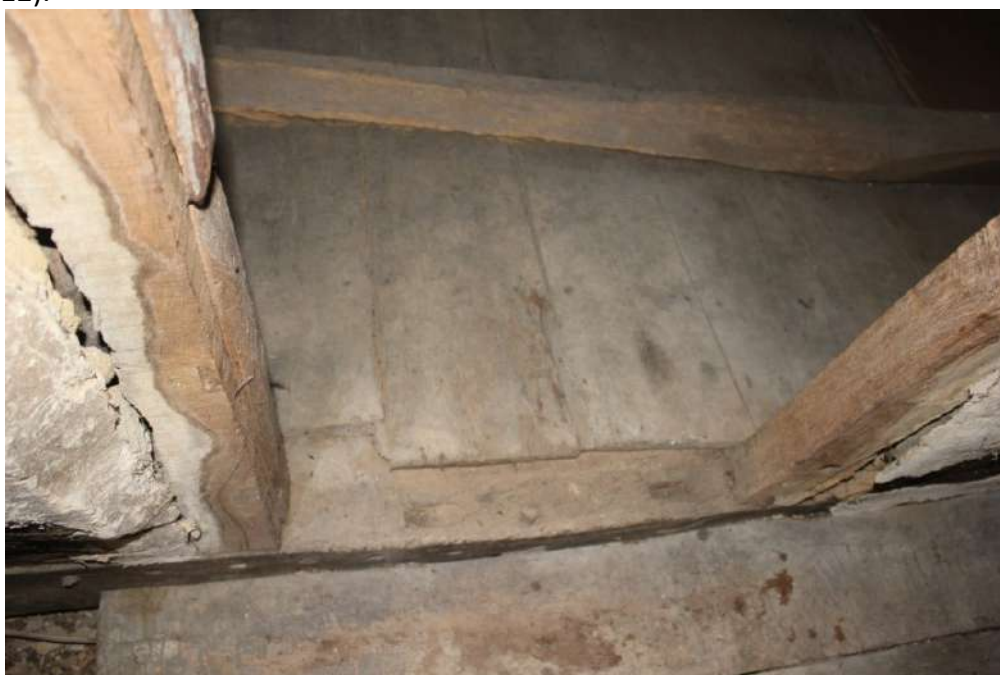
**Plate 18. The tiebeam in Truss C with lack of soot staining in the middle, which is heavily stained towards the outer edges of the beam.**

Another unusual feature noticed was the presence of a line of small holes, drilled at close interval into the middle of the tiebeam at Truss C (Plate 18). These holes form a line, which curves slightly to the east and the holes extend all the way through the beam. They have been cut with a chisel on the south side, so this face of the holes is square to the south (Plate 19), but deeper into the timber the hole consists of a round, drilled profile, 15mm in diameter. Whatever was pegged against the tiebeam from the north side in this location prevented soot staining to the top and both sides of the tiebeam which is *very* clean in the middle but soot stained to the sides (Fig. 12).

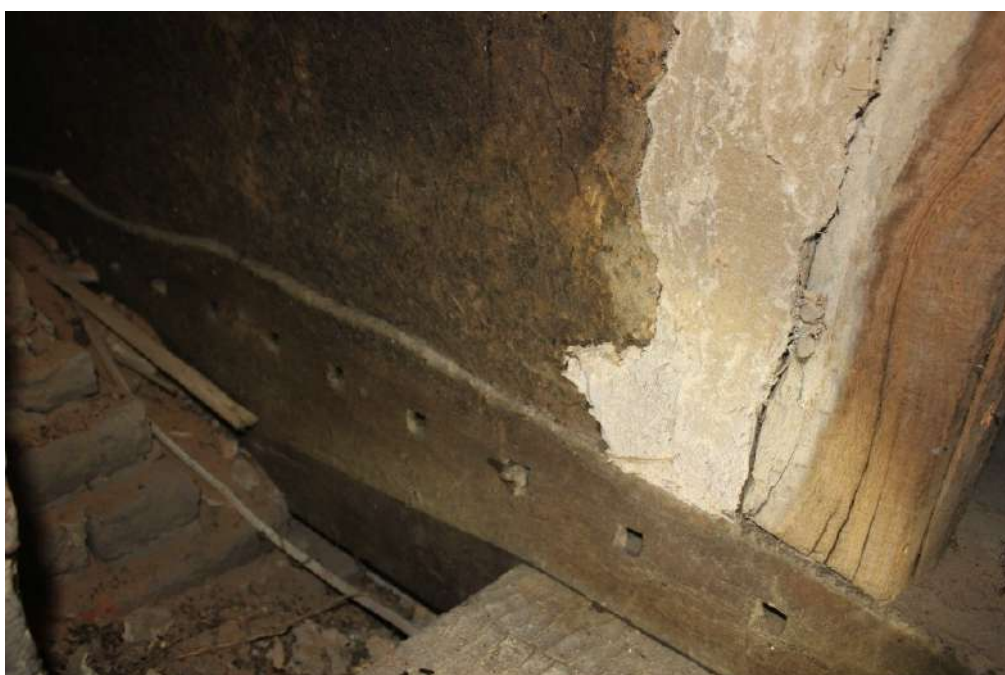
**Plate 19. Square holes to the south side of the tiebeam.**

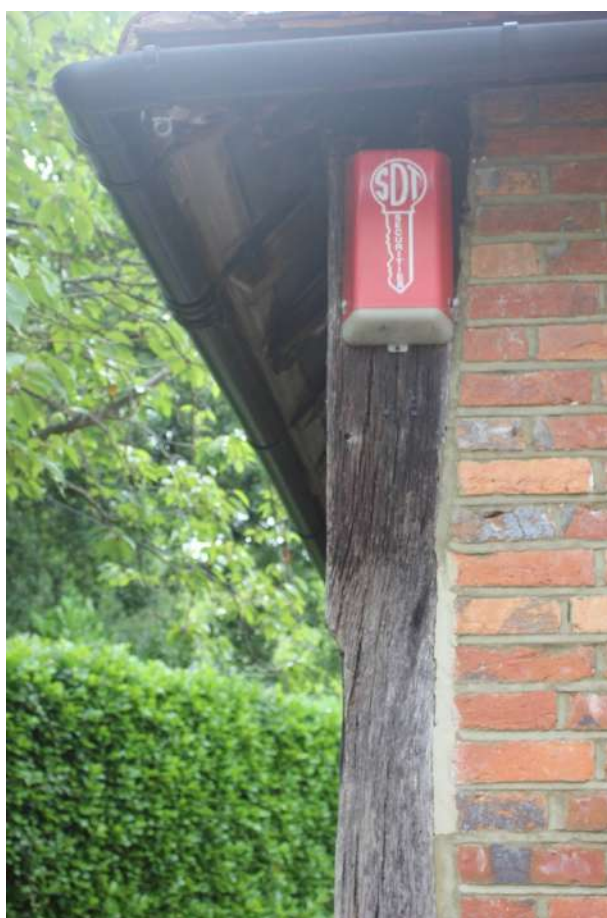
**Plate 20. Un-conventional re-use of a post with out-turned jowl.**

This structure is also unconventional, with two bays (Trusses E-G) built at right angles to the existing Period A2 hall. However, although *some* of the posts are placed at right angles to the earlier hall (one even has the jowl turned out externally See Plate 20), the whole structure is aligned to the existing hall, with the walls to the sides almost flush with the walls although the wallplates line up perfectly between the two frames.

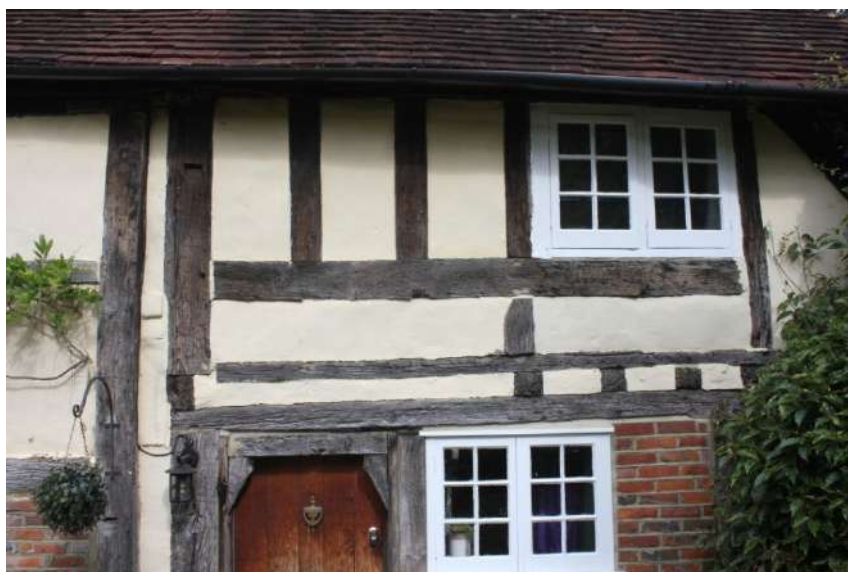
**Plate 21. The east side of the Period B cross wing with later timbers nailed into place.**

The wall design for this frame is also of large panel construction. As has already been discussed, there have been some re-used timbers utilized in this structure which confuses the picture somewhat. This includes the use of posts and rails where braces once existed, so the true picture is difficult to interpret and later insertions have also confused the story further (Plate 21).

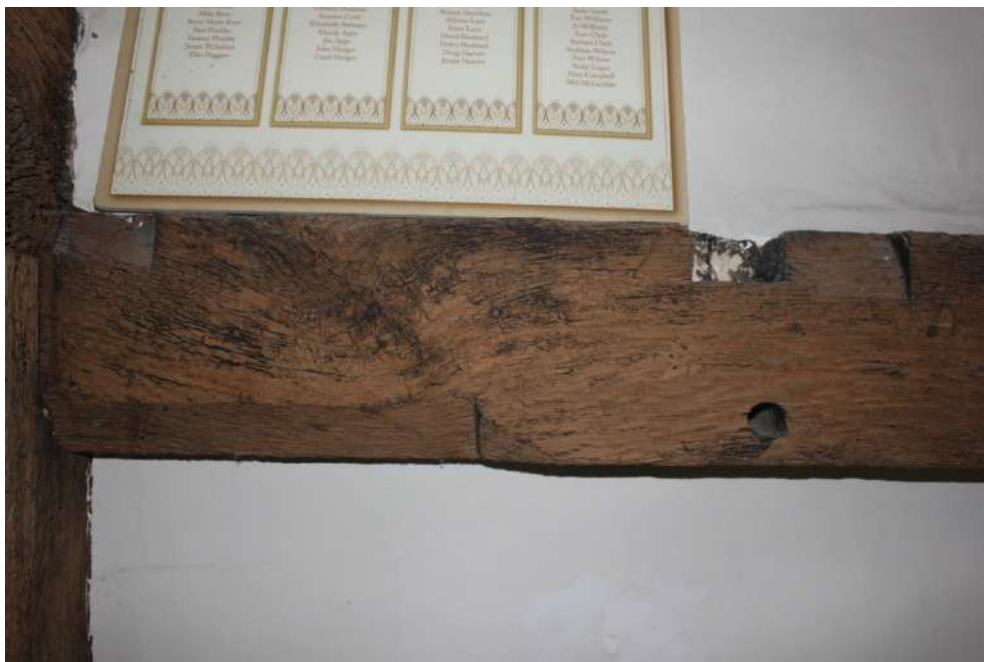
**Plate 21. Chamfered southern wall plate of the Period B cross wing with empty birds mouth rafter scotch.**

The wall plates have chamfers internally that respect the *original* vertical studs within the wall which is evidence they have come from a different building as they are effectively a 'full set' but re-used in this structure. Rafter scotches for missing rafters were seen in some timbers where a roof terminal didn't exist (Plate 21), so these represent definite re-use.

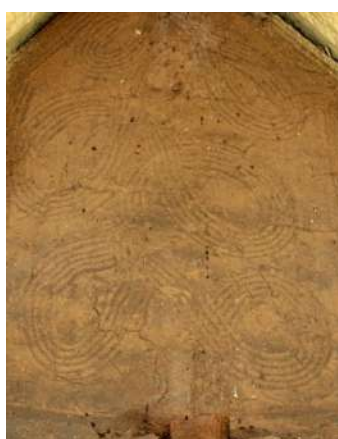
**Plate 22. Binocular type pattern in the infilled open Truss C.**

It is very likely they came from the earlier Period A1 range but this can only ever be conjecture but it is a reasonable suggestion to make. The comb decoration in the surviving daub panels has two slightly different forms with 'binocular' type patterns as well as serpents being formed (Plate 22).

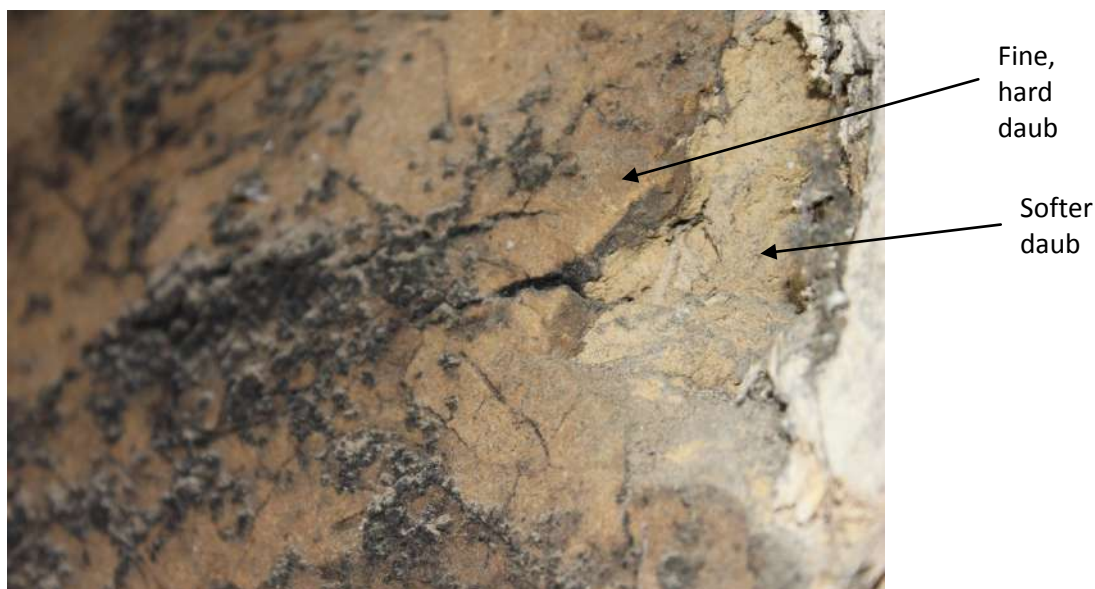
**Plate 23. Two distinct layers of daub seen in section with the harder form on the face.**

The daub is of interest as this is not conventional either; instead of being a standard clay based material, this is extremely consolidated and resembling modern sandy/cementitious mortar applied over a more conventional, softer daub (Plate 23). A very small piece was retrieved to test the material, which resisted being

submerged in water for 48 hours without losing its integrity. Submerging in vinegar did nothing to breakdown its structure so a cross section was examined microscopically. This contained a very high percentage, <75% of small, rounded quartz grains plus a fine consolidated buff coloured silt. It is not clear where the silt material derives from but the fact that the daub did not dissolve in water is of interest. It is likely due to the fact that this panel was subjected to higher temperatures than elsewhere in the building, which effectively has hardened the surface.

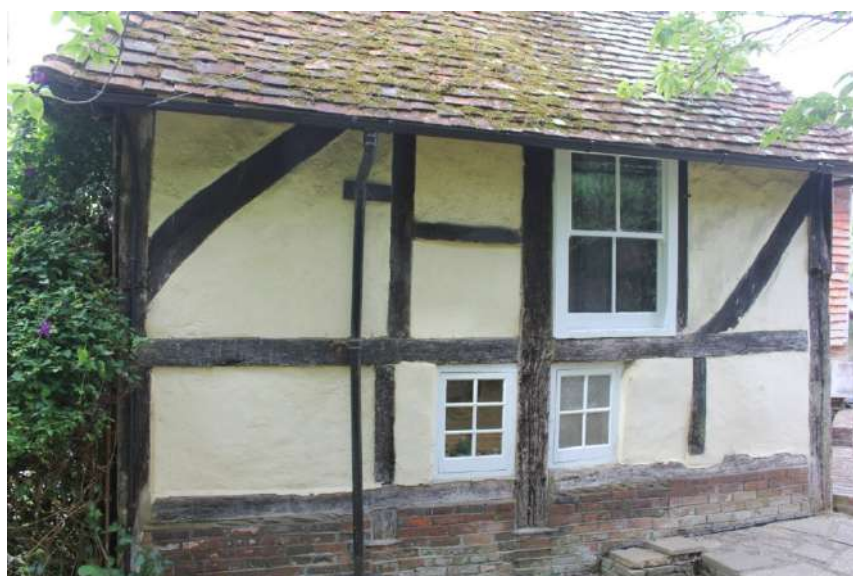
**Plate 24. The north side of the cross range with central bay post with mis-matched braces.**

The bracing is also very different to the earlier range, with a wide head brace used in the north-east corner which has a shallow curvature, rather than the very curved braces of the Period A2 range. It is reminiscent of an earlier brace, due to its wider scantling (Plate 24).

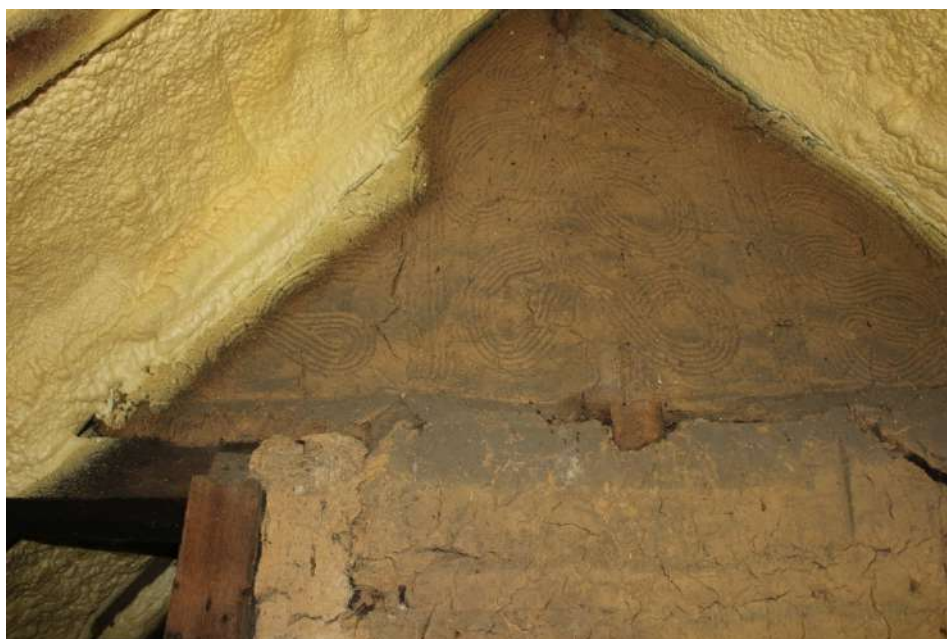
**Plate 25. Partitioning of the open Truss C (clean stud to the left is from a later period)**

During this period, after the roof was re-constructed, it is evident that the top of the open Truss C was partitioned in the roof space. It is not clear why this was necessary and the partition would not have extended below the roof as there was no mid-tiebeam present during this period.

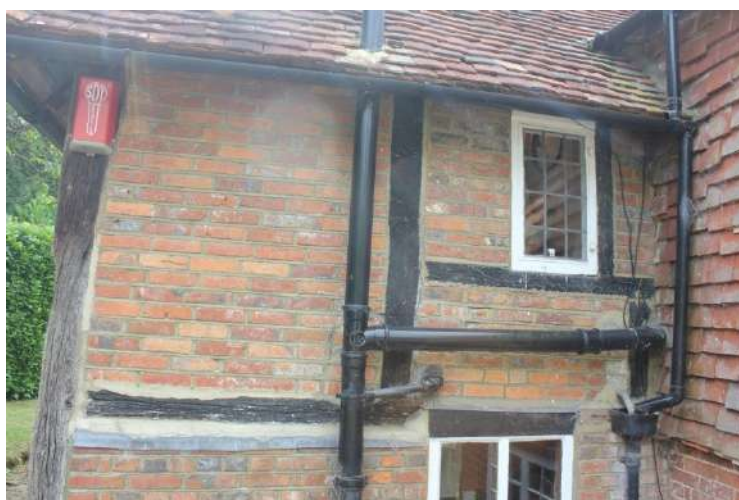
**Plate 26. Presence of a pegged stud and window cill in the west side wall of the cross range.**

No surviving windows from this period could be confidently located apart from a first floor window in the east side which has a modern window within (Plate 26).

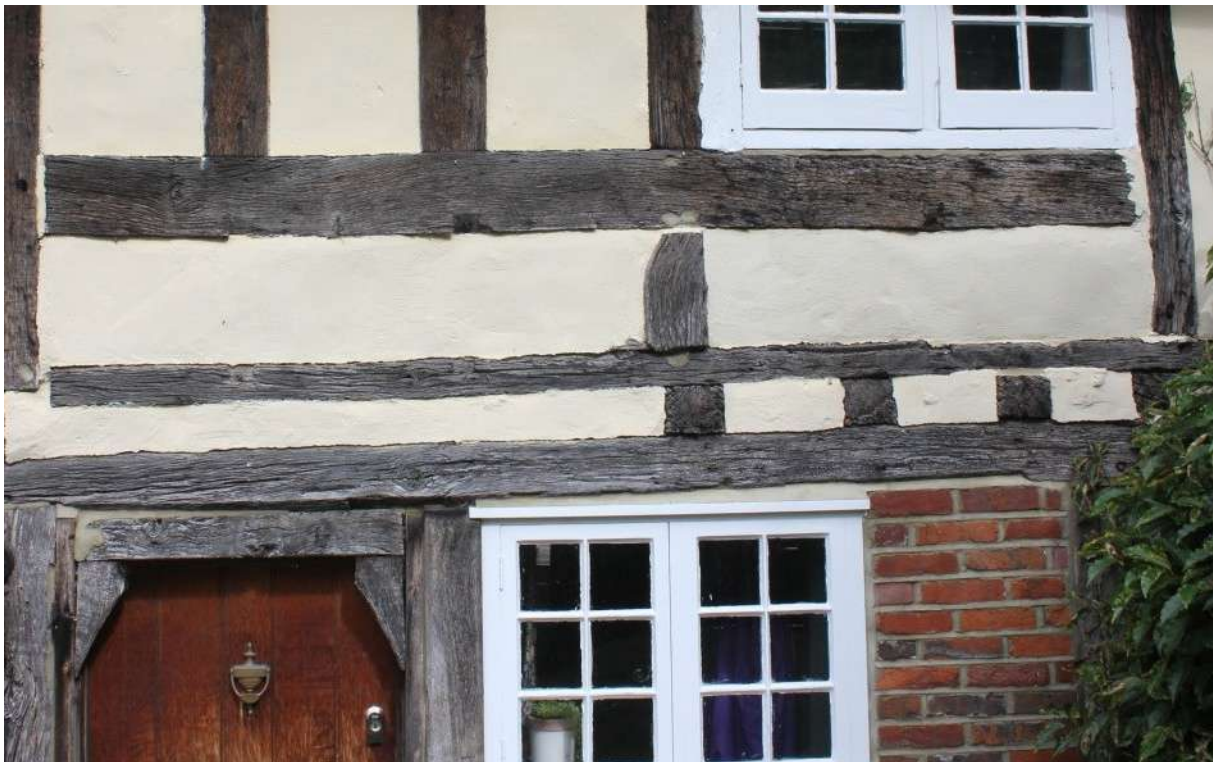
**Plate 27. Exposed floor joists over half the width of the range which cannot be interpreted.**

The east wall has a series of inserted timbers added at a later date, and the presence of a set of joist ends which are clearly present in this wall is confusing (Plate 27). It suggests a continuation of the floor in this location but they are only present in half of the wall. Joist ends are only ever present in external walls if they form a jetty, which this is not, or if they continued across into a further bay so this forms another un-answerable question.

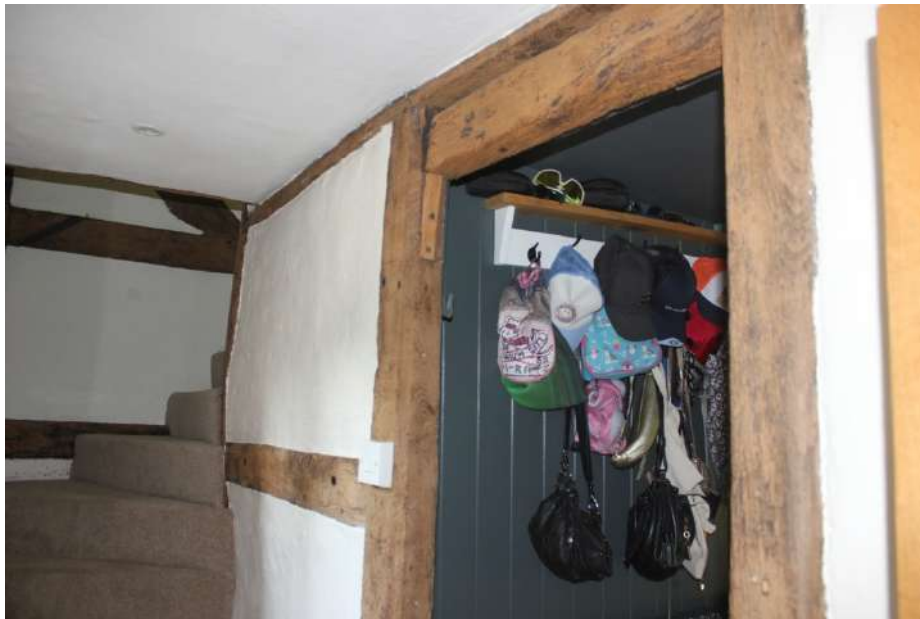
**Plate 28. Period B stairs in the north-west corner.**

There is currently a set of quarter-wind stairs positioned against the north-west corner of the cross range (Plates 28 and 29). There is no reason to doubt these are in the correct location, giving access from the earlier Period A1/2 door in the west side of Truss C, however it is unlikely the original stairs would have quarter turn and it is more likely there would have been a straight run. The steps are covered with carpet so cannot be inspected further but there are no cut joists in the side girt or elsewhere which would suggest the floor has been cut to receive the stairs.

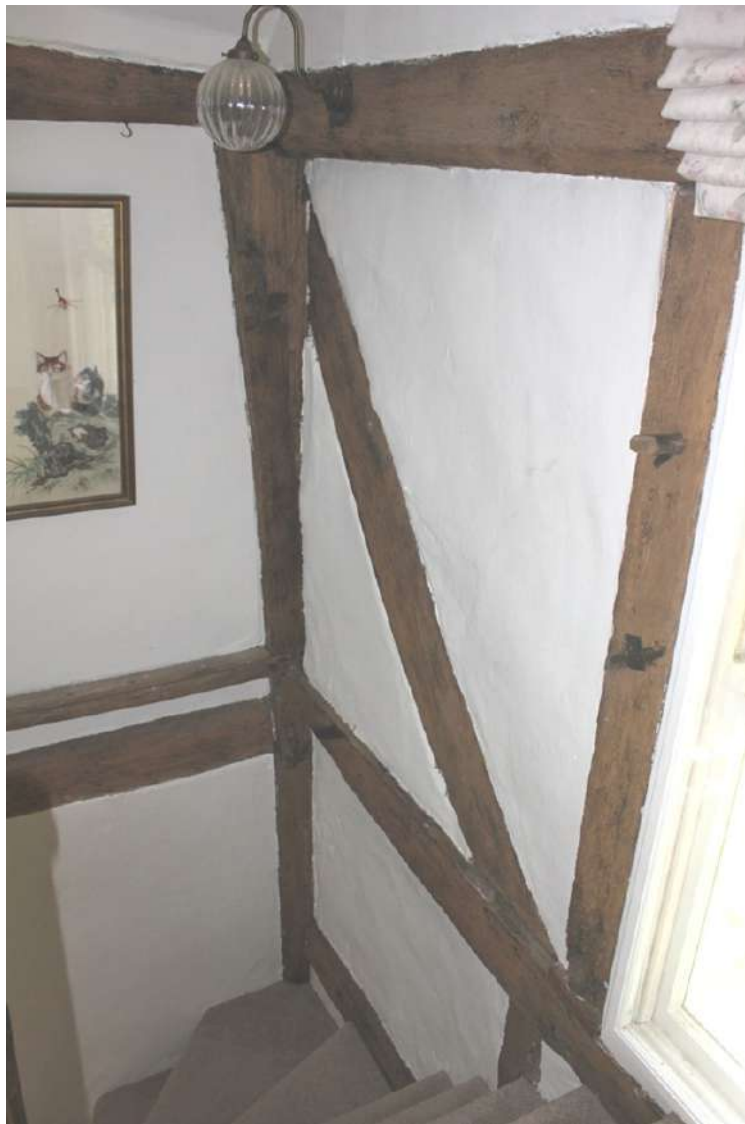
**Plate 29. Looking down the stairs in the north-west corner.**

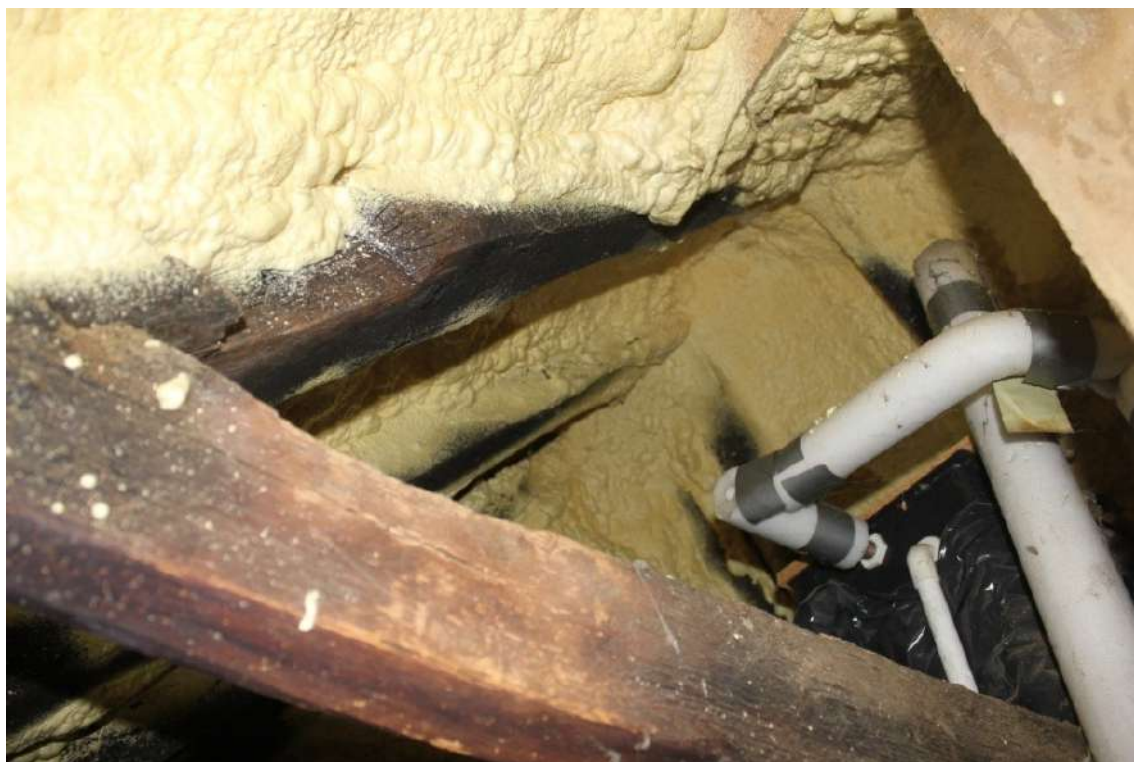
**Plate 30. Later collars attached to sooted rafters in Bay 1.**

The roof during this period was built as an over-sailing structure which continues across both frames, so belongs to this period as previously discussed. However, besides Bay 3 being replaced at a much later date, the construction methods also use different conventions which do not fit as a consistent roof form. The method of construction in Bays 1 and 2 follows a common paired rafter design, with new collars attached to re-used rafters as previously discussed. The higher, empty collar mortices suggest the roof they came from was much wider but these are also considerably soot stained, from Period A2 use. The collars have also since been replaced and are not soot stained so should be ignored for this period (Plate 30).
