AN ARCHAEOLOGICAL INTERPRETIVE STUDY FOR  
BARROW HILL FARMHOUSE, BARROW HILL, HENFIELD,  
WEST SUSSEX, BN5 9DN.

Report number: ASL 358-25

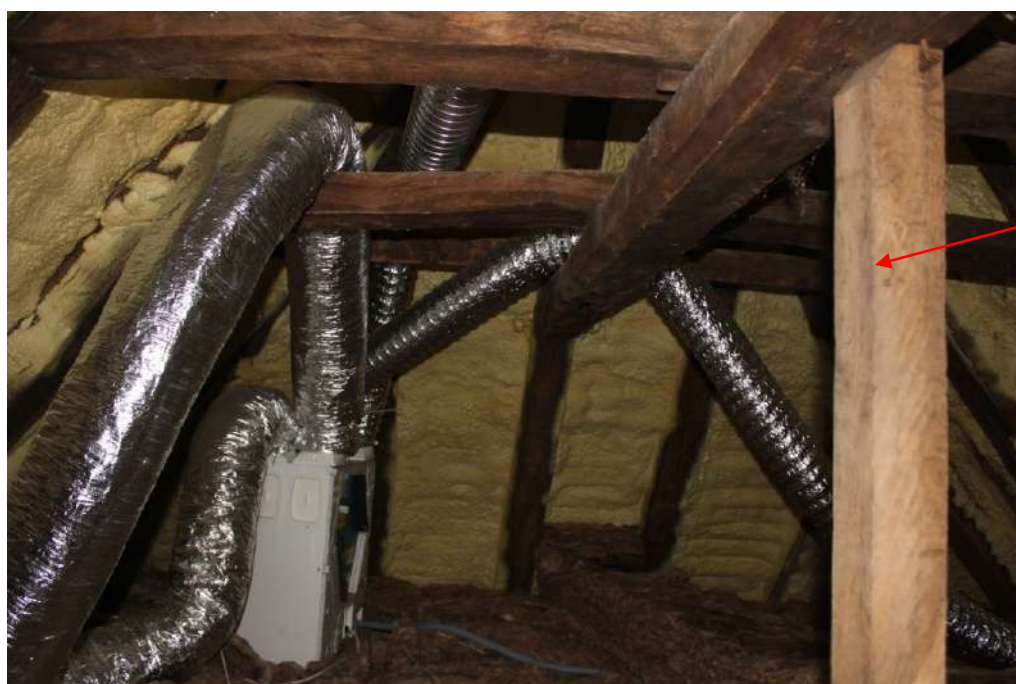
Later  
support  
post

**Plate 31. Soot stained collar purlin and collars in the cross range.**

The method of construction in Bays 4 and 5 are that of a crown post design although this is also re-used and not conventional. The collar purlin is positioned transversely to the frame, rather than the normal axial alignment to the cross range. Being positioned to run axially through the over-sailing roof is further proof that the whole roof was re-built to extend over the replacement cross range during this period. There is only one plain crown post which is soot stained and is very basic and only has one empty mortice for a foot brace at the far north end. The collar purlin, collars and rafters (at 140cm wide which matches those in Bays 1 and 2) clearly belong as a set taken from elsewhere (Plate 31) and are all soot stained and with the empty higher collar mortice as seen at the south end.

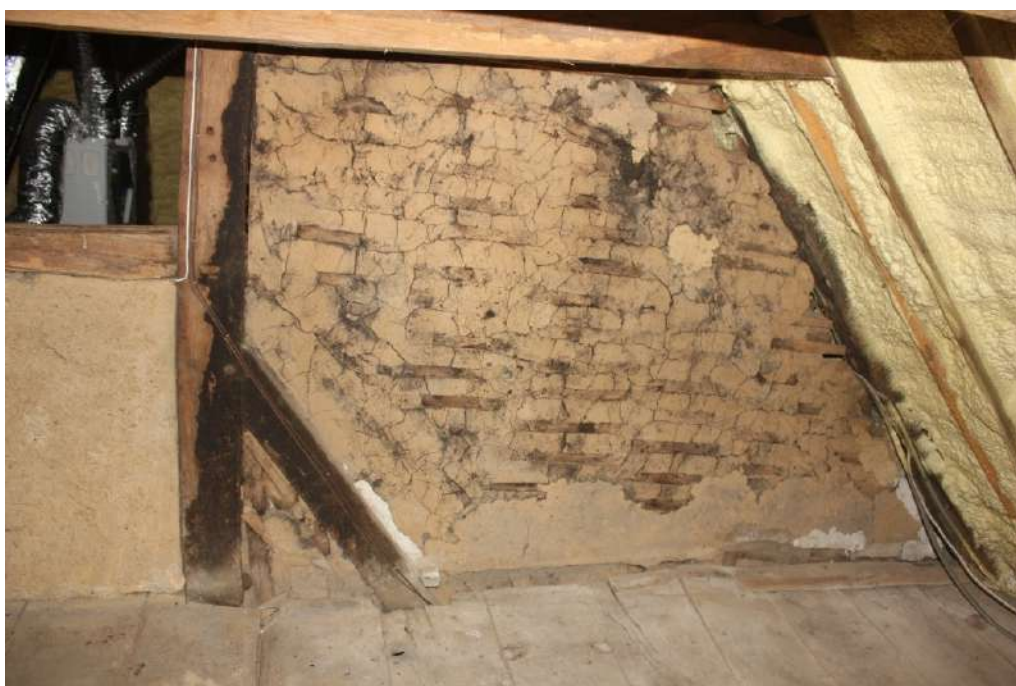
**Plate 32. South side of the crown post which is soot stained but with later daub applied to the panel.**

It is important to note that when this cross range was built, the truncated end of the collar purlin which was cut to fit the present roof, also became soot stained (Plate 32) as it was still subjected to smoke from the Period A2 hall. This is further evidence that the open hearth of the hall range was still in use, although it is not clear if there was a separate hearth in the Period B range. The lack of a consistent pattern of soot staining suggests the new range was never heated, although there is some staining to the north side of the panelled daub which separates the two ranges in the roof (Plate 33) which could be explained by way of seepage.

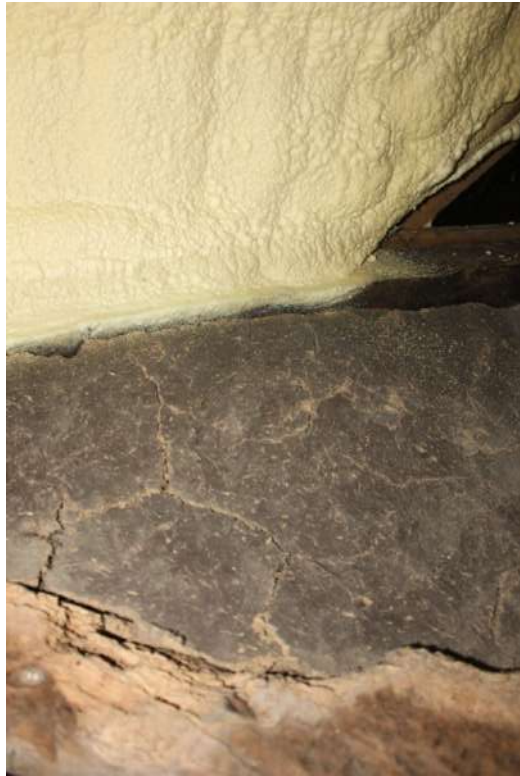
**Plate 33. Soot staining in the north side of the panel which separates the two ranges.**

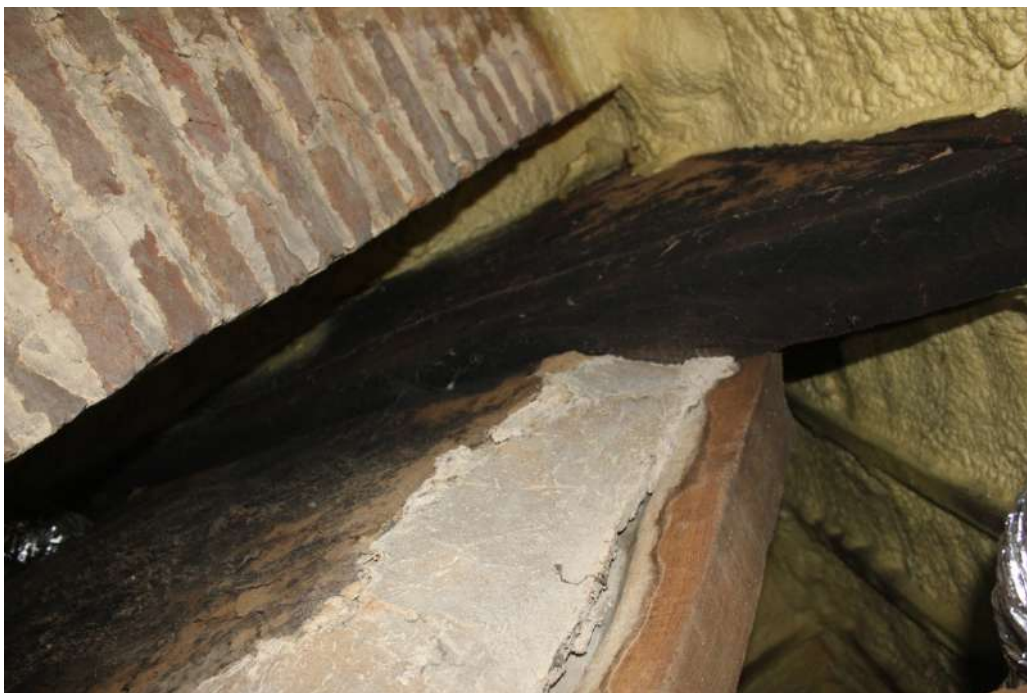
**Plate 34.** Inserted doorway in the roof space in Truss C and daub repairs.

No new walls were built during this period except for a partition wall in the former open Truss C. This partition extended up into the roof although this had previously been partitioned. Repairs were made to the existing daubed panels which are entirely soot free, applied after the inserted door jambs were positioned (Plate 34). The repairs to the panels were not comb decorated.

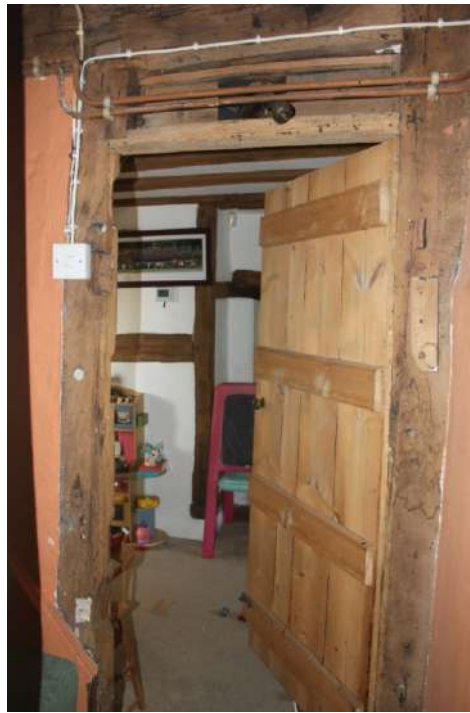
**Plate 35. Period C doorway created in the Period A2 Truss A at ground floor level.**

A new doorway leading into the outshot was inserted to the west side of the interval post in Truss A at ground floor level. The rebate on the south side of the post and the pintles are still in place, but have been superseded by a later doorway and door, probably during Period D (Plate 35).

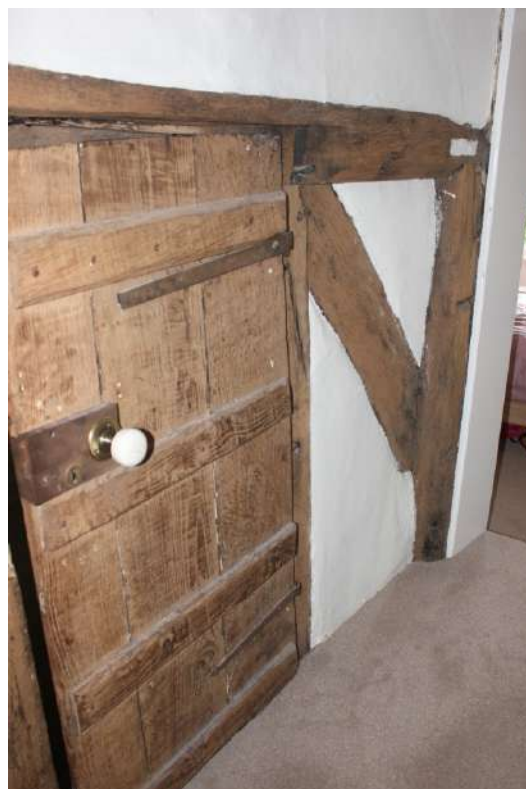
**Plate 36. Low door in the western side of Truss D.**

A possible Period C first floor Door has been cut to size and re-used in Truss D where the two frames meet on the west side. This is a very low door made from pit sawn timber but with two different iron strap hinges set on pintles (Plate 36). There is a possibility it has come from the roof space, as the lower part of the door appears to have been cut down in size creating a shorter door with the lower baton directly against the floor.

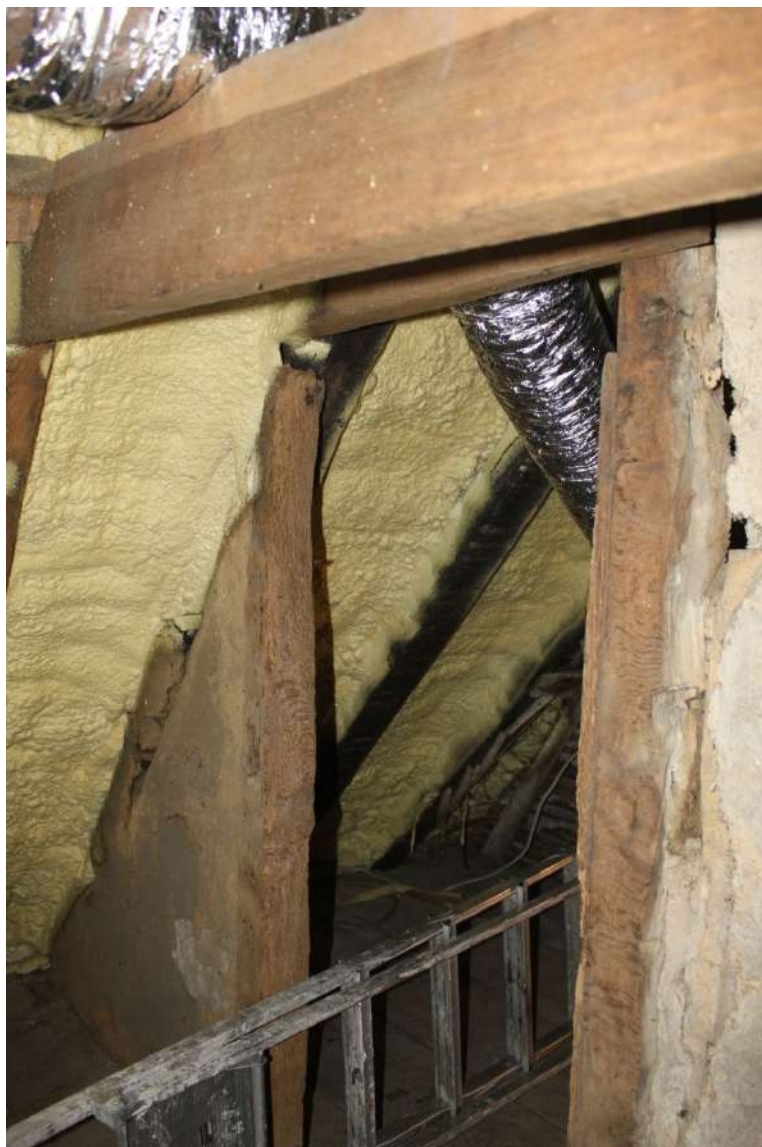
**Plate 37. North side of the Period C doorway created in Truss C to the east.**

The doorway in Truss C in the roof space has also been discussed above, and although there are surviving pintles in the jambs, the door has gone. This doorway must have been punched through into the Period B daubed panel (Plate 37).

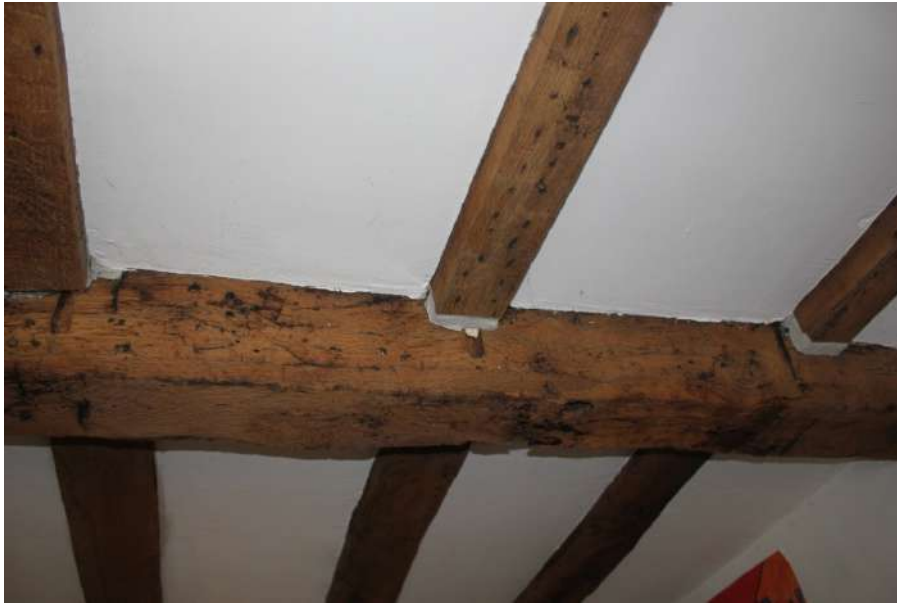
**Plate 38. Inserted girding beam and joists in Bay 1.**

The original Period A2 floor in Bay 1 was removed during this period and the room floored with transverse joists at right angles morticed into a central, inserted axial girder with haunched tenon joints (Plate 38). This was presumably done to create a fully floored room as this was previously only a half floored garret. The girding beam was rather crudely cut into the south wall and laid over the side girt next to an intermediate post in this truss (Plate 39).

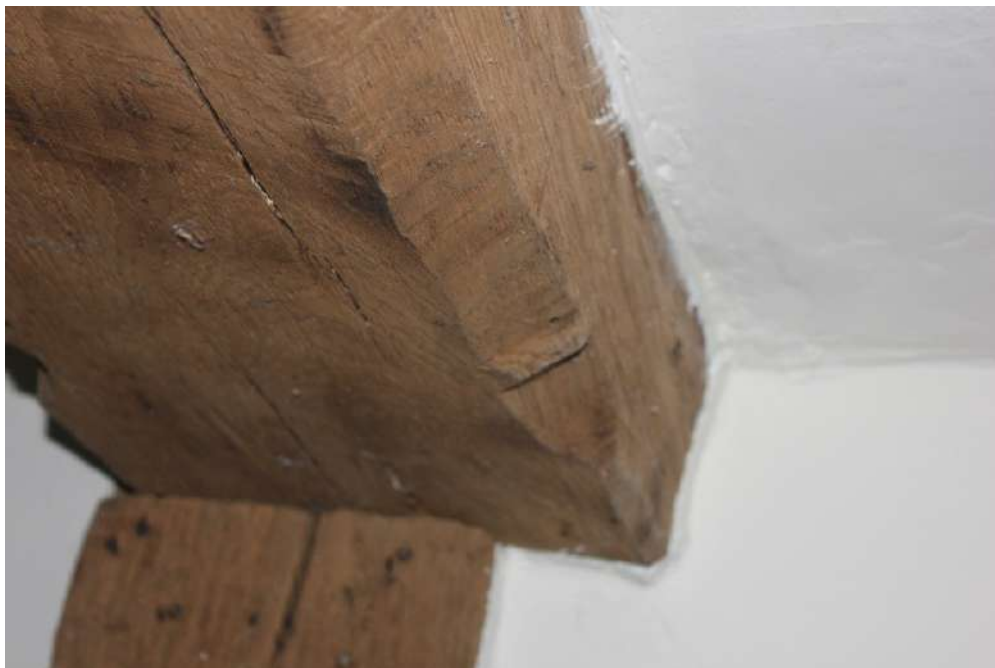
**Plate 40. Bar and curved stop chamfer decoration on the central girder in Bay 3.**

The timbers of the inserted floor girders in Bay 3 have decorative chamfers that are not seen elsewhere in the building, with bar and curved run out stops (Plate 40). However, the ground floor girding beam in Bay 3 has this detail at the north end only, whereas the south end abruptly stops at the chimney bressumer, with no run out. This also suggests re-use. Elsewhere, the chamfer stops on the joists for this period are lambs tongue run out chamfers.

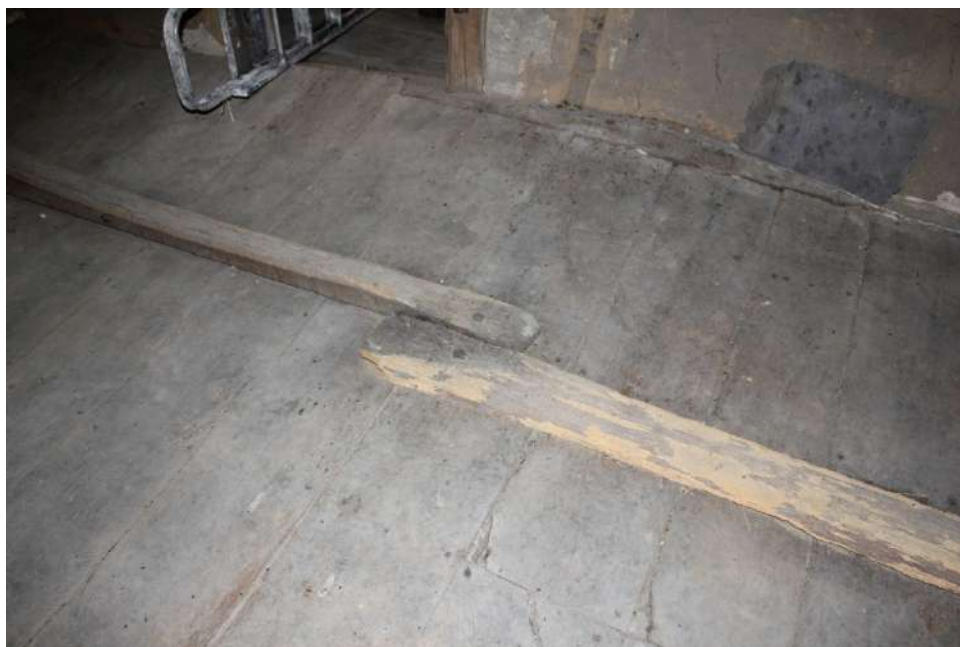
The attic room within Bay 3 was also floored over during this period. The boards survive intact and are hardwood boards up to 30cm wide, with rebates. Due to the movement of the building over time, the boards have been retained in place by some later, overly large beams which have been bolted on top. This was probably undertaken during Period D (Plate 41).

**Plate 41. Period C floorboards *in-situ* in the roof space of Bay 3.**

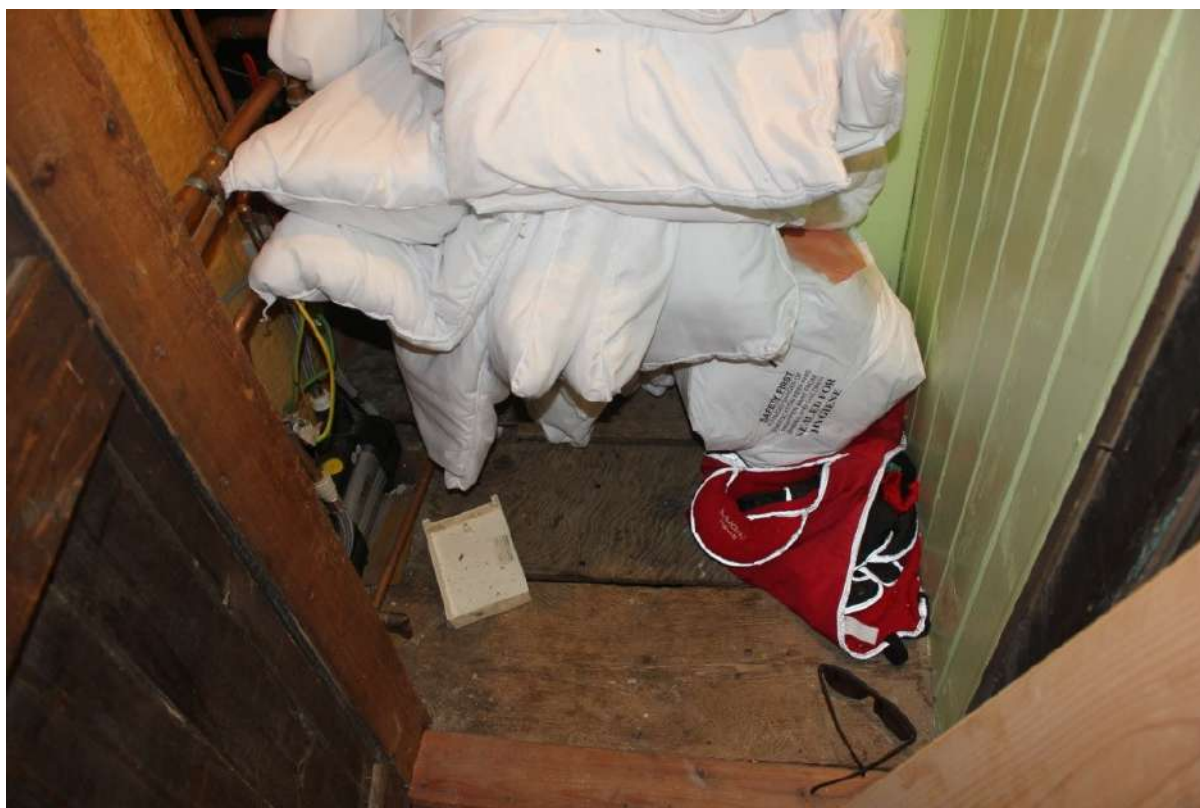
Further floorboards original to this period can be seen inside a modern cupboard at first floor level, to the west side of the fireplace. These boards measure up to 24cm wide and could be an indicator that further *in-situ* survivors may be present at this floor level underneath the carpets (Plate 42).

**Plate 42. Glimpse of Period C floorboards in the cupboard to the west side in Bay 2.**

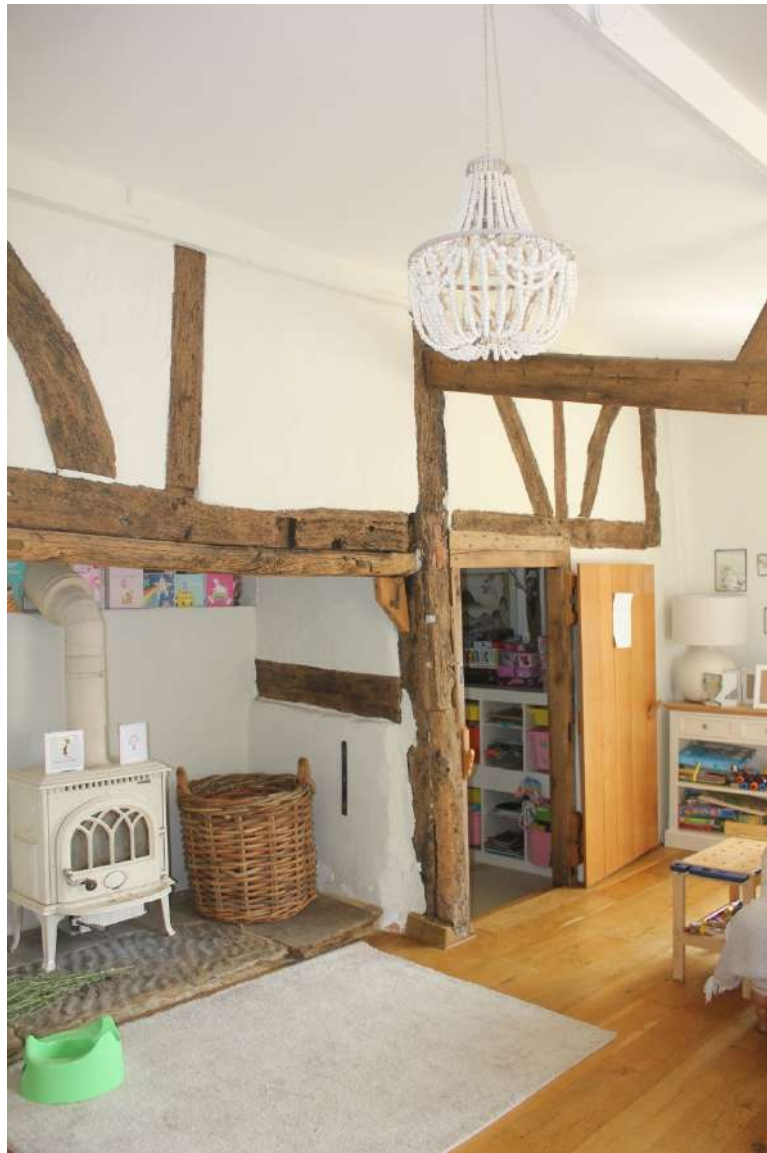
When the chimney stack was inserted during this period, a new set of stairs were created to the west of the stack, within what is now a recently opened up fireplace with a log burner (Plate 43). The stairs would have been accessed from Bay 3, via a doorway west of the fireplace. This would have necessitated the blocking up of the original cross passage doorway to the west side. They ascended axially with a half landing creating a dog leg return to the first floor space next to the fireplace. The space for access on the first floor would have been tight; the two large braces for the open truss were replaced by smaller braces at this point which is discussed in more detail below. There would still have been a need to duck underneath the new brace though or to navigate to the side, as the first floor fireplace was a later insertion. The two inserted joists for the landing have lamb's tongue chamfer stops and can be seen inside the false fireplace created within the aperture during modern times (Plate 44). The other joist next to these is plain and was inserted during Period D when the bread oven replaced the stairs.

**Plate 43. Location of the former stairs within the modern fireplace aperture.**

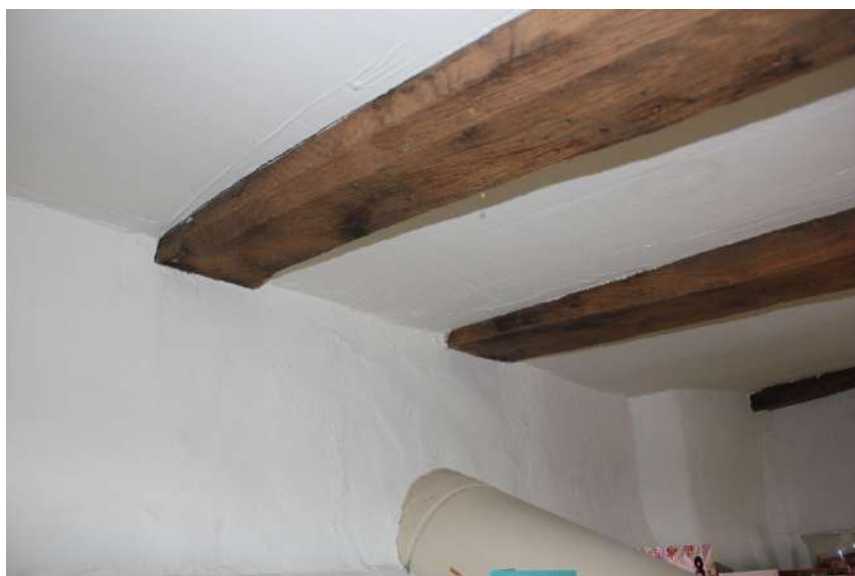
**Plate 44. Inserted joists for the stair landing inside the modern fireplace aperture.**

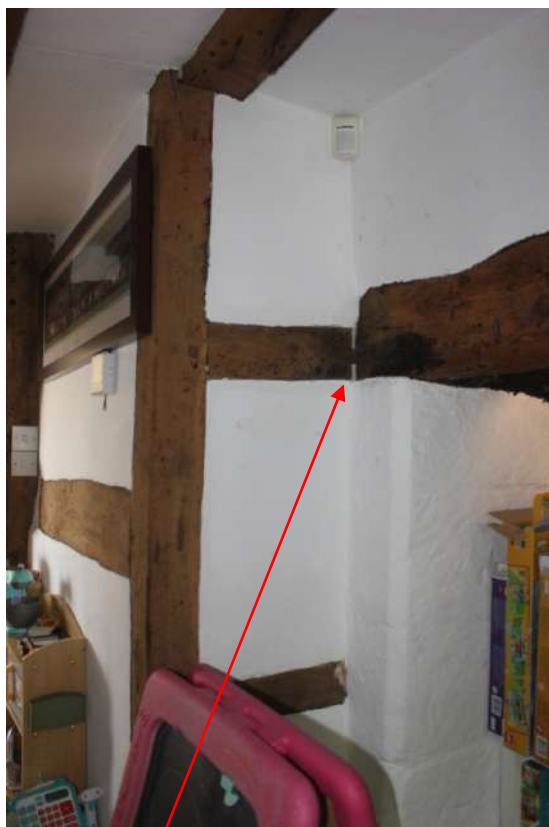
A narrow partition wall was built west of the fireplace in Bay 2, which projects south of the front of the hearth (Plate 45). It is clear that the timber-framed partition is morticed directly into the side of the fireplace, effectively filling the gap between the front of the hearth and Truss B, as the fireplace does not sit flush against the north side of Truss B.

**Plate 45. Partition wall morticed to the stack wall creating the side of the stairwell.**

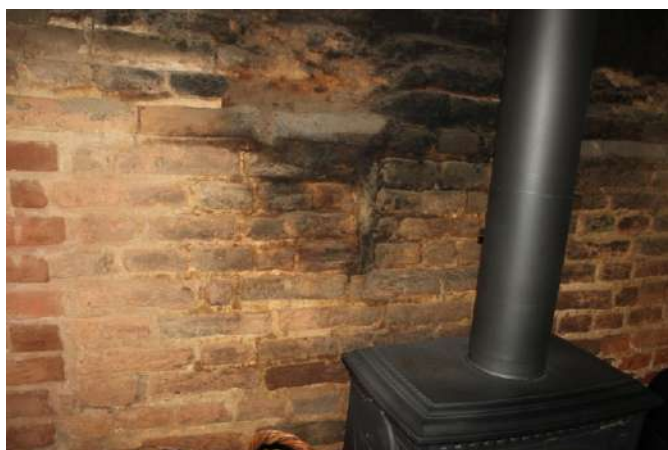
A back to back chimney stack was inserted into the ground floor cross passage during this period, creating a 'baffle entry' building. The bricks are thin and not well made or fired, with some erosion present even internally (Plate 46). An additional hearth was created at first floor level, later in this period, which faced into the chamber above the former open hall.

**Plate 46. Thin, Tudor bricks within the hearth serving the Bay 3 parlour.**

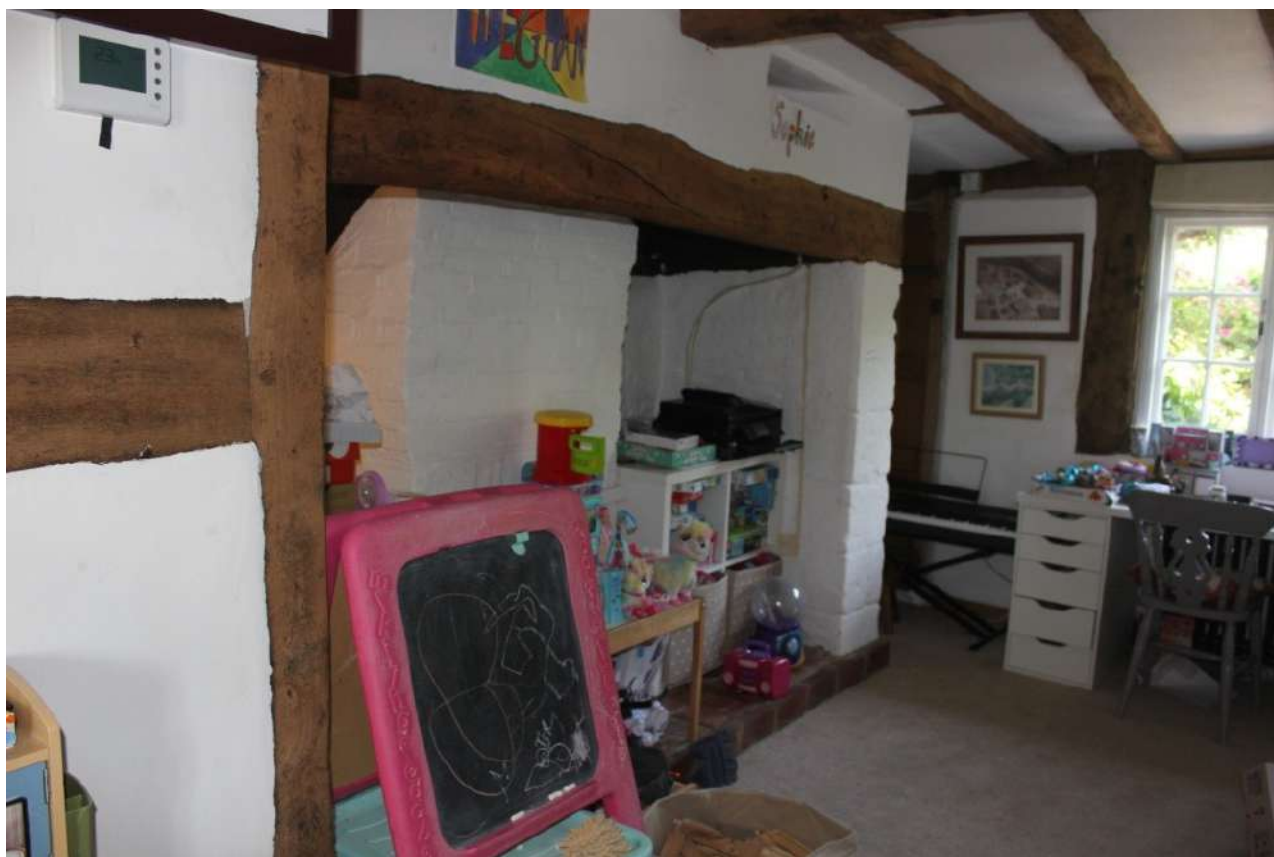
The fireplace to the south (Plate 47) which serves Bay 1 has lamb's tongue stops to the chamfer which is neatly applied to the timber, continuing down the side of the stone jambs. This hearth has a slightly higher bressumer, along with a hole for a spit-jack mechanism so is presumed to be the cooking hearth. The bressumer has taper burn marks, plus an inscribed 'M' presumed to be a protection mark, invoking the spirit of Mary. Of interest is a line of nails along the west side of the bressumer, which continues along the projecting stair wall. Something has been repeatedly nailed against the face of the timber over a period of time but it is not known what this feature represents.

**Plate 47. The hearth in Bay 2, facing into Bay 1.**

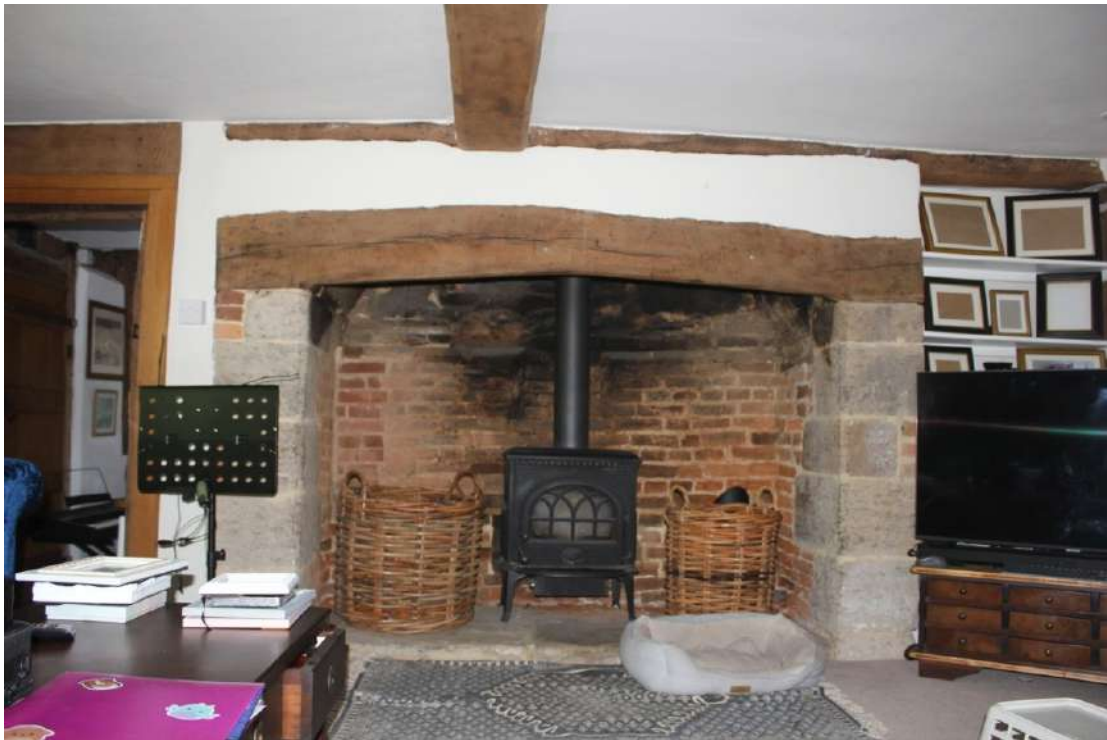
The fireplace to the north (Plate 48) which serves Bay 3 is similar in design but there are differences. There is a run out chamfer which does not extend to the stone jambs, which are built from Hythe beds sandstone formation (*pers.comm* Luke Barber), which is almost blue in colour with veins similar to marble (Plate 49) so likely to specifically be Petworth stone. There are three peg holes for a shelf and there is no evidence for either a fireback or a spit jack. There is one large wrought iron peg driven into the stone at the back of the hearth at an approximate chest height. It is not known what this is for, as it is too centrally positioned for a crane but could potentially be for smoking meats although it is rather low for this. There are taper burns on this bressumer as well.

**Plate 48. Fireplace serving Bay 3.**

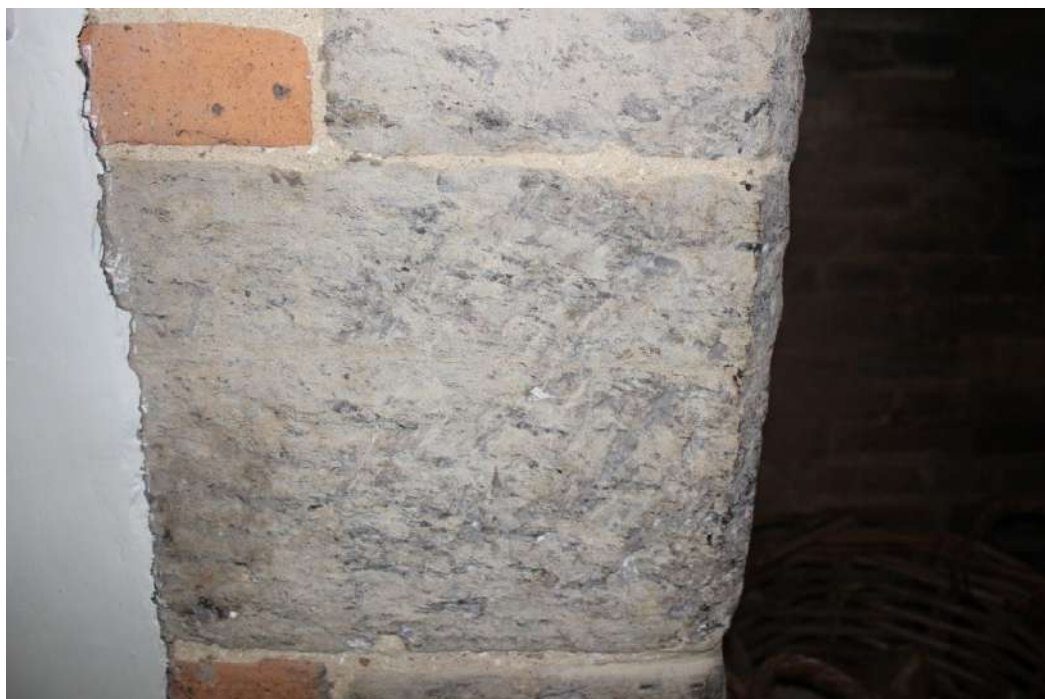
**Plate 49. Blue coloured stone jambs.**

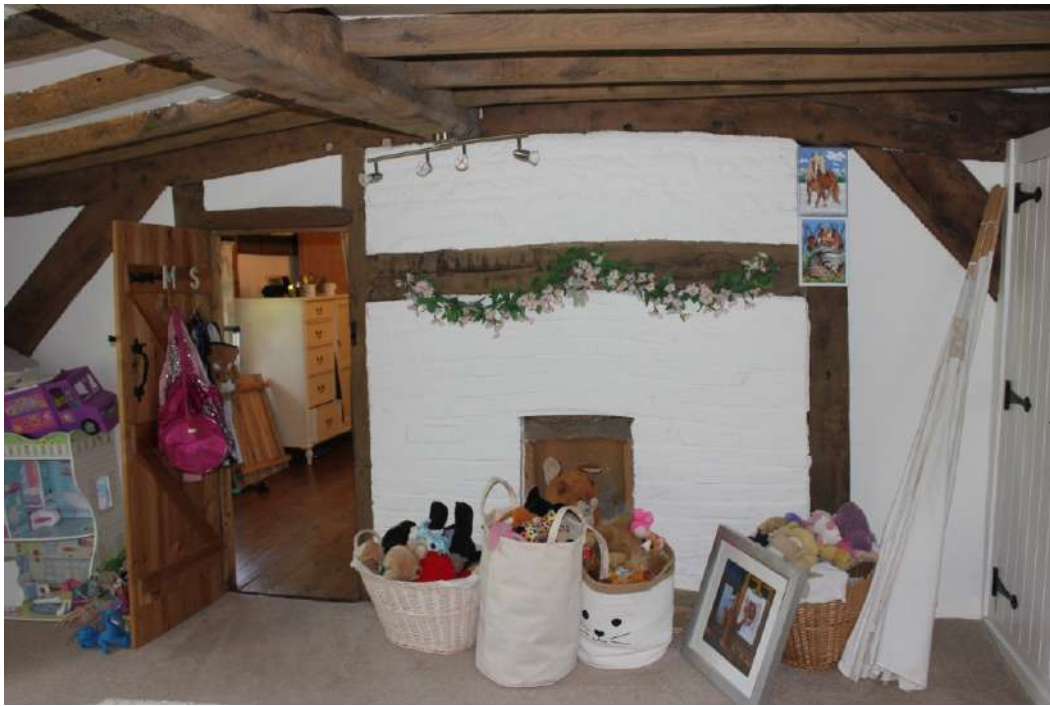
The first floor fireplace (Plate 50) faces north into Bay 3 and is much smaller as is the norm for a first floor chamber and was inserted at a later date, but still most likely within this period. The fireplace insert is modern. The bressumer has a significant amount of taper burns on the face of the timber and it is very evident that the timber has been subjected to some form of blasting; this is also evident throughout the rest of the house which has unfortunately removed some patina and possibly soot staining.

**Plate 50. First floor hearth.**

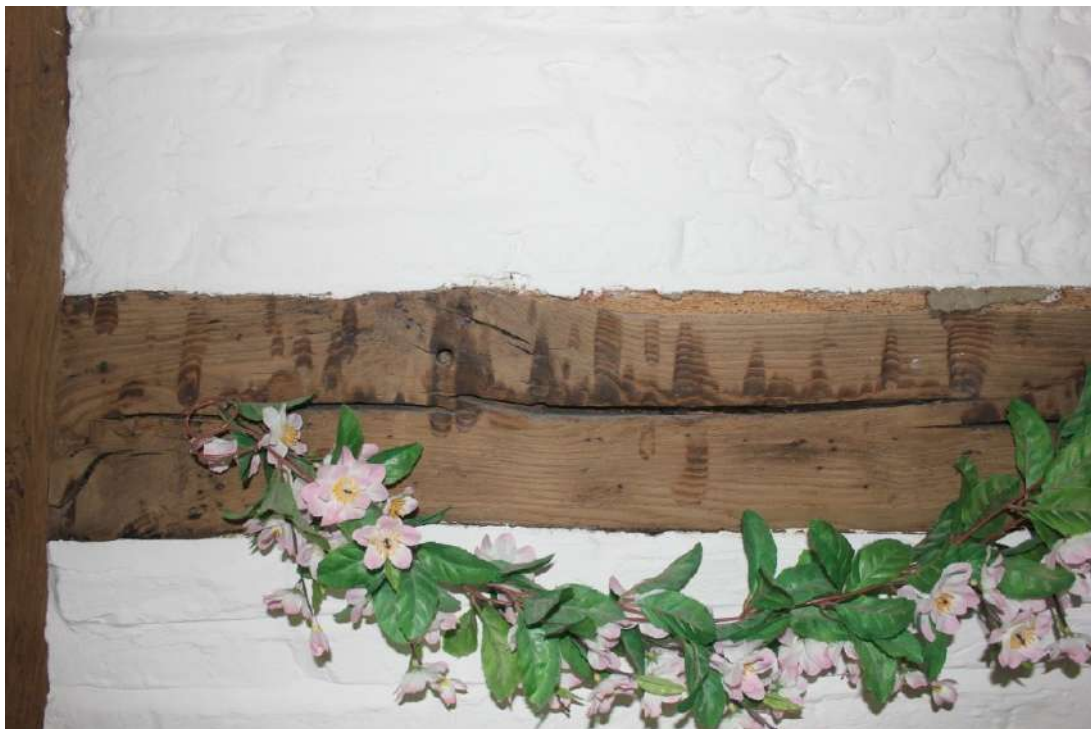
**Plate 50. Significant taper marks on the first floor bressumer.**

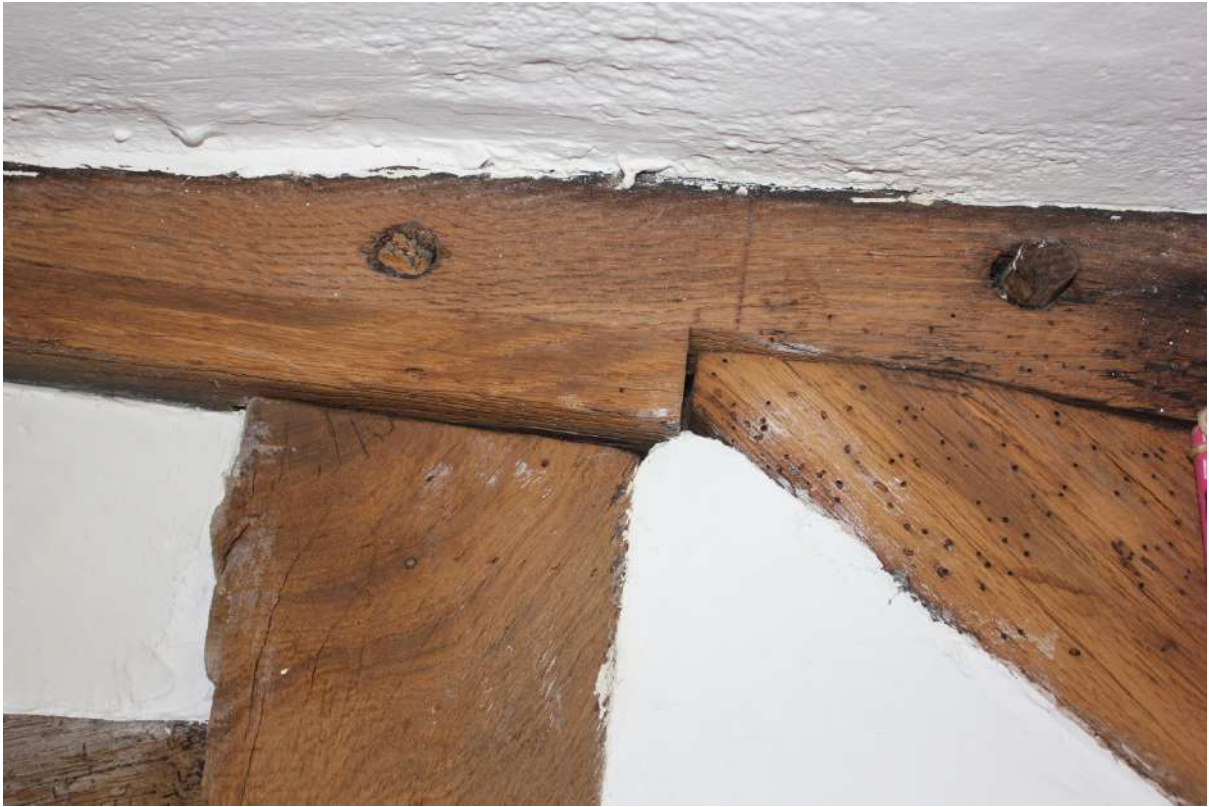
The roof was not subjected to any changes during this period, except for the replacement of the open hall truss braces. These are clearly seen, complete with the carpenter's setting out marks for the new braces (Plate 51). These were designed to be much shorter to enable movement through the truss and the insertion of doorways.

**Plate 51. Inserted brace cut into the Truss C tiebeam.**

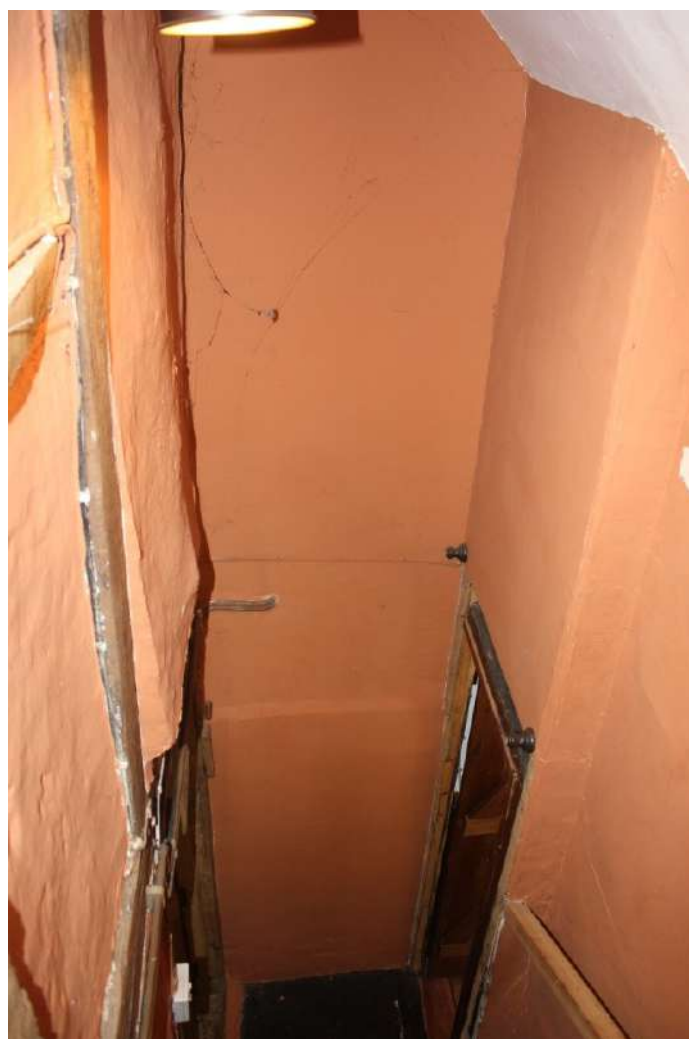
The main exterior walls of the building were under-built in brick during this period, apart from the walls within the two outshots. The internal walls within the southern outshot are mostly lath and plaster (Plate 52) and the brickwork from this period is Flemish Bond with burnt headers. The brickwork is present in all walls of the outshot; in the southern wall (Plate 53), the rear wall (Plate 54) where it is used in combination with re-used timber and the whole of the east elevation, including the main building where it is a continuous build (Plate 55). Various additional areas of under-building belong to later periods.

**Plate 52. Lath and plaster internal walls in the outshot.**

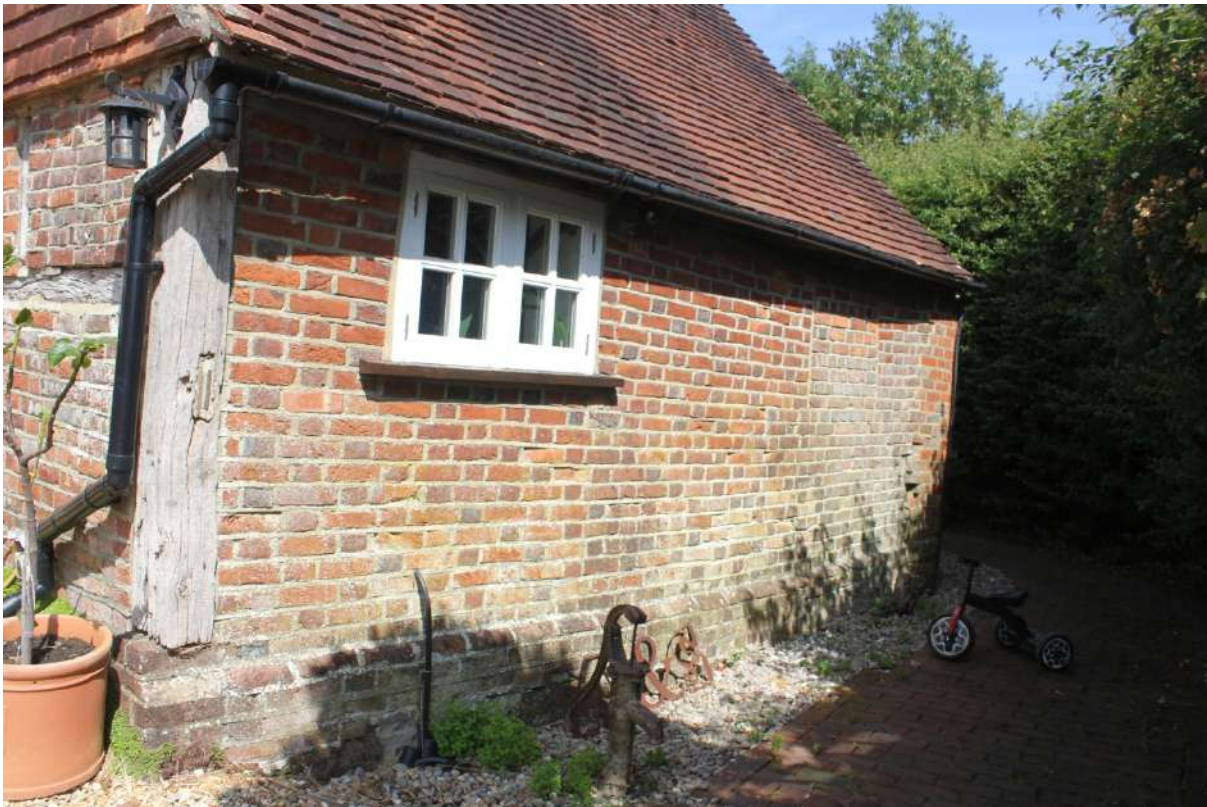
**Plate 53. Brick wall in the southern side of the outshot.**

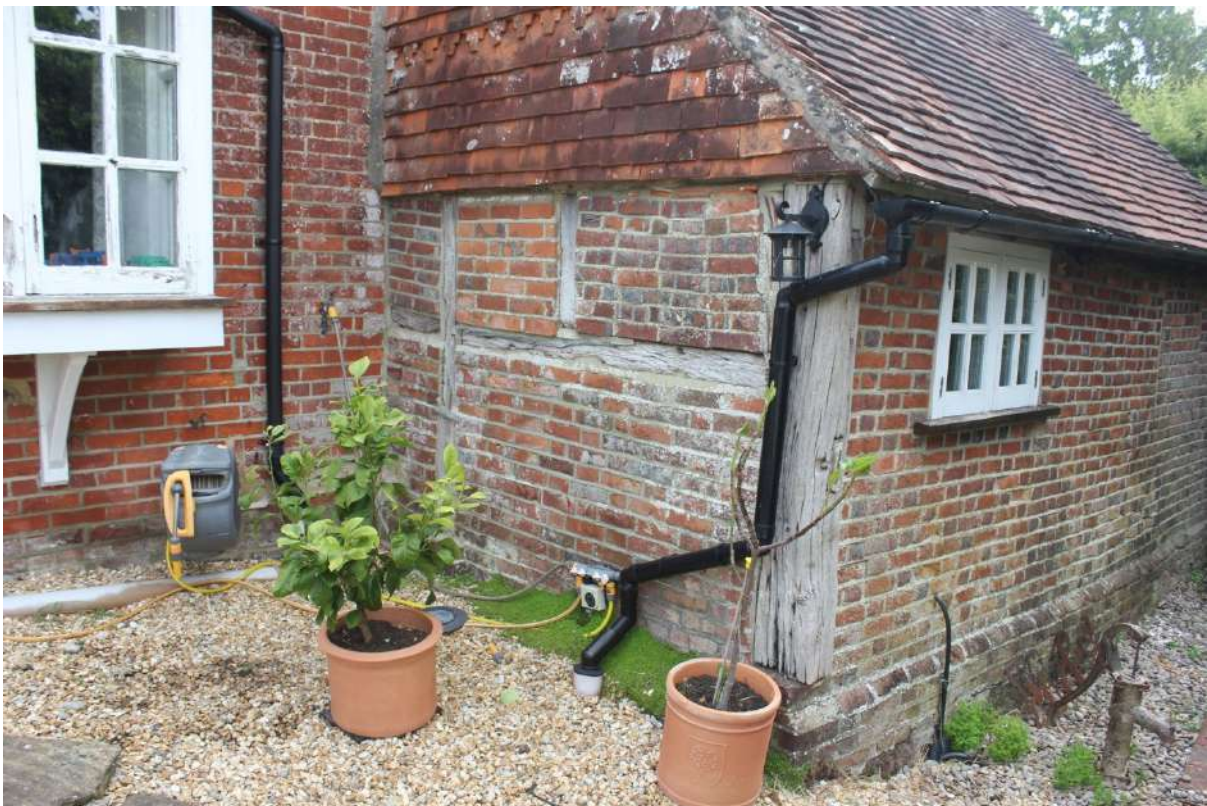
**Plate 54. Brick and timber rear wall of the southern outshot.**

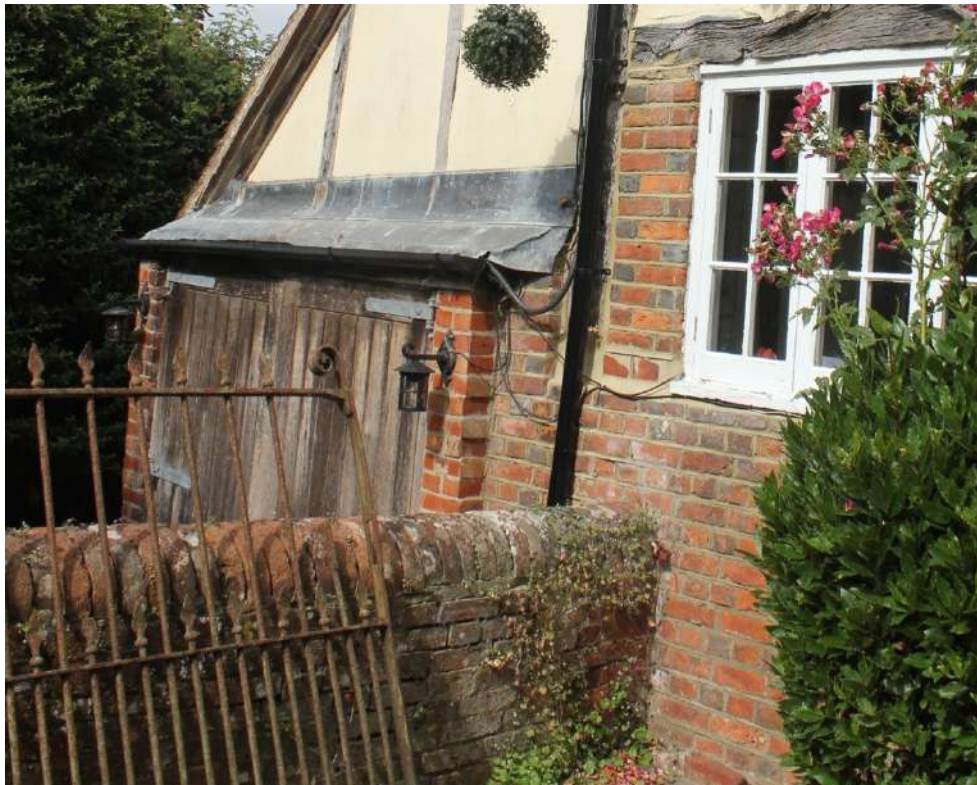
**Plate 55. Brickwork in the east elevation of the house extends across the front of the outshot although there are later projecting piers.**

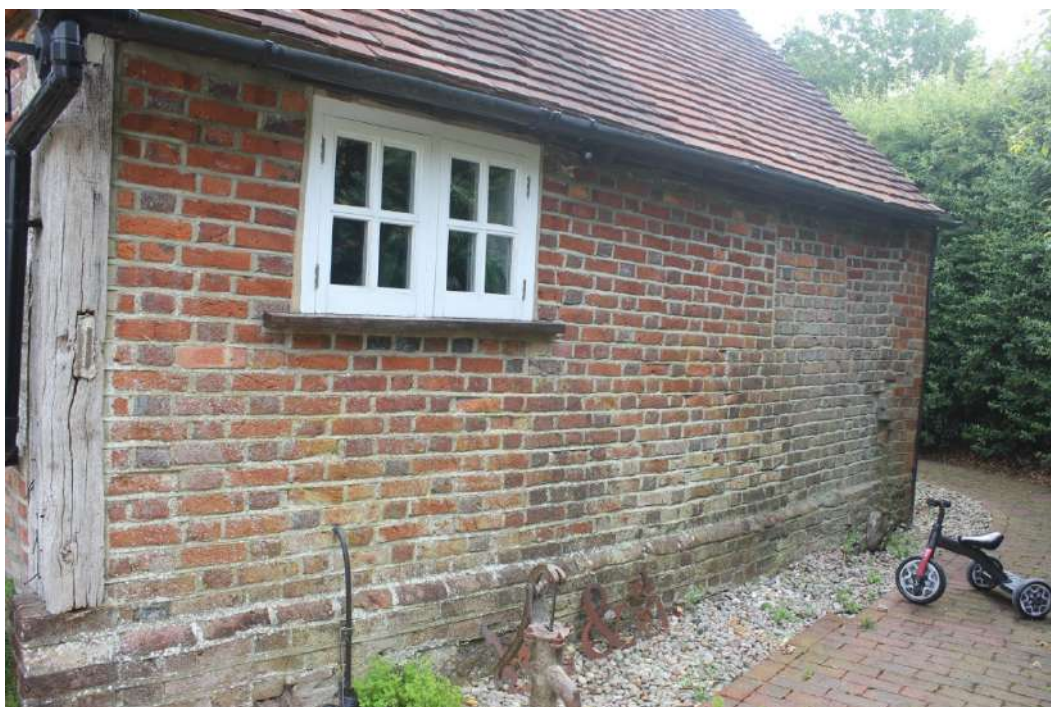
No windows from this period survive although the bricked up aperture of a former southern window in the outshot is evident (Plate 56).

**Plate 56. Blocked Period D window in the south wall of the outshot.**

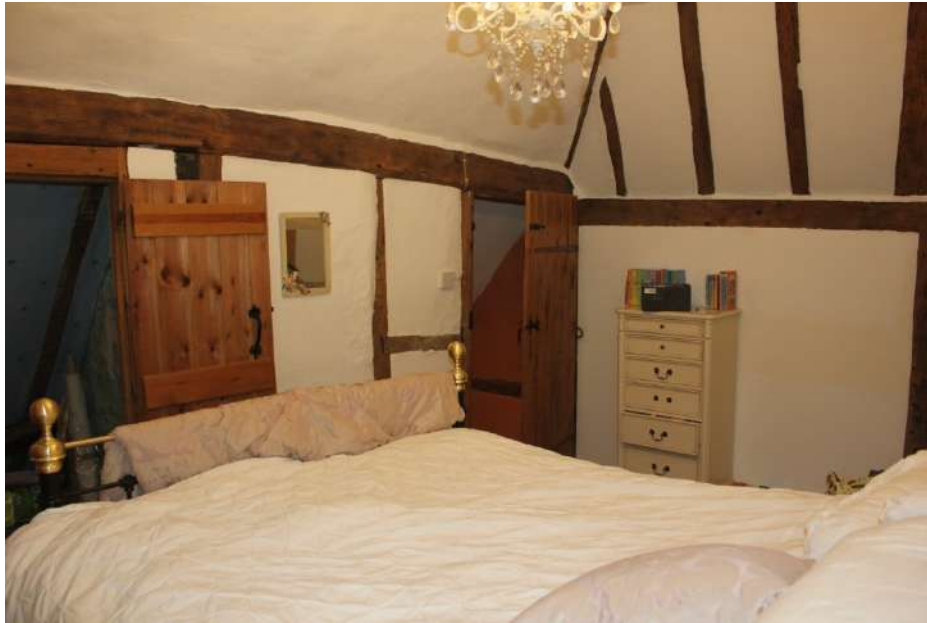
The ground floor doorway leading into the southern outshot in Truss A was replaced during this period as discussed above. A second doorway in this wall was inserted at first floor level (Plate 57) and provided a small storage area or may have been used as a private closet for the chamber pot.

**Plate 57. First floor door inserted in the west side of Truss A.**

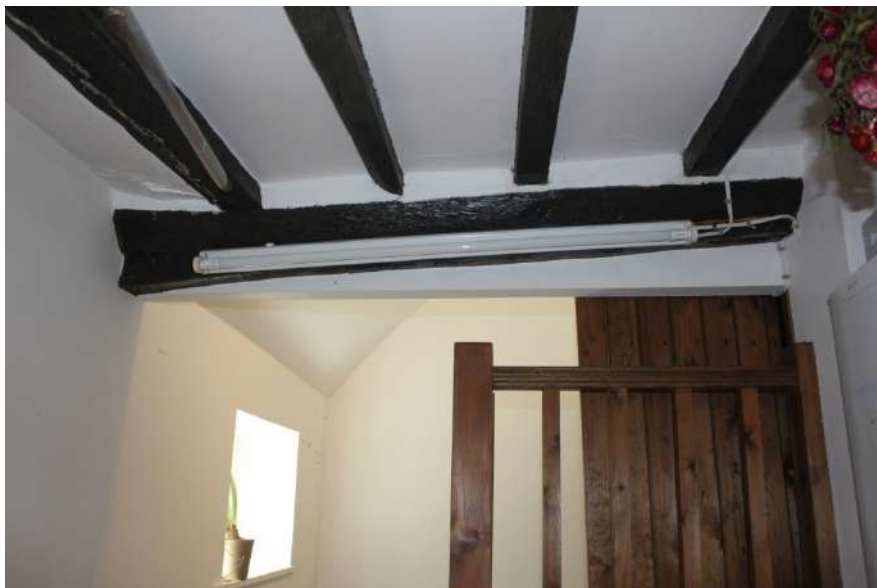
With the re-build of the southern outshot, slim joists were used for the floors here (Plate 58). In addition, changes in the roof in Bay 1 were undertaken whereby the ceiling was raised, creating a new floor in Bay 1 only, exposing the skielings in the first floor chamber (Plate 59).

**Plate 58. Slim joists used in the lower outshot ceiling.**
