AN ARCHAEOLOGICAL INTERPRETIVE STUDY FOR  
BARROW HILL FARMHOUSE, BARROW HILL, HENFIELD,  
WEST SUSSEX, BN5 9DN.

Report number: ASL 358-25

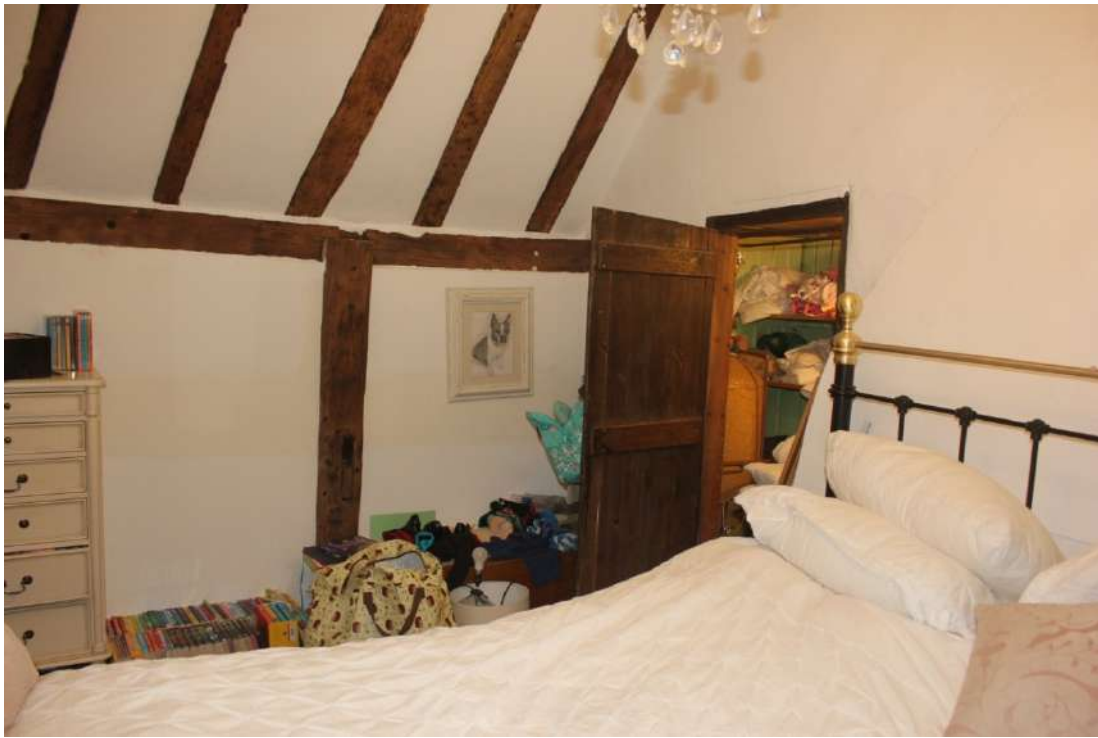
**Plate 59. Raised ceiling height in the first floor chamber of Bay 1.**

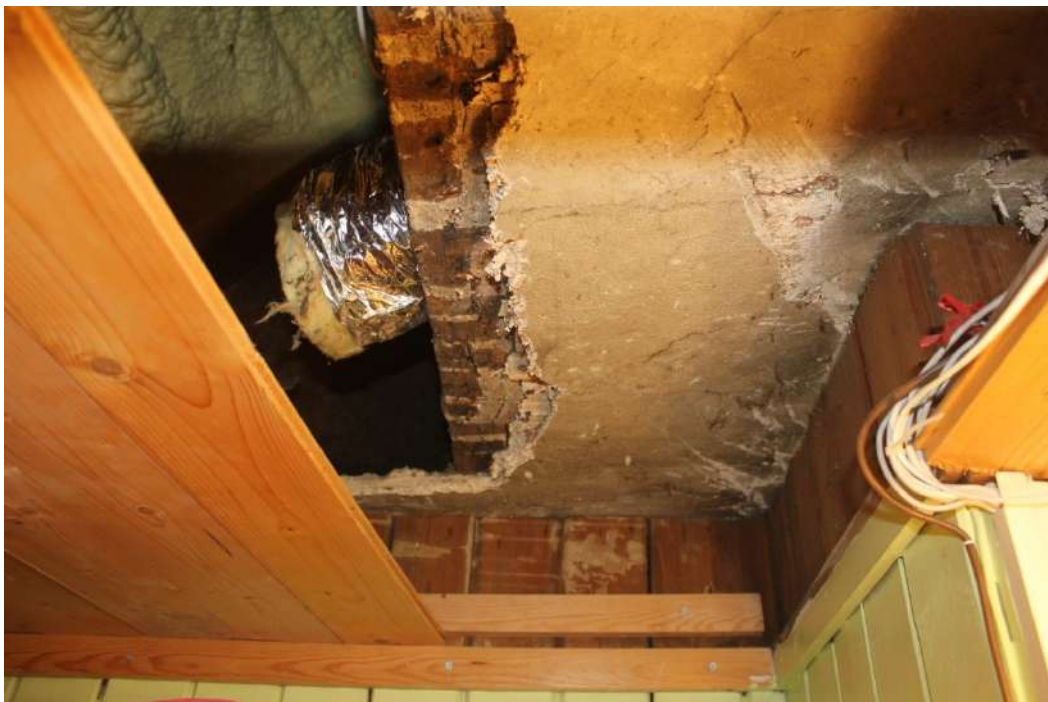
A lath and plaster ceiling was added to the side of the stack at first floor level in Bay 1 when a small cupboard was created. This only partly survives (Plate 60).

**Plate 60. Period D lime plastered ceiling exposed in the cupboard space on the west side of the chimney stack.**

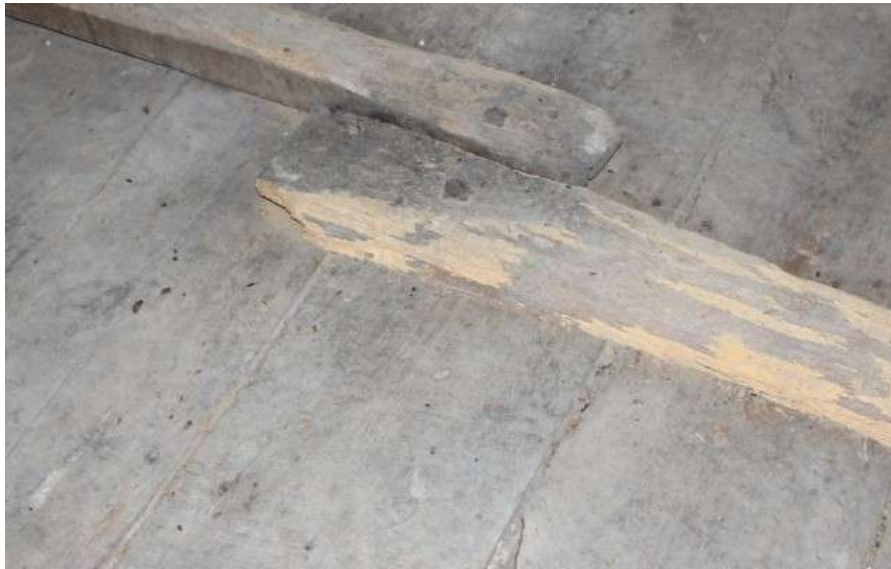
Finally, some retaining beams were bolted to the top of the Period C floorboards in the attic space of Bay 3 (Plate 61). These are particularly chunky beams which would have made it difficult to use this space easily so it is not clear why this was necessary

**Plate 61. Large retaining beams bolted to the Bay 3 boards in the attic.**

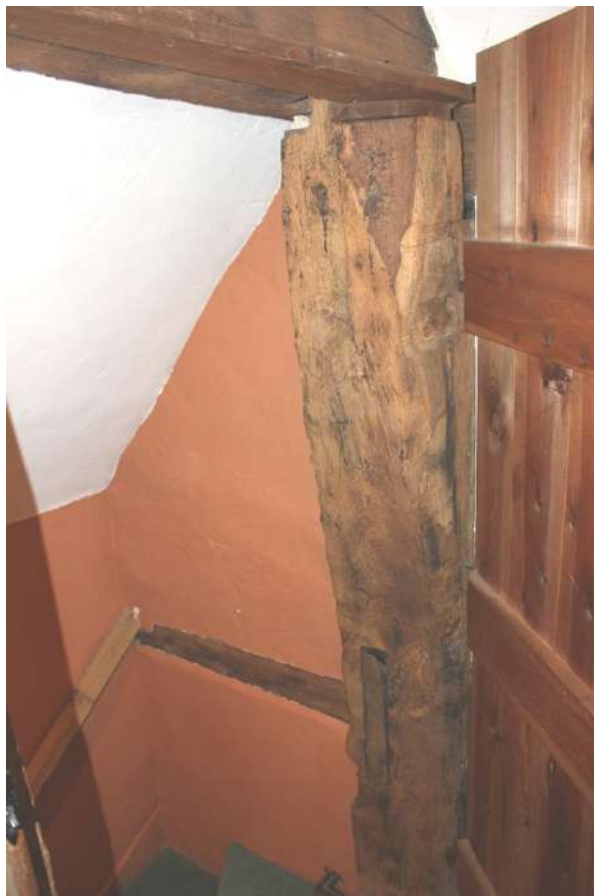
**Plate 63. Cut head brace in the south-west corner of Truss A.**

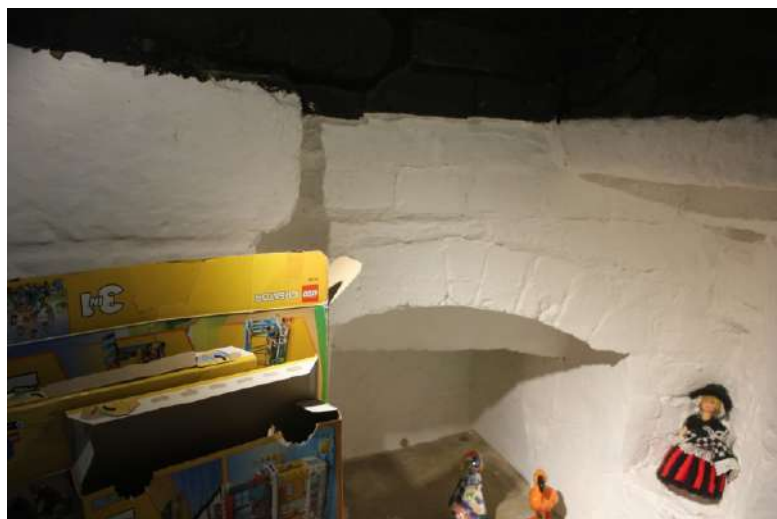
The Period C stairs west of the stack were removed during this period, with the stairwell aperture blocked up by inserted joists. This enabled the construction of a bread oven, although very little of this could be seen during the survey. A segmental arched brick lintel is evident to the west of the fireplace serving Bay 2 (Plate 64). This also necessitated the blocking up of the ground floor door to the west of the fireplace in the adjacent room in Bay 3.

**Plate 64. Segmental arched bread oven lintel to the side of the fireplace in Bay 2.**

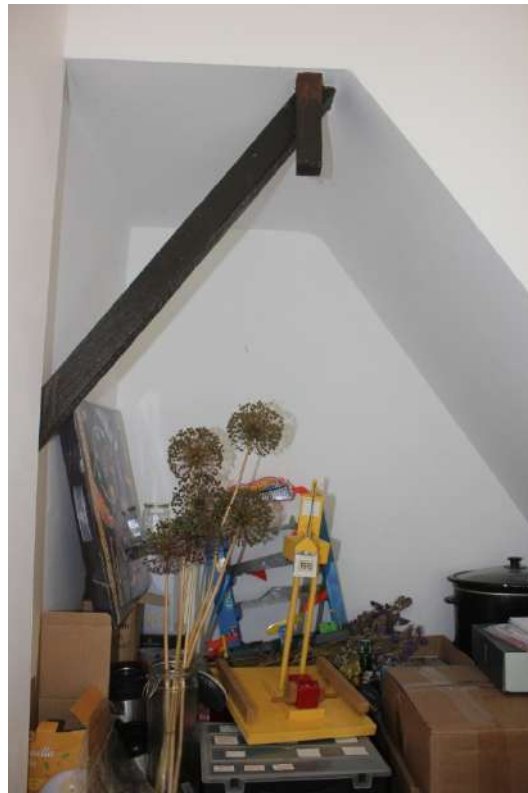
The roof ties from this period within the new outshot are also slim, matching the joists here (Plate 65). It is also during this period that the roof of Bay 3 was entirely replaced although it is not clear why this was necessary. The roof in the other bays remained, but in Bay 3 the rafters and collars were replaced and side purlins were introduced (Plate 66). The method of conversion of the timber was reciprocating saw, usually in water driven sawmills.

**Plate 65. Slim roof ties in the outshot.**

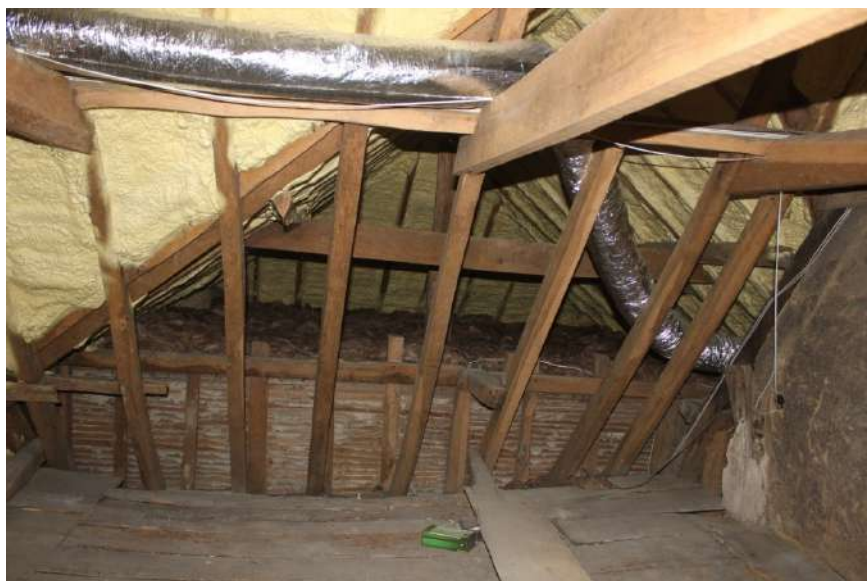
**Plate 66. New rafters, collars and side purlin of the Period D roof in Bay 3.**

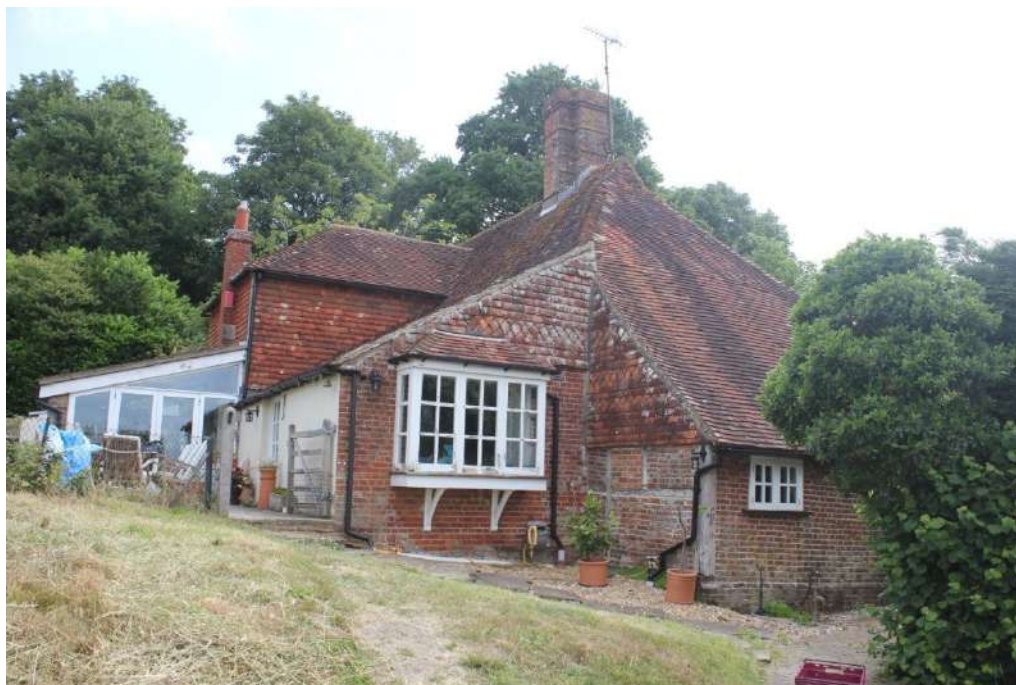
The structure is solid masonry built with English Garden wall bond at ground floor level which is part rendered to the rear, west side but with exposed brickwork in the north and south side walls (Plate 67). There is a low segmental arch in the south wall which is presumed to serve a drainage gully which is known to have been underneath the original floor here.

**Plate 67. The south side of the rear outshot with later bay window.**

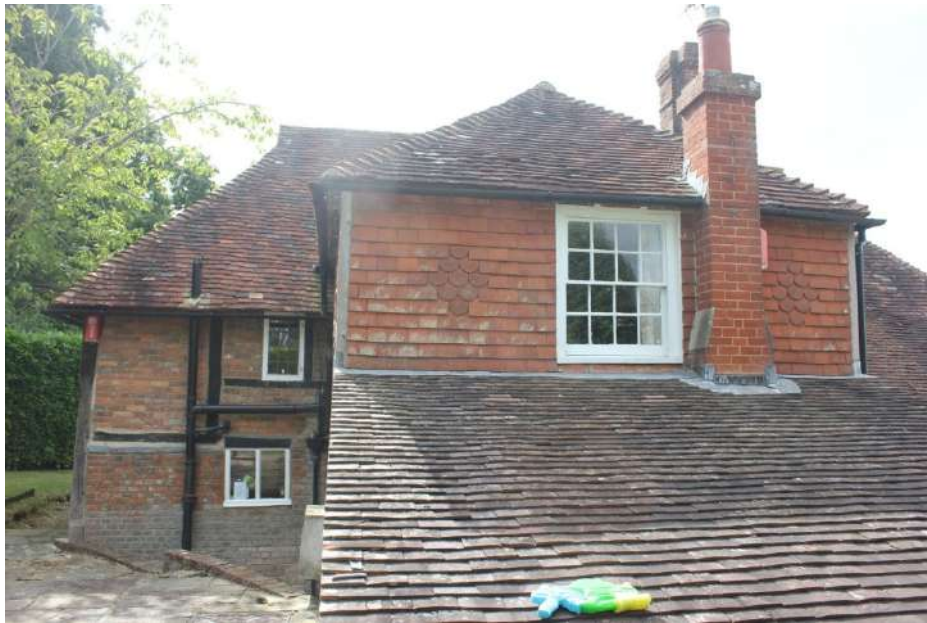
The two storey section may possibly be from this period but it is difficult to say for certain; the walls of the first floor level are presumed to be timber-framed covered with tile hanging with small bull-nosed diamond patterns in the west side (Plates 68 and 69). The single flue stack belongs to the two-storey structure as it is too high to have served a single-storey outshot. The brickwork does appear to be later in date than the side walls of the outshot so this may be proof that a single-storey structure was raised in height at a later date. Internally there have been several changes, including the opening up of the rear wall when the modern garden room was built to the west.

**Plate 68. Possible two-storey later extended outshot which is timber-framed.**

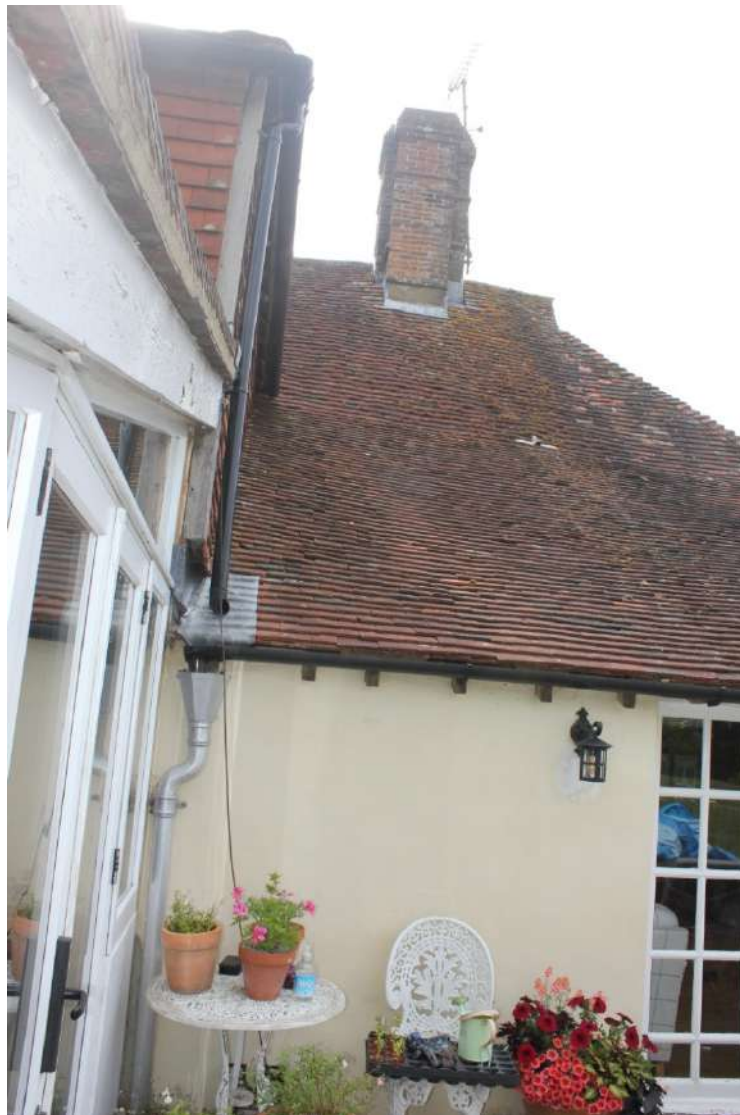
**Plate 69. Rendered rear wall of the outshot with catslide roof.**

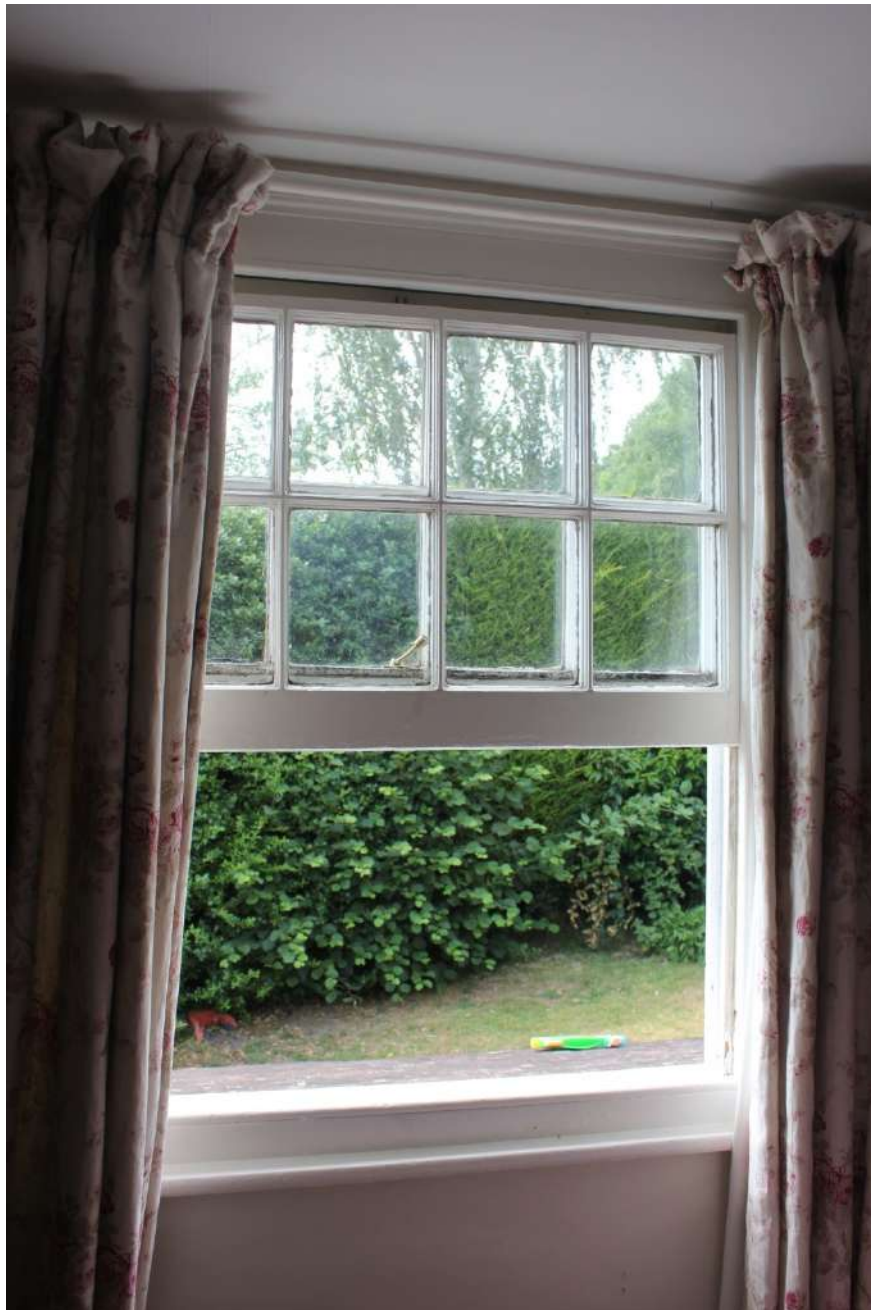
There is potentially one window from this period although even this is unlikely, given that it is within the first floor, west wall of the two-storey part of the rear outshot (Plate 70). It is an eight over eight sliding sash window in good condition, so unlikely to be of any great age but a replacement, most likely mid-20<sup>th</sup> century in date.

**Plate 70. Sliding sash window in the first floor room of the rear outshot.**

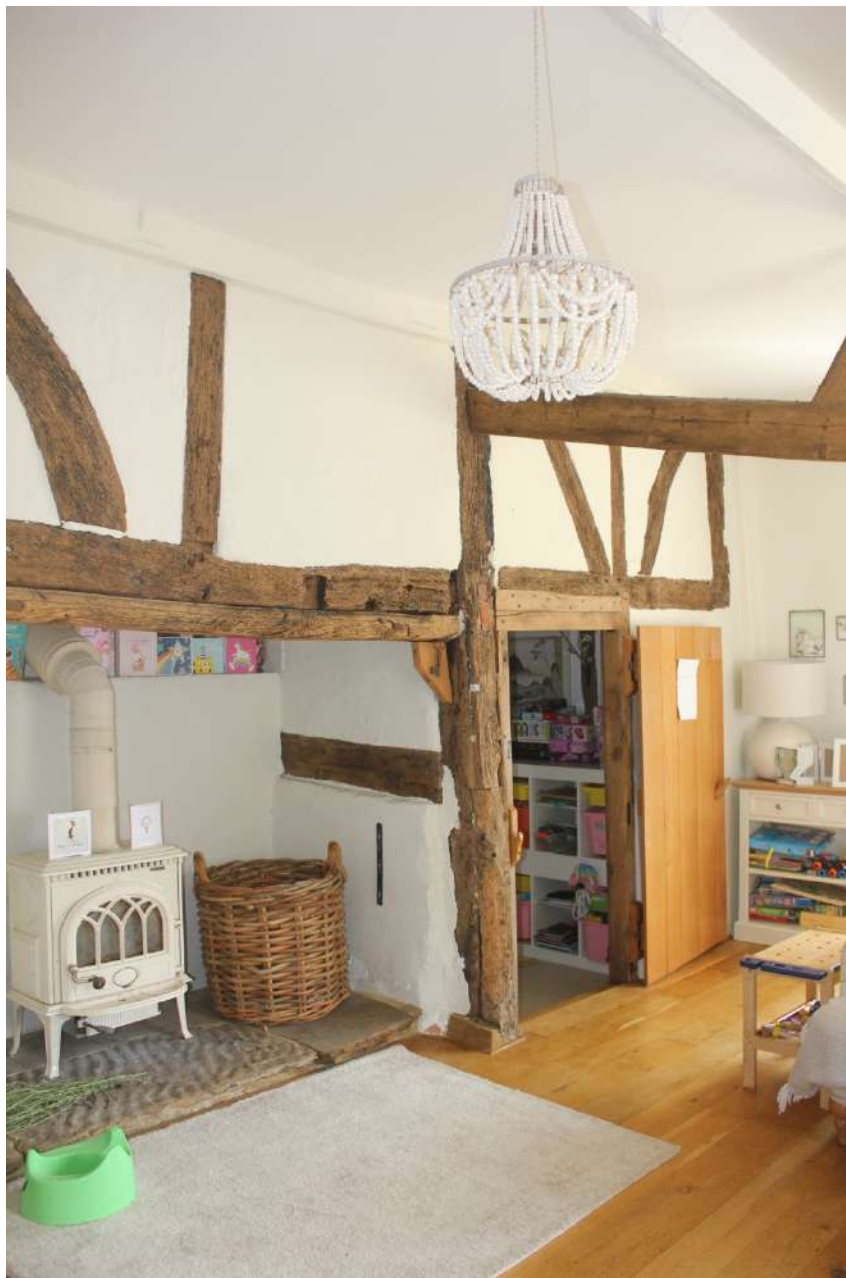
Three new doorways were created when the rear outshot was added during this period. One was inserted in the west wall of Bay 1 at ground floor level (Plate 71) with another in Bay 5 at the same level and a new door above this for the first floor bedroom in the west wall of Bay 5.

**Plate 71. New Period E doorway created in the west wall of Bay 1.**

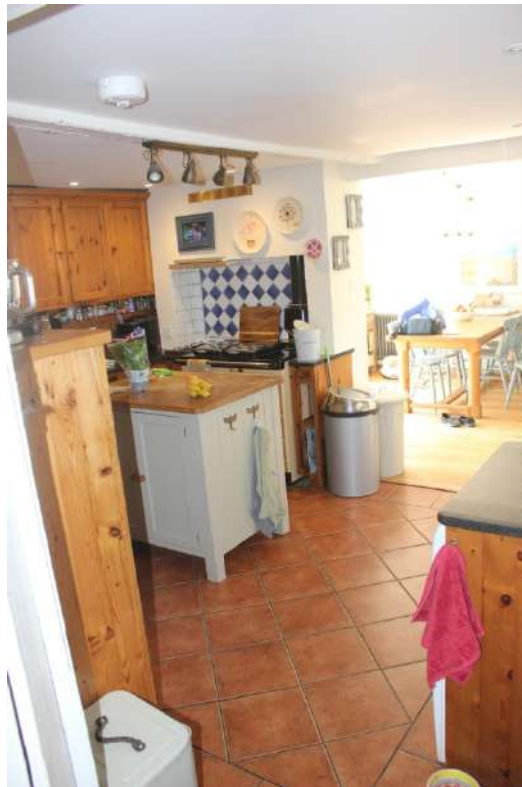
A new external stack was built to serve the new kitchen, positioned against the west wall of the outshot, probably at a later date as discussed above. This has a single flue and the fireplace now has a modern Aga range within (Plate 72).

**Plate 72. Modern Aga range within the Period E fireplace.**

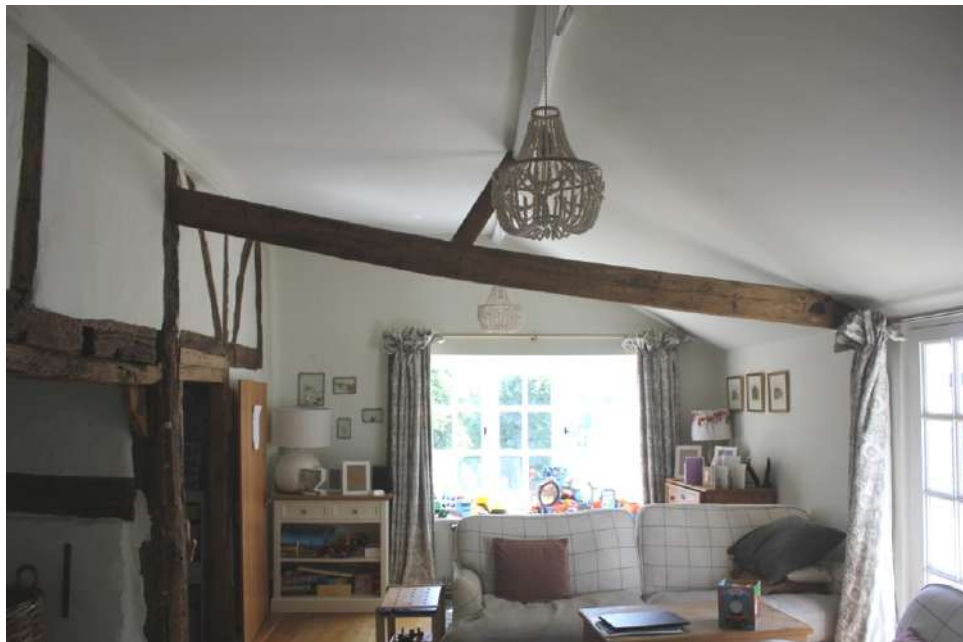
The rear outshot roof has a simple roof tie exposed in the single-storey structure (Plate 73). Externally the shallow pitch is covered with ceramic peg tile.

**Plate 73. Roof tie of the single storey structure.**

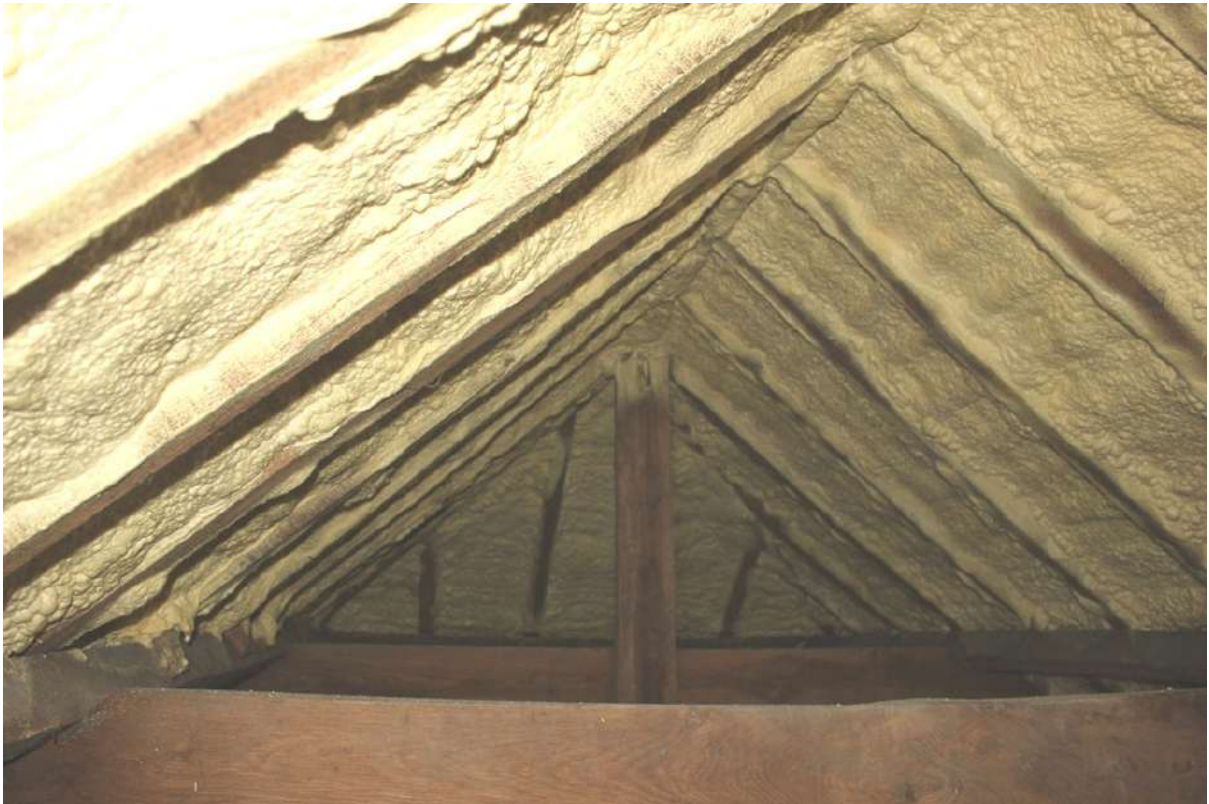
The double-pitched roof over the second storey element of the outshot is covered with spray foam but machined, regular sized softwood timber can be seen. The rafters here are very slim and there are side purlins present (Plate 74). The catslide

**Plate 74. Slim, softwood rafters present in the rear outshot roof.**

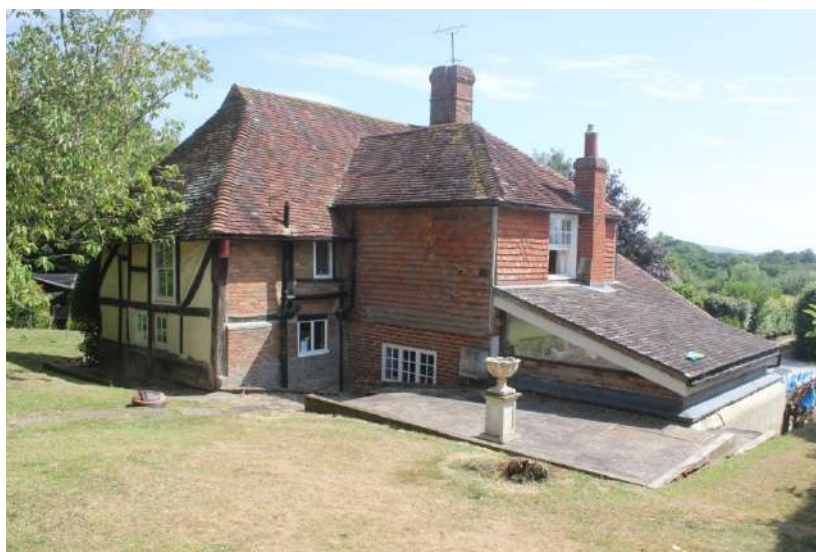
The walls of the garden room are a mixture of glass panels and brickwork, rendered to the west.

**Plate 75. The modern garden room looking south-east.**

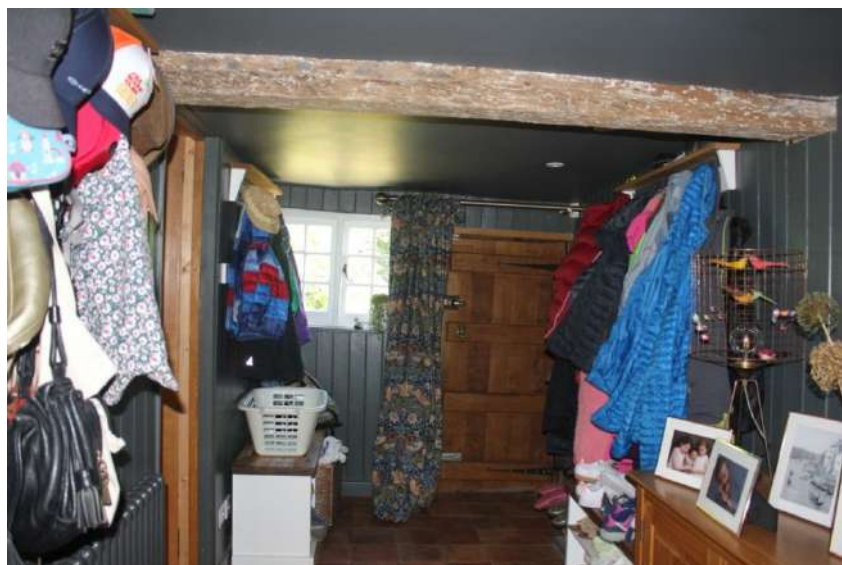
The only other wall additions during this period are the creation of two small washrooms within Bay 5. The ground floor one has a transverse partition which also divides the cross wing providing a cloakroom in the other half (Plate 76).

**Plate 76. Creation of modern cloakroom and washroom within Bays 4 and 5 at ground floor level.**

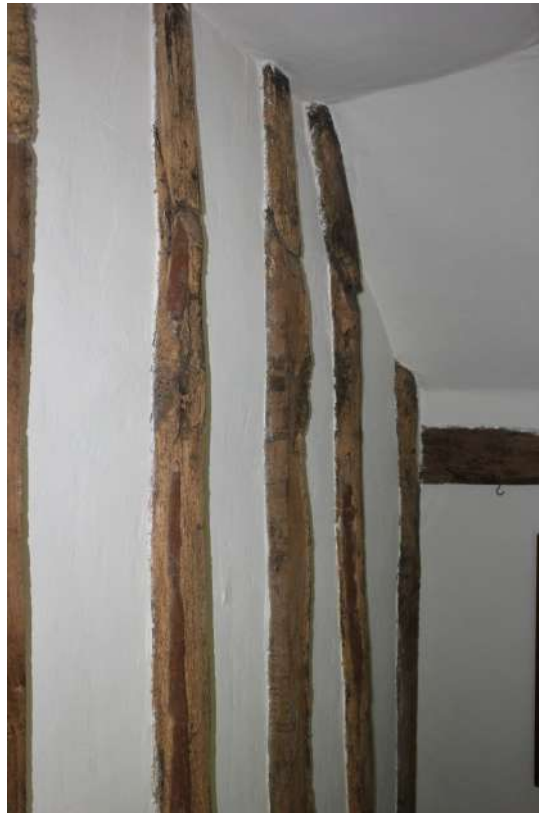
The second washroom has been created at the top of the landing area next to the stairs in the north-west corner at first floor level. Borrowed space here is formed by three partition walls, including a wall built from re-used timbers on the north side (Plate 77).

**Plate 77. Re-used timber in the north wall of the first floor washroom.**

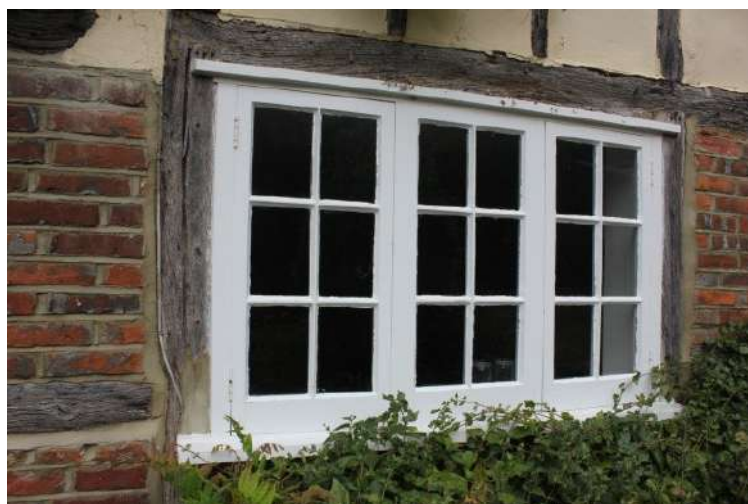
All of the windows within the building are from this period, mostly timber casements with thick glazing bars. Some of these have six lights (Plate 78), whereas some have only four (Plate 79) and one has just two (Plate 80).

**Plate 78. Modern casement window in the east elevation of Bay 3.**

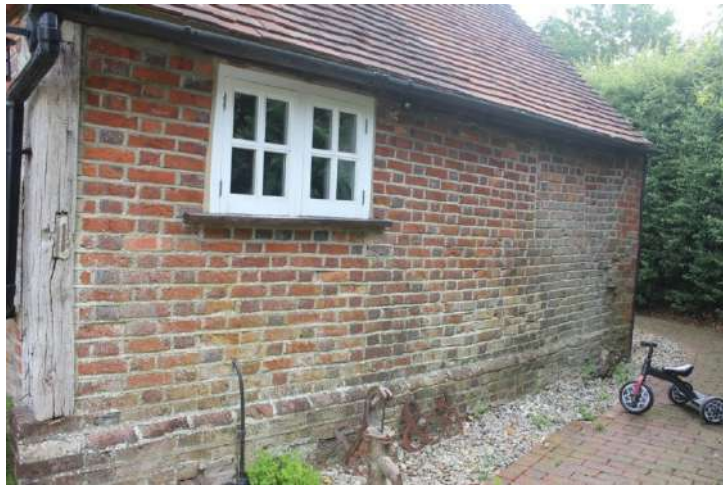
**Plate 79. Four light casements in the south wall of the southern outshot.**

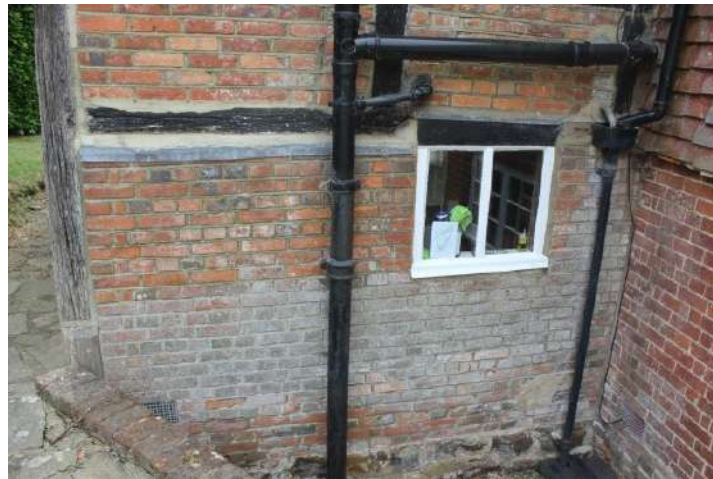
**Plate 80. Two light casement in the west side of bay 5.**

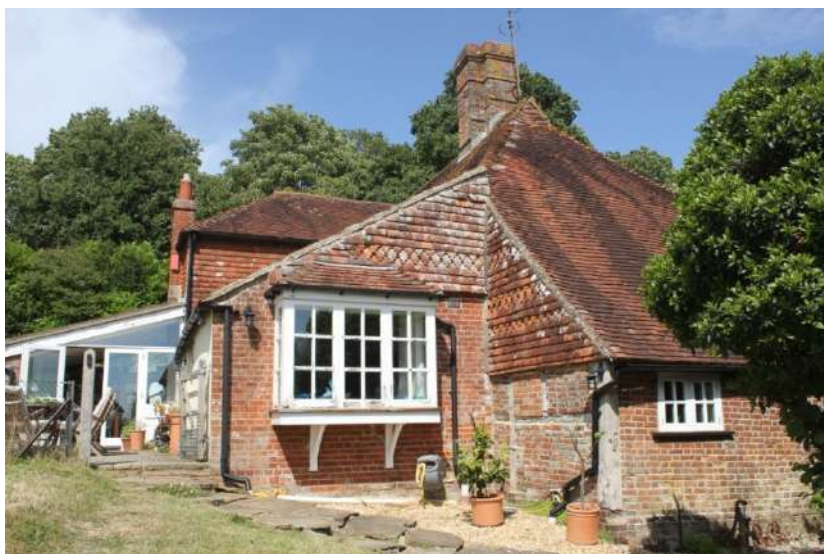
**Plate 81. Modern bay window in the south wall of the rear outshot.**

There is a bay window with six-light casements which has been inserted into the south wall of the Period D rear outshot (Plate 81). The adjustments in the brickwork here can be clearly seen but it is likely it replaced an earlier window in this location.

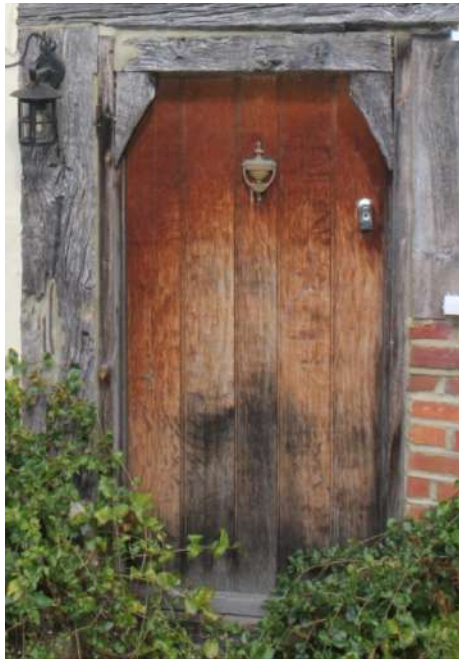
**Plate 82. Main eastern entrance door**

Most of the historic doors were replaced during this period, notably the main entrance doors to the east (Plates 82 and 83).

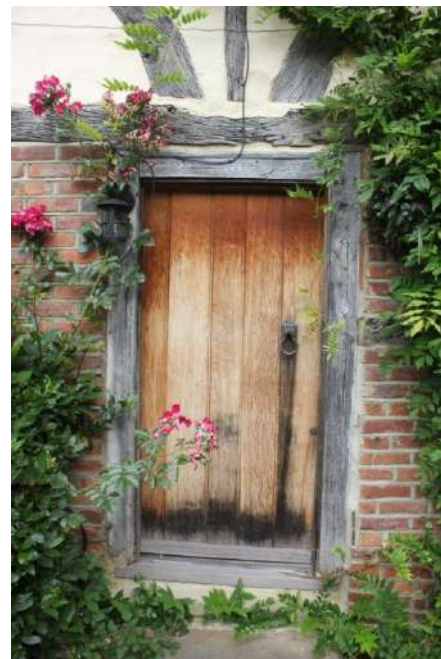
**Plate 83. Northern entrance door to east.**

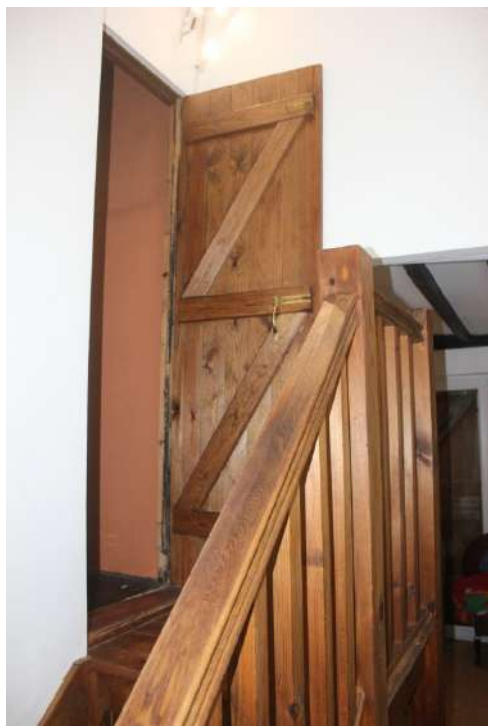
**Plate 84. Door of the lower southern outshot.**

In addition, most of the internal doors are from this period apart from the historic doors as previously discussed above, consisting of ledge and braced doors, some of which are re-used from elsewhere (Plates 84-85). There is a modern sliding door in the new first floor washroom in Bay 5 (Plate 86).

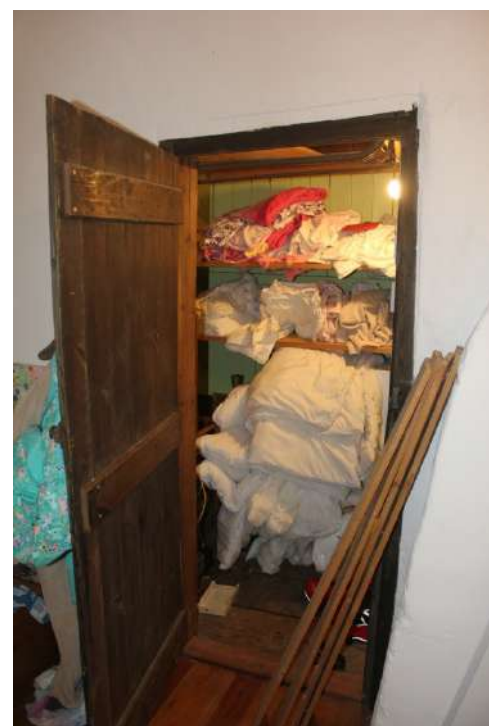
**Plate 85. First floor door west of the stack.**

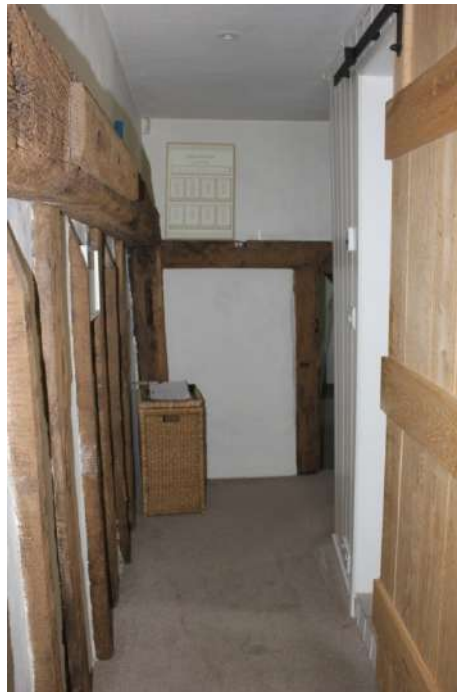
**Plate 86. New sliding door in the first floor washroom of Bay 5.**

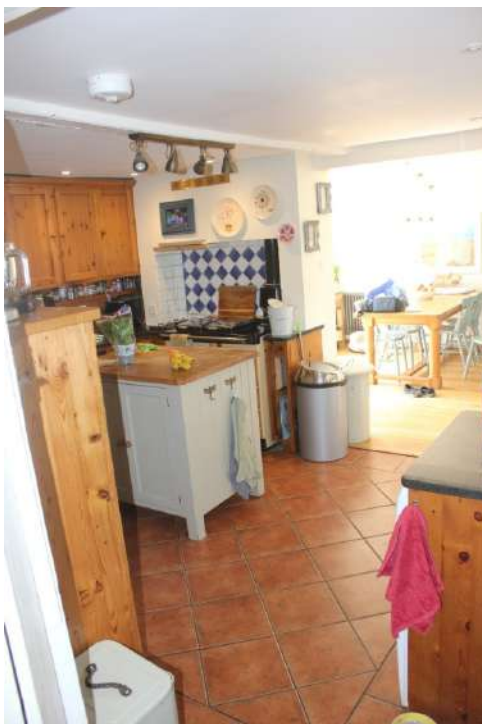
**Plate 87. Modern tiled kitchen floor in outshot.**

Modern floor coverings include ceramic tiles in the rear outshot kitchen (Plate 87) alongside oak boards here; ceramic tiles in the Bay 4/5 cloakroom and corridor (Plate 88) with carpets covering all other floors in the main rooms.

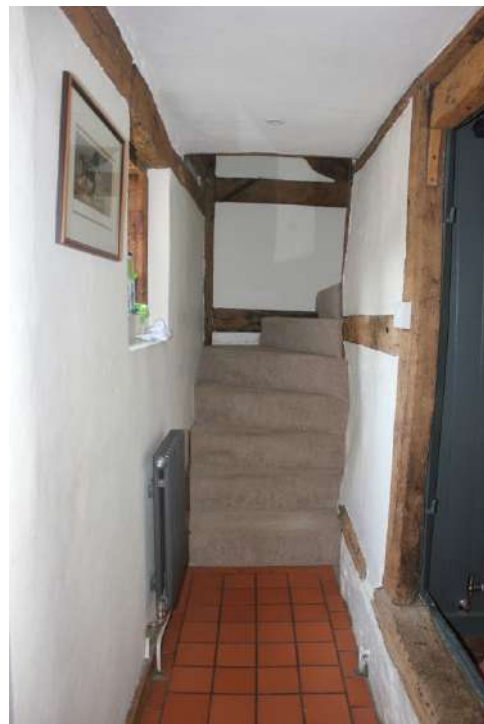
**Plate 88. Modern tiles in Bay 5 corridor.**

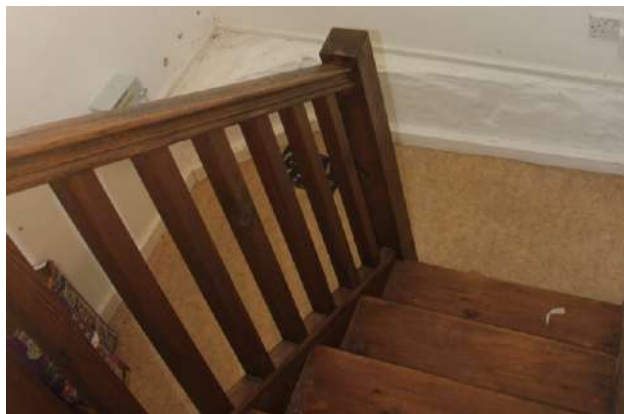
**Plate 89. Modern steps leading to the lower basement level.**

There are no modern stairs as far as can be ascertained without pulling up carpet. The two sets of stairs already discussed belong to Period B and D. However, the lower basement steps in the southern outshot (Plate 89) have been replaced during this period.

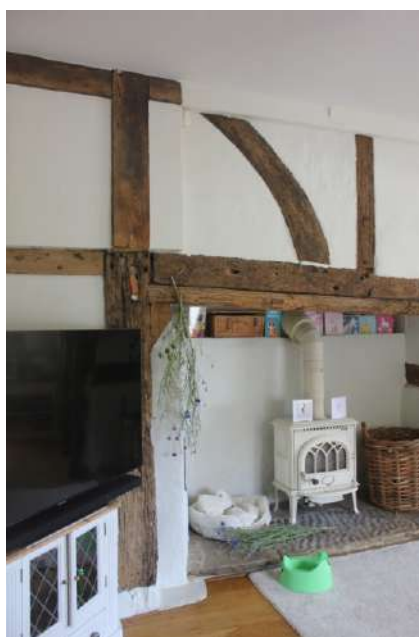
**Plate 90. False hearth created for the log burner.**

During this modern period, the lower part of the Period A2 wall in Bay 2 was removed in order to open up the space next to the stack so a log burner could be installed (Plate 80). At first glimpse this space appears to be a fireplace with hearth but this is not the case, as the Period C inserted joists can be seen inside. If this were a fireplace they would have caused a fire hazard. It is simply the case that the wall was removed and a false bressumer inserted (which is actually a 17<sup>th</sup> century, ovolo moulded timber) and a false hearth. The stone inside the 'hearth' is a fine example of a fossilized marine sand deposition shaped into sand waves. The flue of the log burner has been inserted into the bread oven.

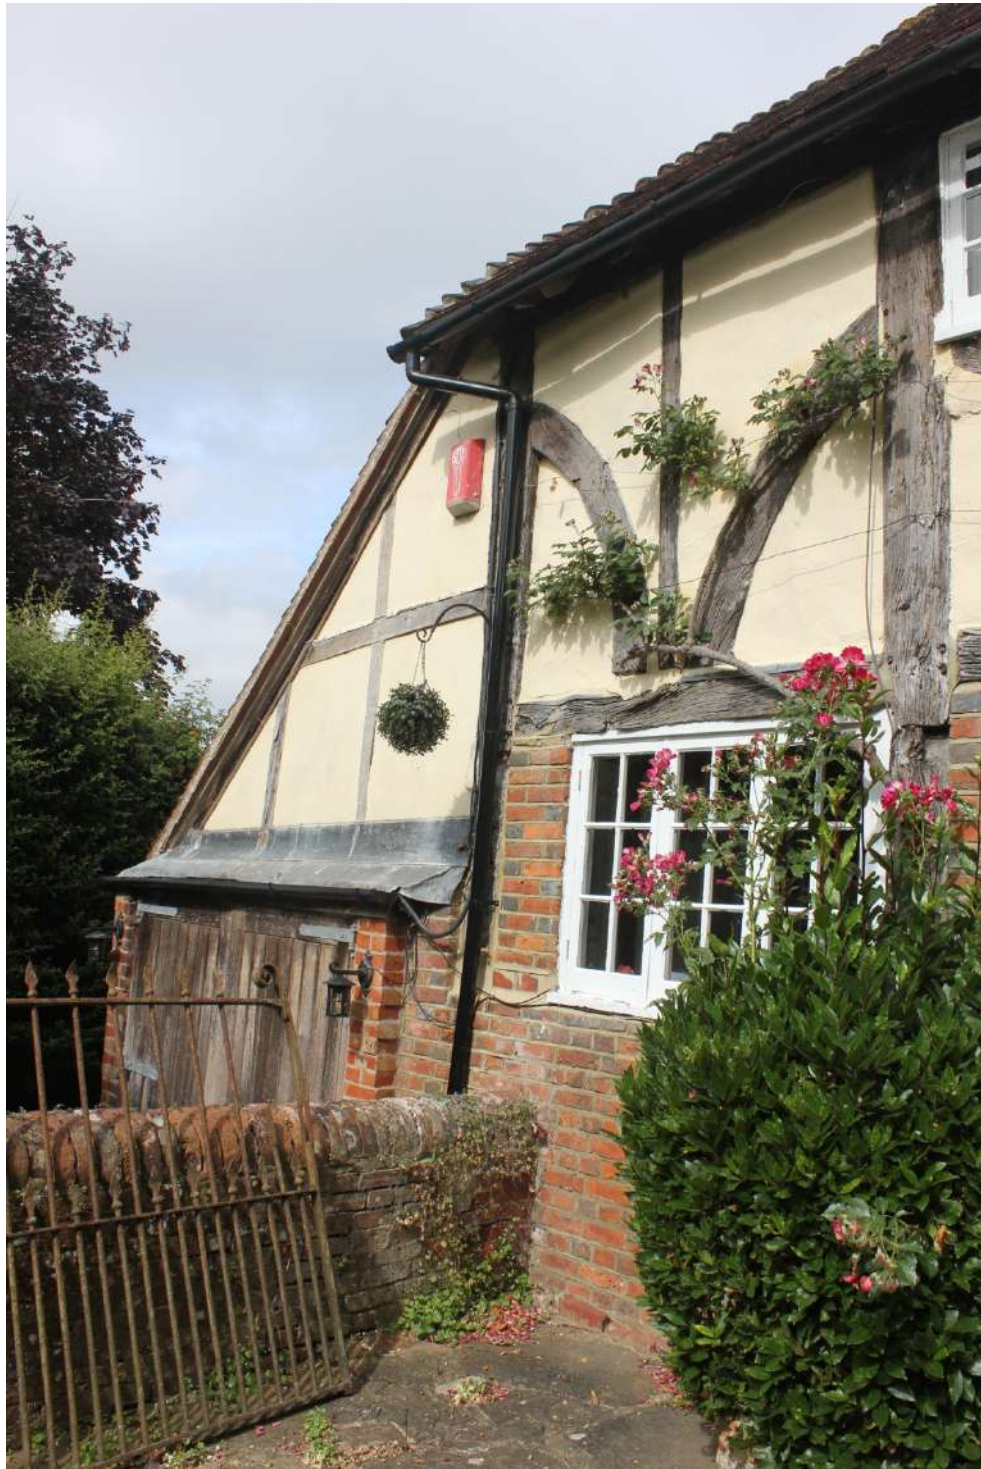
**Plate 91. The east side of the southern outshot.**

It appears that the southern outshot roof was replaced and repaired at this point in time, with new fascia panels attached to the east side and most likely some timbers replaced in the panel above the garage doors (Plate 91).
