## HORSHAM DISTRICT COUNCIL CONSULTATION

| <b>LOCATION:</b> | Phases 2 and 3 Land at Wellcross Farm Broadbridge Heath |
| <b>DESCRIPTION:</b> | Application for Approval of Details Reserved by Condition 2 (Construction Management Plan), <sup>3</sup> (borehole to meet Private Water Supplies), <sup>4</sup> (Private Water Supply Management Plan), <sup>5</sup> (finished floor levels and external ground levels) and 7 (underground services) to approved application DC/24/0205 Reserved matters application pursuant to condition 5 of outline planning permission DC/19/1897 for the provision of phases 2 and 3 of Land at Wellcross Farm to provide a continuing care retirement community with 94 units of accommodation (C2), with access, infrastructure, open space, landscaping and associated works including an onsite borehole water supply). |
| <b>REFERENCE:</b> | DISC/26/0012 & DISC/26/0013 |

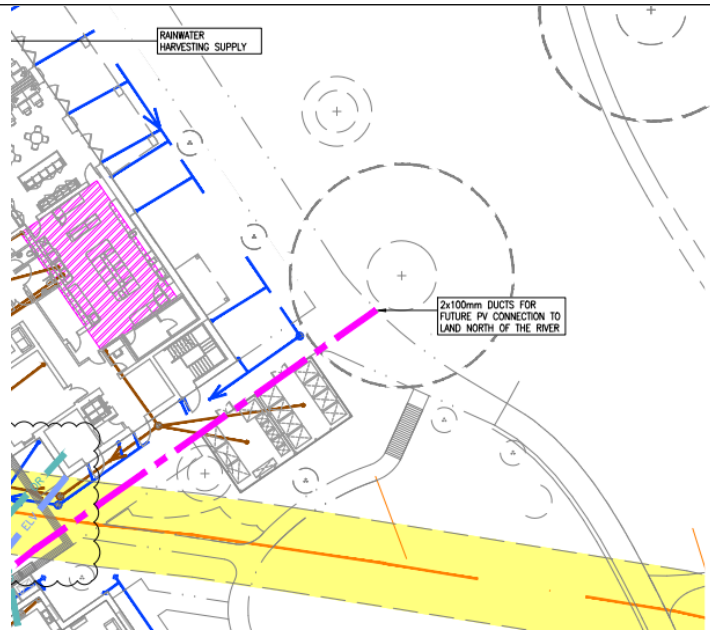
The RPA, of the unknown tree shown in the image above, taken from Electrical & Electrical Services Drawing No. 1163-ESD-XX-00-DR-XX-P2-1001, revision 2, still indicates that the ducts for the future PV connection to land north of the river fall within the tree's RPA. Please seek confirmation that the ducts will be removed and that the PV connection will not be sited within the RPA, or alternatively that trenchless installation methods will be used at a depth greater than 1.5 m below existing ground levels. Concerns addressed.

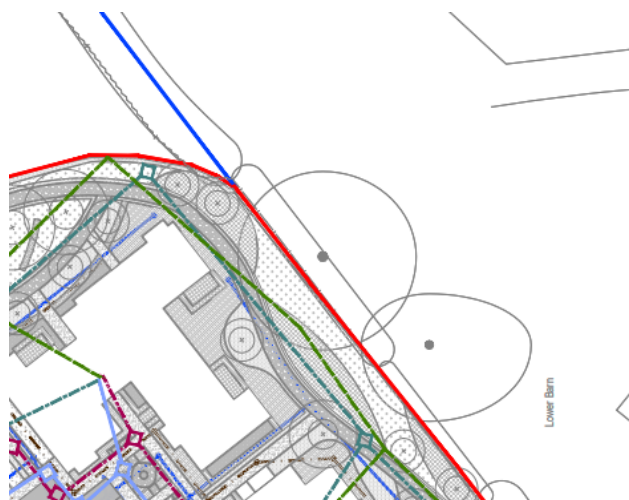
If the new services are installed using an open-trench method, the historically greenfield nature of the site and the absence of physical constraints that would have limited root development to the northwest of the tree indicate a high likelihood that trenching works would result in substantial root severance and long-term damage to T31.

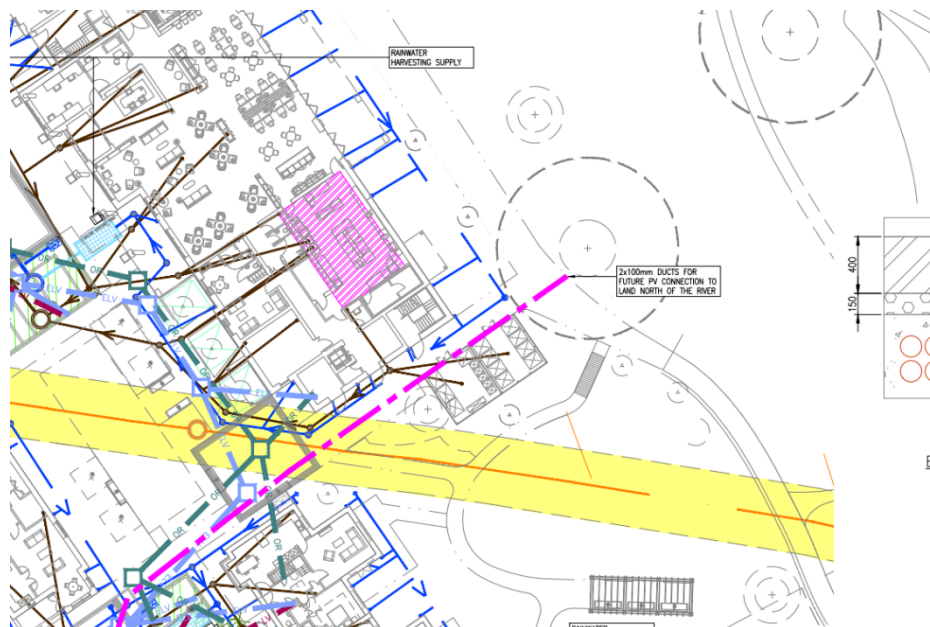
Accordingly, amendments should be sought to the route of the service runs to ensure that they do not encroach within the RPA of tree T31, and outside of the RPA, of the unknown tree in the above image taken from Electrical & Electrical Services Drawing No. 1163-ESD-XX-00-DR-XX-P2-1001. [Concerns addressed.](#)

One potential solution would be to relocate the service runs further north, outside the RPA of T31, and outside of the RPA, of the unknown tree in the above image. If this is not considered feasible, trenchless installation methods should be employed, such as thrust boring or impact moling.
