Arboricultural impact appraisal and method statement

Furners Lane, Henfield, West Sussex. BN5 9JD

More specifically, the development proposal is for the erection of 29 homes with associated landscaping, open space, parking and creation of new vehicular access from Furners Lane at Furners Lane, Henfield, West Sussex. BN5 9JD.

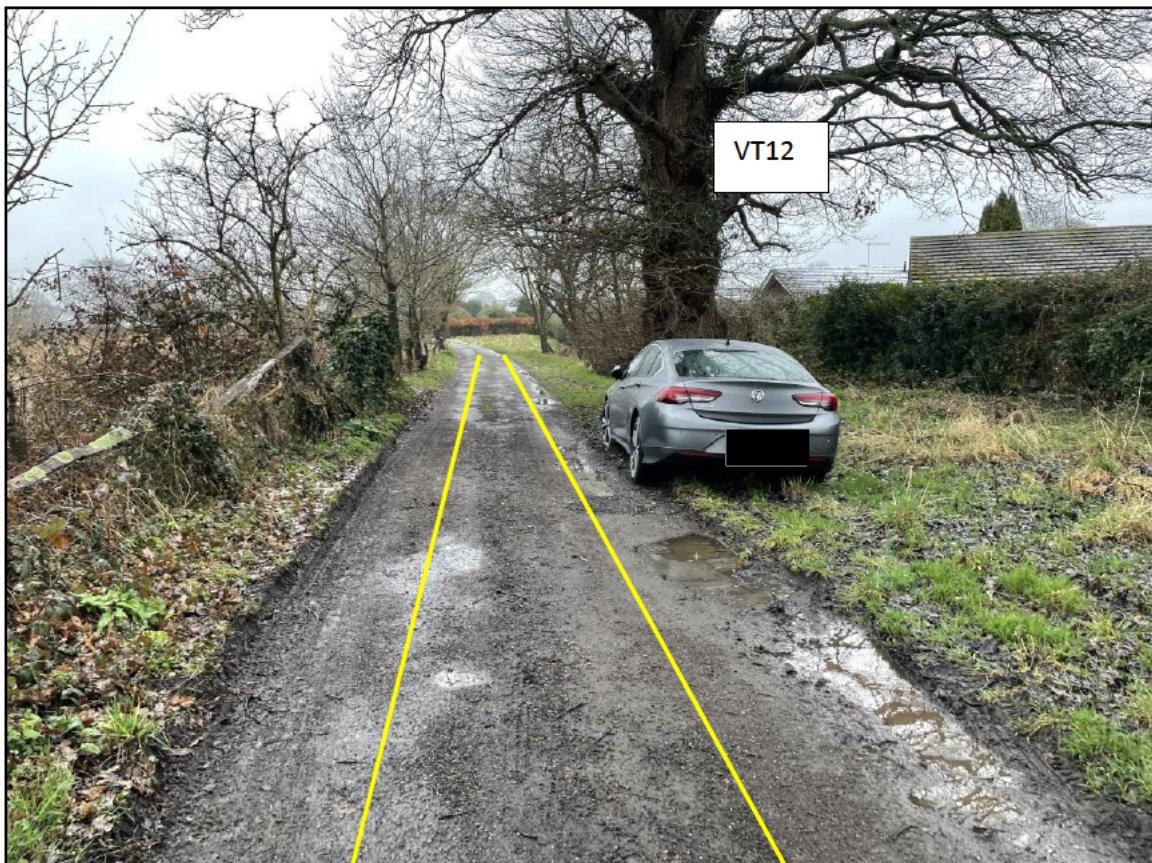
Photo 1: Looking south along the existing access track. The existing tarmac surface will be carefully removed and a new footpath (no vehicular access) will be installed approximately where the yellow are shown which will be narrower than the existing track and constructed using a cellular confinement system improving the available rooting zone for the trees adjacent to the access, including VT1 & VT12.

There will be encroachment into the RPAs of these trees in the form of new no-dig surfacing. The existing tarmac access drive will be carefully removed and replaced with a footpath only but within the alignment of the existing access. A Cellular confinement system will be utilised which will result in a gain in terms of available and productive rooting zone than currently exists. From our previous experience at installing such surfacing (www.barrelltreecare.co.uk/case-studies/SurfacingNearTrees.pdf), we are confident that this can be implemented without any long

term detrimental impact on tree health, with the detail to be agreed as part of a planning condition. This surfacing solution is within the advice set out in BS 5837 (8.6) and would be appropriate in this situation. In addition, the existing soft area to the east of VT1 & VT12 will be improved by applying same species mulch to improve the rooting zone for both trees.
