WATER/DRAINAGE PLAN :
LIMEKILN FARM TEMPORARY
EQUINE WORKERS' DWELLING

PROJECT: LIMEKILN FARM
BROADWATER LANE
COPSALE RH13 6QW

DESCRIPTION: WATER/DRAINAGE PLAN

DRAWING No: 082/04

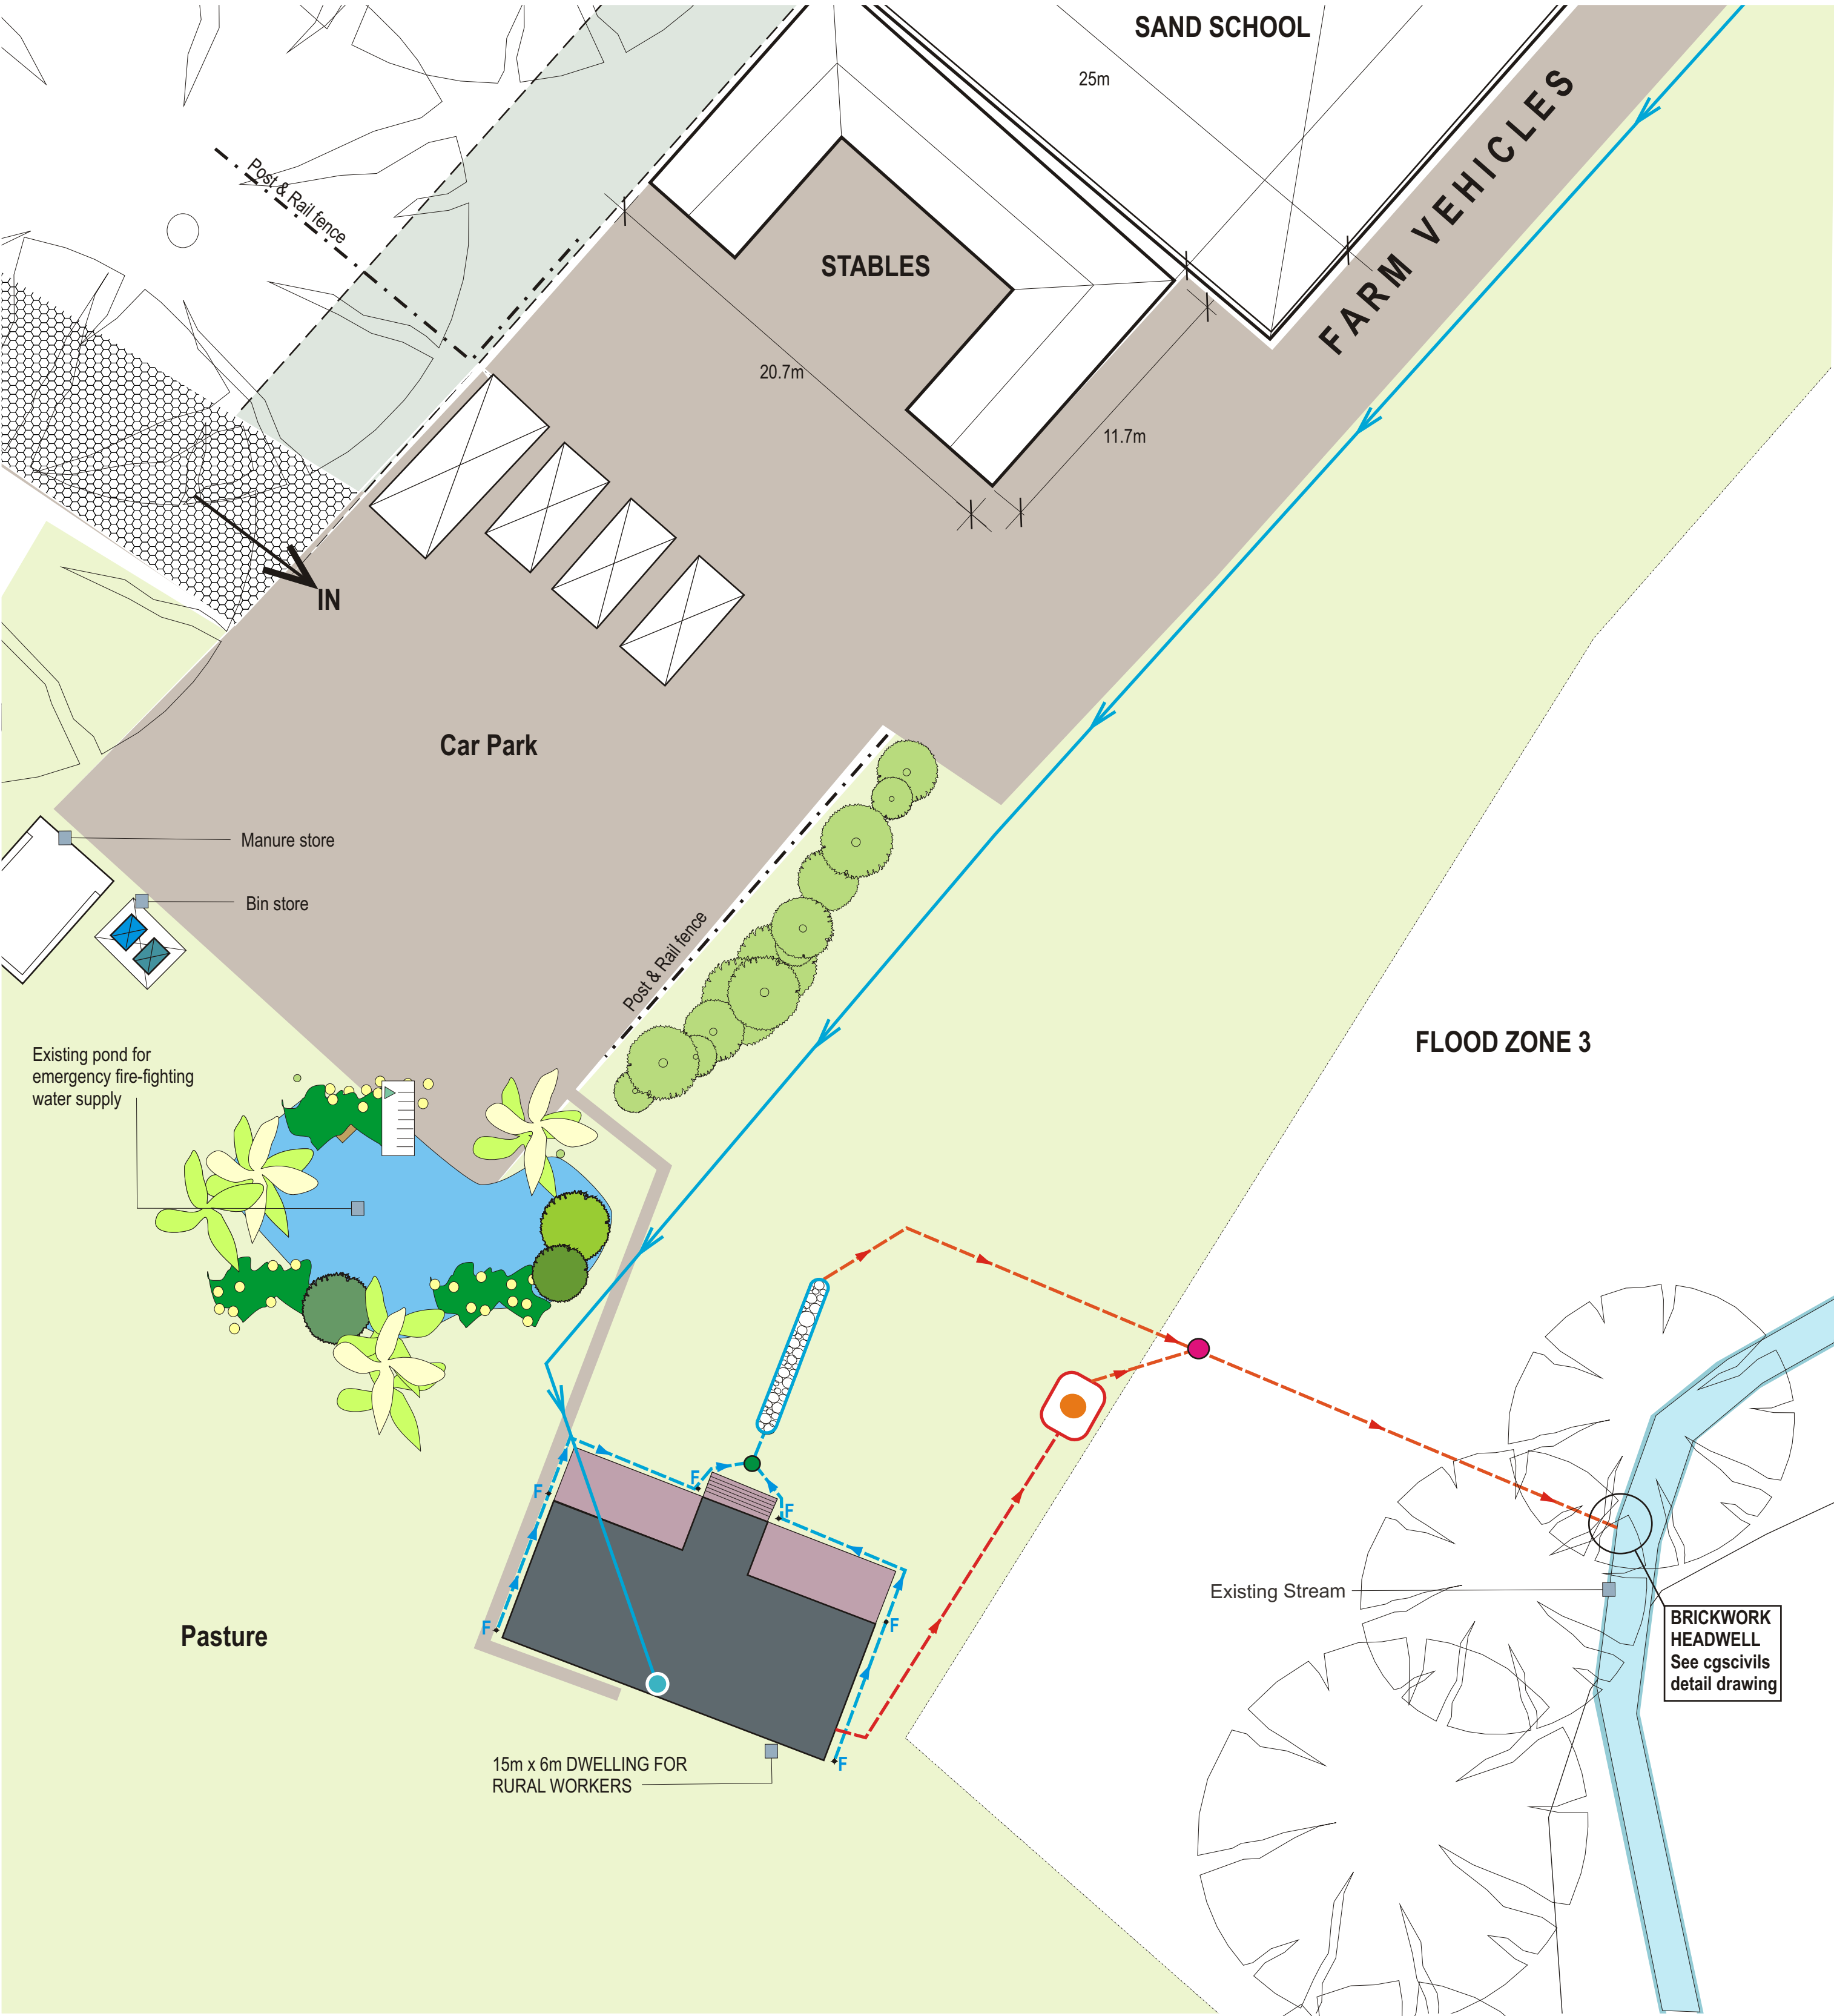
Kingspan Klargest package sewage treatment plant located more than 10m from dwelling and existing stream

Rainwater downpipe from guttering with "Celtic Sustainable" 3P filter collector

This is a temporary dwelling to be erected on "Groundscrews" because of the sloping land contours, so bio-retention planters cannot be fitted. Filter collectors are, however, fitted on each rainwater down-pipe and clearance of these and checking of the rainwater inspection chamber can be added to the maintenance regime for the whole of the Limekiln Farm site as set out for approved scheme DC/23/1325.
