## **LANDSCAPE & DRAINAGE MITIGATION NOTE**

**TEMPORARY (THREE YEARS) DWELLING FOR EQUINE  
WORKERS**

**NEWELL STUD  
LIMEKILN FARM  
BROADWATER LANE  
COPSALE  
RH13 6QW**

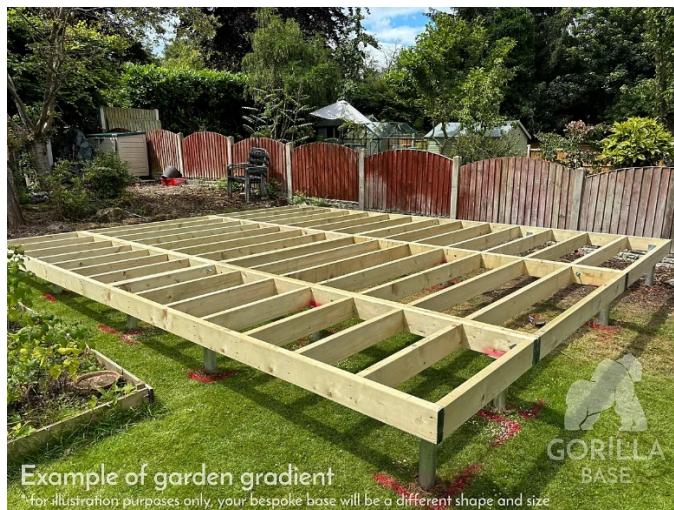
Because of the sloping land on the specific area of the proposed house and so as to preserve the existing rough grazing grass field surface as much as possible, the building will be constructed on a “raft” supported on groundscrews. At the conclusion of the permitted time for retention of the house, the groundscrews can be removed to leave the site in its current condition.
