**Subject:** Fwd: DC/26/0530. Land at Hornbook Farm  
**Date:** 7 May 2026 at 15:51  
**To:** [REDACTED]

I am writing to formally object to the proposed development at Hornbrook Farm. As a resident of 30 years at the valley floor, and a riparian owner of the stream I have direct evidence that the current proposal fails to account for critical topographical, geological, and ecological constraints at the southern boundary.

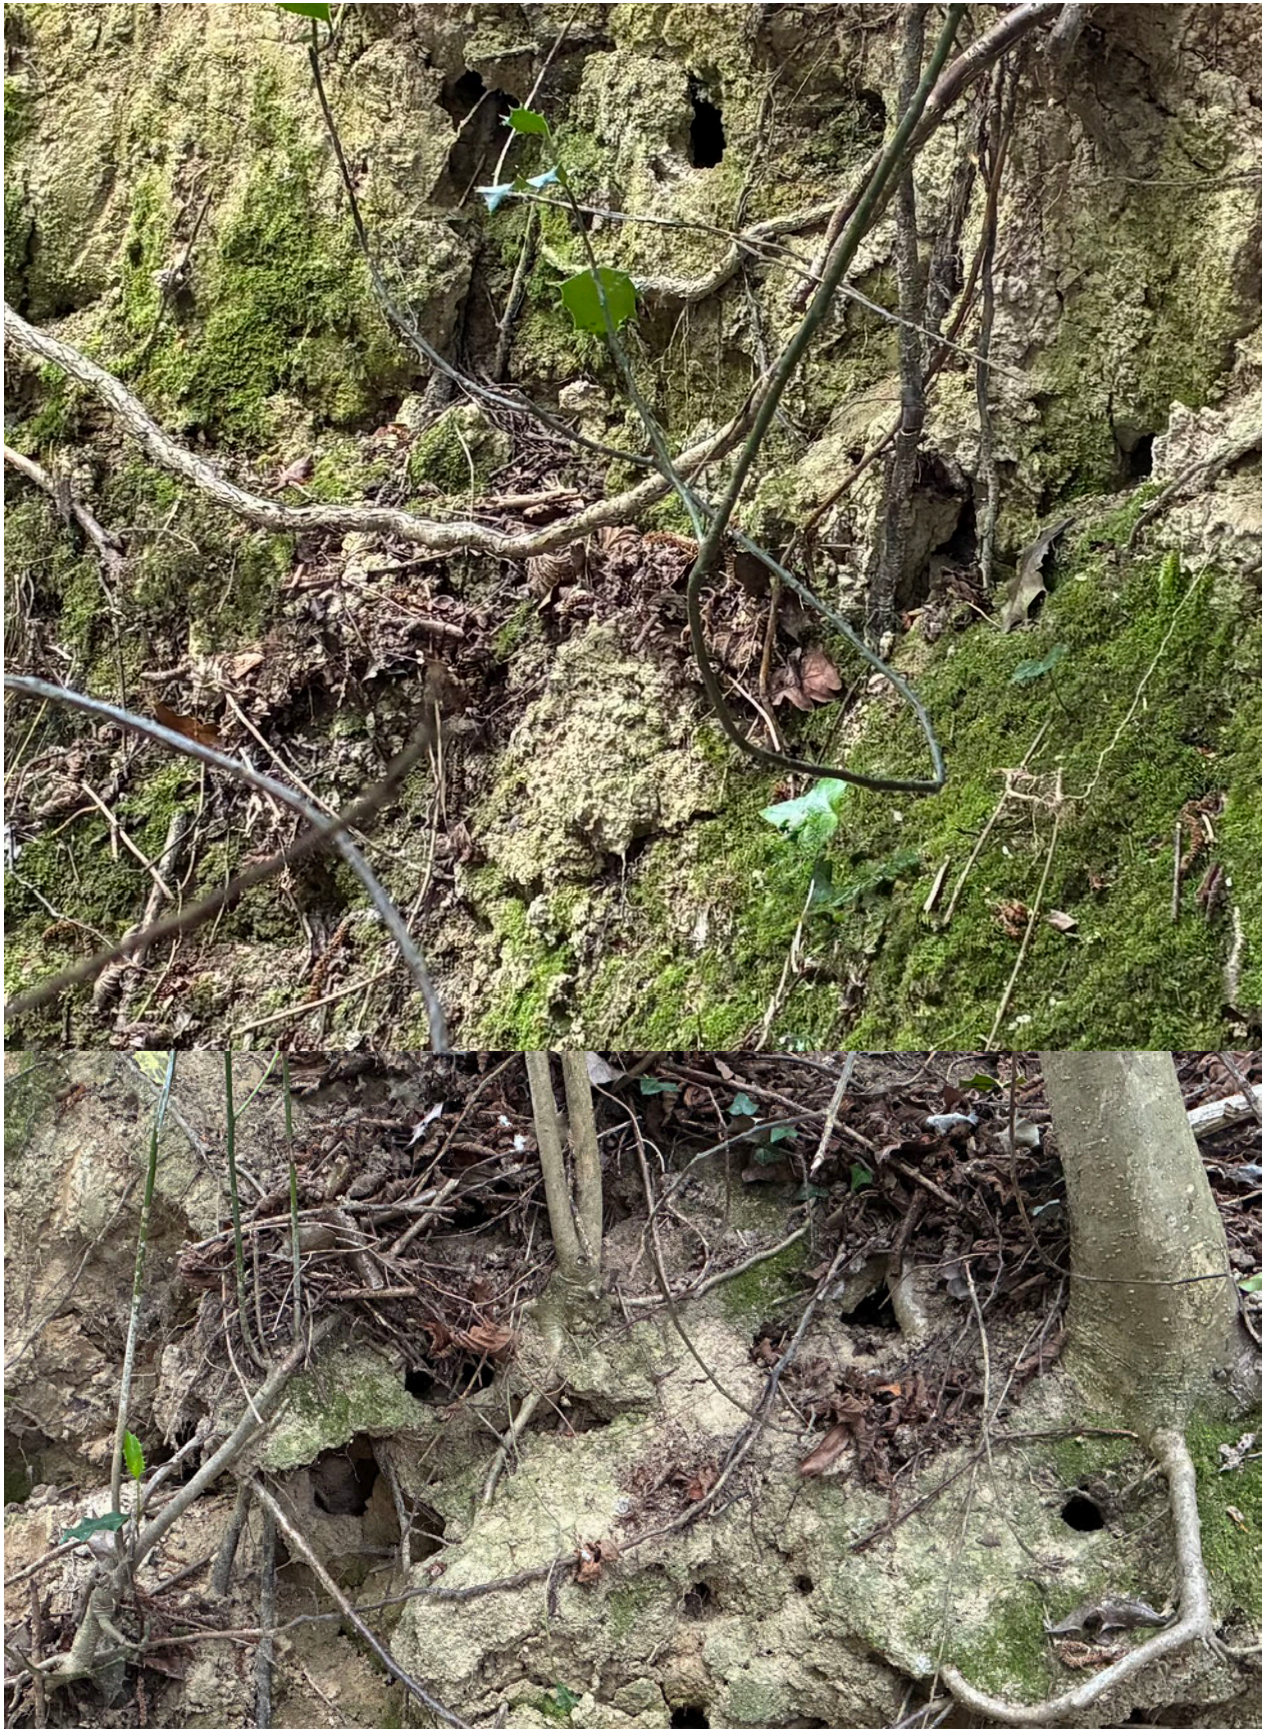
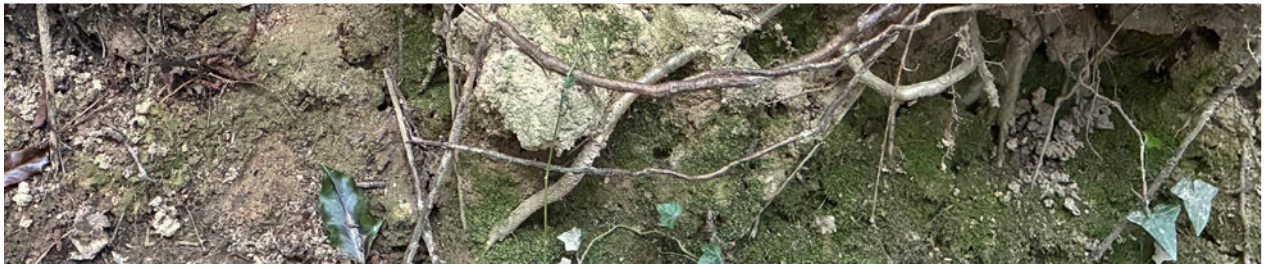
Further to my email below I am pleased to be able to provide evidence of my assertion that water voles are present in the Hornbrook. I accept that this is not accepted protocol but once again I attach two photographs that show vole burrows. Please can we press for a comprehensive survey of the brook, flora, fauna and archaeological .

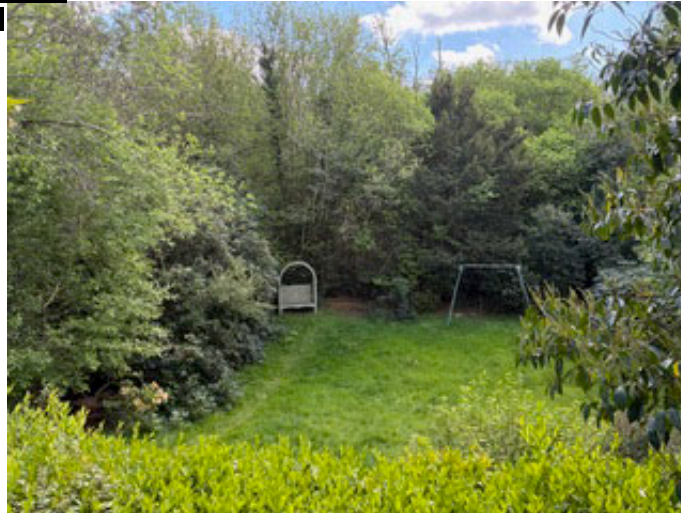
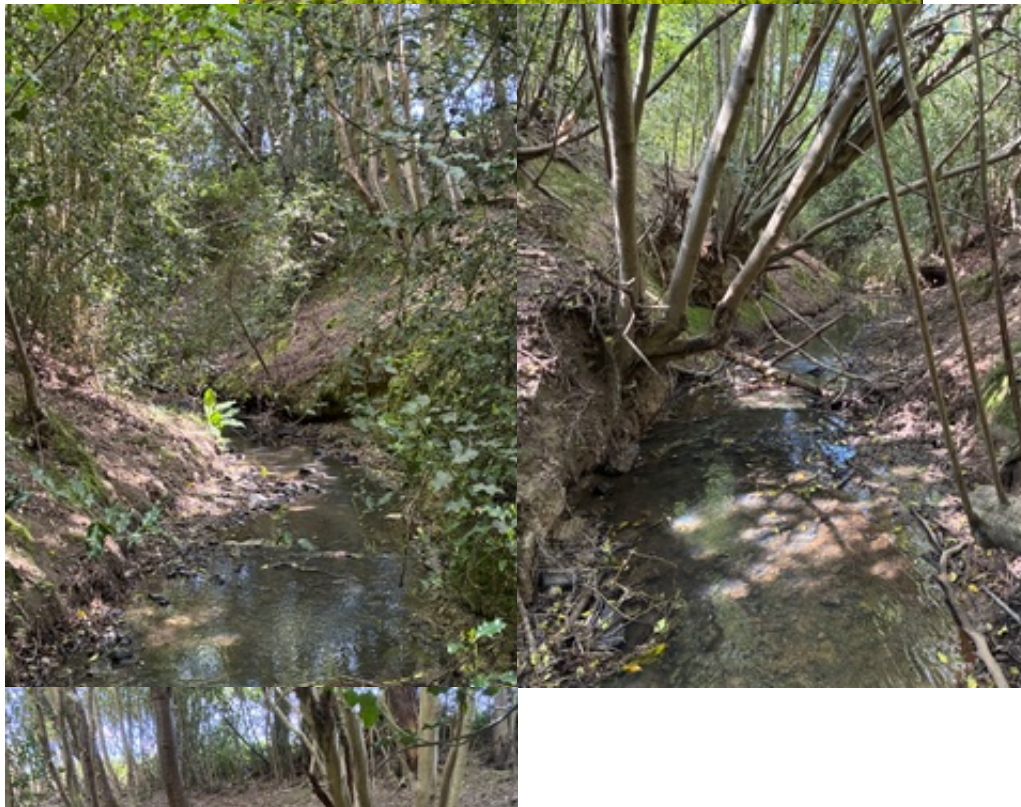
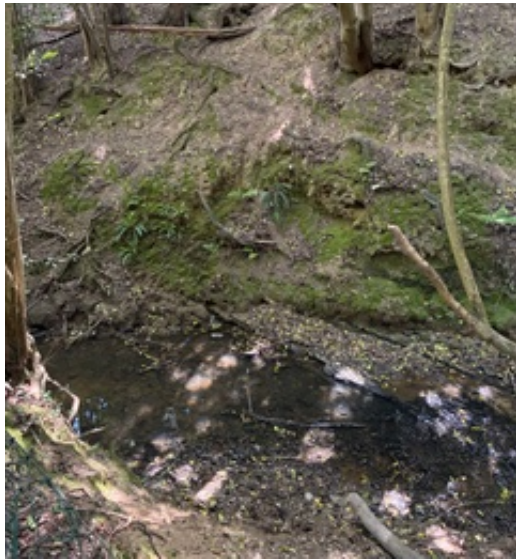
The proposal includes a public footpath along the crest of a bank that is approximately 10 metres high max with an extremely steep gradient. This bank is currently stabilized solely by a screen of mature trees. However:

**Active Erosion:** The trees are in significant decline, with root systems being undercut by active bank erosion. As these roots rot, the structural integrity of the slope will fail.

**Survey Deficit:** The site has not been surveyed from the valley floor. A top-down assessment fails to reflect the severity of the drop or the active rate of bank retreat.

1. Mandate a 20-metre 'No-Build/No-Path' Buffer Zone from the top of the bank to allow for natural retreat and stabilization.
2. Require a comprehensive bank stabilization and replanting scheme using water-tolerant species (e.g., Alder/Willow) to replace the dying screen.
3. Ensure a structural engineer assesses the impact of construction vibrations on the stability of these 10-metre slopes.

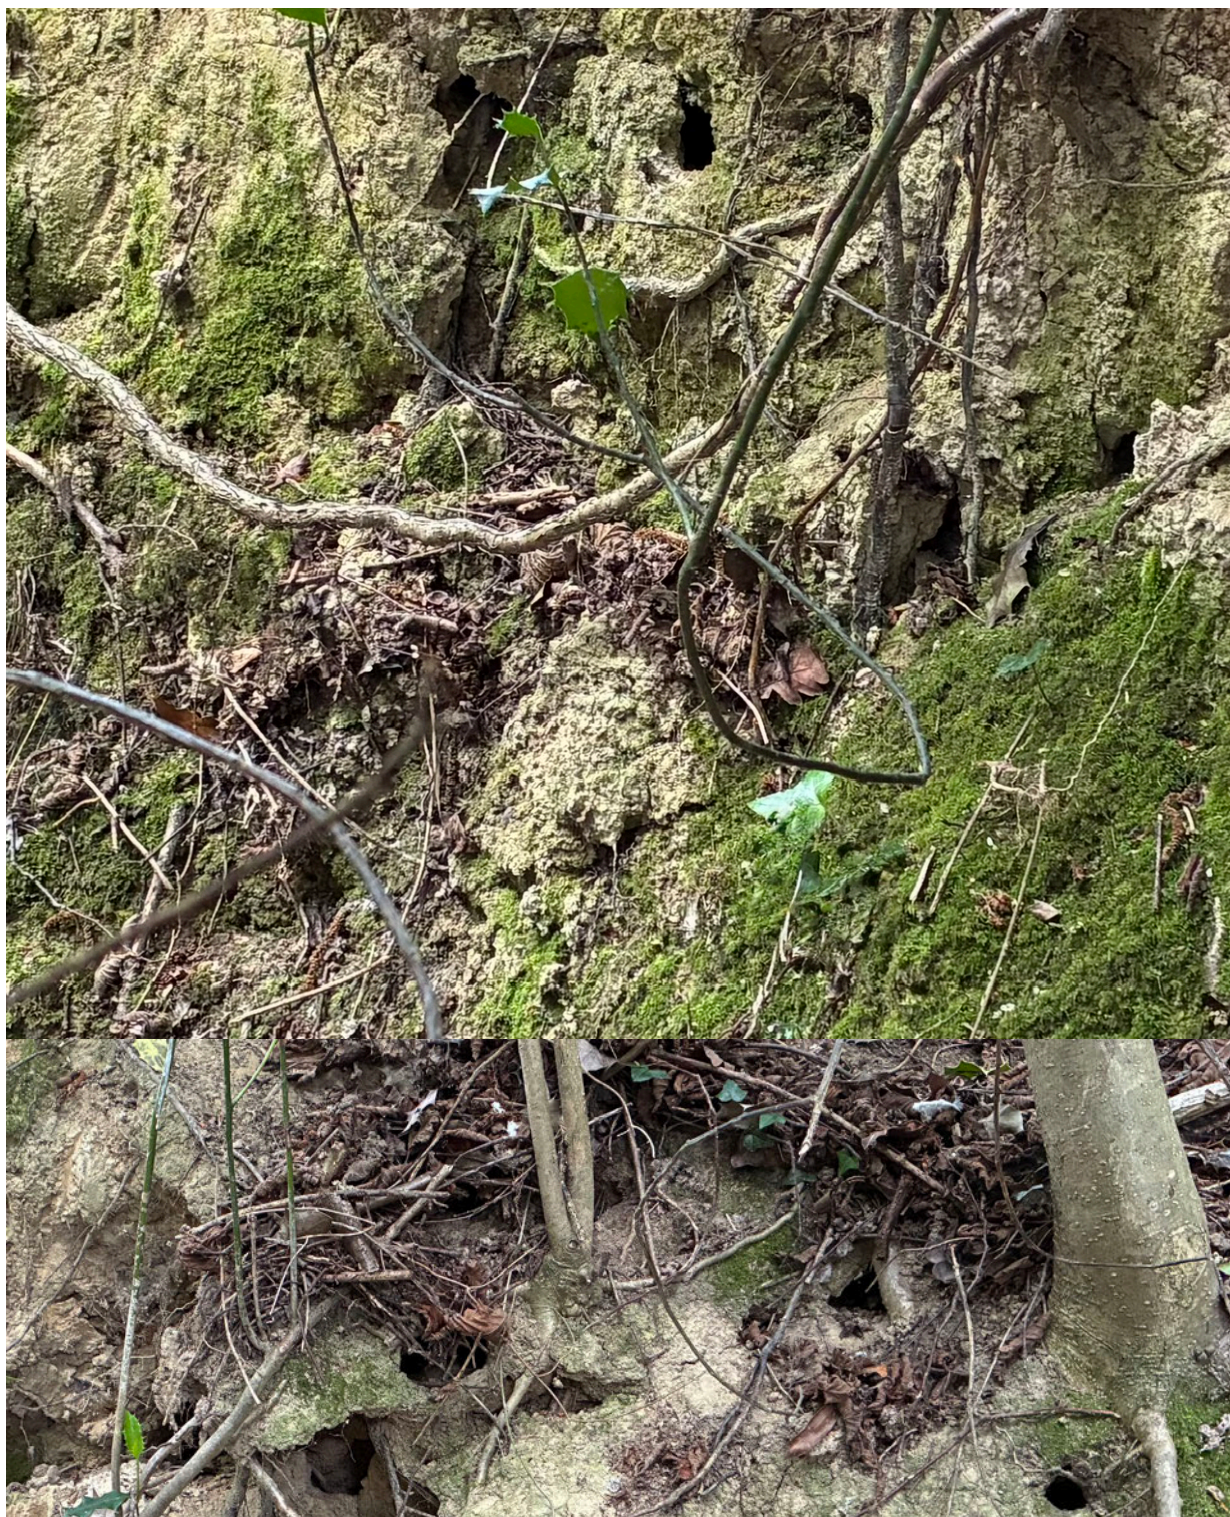
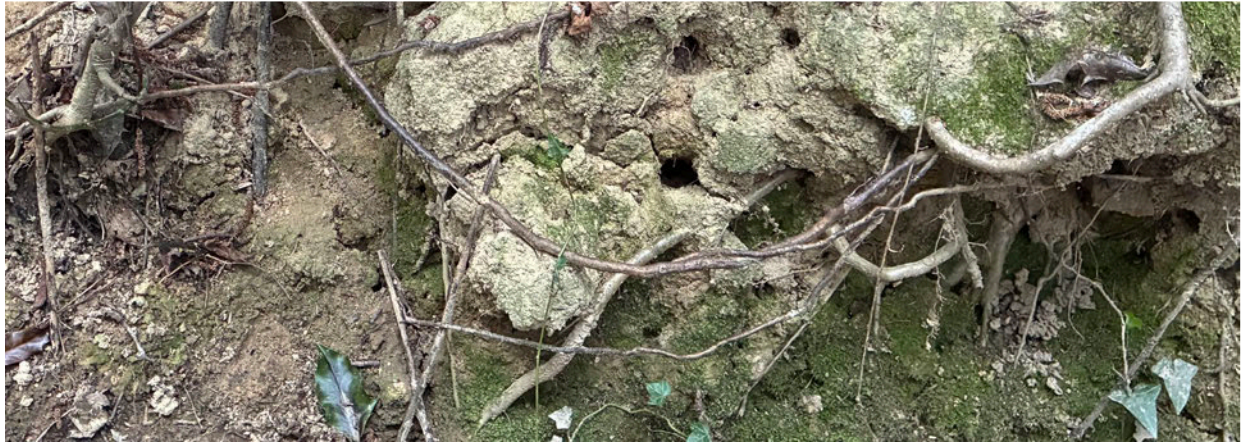
Further to my email below I am pleased to be able to provide evidence of my assertion that water voles are present in the Hornbrook. I accept that this is not accepted protocol but once again I attach two photographs that show vole burrows. Please can we press for a comprehensive survey of the brook, flora, fauna and archaeological .

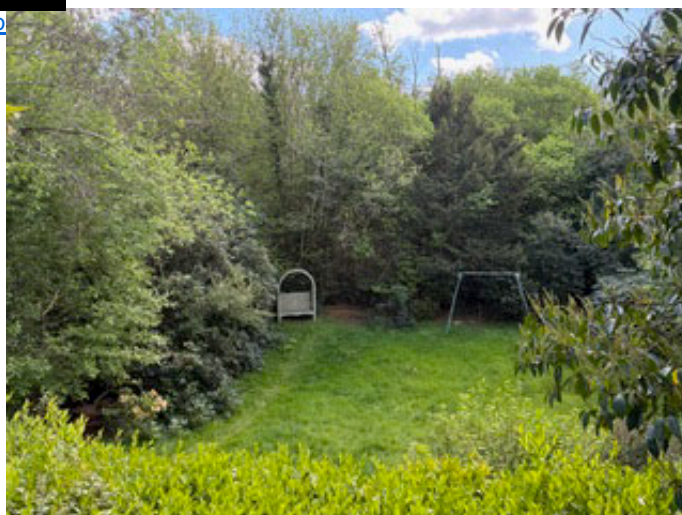
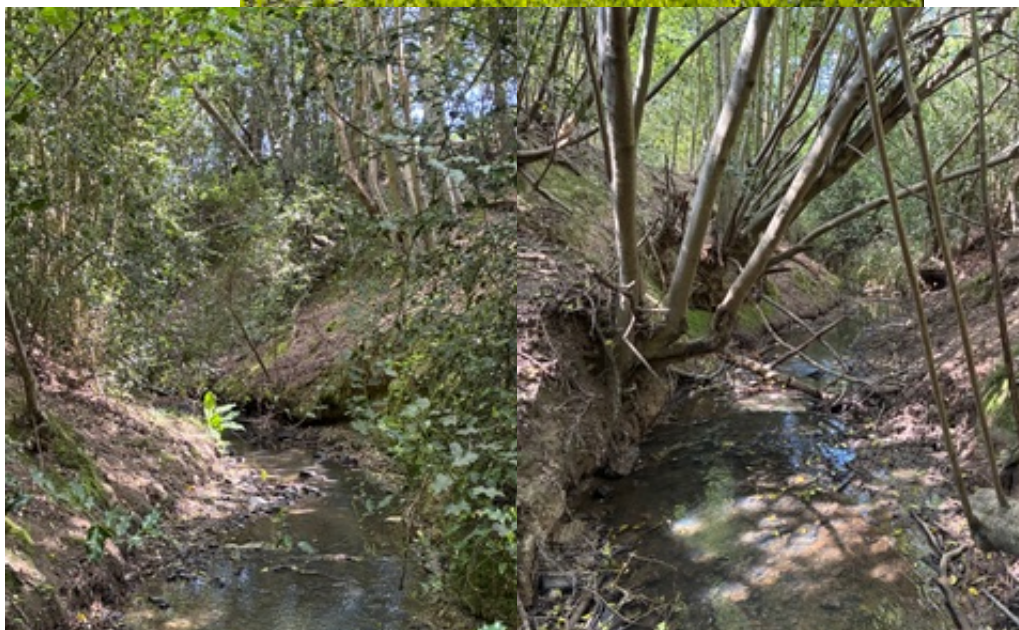
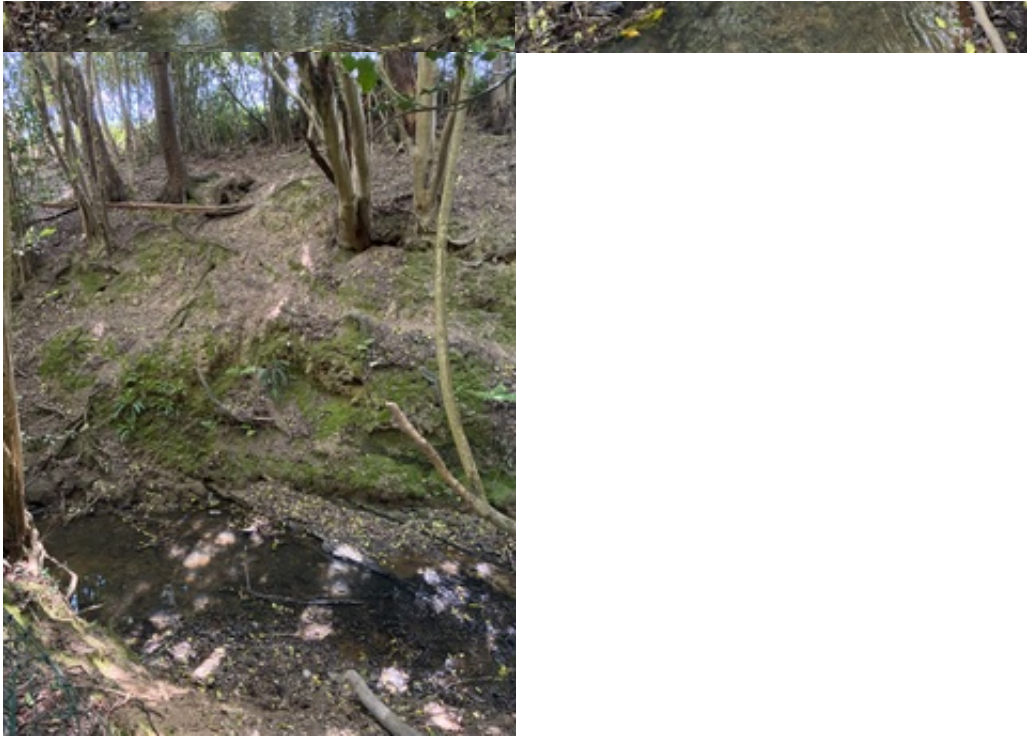
The proposal includes a public footpath along the crest of a bank that is approximately 10 metres high max with an extremely steep gradient. This bank is currently stabilized solely by a screen of mature trees. However:

**Active Erosion:** The trees are in significant decline, with root systems being undercut by active bank erosion. As these roots rot, the structural integrity of the slope will fail.

**Survey Deficit:** The site has not been surveyed from the valley floor. A top-down assessment fails to reflect the severity of the drop or the active rate of bank retreat.

1. Mandate a 20-metre 'No-Build/No-Path' Buffer Zone from the top of the bank to allow for natural retreat and stabilization.
2. Require a comprehensive bank stabilization and replanting scheme using water-tolerant species (e.g., Alder/Willow) to replace the dying screen.
3. Ensure a structural engineer assesses the impact of construction vibrations on the stability of these 10-metre slopes.
