# Stage 1 Road Safety Audit: Designers Response Report

Land at Eastlands Lane,  
Cowfold,  
West Sussex

**Cowlands Farm  
Eastlands Lane  
Cowfold  
Horsham**

Report No. EC/2025/11/GTA1

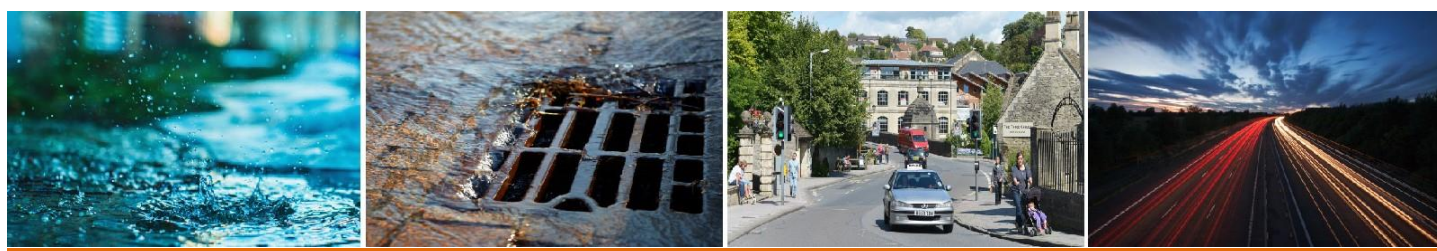
### Site Access Plan

- Installation of pedestrian crossing facilities, including dropped kerbs and tactile paving on both sides of the access.
  - Removal of existing obstructions, including an existing road sign and a brick pillar, with replacement sign location to be confirmed.

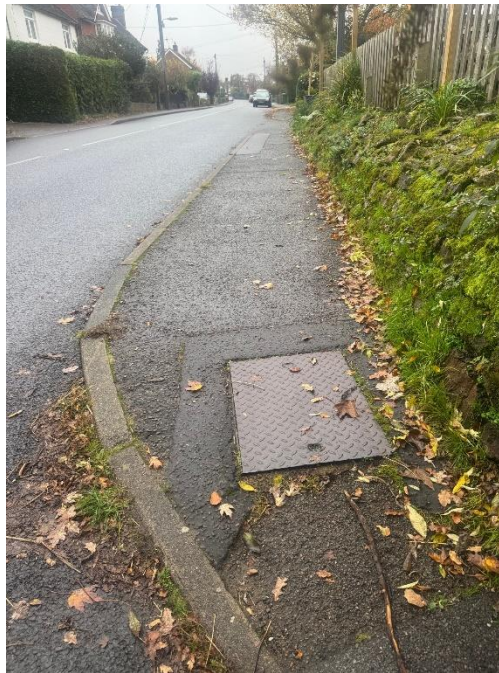
Summary: Interrupted or incomplete tactile paving may mislead visually impaired pedestrians and increase the risk of pedestrian–vehicle conflict.

Detail: An existing utility cover is located within the area proposed for tactile paving. Continuous tactile paving is required to clearly define the crossing point, particularly for blind and partially sighted pedestrians. If the tactile pattern is broken or cannot be installed across the cover, significant sections of the detectable surface may be missing, reducing its effectiveness, increasing the risk of it being undetected by sight impaired pedestrians. This could cause uncertainty over the correct crossing location and may lead sight impaired pedestrians to step into the carriageway inadvertently, increasing the risk of collisions with vehicles .

| Problem | Location | Description | Recommendation | Design Organisation Response | Overseeing Organisation Response | Agreed RSA Action |
|---|---|---|---|---|---|---|
| 4.1 | Proposed Informal Crossing | <p>Interrupted or incomplete tactile paving may mislead visually impaired pedestrians and increase the risk of pedestrian-vehicle conflict.</p> <p>An existing utility cover is located within the area proposed for tactile paving. Continuous tactile paving is required to clearly define the crossing point, particularly for blind and partially sighted pedestrians. If the tactile pattern is broken or cannot be installed across the cover, significant sections of the detectable surface may be missing, reducing its effectiveness, increasing the risk of it being undetected by sight impaired pedestrians.</p> | It is recommended an infill cover be with tactile surfacing is provided. | <p>Agreed. An infill cover will be provided in this instance. This will be agreed and incorporated at detailed design stages.</p> <p><b>This point is now resolved.</b></p> | | |

It is recommended an infill cover be with tactile surfacing is provided..

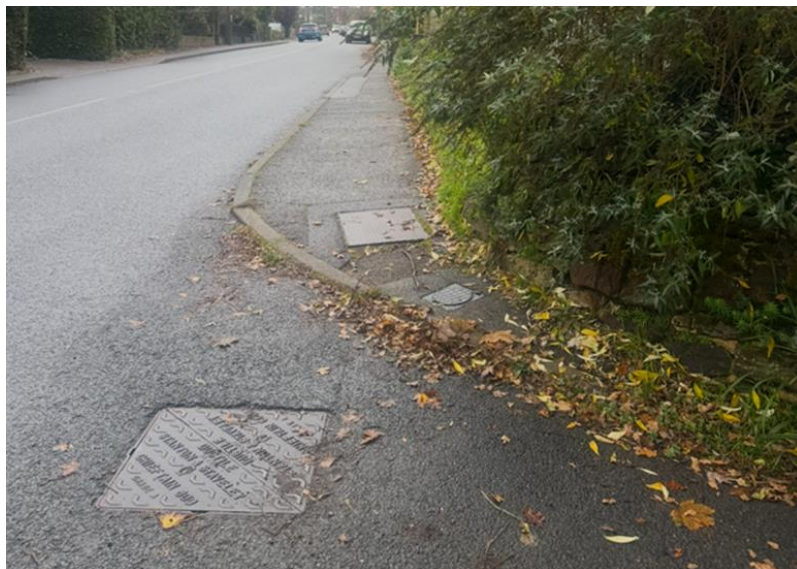
Summary: Risk of slips, trips, or falls, particularly in wet weather due to the position of the utility cover on the desire line.

Detail: A utility cover is located centrally, directly on the natural desire line between the footway and the crossing points. Utility covers can become slippery when wet. This introduces a potential hazard for pedestrians, especially for those with reduced mobility, wheelchair users, or during adverse weather conditions. Two-wheeled users may be susceptible to being unseated when turning into and out of the access road during periods of wet weather when the cover may become slippery.

| 4.3. | Proposed Access | <p>Risk of slips, trips, or falls, particularly in wet weather due to the position of the utility cover on the desire line.</p> <p>A utility cover is located centrally, directly on the natural desire line between the footway and the crossing points. Utility covers can become slippery when wet. This introduces a potential hazard for pedestrians, especially for those with reduced mobility, wheelchair users, or during adverse weather conditions. Two-wheeled users may be susceptible to being unseated when turning into and out of the access road during periods of wet weather when the cover may become slippery.</p> | <p>It is recommended the utility cover is replaced with a skid-resistant type.</p> | <p>Agreed. The utility cover will be replaced with a skid-resistant type. This will be agreed and incorporated at detailed design stages.</p> <p><b>This is now deemed to be resolved.</b></p> | | |

It is recommended the utility cover is replaced with a skid-resistant type.
