# LEVEL MONITORING

## for SMS (AXA)

**1 Leith View Cottages, Dorking Road, Kingsfold, Horsham, RH12 3SB**

## Level Monitoring Readings

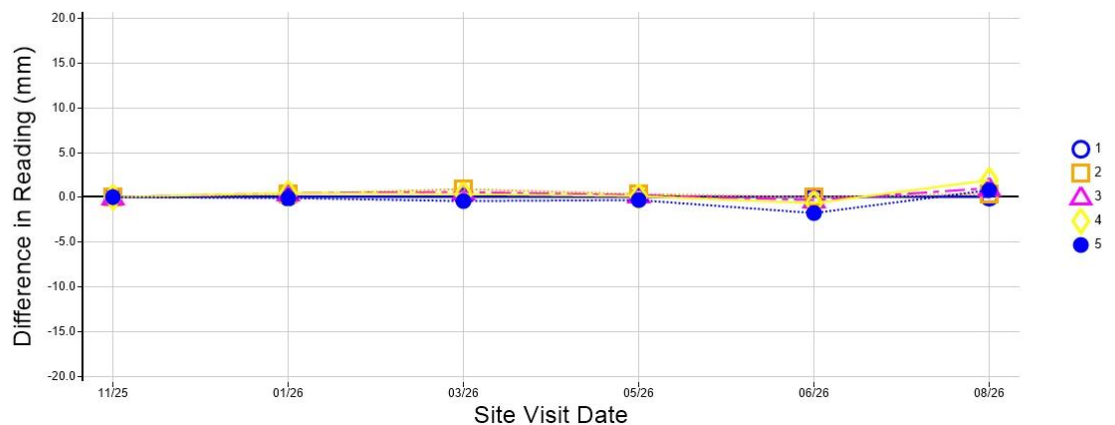
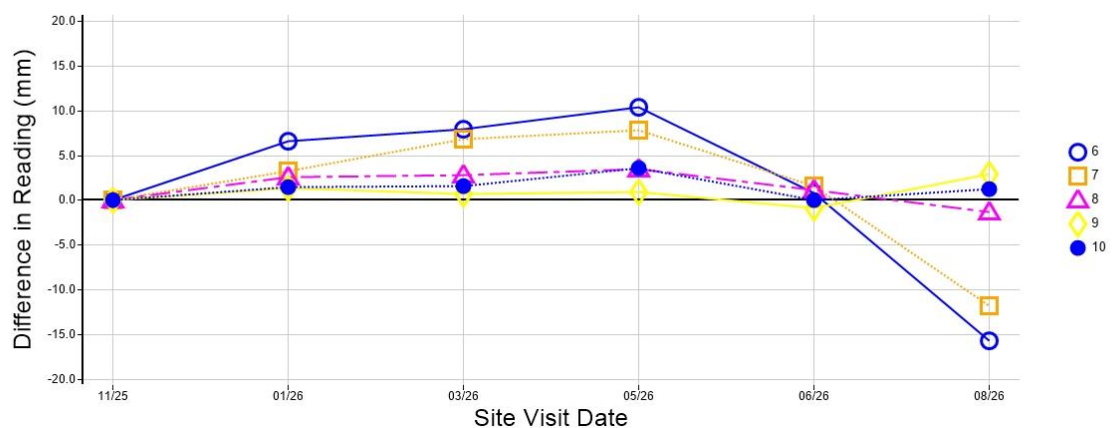
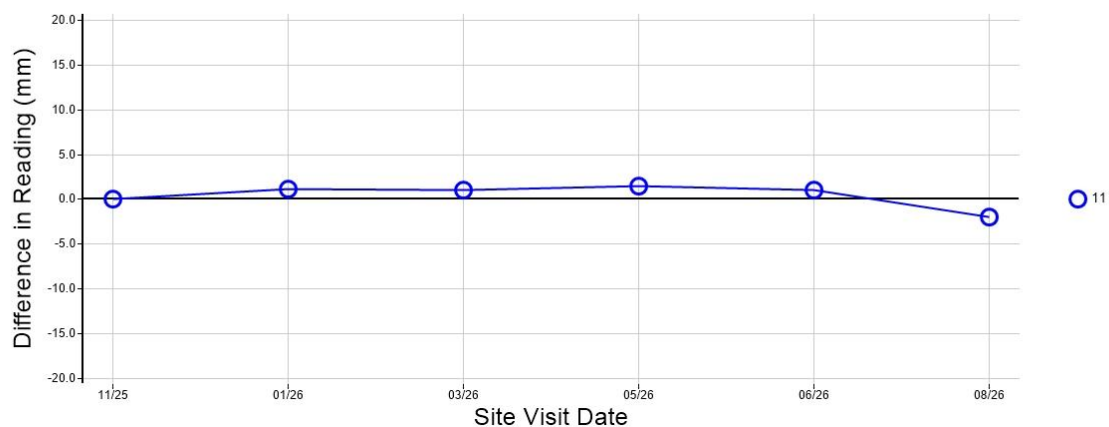
## Level Monitoring Difference Graphs

The following graphs display the progressive movement that each Level Monitoring Station recorded at each separate site visit date to give an overall look at how much the property is moving.

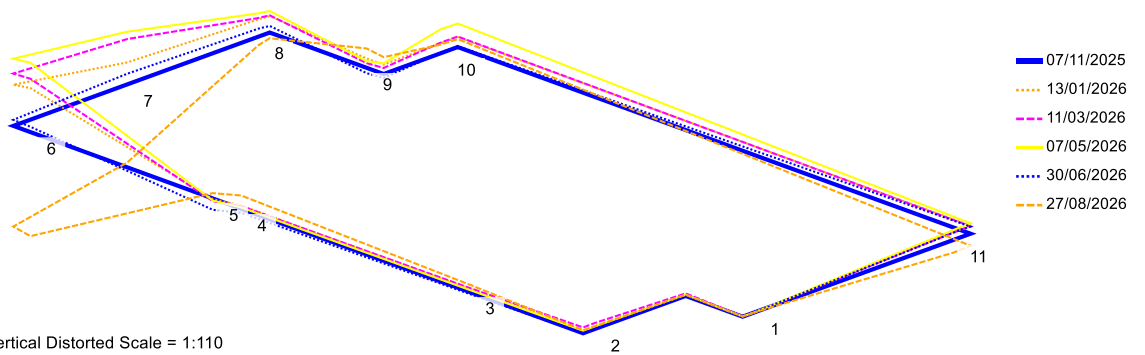
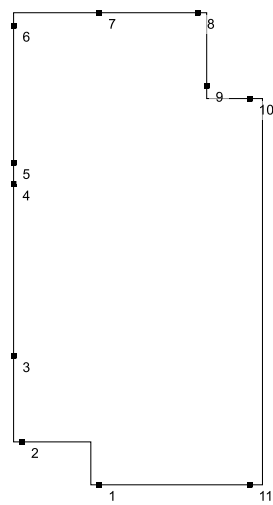
## Level Monitoring Displacement Map

The following image shows an isometric representation of the movement of the property, based on the Level Monitoring Stations that were installed.
