# LEVEL MONITORING

## for SMS (LBG)

**Montrose House, Twittenside, Steyning, BN44 3TW**

Report Date: 4 February 2026

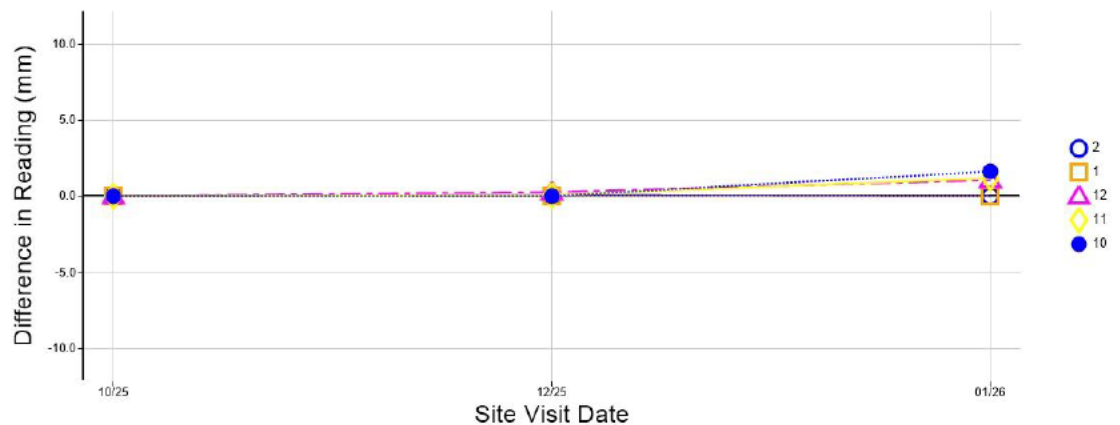
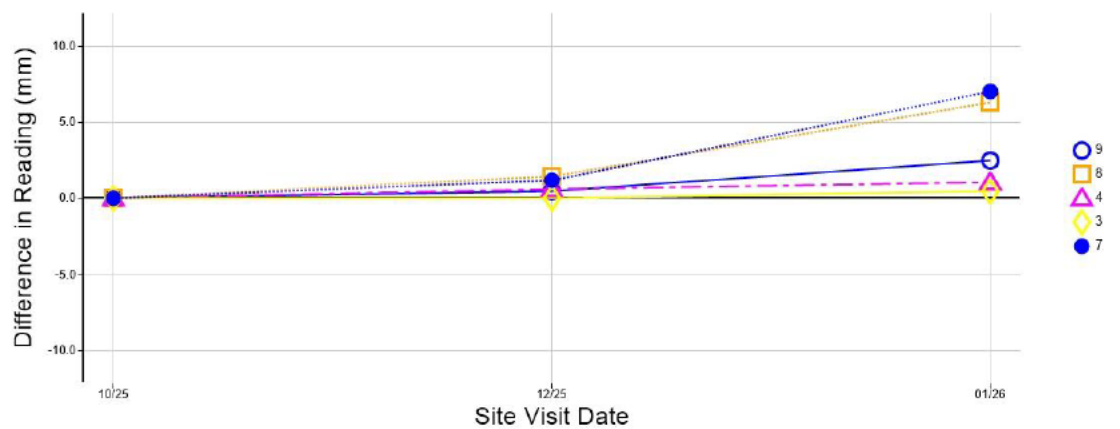
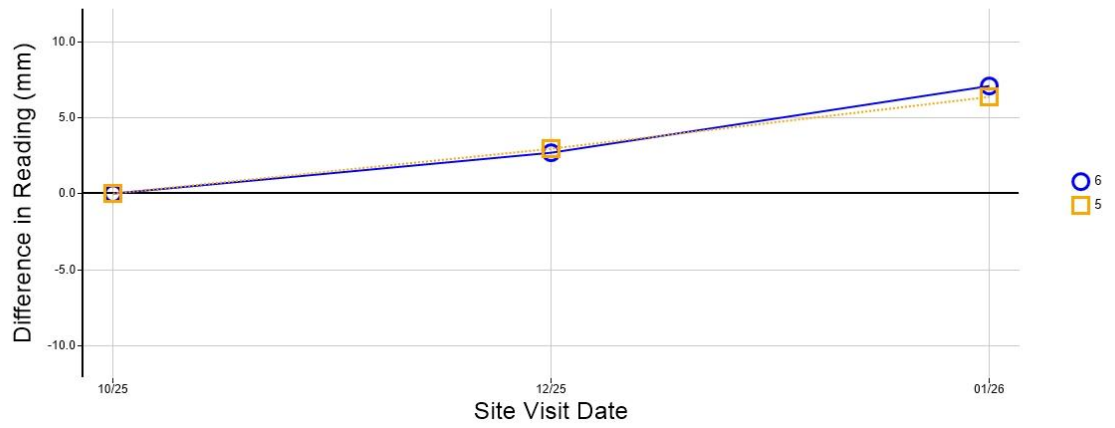
## Level Monitoring Difference Graphs

The following graphs display the progressive movement that each Level Monitoring Station recorded at each separate site visit date to give an overall look at how much the property is moving.

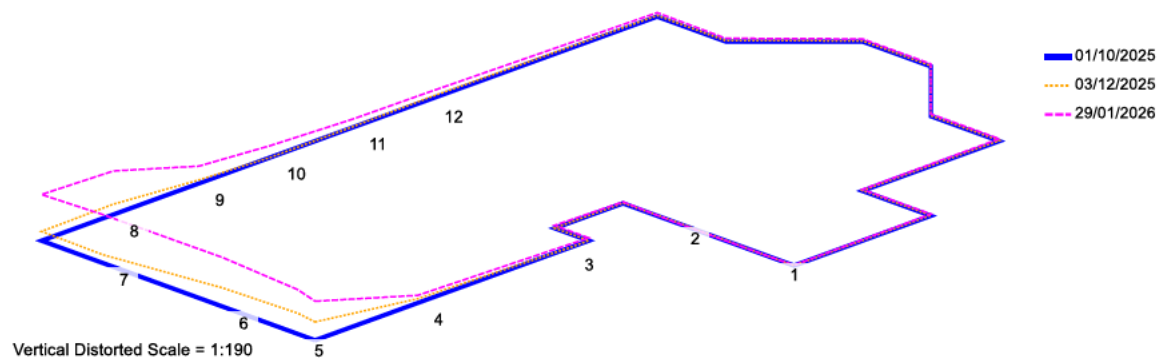
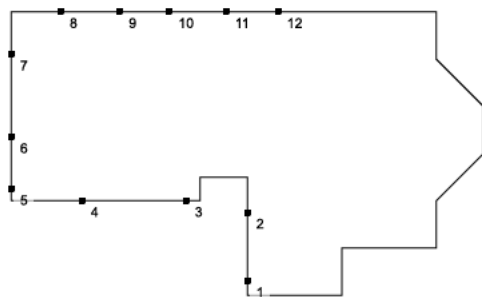
## Level Monitoring Displacement Map

The following image shows an isometric representation of the movement of the property, based on the Level Monitoring Stations that were installed.

FRONT

Datum located at P1 on the front elevation as per instruction.
