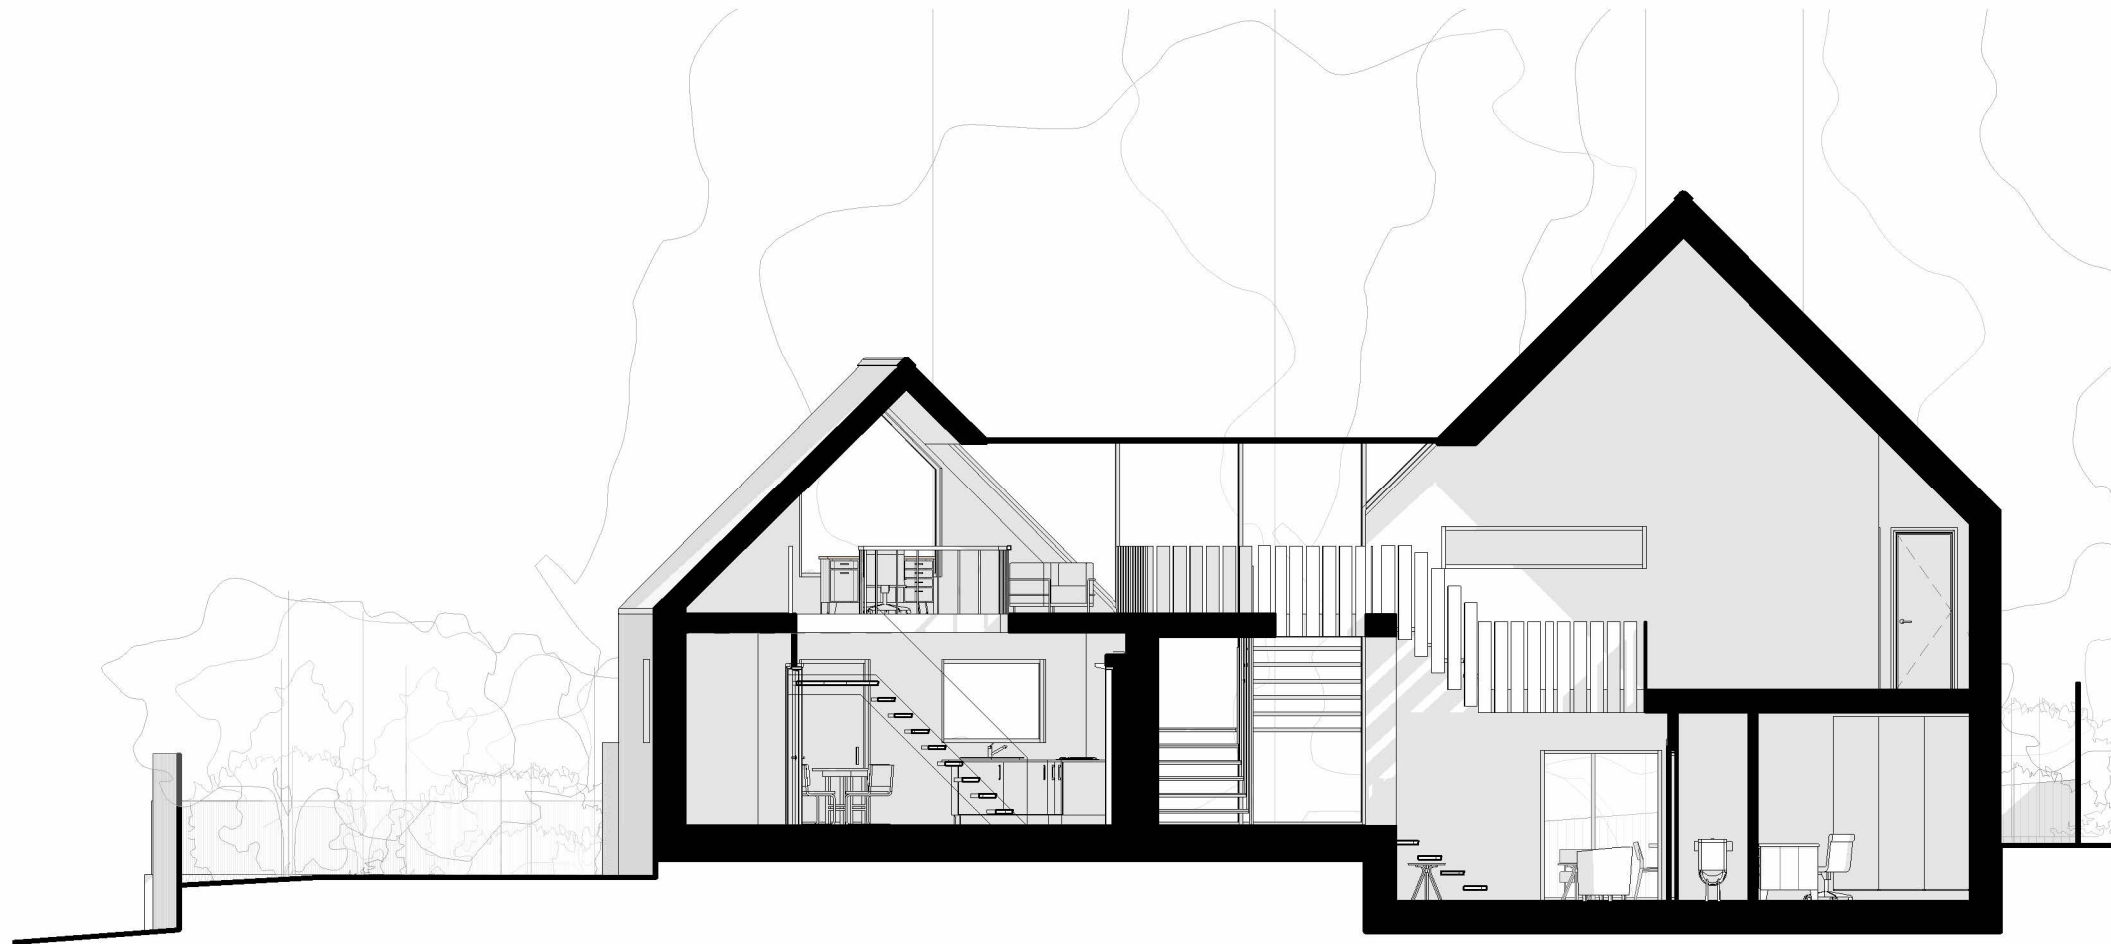
Section AA  
1:100

- Key
- 1 Sunken Living space
  - 2 Level Access to Garage
  - 3 Masonry Retaining Wall with Native Hedgerow Screening
