## LEVEL MONITORING - RELATIVE SURVEY READINGS

| Provider Details | | | Client Details | | Risk Address | |
|---|---|--|---|---|---|---|
| Name: | Gryphon Surveys | | Client Name: | | Occupier: | Mr C & Miss R Sandhu |
| Instruction Date: | 20/6/22 | | Address: | Matthew Street | Post Code: | RH12 3HG |

## LEVEL MONITORING - RELATIVE MOVEMENT SKETCH

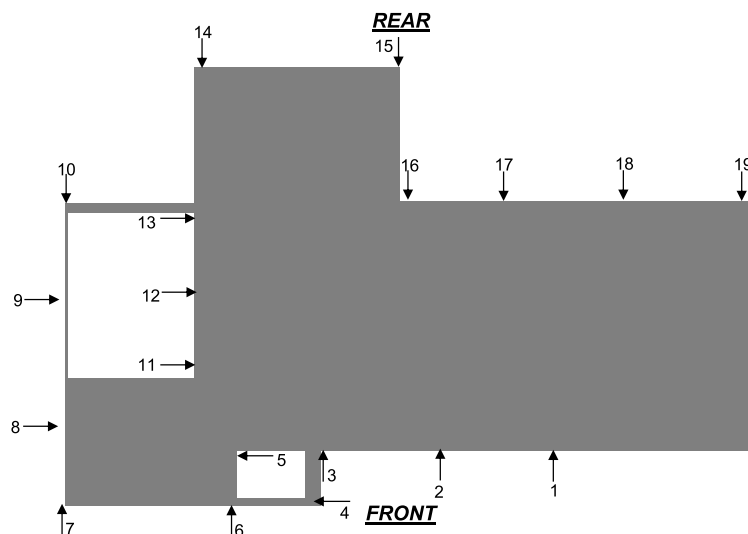
- The points could not be taken on a common brickcourse subsequently relative data only
- TBM 1 appears damaged, We have used TBM 2 as the stable point. 16/09/22
- Further readings will be taken on a bi-monthly basis.

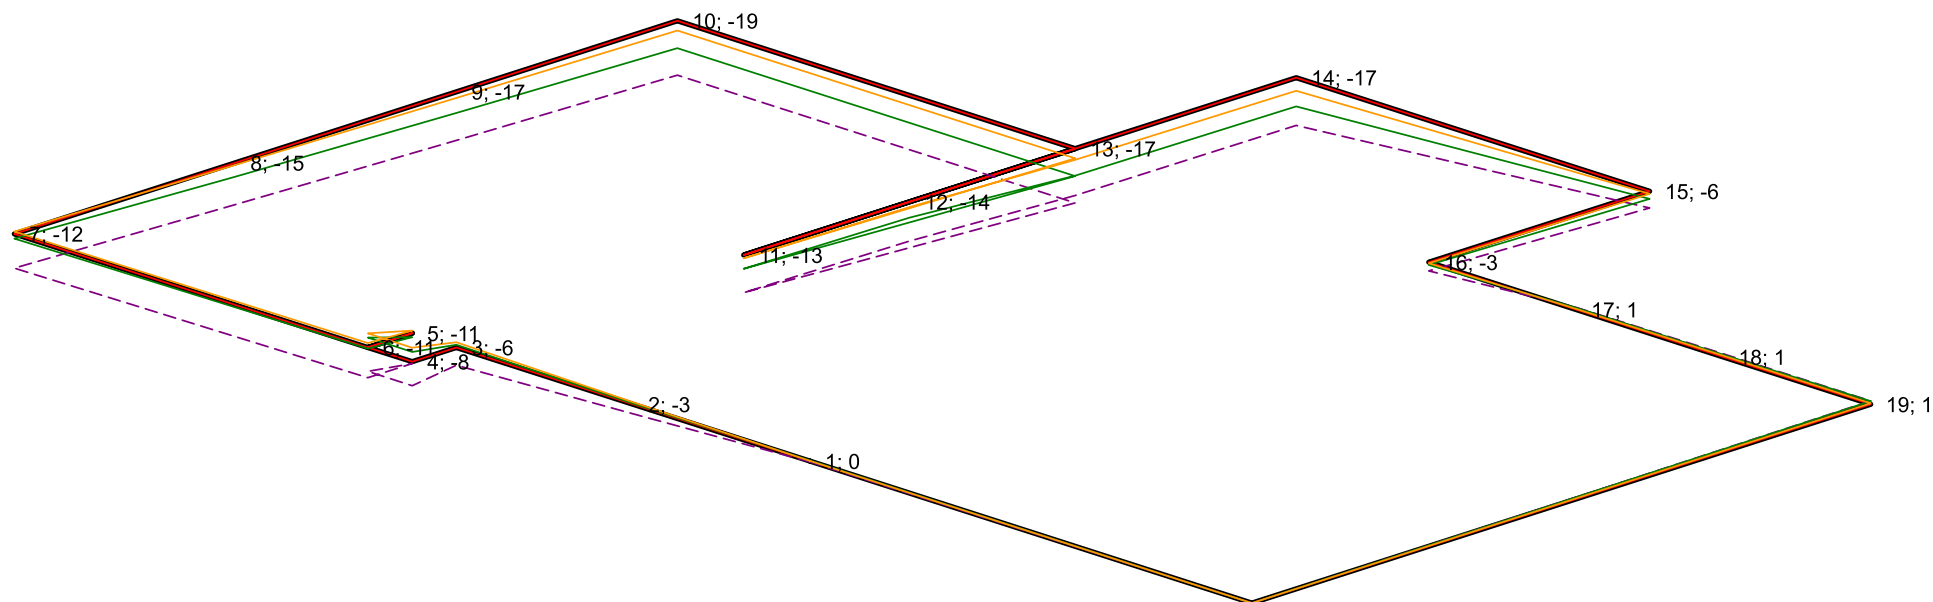
Notes:  
Vertical distorted scale 1: 100

Point labels give level difference of last reading from original datum in mm.
