| Code | Observation | Rem |
|---|---|---|
| MH | Start node, manhole, reference: FW1 | |

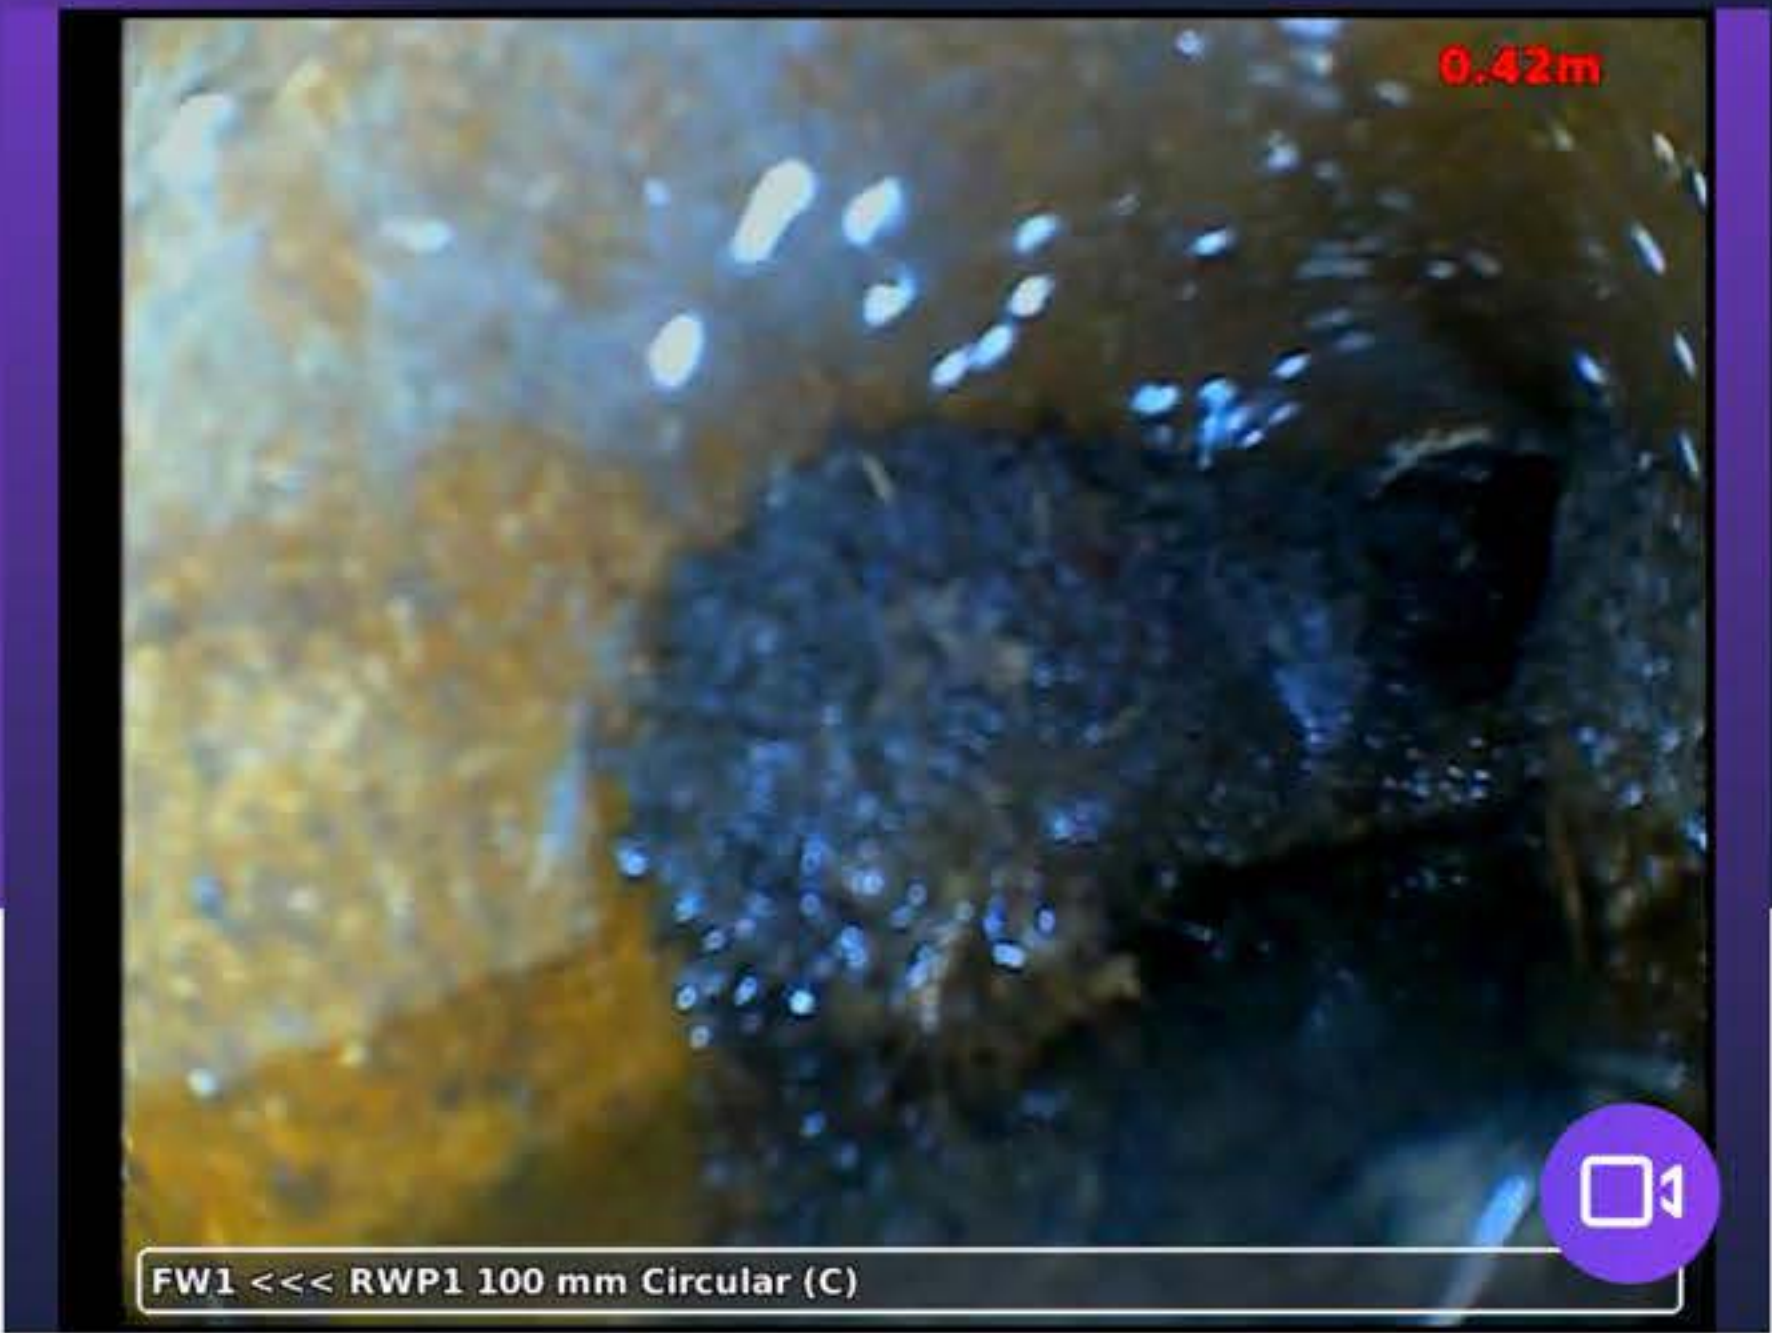
| Code | Observation | Rem |
|---|---|---|
| RM | Roots, mass, 100% cross-sectional area loss | |
| SA | Survey abandoned | Ur |
