## LISTED BUILDING APPLICATION

Project  
**10 MARKET SQUARE HORSHAM:**  
Remedial works including proposed replacement of the decayed timber floor structure within the commercial unit

Drawing Title  
**Block Plan As proposed**

Drawing No. **M215PC/LB/02** Rev.

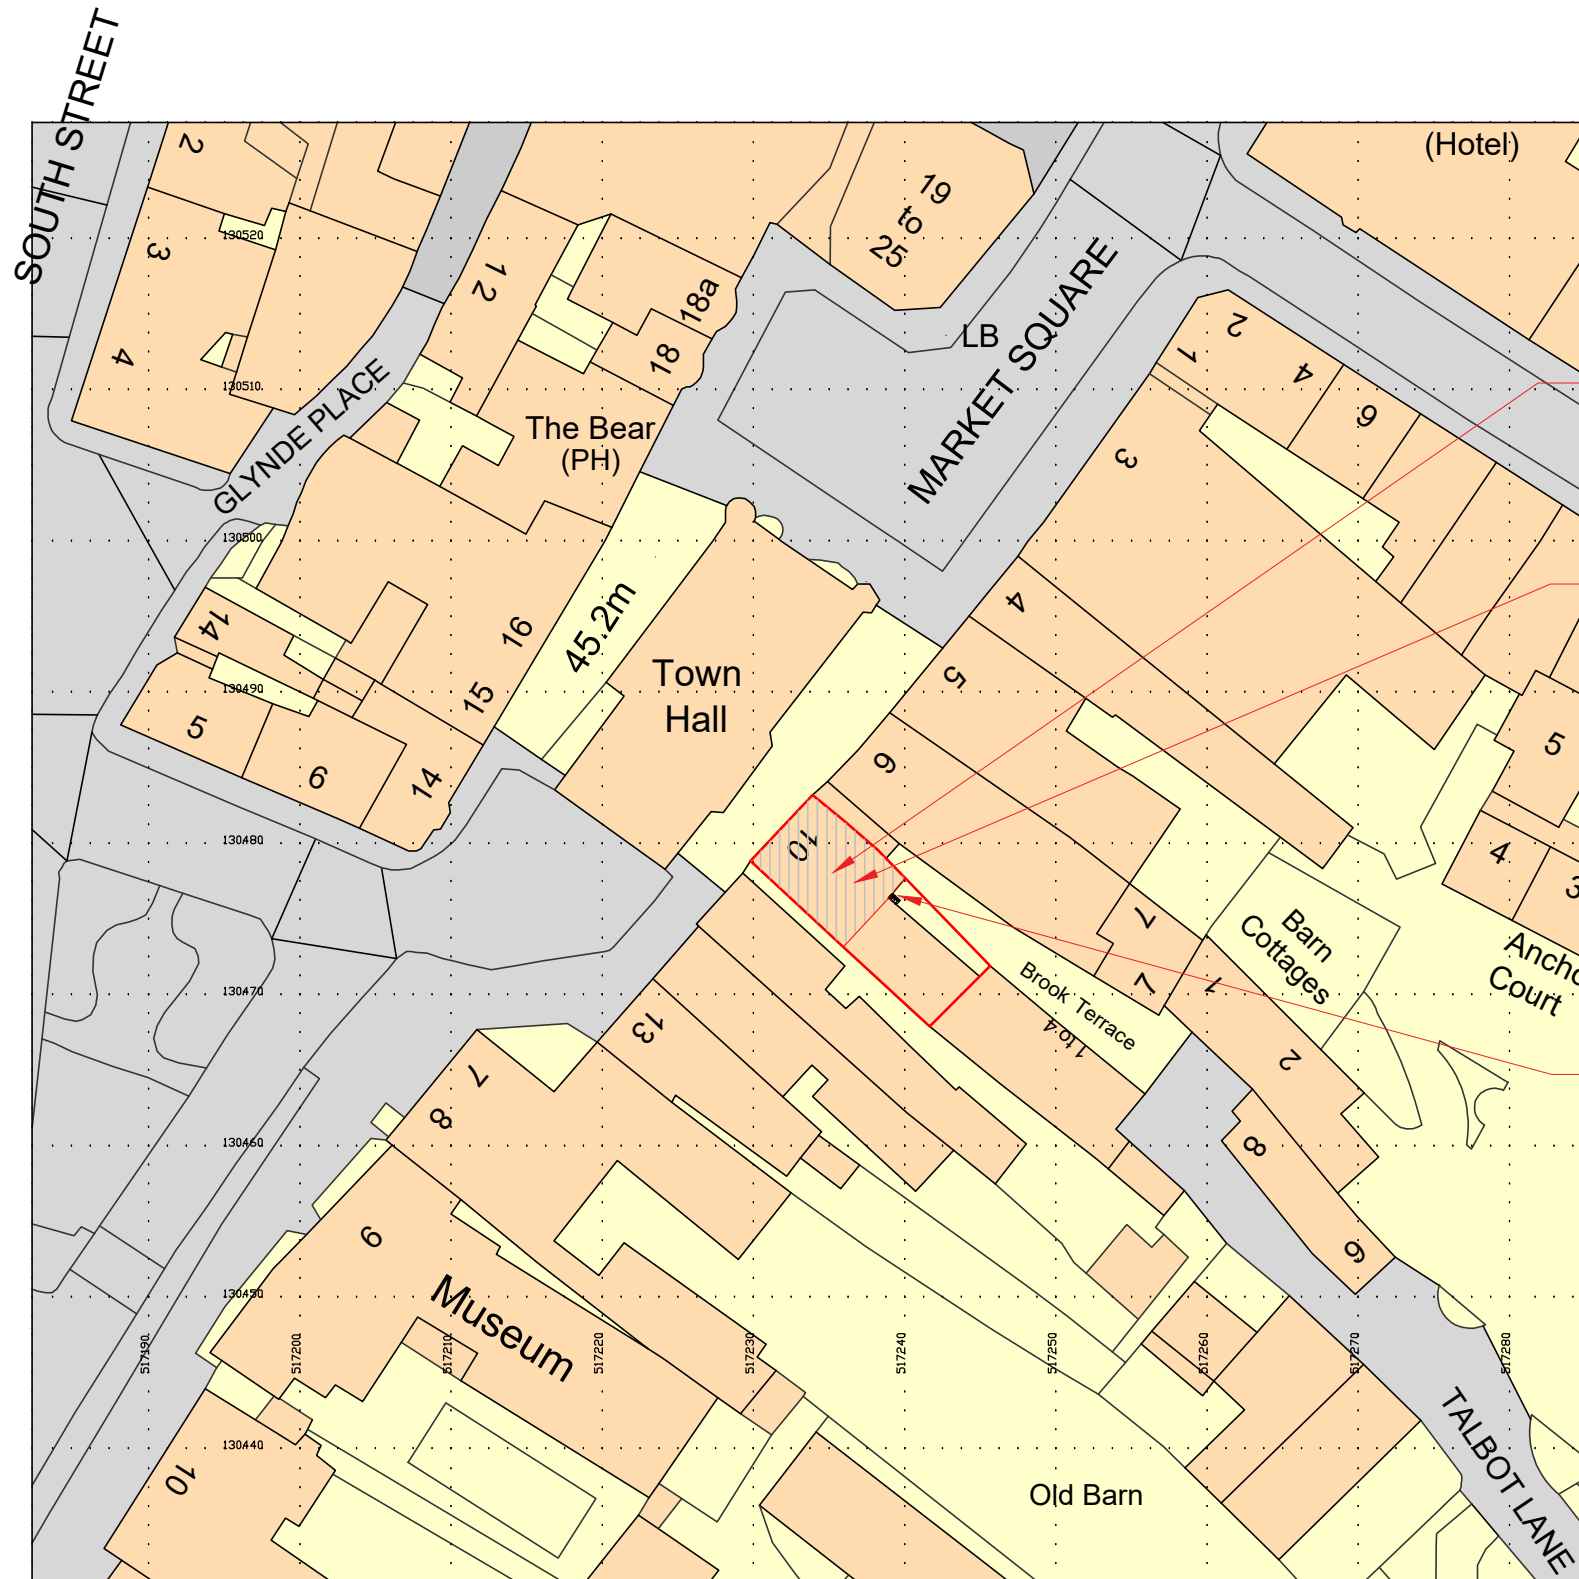
**BLOCK PLAN**  
As Proposed  
Scale 1:500

**DRY ROT REMOVAL & TREATMENT**  
Dry rot to be removed and the area treated by specialist company.

**FLOOR STRUCTURE**  
The internal ground floor suspended timber floor structure within this hatched section of the shop has decayed (wet & dry rot present). Floor to be stripped out completely, and a new suspended timber floor installed and supported on the existing steel beams. New padstones to be installed to ends of steel beams.

**DRAINAGE PIPEWORK**  
Defective and leaking soil pipework to be replaced with new clay pipework.
