Lower Broadbridge Farm  
Broadbridge Heath

# **Arboricultural Method Assessment**

| Project Details | |
|---|---|
| <b>Project:</b> | Lower Broadbridge Farm, Broadbridge Heath |
| <b>File Reference:</b> | 12790_AMS.001 Rev C |

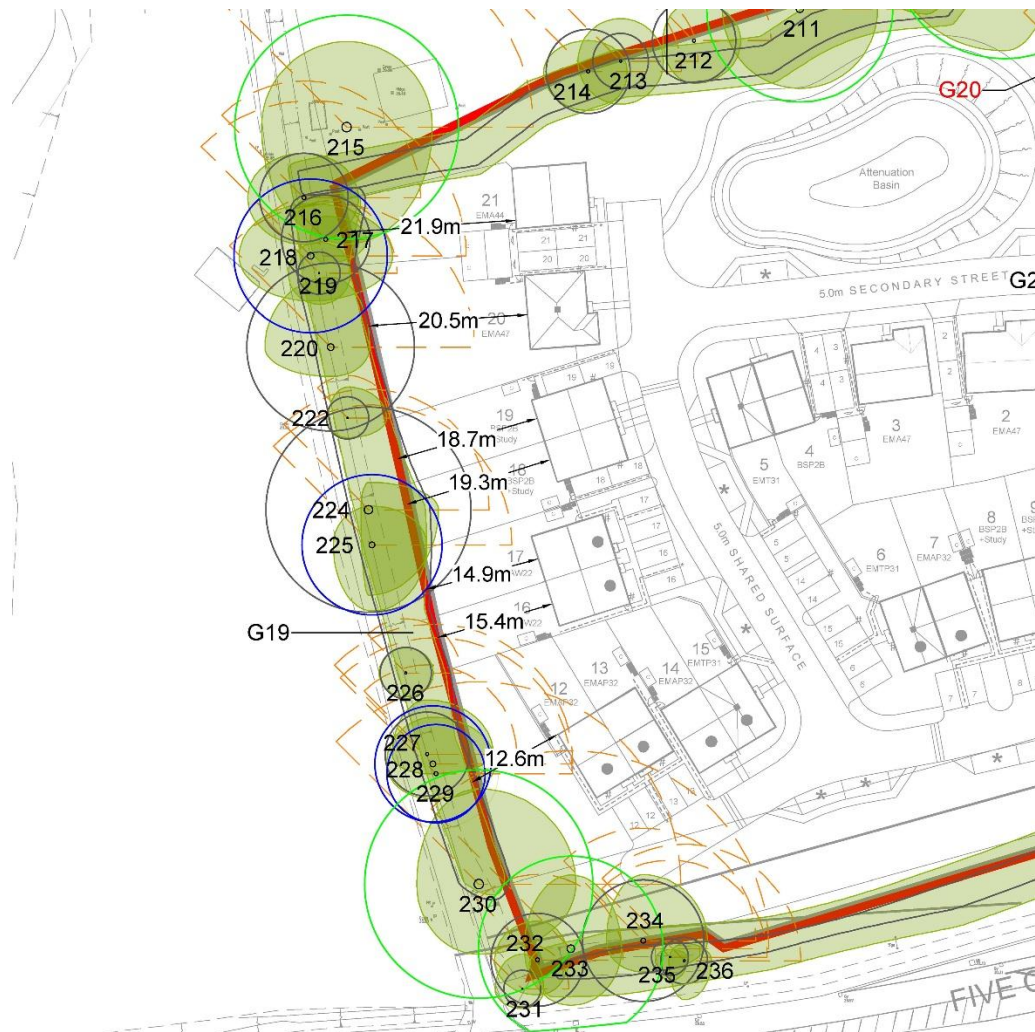
1.5.4 Figure 1. Plots 12 to 21 in relation to boundary trees T215 – T236.

- 1.5.3 Plots to the north (16 to 21) are also offset further from the boundary than proposed at outline stage and gardens have been configured to ensure there will be a degree of choice between receiving sunlight or oversailing canopy and tree shade. The provision of choice is therefore proof of a reasonable relationship; wherein future occupants will be unlikely to pursue unsympathetic or unreasonable tree works. The trees and hedgerow are also shown outside of private ownership. Figure 1 overleaf illustrates BS5837:2012 tree shade arcs from retained trees in relation to plots 12 to 21.

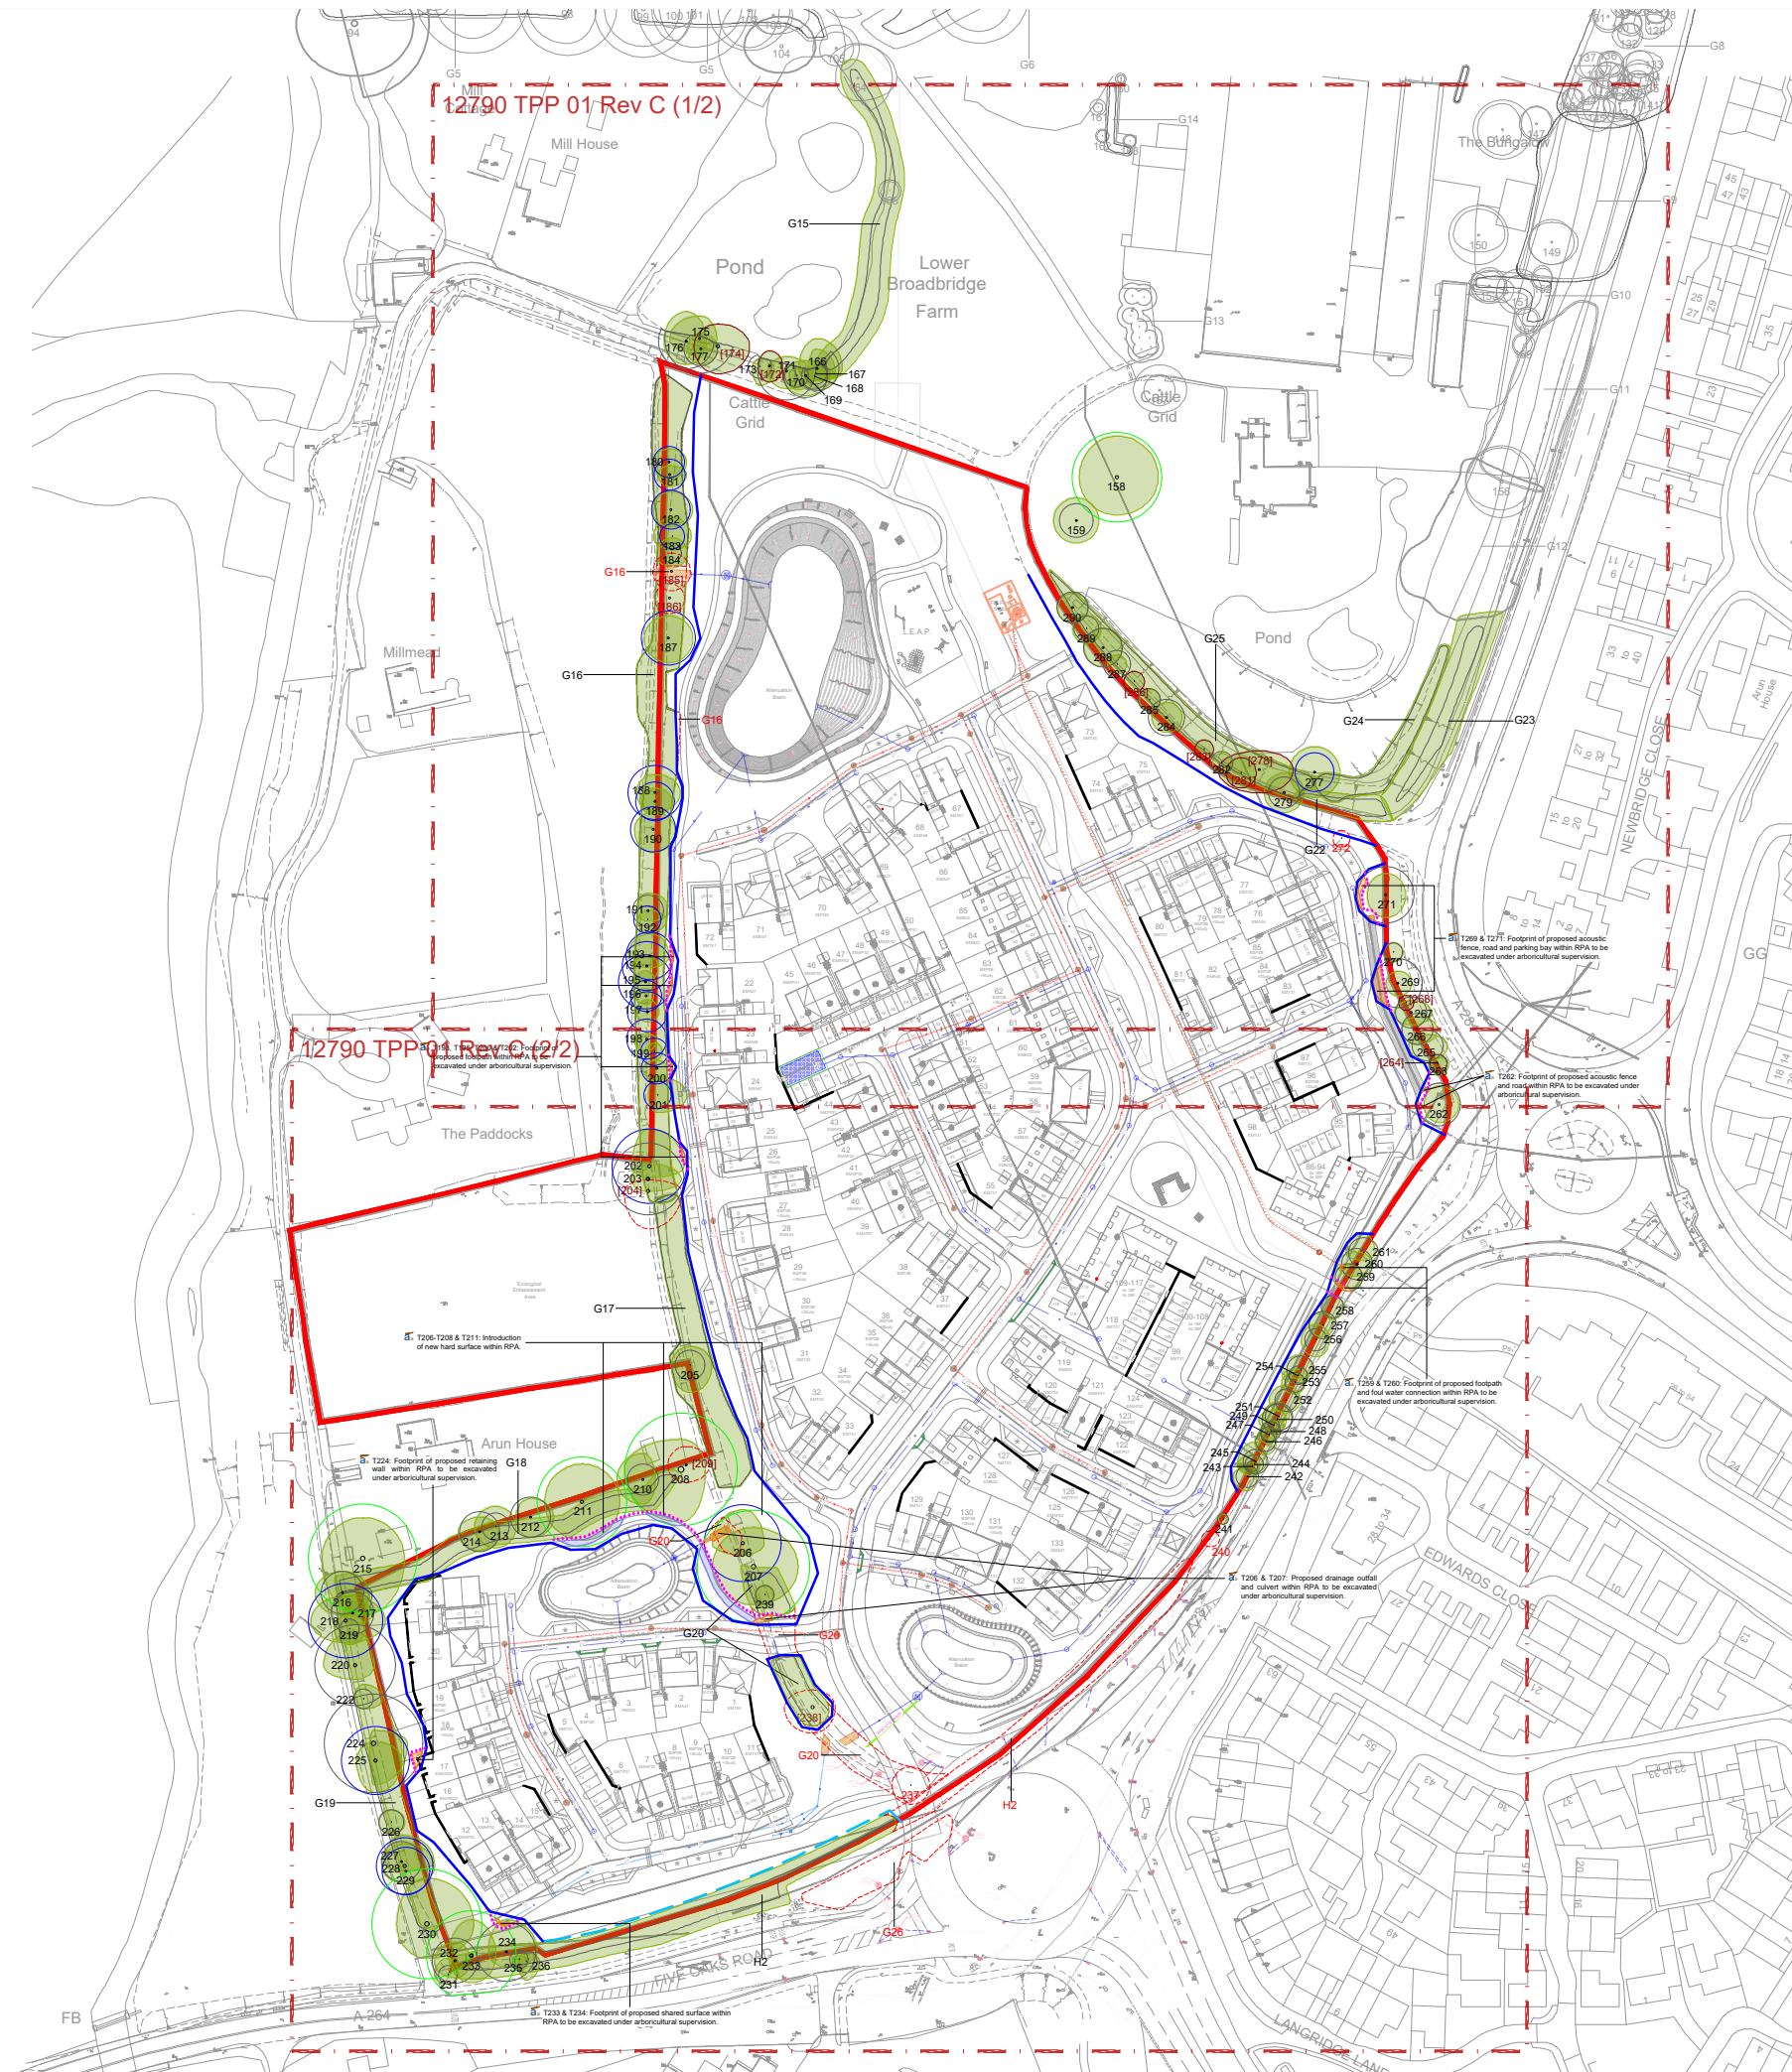
### TREE PROTECTION PLAN (12790 TPP 01 Rev C)

Note: The RPA footprint for Trees 164-177, 233, 245 & 250 have been displaced to allow for the effect of the adopted highway and existing watercourse. The surface area of the RPA has not been reduced.

- 2.4.1 Tree protection barriers are required to safeguard trees from damage during construction works. The specification for protective barriers which are to be installed is illustrated within the TPP at appendix A and as a technical sheet provided within appendix D. The location for protective barriers has been informed by retained trees' canopy extents, root protection areas (RPAs) and the presence of existing site features, with locations illustrated with a dark blue line within the TPP.

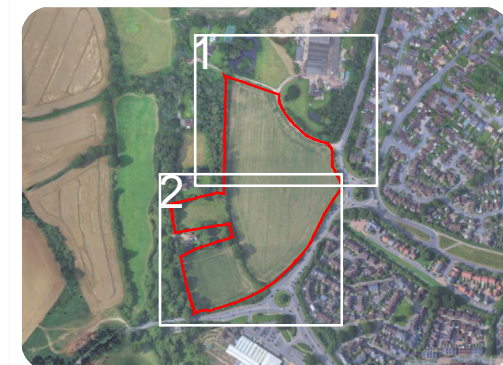
| DRAWING NUMBER<br>12790 TPP 01 Rev C (Overview) | | REVISION<br>C |

Note: Trees 160, 164, 167, 168, 177, 179, 181-183, 187, 190, 199-201, 205, 209, 210, 212, 213, 217, 231, 237, 239, 240, 241, 243, 245, 248, 251, 254, 264, 268, 270, 272, 280 have been plotted using measurements onsite in conjunction with aerial imagery. Their locations were not recorded on the topographical survey of the site (drawing ref: 1905017 - Lower Broadbridge Farm Broadbridge Heath Final.dwg).

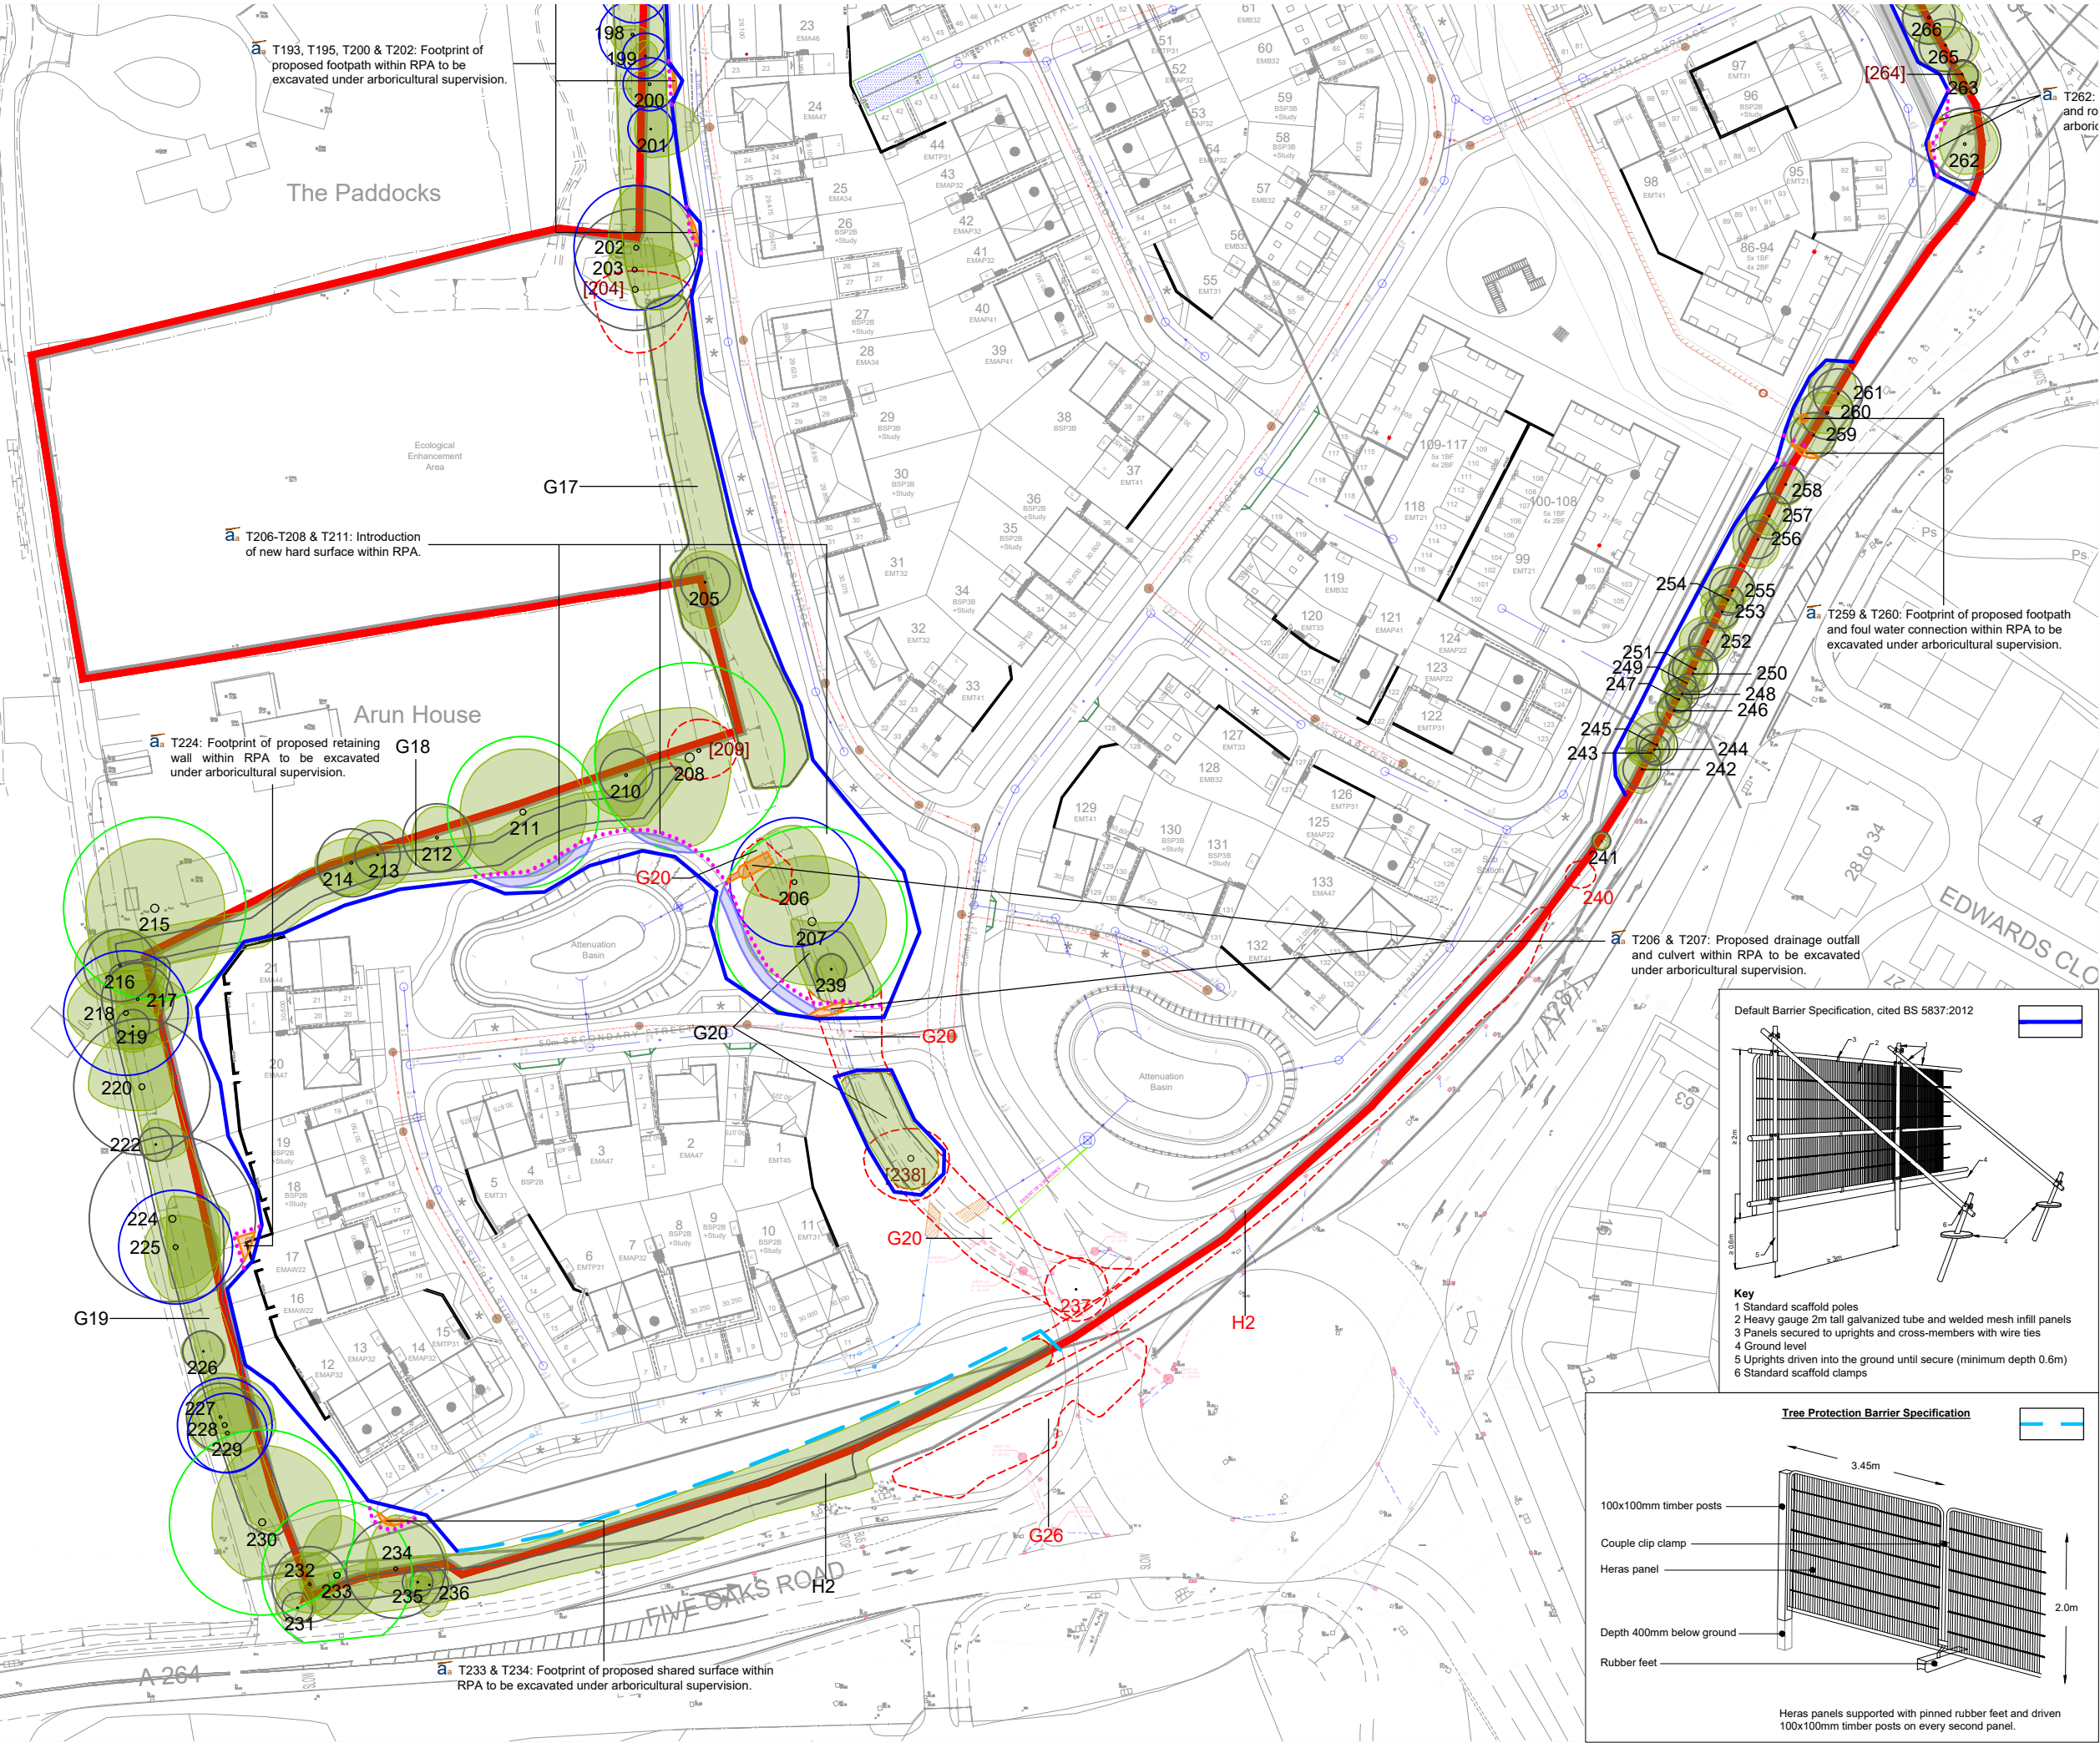
Note: The RPA footprint for Trees 164-177, 233, 245 & 250 have been displaced to allow for the effect of the adopted highway and existing watercourse. The surface area of the RPA has not been reduced.

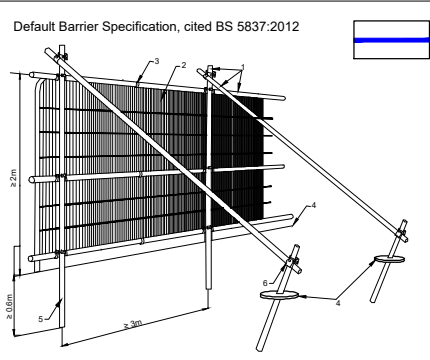
- Key**
- 1 Standard scaffold poles
  - 2 Heavy gauge 2m tall galvanized tube and welded mesh infill panels
  - 3 Panels secured to uprights and cross-members with wire ties
  - 4 Ground level
  - 5 Uprights driven into the ground until secure (minimum depth 0.6m)
  - 6 Standard scaffold clamps

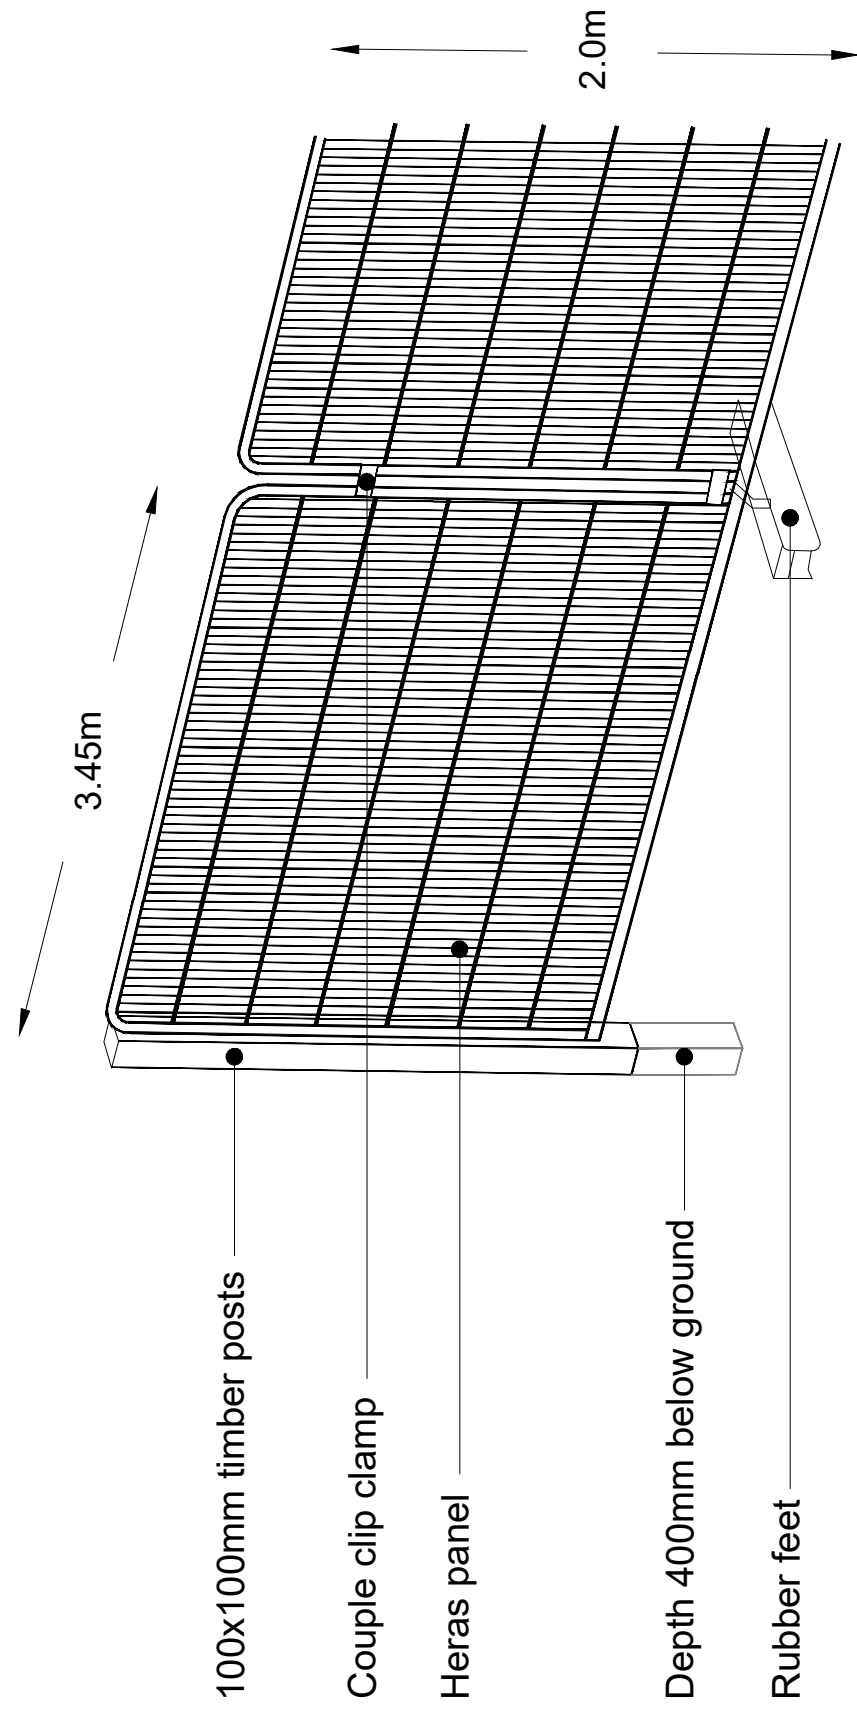
## Tree Protection Barrier Specification

Heras panels supported with pinned rubber feet and driven 100x100mm timber posts on every second panel.
