**MOWBRAY (FORMERLY LAND NORTH OF HORSHAM)**

**EMPLOYMENT ROAD (RMA2) – BS:5837 ARBORICULTURAL REPORT**

**DJA Reference:** 2898-2-17-TD-0001-S5-P1 Employment Road RMA2 AIA AMS

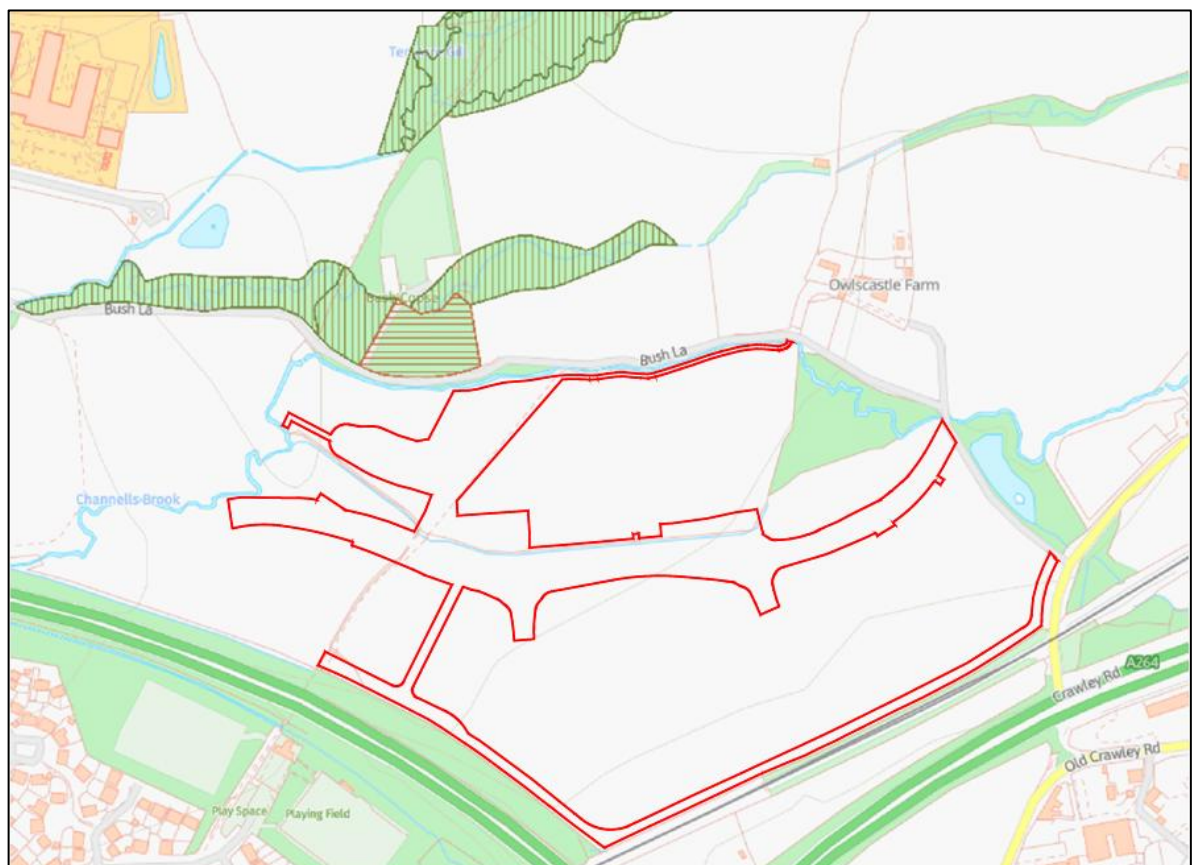
Figure 1 – MAGiC Map showing Ancient Woodland (green & red hatch) in relation to the Employment Road Site

- 4.3 Woodland beyond the northwest boundary of the site is recorded as Ancient Woodland.
- 4.4 For ancient woodlands, Government guidelines recommend a buffer zone of at least 15 metres from the boundary of the woodland. Where assessment shows other impacts are likely to extend beyond this distance, the proposal is likely to need a larger buffer zone.
- 4.5 The proposed new Employment Road and associated pathways are located over 15m from the woodland edge and therefore is outside of the Ancient Woodland Buffer Zone.

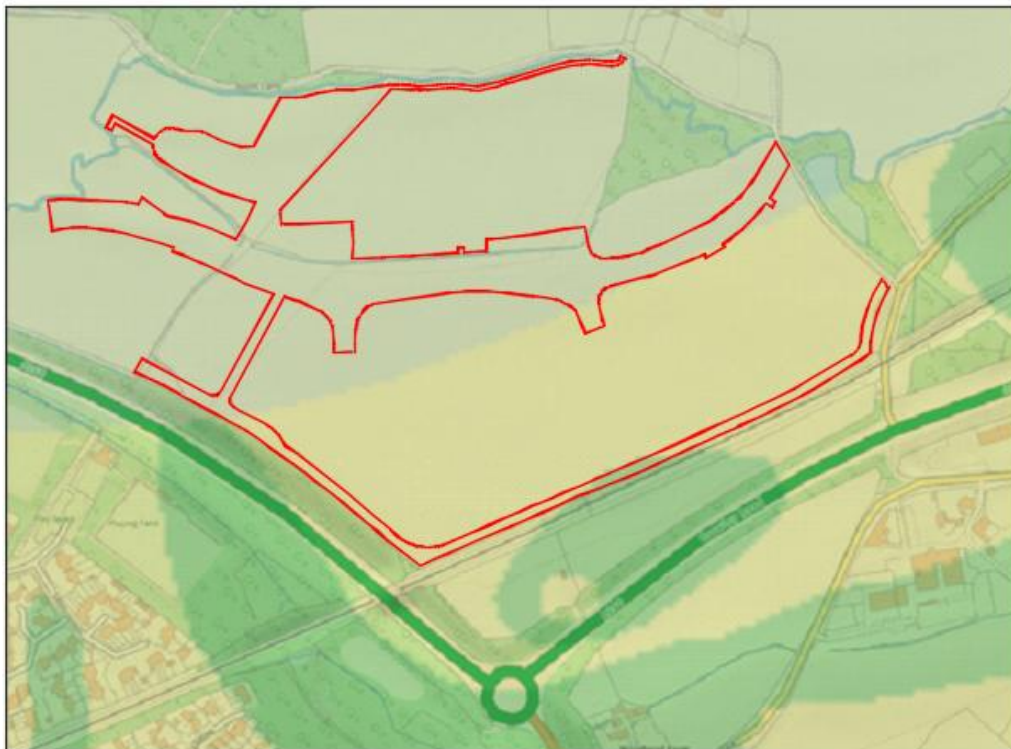
Figure 2 – BGS Geology Viewer Map

- 5.7 The British Geological Survey 1:50 000 scale bedrock geology description for this area is Weald Clay Formation to the north, and Upper Tunbridge Wells Sand to the south consisting of Sandstone and mudstone.

- 5.8 The soil in this area is therefore vulnerable to damage through compaction. Where clay is present, soil may be 'shrinkable' and may have some capacity to shrink and swell with changing moisture levels.
- 5.9 Due care must be taken to construct foundations to a depth sufficient to resist soil shrinkage through desiccation, taking into account the presence and future growth of the adjacent trees.

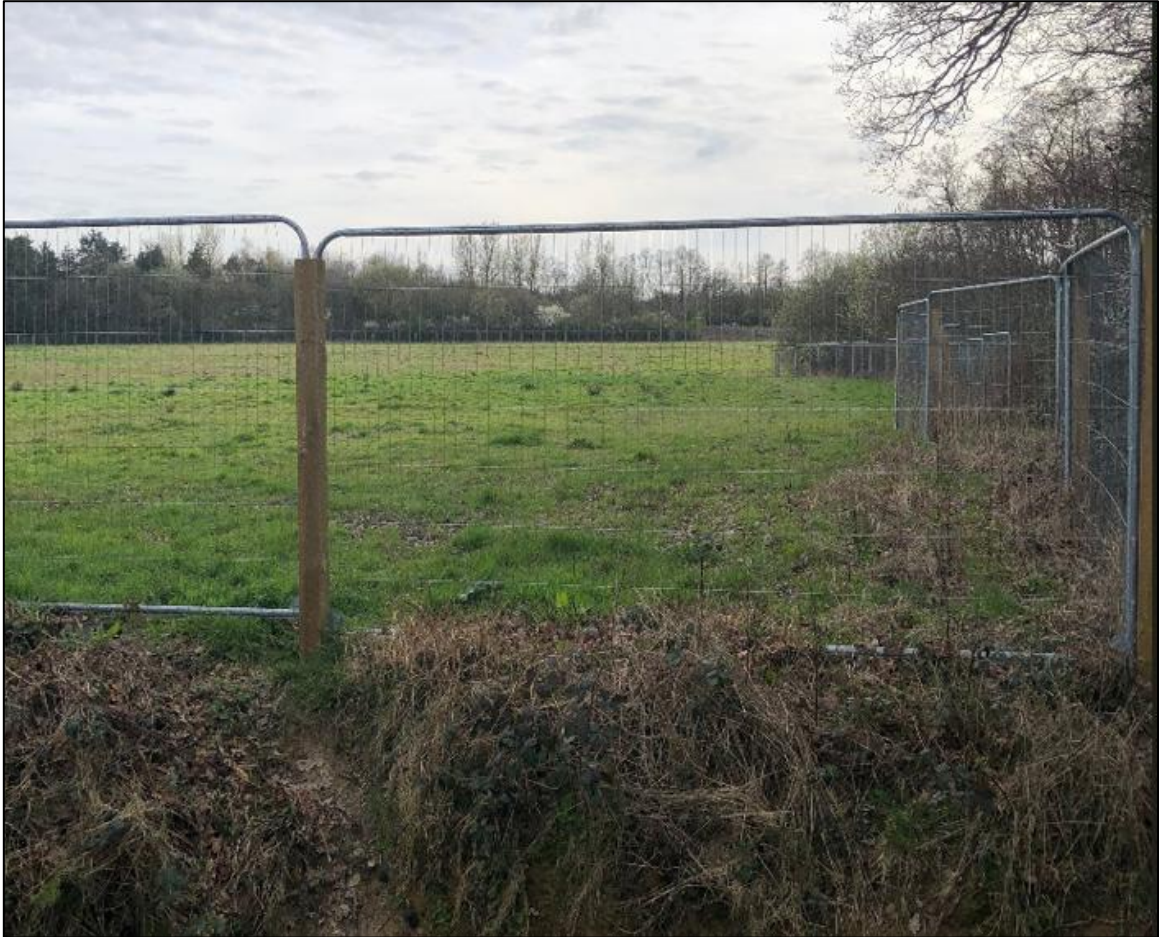
### Tree Protection Fencing<sup>3</sup>

<sup>3</sup> Tree protection fencing within the North Horsham Strategic Development Area will be formed Heras fence panels supported on wooden posts sunk into the ground. This style of fencing will reduce risk of injury to operatives with the installation of fencing near to over / underground services. The fencing will be robust and fit for purpose. Panels will be rigidly attached to the posts to prevent movement.

- 5.20 Where at risk of harm during the roadway construction, the rooting areas of the retained category 'A' and 'B' trees will be protected with fit for purpose Tree Protection Fencing set out as shown in the Tree Protection Plans and in accordance with BS:5837 (2012).
- 5.21 The Tree Protection Fencing will consist of Heras panels supported on vertical wooden posts. The fencing will be rigid to resist movement from work operatives and vehicle impact.
