## Crack and Level Monitoring

Job Reference: 10060204

Address: 30 Brushwood Road, Horsham, West Sussex, RH12 4PE

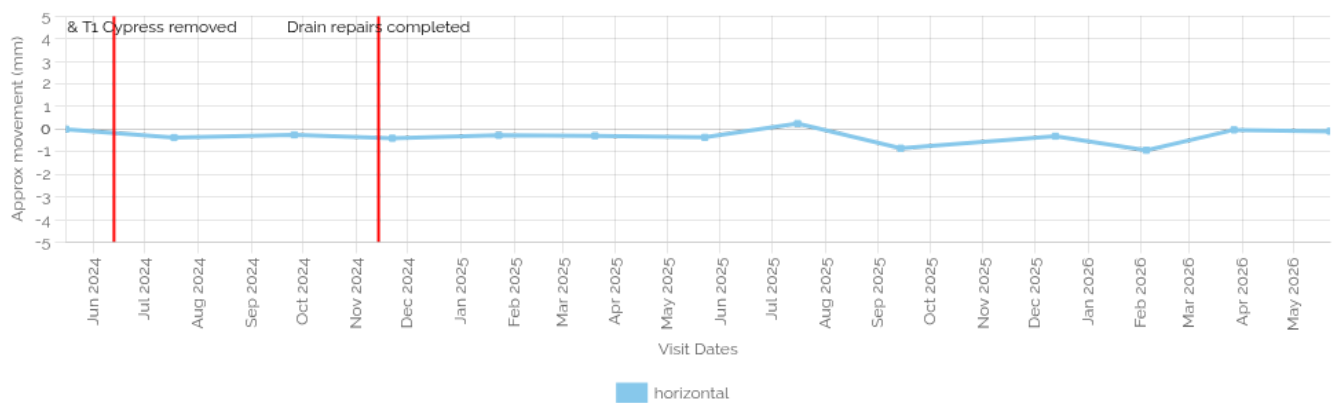
Int dining room below window - Visit #1

Int dining room below window - Crack Readings Differences (Displayed in Millimetres)

| | Visit 9 | Visit 10 | Visit 11 | Visit 12 | Visit 13 | Visit 14 | Visit 15 | Visit 16 |
|---|---|---|---|---|---|---|---|---|
| H | -0.84 | -0.31 | -0.93 | -0.03 | -0.09 | | | |

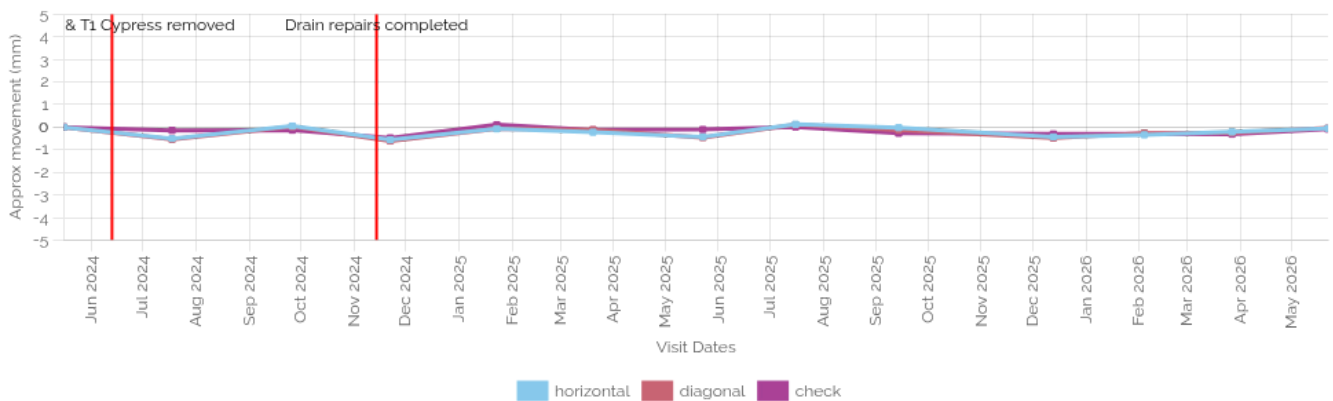
Int front left bedroom above door - Visit #1

Int front left bedroom above door - Crack Readings Differences (Displayed in Millimetres)

| | Visit 9 | Visit 10 | Visit 11 | Visit 12 | Visit 13 | Visit 14 | Visit 15 | Visit 16 |
|---|---|---|---|---|---|---|---|---|
| D | -0.13 | -0.48 | -0.26 | -0.25 | -0.04 | | | |
| C | -0.27 | -0.3 | -0.3 | -0.31 | -0.08 | | | |

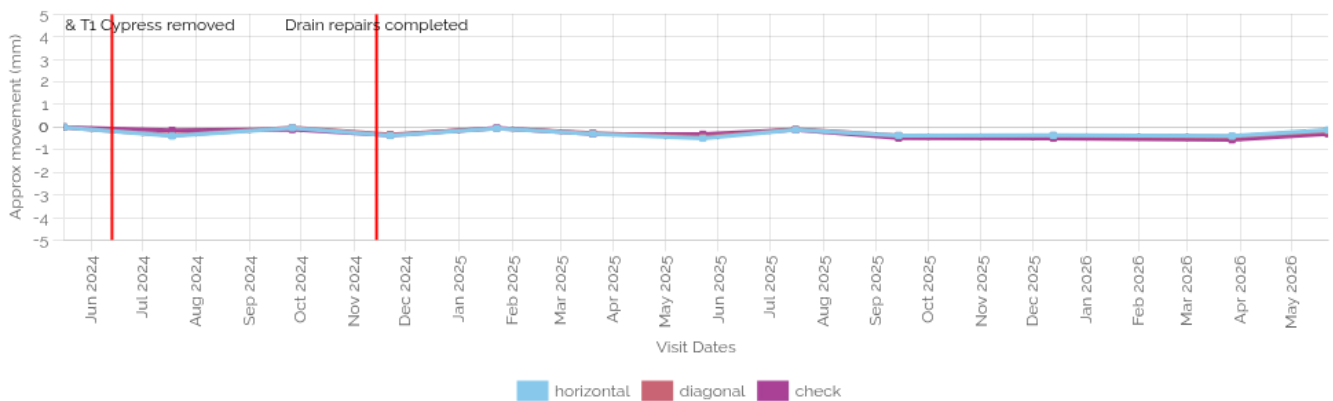
Int upstairs landing above rhs bedroom door - Visit #1

Int upstairs landing above rhs bedroom door - Crack Readings Differences (Displayed in Millimetres)

| | Visit 9 | Visit 10 | Visit 11 | Visit 12 | Visit 13 | Visit 14 | Visit 15 | Visit 16 |
|---|---|---|---|---|---|---|---|---|
| D | -0.37 | -0.37 | | -0.41 | -0.17 | | | |
| C | -0.48 | -0.49 | | -0.56 | -0.29 | | | |

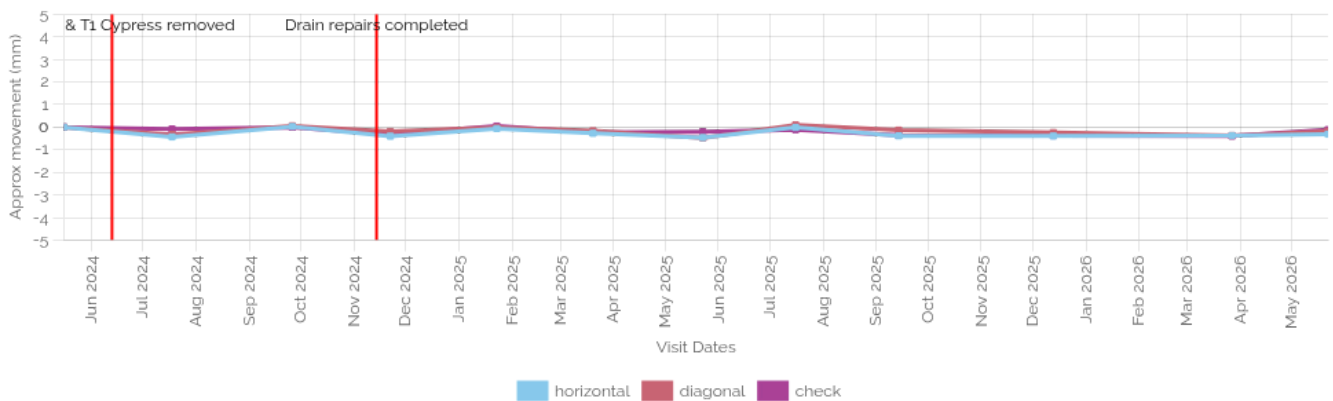
Int upstairs landing above bathroom door - Visit #1

Int upstairs landing above bathroom door - Crack Readings Differences (Displayed in Millimetres)

| | Visit 9 | Visit 10 | Visit 11 | Visit 12 | Visit 13 | Visit 14 | Visit 15 | Visit 16 |
|---|---|---|---|---|---|---|---|---|
| D | -0.13 | -0.24 | | -0.37 | -0.18 | | | |
| C | -0.36 | -0.37 | | -0.39 | -0.11 | | | |

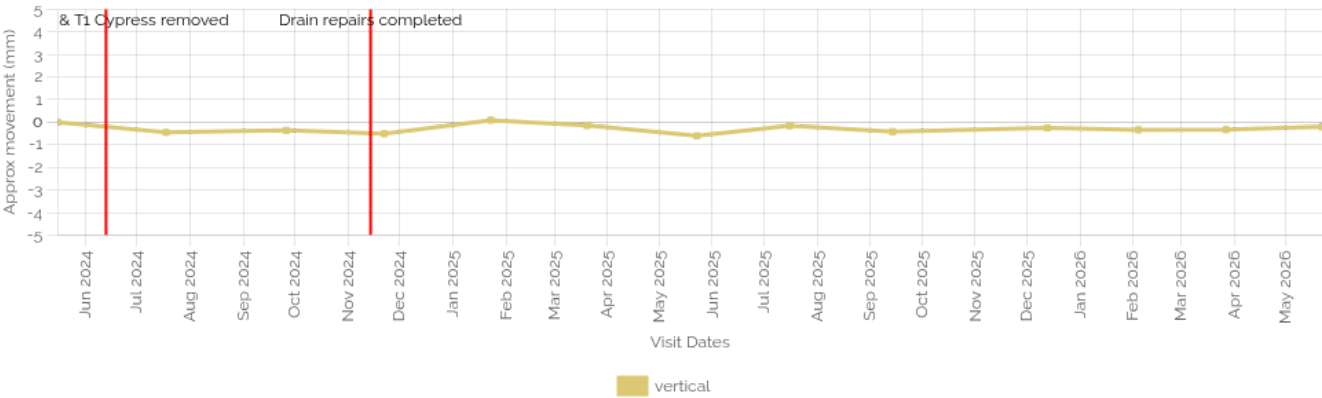
Int front hall above front door - Visit #1

Int front hall above front door - Crack Readings Differences (Displayed in Millimetres)

| | Visit 9 | Visit 10 | Visit 11 | Visit 12 | Visit 13 | Visit 14 | Visit 15 | Visit 16 |
|---|---|---|---|---|---|---|---|---|
| V | -0.42 | -0.25 | -0.34 | -0.33 | -0.21 | | | |
