SOUTH STREET ELEVATION (SIDE ELEVATION)

| PROJECT ADDRESS<br>Lloyds Bank<br>Horsham West St<br>1 West Street Horsham<br>West Sussex RH12 1PA | SCALE<br>A1 - 1:50<br>A3 - 1:100 |
| DRAWING DESCRIPTION<br>Side Elevation<br>Proposed Layout | DRAWN BY<br>PC |
| DRAWING NUMBER<br>50327300-MLA-CP-E2-M2-AR-7201 | REVISION<br>- |

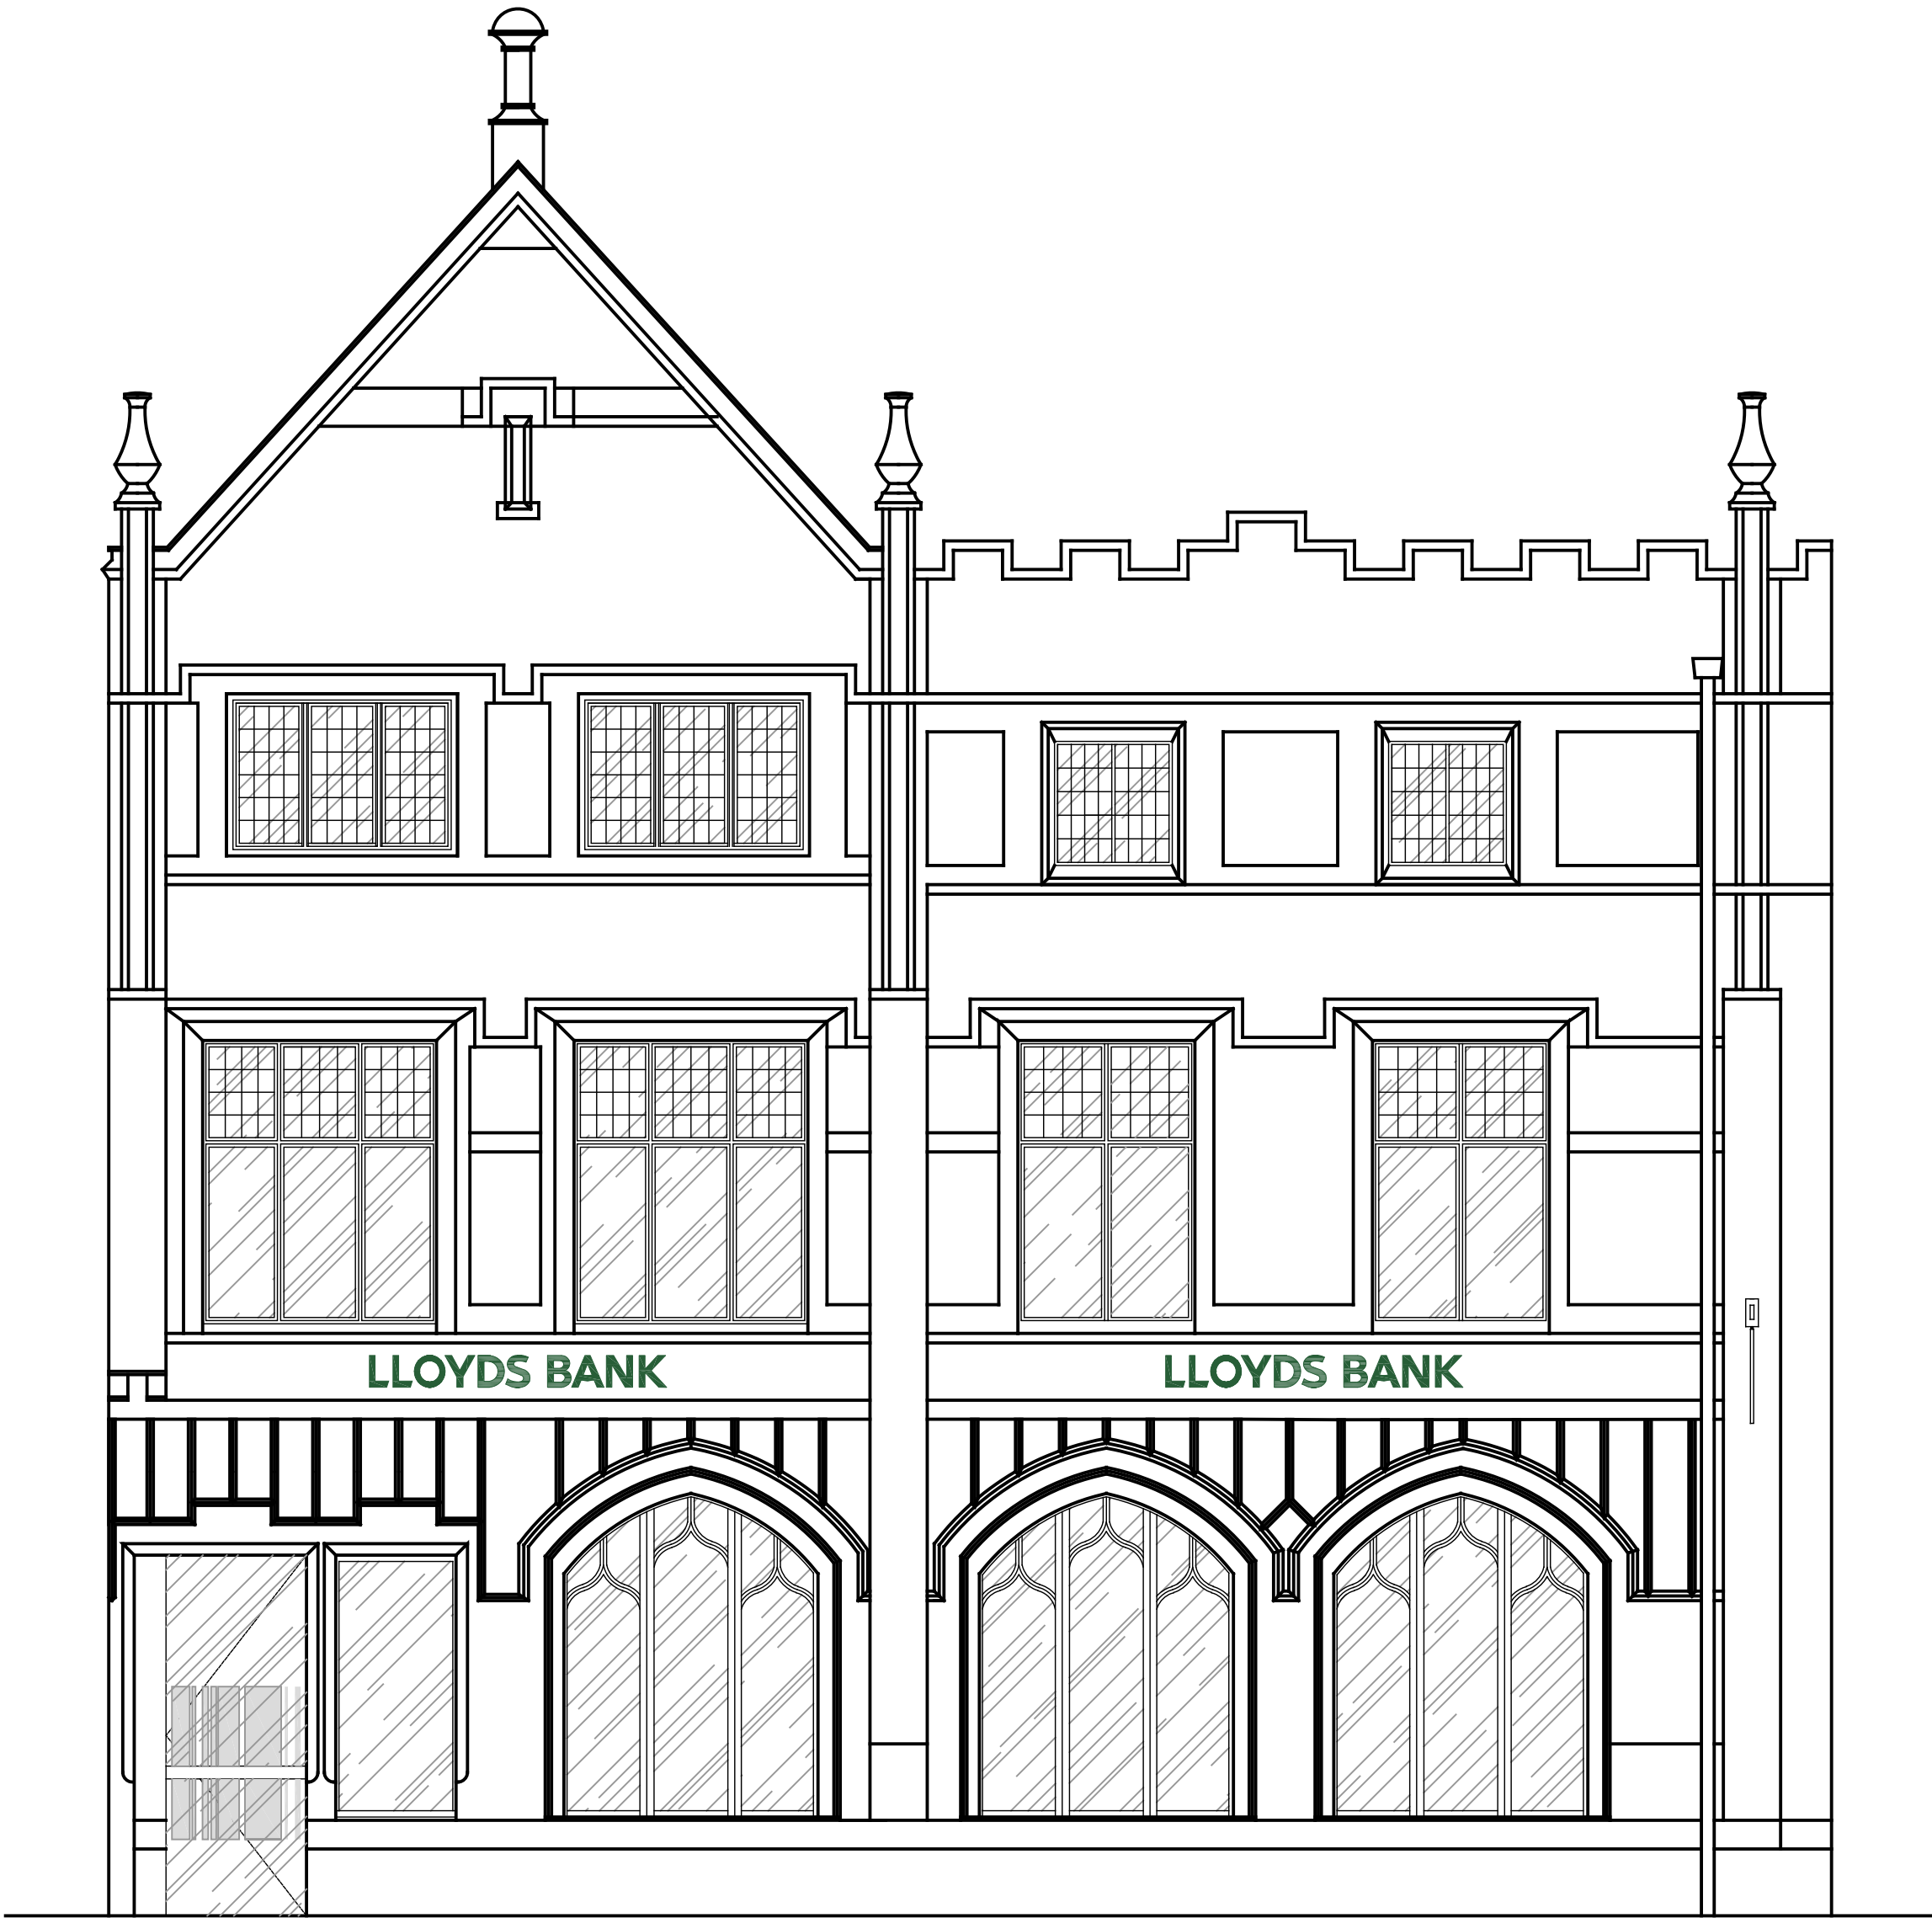
Side Elevation

- There are multiple open mortar joints across the elevations.
- Following scaffolding all open mortar joints across all elevations should be tap tested and all loose and defective mortar joints should be removed and filled in with a suitable lime based mortar to match existing.

- All stonework should be cleaned via a DOFF cleaning system or similar.
- Stone cleaning should also include the stone on the chimney stack.
- Following stone cleaning works the stone should be repaired where spalled.

- Following access the bricks should be repaired where previous fixings are evident.
- Areas to concentrate on are visualized within appendix C however this is not a complete list and the site team are to establish wider areas of brick repairs following commencement of the works.

- Where the windows show signs of corrosion this should be rubbed down and treated with a corrosion inhibitor.
- The window putty should be inspected following access and loose and defective putty should be removed and replaced to match existing.

- Following repair works all windows on the side elevation are to be redecorated to match existing (Includes window repairs).
- Replace the cracked window pane.
