# HERITAGE IMPACT ASSESSMENT **7 MARKET SQUARE**

Report Carried out by J Knowles ARB RIBA of BOND Architecture Ltd

This is an assessment for the property 7 Market Square, Horsham, RH12 1EU in relation to the proposed works to be carried out on the existing roof covering.

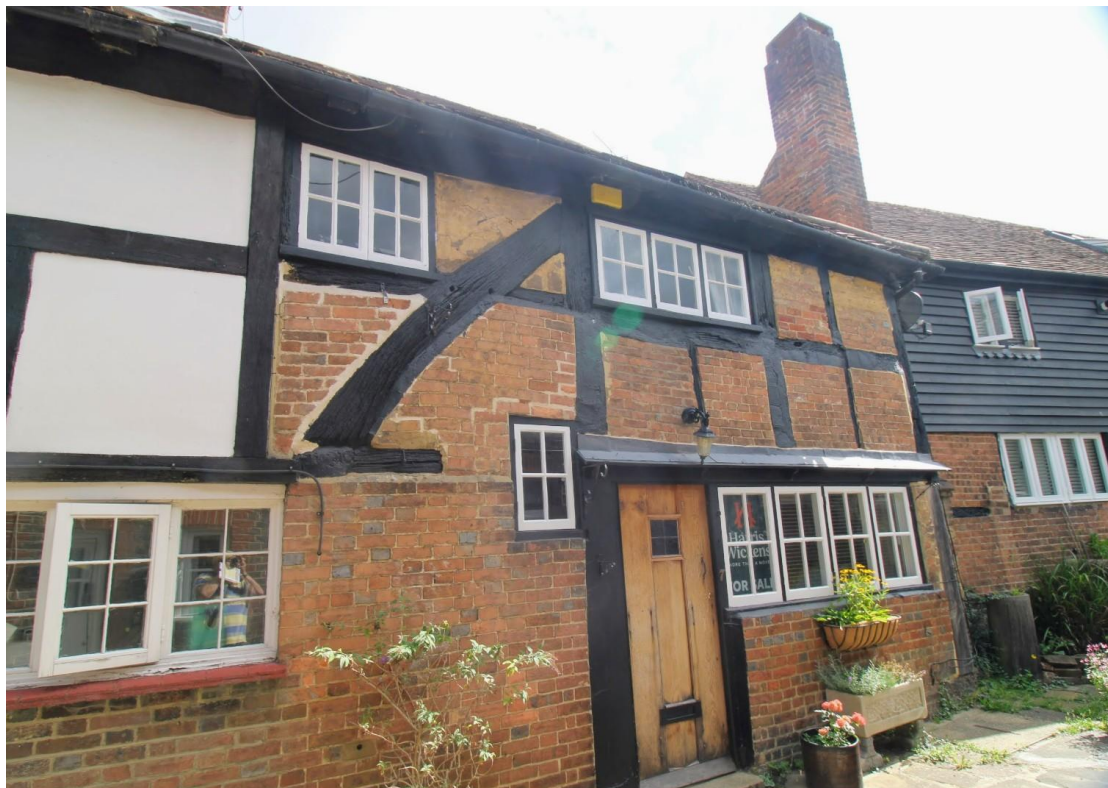
2. Said to be the outbuildings of the former Anchor Hotel, forming a yard now called Talbot Lane. Single range runs south-east from the back of No 6. Probably C16 with later alterations. 2 storeys. Timber-framed with red brick and grey headers and some plaster infilling above. 1 curved brace on 1st floor. Tiled roof. Overhanging eaves with exposed rafter ends. 6 windows. All casements of varying sizes, glazing bars mostly intact. To the east and slightly set back from Talbot Lane is a further half-timbered building with red brick infilling. 2 storeys. 1 asymmetrically placed window. Further east still and projecting into the Lane is No 8 Market Square. Timber-framing can now be seen only in west gable at the side. The south front has been refaced with red brick and grey headers. Overhanging eaves with exposed rafter ends.

A shorter range runs east on south side of Talbot Lane, from the back of No 10. Half-timbered building with painted brick infilling. 2 storeys. Tiled roof. Overhanging eaves with exposed rafter ends. 3 windows, a mixture of casements and sashes, glazing bars missing.

The principal range runs south-east from the rear of No. 6 Market Square. It is considered to be probably 16th century, with later alterations. It is a two-storey, timber-framed building with red-brick noggings and plaster infilling and a tiled roof.
